Project #: 13916

**ASBESTOS ASSESSMENT
Doyle House
Memorial University of Newfoundland
St. John's, NL**

August 2011

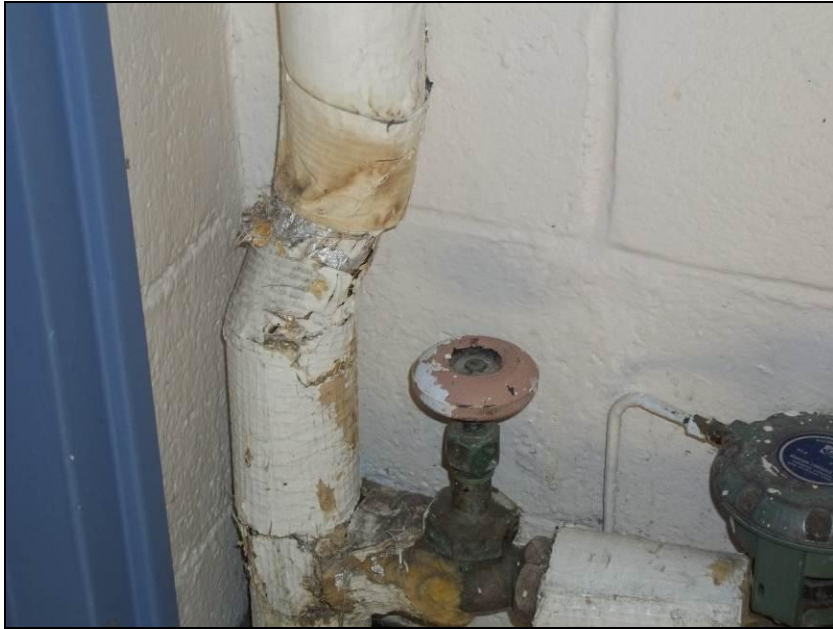
Pipe fitting insulation which could potentially contain asbestos was observed in select areas throughout the building during this assessment. Samples were collected and analyzed for asbestos content using the PLM method of detection and found to contain 15% Chrysotile asbestos (see sample DO-12 in Appendix II, Photographs 1-4, Appendix I)

Photograph 1: Pipe fitting insulation in the Corridor DO3C01, in poor condition.

- All materials listed in fair and/or poor condition are to be repaired or removed immediately. See APPENDIX III – Asbestos Building Survey Information for materials condition and locations.

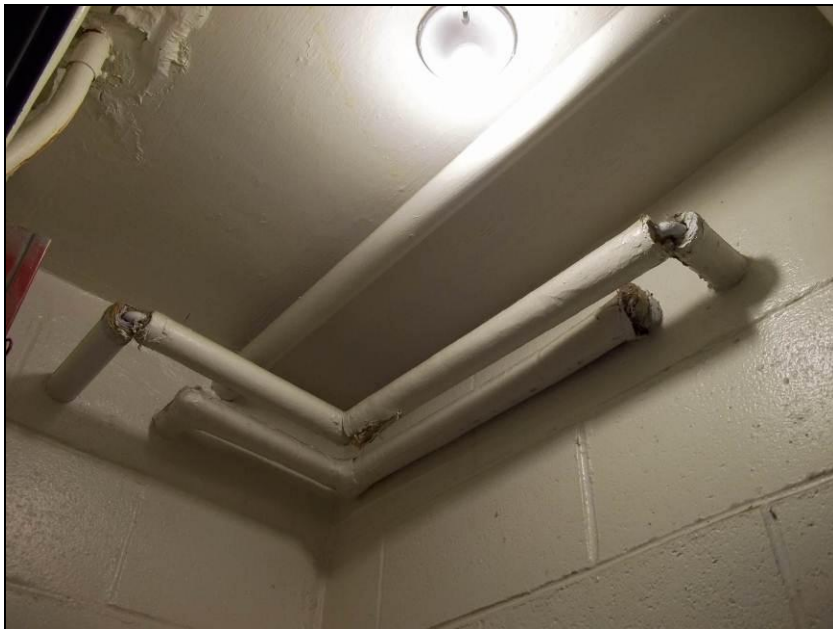
Photograph 2: Pipe fitting insulation in Room DO216, in poor condition.

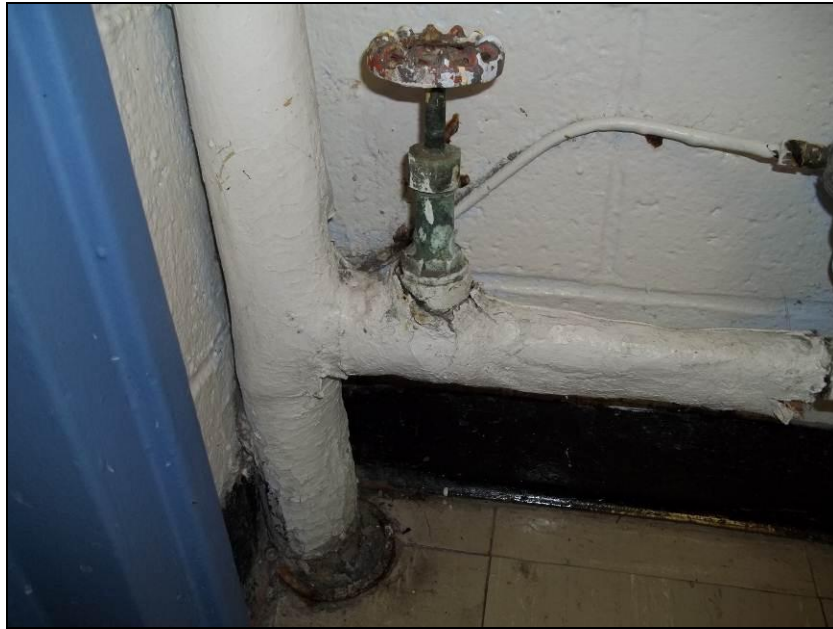
Photograph 3: Pipe fitting insulation in Room DO216, in poor condition.

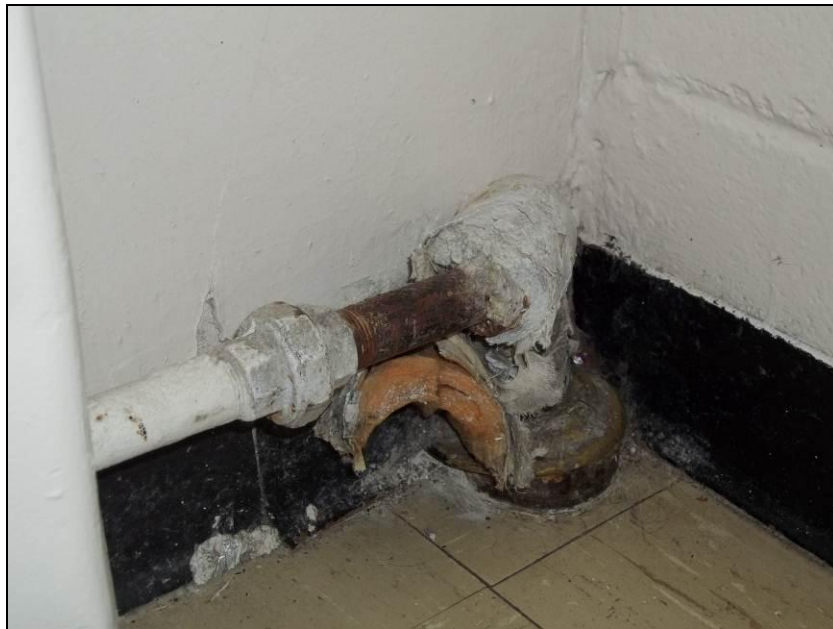
Photograph 4: Pipe fitting insulation in Corridor DO4C01, in poor condition.

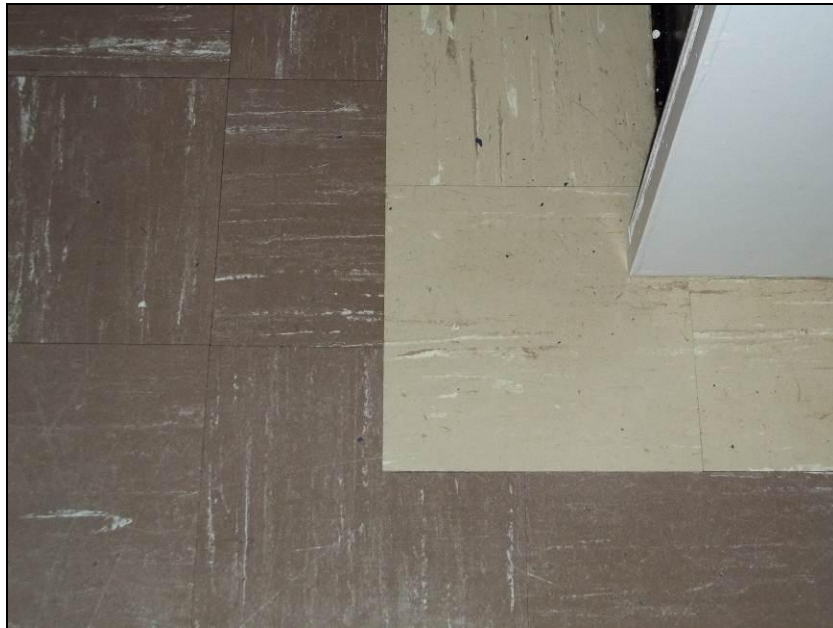
Two (2) samples of 9" x 9" vinyl floor tiles were sampled and analyzed for asbestos content using the PLM method of detection. Both of the samples were identified as containing 2 % Chrysotile asbestos. Their associated mastics were identified as non-asbestos containing. (See samples DO-4, DO-5, in Appendix II, Photographs 5, 6, Appendix I)

Photograph 5: Samples DO-4 (dark brown) and DO-5 (light brown), as found and sampled from Room DO108.

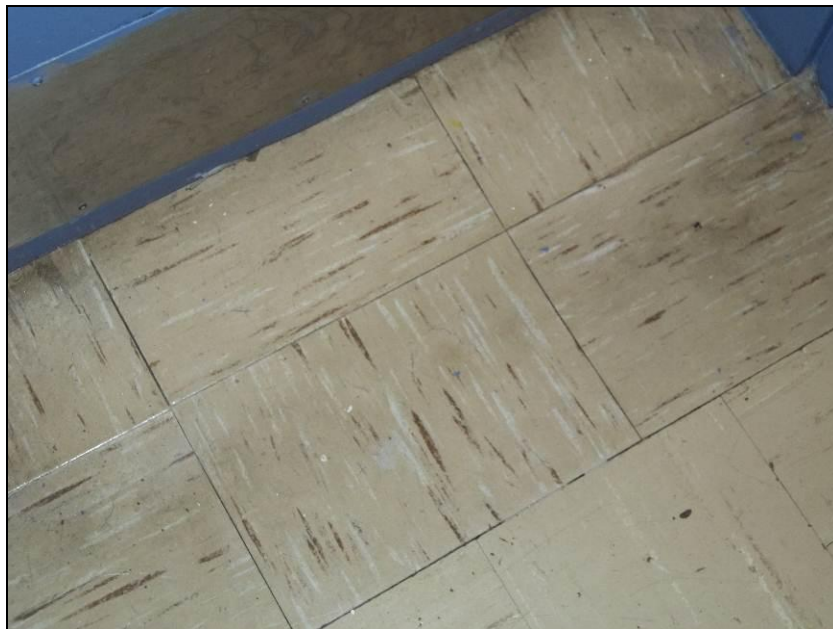
Photograph 6: Sample DO-10 as found in Corridor DO1C03, outside of Room DO104.

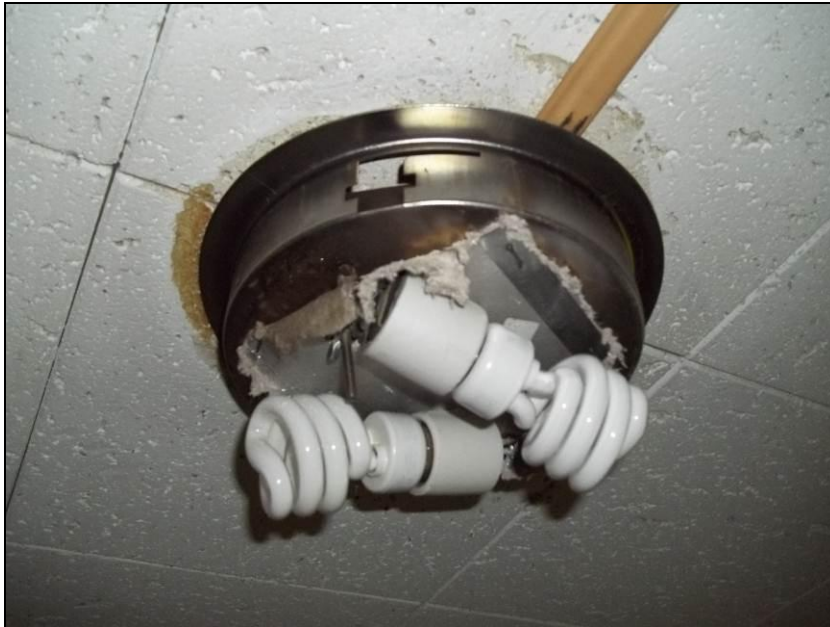
One type of a light fixture heat shield was observed throughout the building. A sample was collected and analyzed for asbestos content using the PLM method of detection, this sample was found to contain 20% Chrysotile asbestos (see samples DO-13 in Appendix II, see Photograph 7 in Appendix I).

Photograph 7: Sample DO-13 as found in Room DO111. Light fixture heat shield in poor condition.

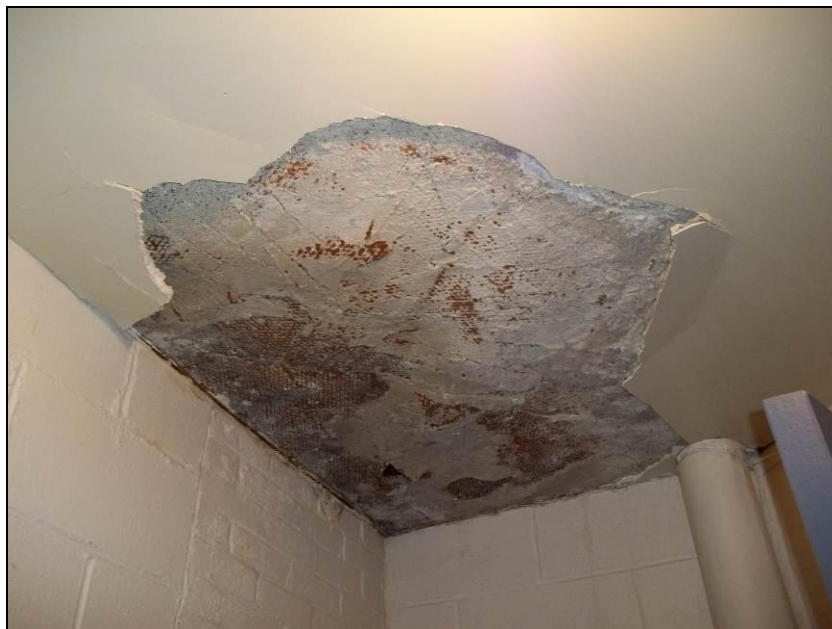
Plaster finishes were observed throughout the building during the assessment. Six (6) samples of this material were sampled and analyzed for asbestos content using the PLM method of detection. One (1) sample was found to contain 2% Chrysotile asbestos. (See samples DO-14, DO-16, DO-17, DO-18, DO-19, DO-20, DO-21, in Appendix II, see Photograph 8 in Appendix I).

It should be noted that due to the uncertainty of when and where a specific type of plaster was used, it is to be assumed that all plaster present in the building contains asbestos.

Photograph 8: Sample DO-21, as found in Room DO409. The plaster is in poor condition.

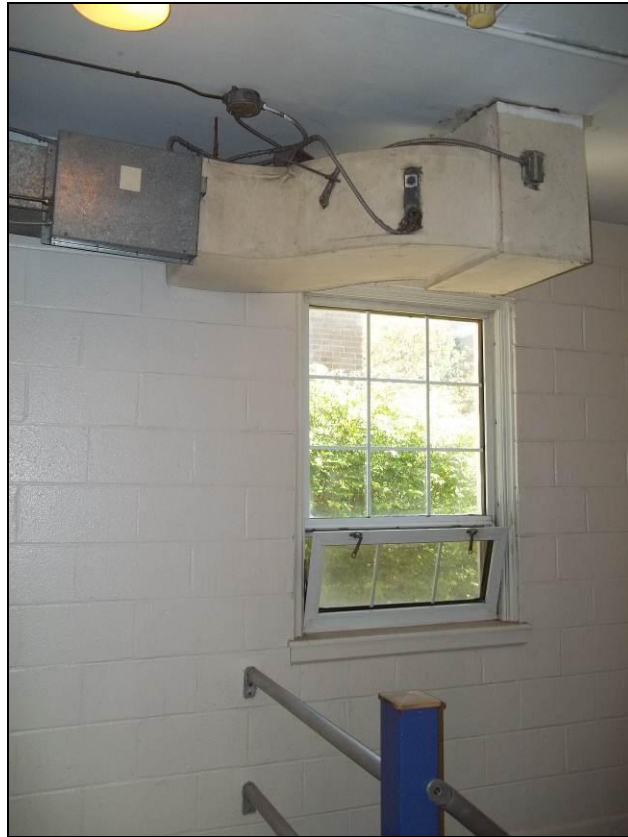
An insulated duct unit was observed at ceiling height in the stairway DO1S03. This duct was inaccessible for sampling due to height and safety restrictions. As such, the duct must be considered to be asbestos containing until proven otherwise. (see Photograph 9, Appendix I)

Photograph 9: Insulation duct located above a stairway of DO1S03. The duct was not accessible for sampling. As such it must be considered to be asbestos containing until proven otherwise.
