# ASBESTOS AND LEAD PAINT BUILDING MATERIALS SURVEY 208 ELIZABETH AVENUE MEMORIAL UNIVERSITY OF NEWFOUNDLAND

Pinchin LeBlanc Environmental Ltd Project No. 02-02-00900

March, 2013

BUILDING DESCRIPTION: 208 ELIZABETH AVENUE

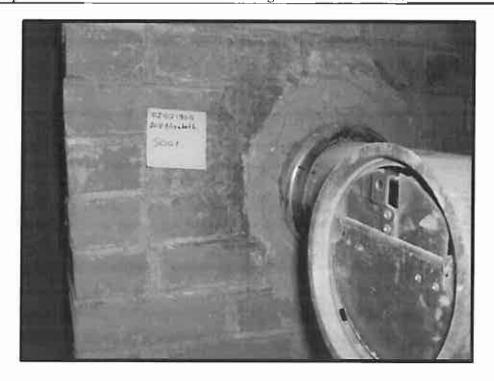
One (1) sample of the mechanical insulation was collected on the furnace chimney. Analysis of this sample did not identify the presence of asbestos (reference sample 02-02-900-S001).

<u> </u>				
Sample #:	S001	Date Sampled:	August 24, 2012		
Building:	208 Elizabeth Ave	nue Sampler:	Trent Hardy		
Location:	001, basement	Analysis:	SAI - PLM		
MUN Project #:	02-02-900	Work Order #:			
		<b>Bulk Sampling Parameters</b>			
Pipe/Tank	Flooring	Ceiling	Roofing	Location	
☐ Insulation	□12'x12' Tile	☐ Textured	☐ Shingle	☐ Floor	
□ Elbow	☐ 9'x9'Tile	☐ Stucco	☐ Rolled	☐ Wall Orientation	
☐ Fitting	□ Vinyl Sheet	□ Popcom	☐ Felt	☐ Ceiling	
☐ Transite Pipe	☐ Mastic	□ DWJC	☐ Tar	☐ Above Ceiling	
☐ Gasket	Wall	☐ Plaster		X Other (chimney)	
☐ Tank Insulation	☐ Transite Panel	☐ Acoustic Tile (Dropped)			
☐ Pipe Wrap	☐ Textured Wall	☐ Acoustic Tile (Glued-on)			
HVAC	☐ Plaster	☐ Mastic	Miscellaneous:	Insulation on	
IIVAC		□ Iviastic	furnace chimne	<u>y</u>	
☐ Insulation	□ DWJC	Structural			
□ Tape		☐ Steel F. P. ing	No. of Phases:		
☐ Paper Wrap		Deck F. P. ing	Colour:

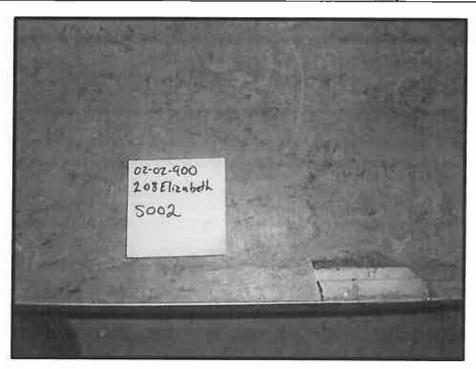
Sample #:	S002		Date Sampled:	August 24, 2012	2
Building:	208 Elizabeth Aver	nue	Sampler:	Trent Hardy	
Location:	002, central stairwe	ell:	Analysis:	SAI - PLM	
MUN Project #:	02-02-900		Work Order #:		
		Bulk	Sampling Parameters		
Pipe/Tank	Flooring		Ceiling	Roofing	Location
☐ Insulation	□12'x12' Tile	T	`extured	☐ Shingle	X Floor
□ Elbow	□ 9'x9'Tile	$\square$ S	tucco	☐ Rolled	☐ Wall Orientation
☐ Fitting	X Vinyl Sheet	$\square$ P	орсот	☐ Felt	☐ Ceiling
☐ Transite Pipe	☐ Mastic		)ŴJC	□ Таг	☐ Above Ceiling
☐ Gasket	Wall	$\square$ P	laster		□ Other
☐ Tank Insulation	Transite Panel	$\Box$ A	coustic Tile (Dropped)		
☐ Pipe Wrap	☐ Textured Wall		coustic Tile (Glued-on)		
HVAC	☐ Plaster	$\square N$	flastic	Miscellaneous:	
☐ Insulation	□ DWJC		Structural		
☐ Tape			teel F. P. ing	No. of Phases:	
☐ Paper Wrap		□ D	Peck F. P. ing	Colour: Grey w	ith blue and cream

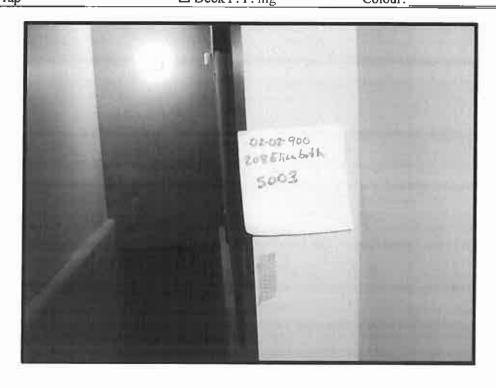
UNIVERSIT	Y					
Sample #:	S003		Date Sampled:	August 24, 2012		
Building:	208 Elizabeth Aver	ıue	Sampler:	Trent Hardy		
Location:	003, west stairwell		Analysis:	SAI - PLM		
MUN Project #:	02-02-900		Work Order #:			
		Bulk	Sampling Parameters			
Pipe/Tank	Flooring		Ceiling	Roofing	Location	
☐ Insulation	□12'x12' Tile	☐ Textured		□ Shingle	☐ Floor	
□ Elbow	□ 9'x9'Tile	☐ Stucco		☐ Rolled	X Wall Orientation	
☐ Fitting	□ Vinyl Sheet	$\square$ P	opcom	☐ Felt	☐ Ceiling	
☐ Transite Pipe	☐ Mastic		)ŴJC	☐ Tar	☐ Above Ceiling	
☐ Gasket	Wall	$\square$ P	laster		☐ Other	
☐ Tank Insulation	☐ Transite Panel		(Coustic Tile (Dropped)			
☐ Pipe Wrap	☐ Textured Wall		coustic Tile (Glued-on)			
HVAC	☐ Plaster	$\square$ N	1astic	Miscellaneous:		
☐ Insulation	X DWJC		Structural			
☐ Tape		$\square$ S	teel F. P. ing	No. of Phases:		
Paper Wran			leck F P ing	Colour	<del></del>

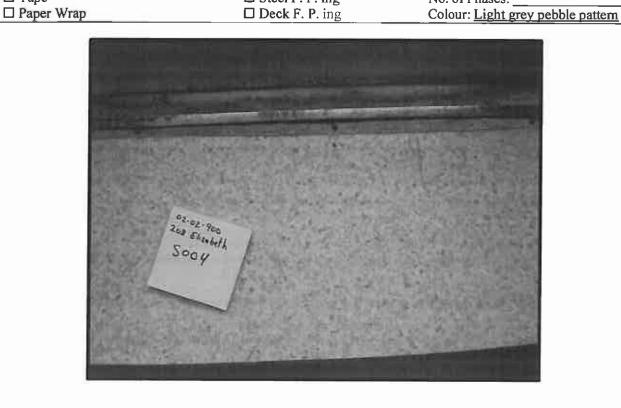
MEMORIA UNIVERSIT		ASE	BESTOS BULK	SAN	IPLING F	ORM	
Sample #:	S004		Date Sampled:		August 24, 201	2	
Building:	208 Elizabeth Ave	208 Elizabeth Avenue		- 1	Trent Hardy		
Location:	004, rear porch		Analysis:		SAI - PLM		
MUN Project #:	02-02-900		Work Order #:				
		Bulk	Sampling Parameter	rs			
Pipe/Tank	Flooring		Ceiling		Roofing	Location	
☐ Insulation	□12'x12' Tile		`extured		☐ Shingle	X Floor	
☐ Elbow	□ 9'x9'Tile		tucco		☐ Rolled	☐ Wall Orientation	
☐ Fitting	X Vinyl Sheet	□F	opcom		☐ Felt	☐ Ceiling	
☐ Transite Pipe	☐ Mastic		)WJC		☐ Tar	☐ Above Ceiling

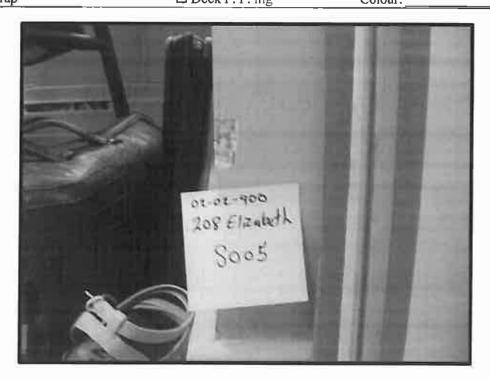
Four (4) samples of drywall joint compound were collected in the Site Building. Results from two (2) of the four (4) samples collected contain 3% Chrysotile asbestos (reference samples 02-02-900-S005, and 02-02-900-S006).

Sample #:	S005		Date Sampled:	August 24, 2012				
Building:	208 Elizabeth Avenue		Sampler:	Trent Hardy				
Location:	006, room 2000		Analysis:	SAI - PLM				
MUN Project #:	02-02-900		Work Order #:					
Bulk Sampling Parameters								
Pipe/Tank	Flooring		Ceiling	Roofing	Location			
☐ Insulation	□12'x12' Tile	☐ Textured		☐ Shingle	☐ Floor			
□ Elbow	□ 9'x9'Tile	☐ Stucco		□ Rolled	X Wall Orientation			
☐ Fitting	□ Vinyl Sheet	☐ Popcorn		☐ Felt	☐ Ceiling			
☐ Transite Pipe	☐ Mastic	□ DŴJC		☐ Tar	☐ Above Ceiling			
☐ Gasket	Wall	$\Box$ F	laster		☐ Other			
☐ Tank Insulation	☐ Transite Panel	$\Box A$	Acoustic Tile (Dropped)					
☐ Pipe Wrap	□ Textured Wall		Acoustic Tile (Glued-on)					
HVAC	☐ Plaster	☐ Mastic		Miscellaneous:				
☐ Insulation	X DWJC		Structural					
□ Tape			teel F. P. ing	No. of Phases:				
□ Paper Wrap			leck F P ing	Colour

1. Under the NL guidance documents for moderate and low risk asbestos abatement procedures, quantities of these materials within an enclosure exceeding 100 ft<sup>2</sup> should be removed using Type III (high risk) asbestos abatement procedures. Quantities less than 100 ft<sup>2</sup> but exceeding 10ft<sup>2</sup> should be removed using Type II (moderate risk) asbestos abatement procedures, while quantities less than 10 ft<sup>2</sup> should be removed using Type I (low risk) asbestos abatement procedures.

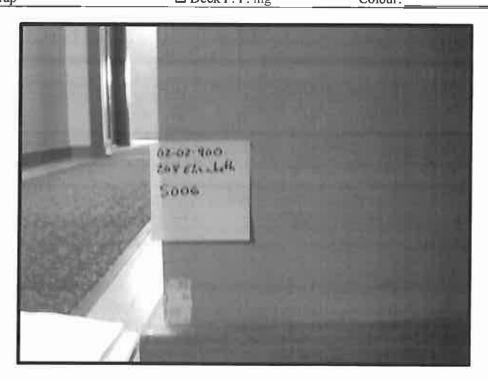
Sample #:	S006		Date Sampled:	August 24, 2012				
Building:	208 Elizabeth Avenue		Sampler:	Trent Hardy				
Location:	007, hallway 2C01		Analysis:	SAI - PLM				
MUN Project #:	02-02-900		Work Order #:					
	Bulk Sampling Parameters							
Pipe/Tank	Flooring		Ceiling	Roofing	Location			
☐ Insulation	□12'x12' Tile	ΠI	`extured	☐ Shingle	☐ Floor			
□ Elbow	□ 9'x9'Tile	☐ Stucco		□ Rolled	X Wall Orientation			
☐ Fitting	□ Vinyl Sheet	□ Popcorn		☐ Felt	☐ Ceiling			
☐ Transite Pipe	☐ Mastic	□ DWJC		□ Tar	☐ Above Ceiling			
☐ Gasket	Wall	$\square$ P	laster		□ Other			
☐ Tank Insulation	☐ Transite Panel	$\Box$ A	(Coustic Tile (Dropped)					
☐ Pipe Wrap	☐ Textured Wall	$\Box A$	coustic Tile (Glued-on)					
HVAC	☐ Plaster	☐ Mastic		Miscellaneous:				
☐ Insulation	X DWJC		Structural					
☐ Tape		$\square$ S	teel F. P. ing	No. of Phases:				
☐ Paper Wran			leck F P ing	Colour

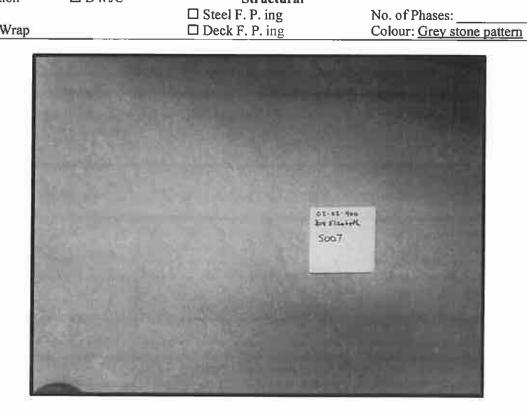
MEMORIA UNIVERSIT	14	ASB	ESTOS BULK SA	MPLING FO	ORM		
Sample #:	S007		Date Sampled:	August 24, 2012	2		
Building:	208 Elizabeth Avenue		Sampler:	Trent Hardy			
Location:	012, rooms 2006-2007		Analysis:	SAI - PLM			
MUN Project #:	02-02-900		Work Order#:				
Bulk Sampling Parameters							
Pipe/Tank	Flooring		Ceiling	Roofing	Location		
☐ Insulation	□12'x12' Tile	T	'extured	☐ Shingle	X Floor		
☐ Elbow	□ 9'x9'Tile	$\square$ S	tucco	☐ Rolled	☐ Wall Orientation		
☐ Fitting	X Vinyl Sheet	☐ Popcorn		☐ Felt	☐ Ceiling		
☐ Transite Pipe	☐ Mastic	□ DŴJC		□ Tar	☐ Above Ceiling		
☐ Gasket	Wall	☐ Plaster			☐ Other		
☐ Tank Insulation	☐ Transite Panel	☐ Acoustic Tile (Dropped)					
☐ Pipe Wrap	☐ Textured Wall	$\Box A$	coustic Tile (Glued-on)				
HVAC	☐ Plaster	☐ Mastic		Miscellaneous:			
☐ Insulation	□ DWJC		Structural				
☐ Tape		$\square$ S	teel F. P. ing	No. of Phases:			
☐ Paper Wrap			eck F. P. ing	Colour: Grey st	one pattern

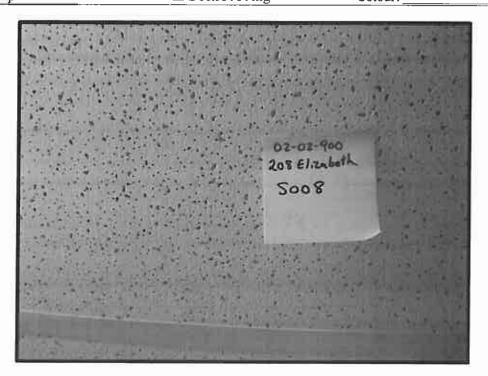
One (1) sample of the 2'x2' acoustic ceiling tile distinguished by a pinhole and fleck pattern was collected from the first floor offices. Analysis of this sample did not identify the presence of asbestos (reference sample 02-02-900-S008).

Sample #:	S008		Date Sampled:	August 24, 2012				
Building:	208 Elizabeth Avenue		Sampler:	Trent Hardy				
Location:	012, rooms 2006-2007		Analysis:	SAI - PLM				
MUN Project #:	02-02-900		Work Order #:					
	Bulk Sampling Parameters							
Pipe/Tank	Flooring	Ceiling		Roofing	Location			
☐ Insulation	□12'x12' Tile	☐ Textured		☐ Shingle	□ Floor			
□ Elbow	□ 9'x9'Tile	☐ Stucco		☐ Rolled	□ Wall Orientation			
☐ Fitting	□ Vinyl Sheet	☐ Popcom		☐ Felt	X Ceiling			
☐ Transite Pipe	☐ Mastic	□ DWJC		☐ Tar	☐ Above Ceiling			
☐ Gasket	Wall	☐ Plaster			☐ Other			
☐ Tank Insulation	☐ Transite Panel	ΧA	coustic Tile (Dropped)					
☐ Pipe Wrap	□ Textured Wall	$\Box$ A	coustic Tile (Glued-on)					
HVAC	☐ Plaster	☐ Mastic		Miscellaneous: 2' x 2' pinhole fleck				
☐ Insulation	☐ DWJC		Structural		•			
☐ Tape		$\Box$ S	teel F. P. ing	No. of Phases:				
☐ Paper Wrap			eck F. P. ing	Colour:

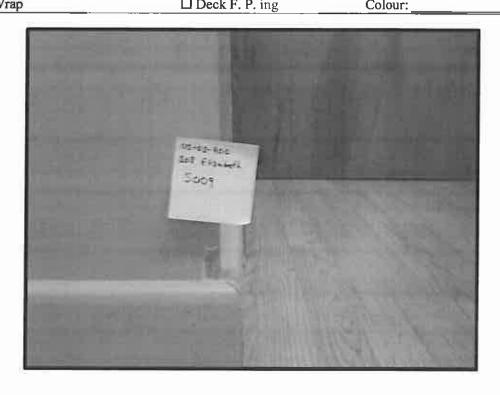
MEMORIA	VIII .	ASB	ESTOS BULK SA	MPLING F(	ORM		
Sample #:	S009		Date Sampled:	August 24, 2012			
Building:	208 Elizabeth Avenue		Sampler:	Trent Hardy			
Location:	013, room 2001		Analysis:	SAI - PLM			
MUN Project #:	02-02-900		Work Order#:				
Bulk Sampling Parameters							
Pipe/Tank	Flooring		Ceiling	Roofing	Location		
☐ Insulation	□12'x12' Tile	ΠI	`extured	☐ Shingle	□ Floor		
☐ Elbow	☐ 9'x9'Tile	☐ Stucco		☐ Rolled	☐ Wall Orientation		
☐ Fitting	□ Vinyl Sheet	□ Popcom		☐ Felt	X Ceiling		
☐ Transite Pipe	☐ Mastic	□ DWJC		□ Tar	☐ Above Ceiling		
☐ Gasket	Wall	☐ Plaster			□ Other		
☐ Tank Insulation	☐ Transite Panel	☐ Acoustic Tile (Dropped)					
☐ Pipe Wrap	☐ Textured Wall	☐ Acoustic Tile (Glued-on)					
HVAC	☐ Plaster	☐ Mastic		Miscellaneous:			
☐ Insulation	X DWJC		Structural				
☐ Tape		$\square$ S	teel F. P. ing	No. of Phases:			
☐ Paper Wrap			eck F. P. ing	Colour:	_
