ASBESTOS AND LEAD PAINT BUILDING MATERIALS SURVEY FOR: AQUARENA MEMORIAL UNIVERSITY OF NEWFOUNDLAND

Memorial University of Newfoundland

Pinchin LeBlanc Environmental Ltd Project No. 02-02-00900

December 12, 2012

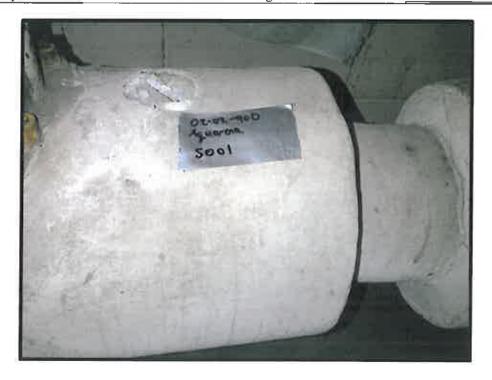
Insulating cement, also referred to as "parging cement", present on pipe elbows and straight sections, was sampled in the mechanical room of the site building. Analysis of this sample did not identify the presence of asbestos (reference sample 02-02-900-S001).

OMINEKSII	T. I.						
Sample #:	S001		Date Sampled:	October 31, 2012			
Building:	Aquarena		Sampler:	Trent Hardy			
Location:	001, mechanical ro	om	Analysis:	SAI - PLM			
MUN Project #:	02-02-900		Work Order#:		· ·		
Bulk Sampling Parameters							
Pipe/Tank	Flooring		Ceiling	Roofing	Location		
☐ Insulation	□12'x12' Tile	☐ Textured		☐ Shingle	☐ Floor		
☐ Elbow	□ 9'x9'Tile	☐ Stucco		□ Rolled	☐ Wall Orientation		
X Fitting	□ Vinyl Sheet	□P	opcom	☐ Felt	☐ Ceiling		
☐ Transite Pipe	☐ Mastic)WJC	☐ Tar	☐ Above Ceiling		
☐ Gasket	Wall	□ P	laster		X Other		
☐ Tank Insulation	☐ Transite Panel		coustic Tile (Dropped)				
☐ Pipe Wrap	☐ Textured Wall	☐ Acoustic Tile (Glued-on)					
HVAC	☐ Plaster	$\square N$	fastic 1	Miscellaneous:	Parging cement		
☐ Insulation	□ DWJC		Structural				
☐ Tape			teel F. P. ing	No. of Phases:			
☐ Paper Wrap			eck F. P. ing	Colour:

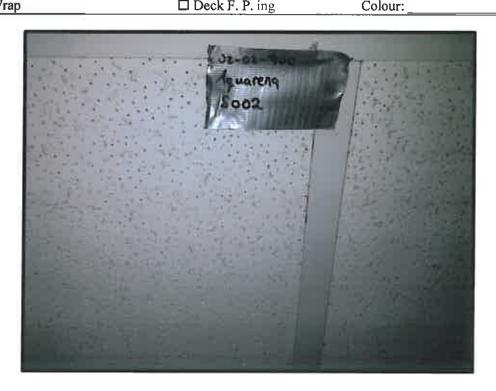
UNIVERSIT	Y					
Sample #:	S002		Date Sampled:	October 31, 2012		
Building:	Aquarena		Sampler:	Trent Hardy		
Location:	008, rooms 1000 ar	nd	Analysis:	SAI - PLM		
	1000A					
MUN Project #:	02-02-900		Work Order #:			
		Bulk	Sampling Parameters			
Pipe/Tank	Flooring		Ceiling	Roofing	Location	
☐ Insulation	□12'x12' Tile	☐ Textured		☐ Shingle	☐ Floor	
□ Elbow	☐ 9'x9'Tile		tucco	☐ Rolled	☐ Wall Orientation	
☐ Fitting	□ Vinyl Sheet	□ Pe	opcom	☐ Felt	X Ceiling	
☐ Transite Pipe	☐ Mastic	\Box D	WJC	☐ Tar	☐ Above Ceiling	
☐ Gasket	Wall	□ P¹	laster		☐ Other	
☐ Tank Insulation	☐ Transite Panel	X A	coustic Tile (Dropped)			
☐ Pipe Wrap	□ Textured Wall	\Box A	coustic Tile (Glued-on)			
HVAC □ Plaster □ Ma		lastic	Miscellaneous: and pinhole	2' x 4' small fissure		
☐ Insulation	□ DWJC		Structural	<u> </u>		
☐ Tape		☐ St	teel F. P. ing	No. of Phases:		
Donos Ween			and F. D. ima	Calarra

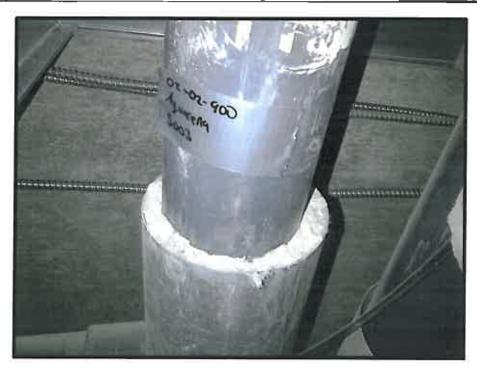
Magnesium Block, also referred to as "Mag Block" insulation, present on pipe straight sections was sampled in room AQ 1501 and contains 10% Chrysotile and 20% Amosite (reference sample 02-02-900-S003). For locations and conditions of this material at the time of the building survey refer to location & data excel document.

Sample #:	S003	Date Sampled:	October 31, 201	12
Building:	Aquarena	Sampler:	Trent Hardy	
Location:	010, hallway 1S01	Analysis:	SAI - PLM	
MUN Project #:	02-02-900	Work Order #:		
		Bulk Sampling Parameters		
Pipe/Tank	Flooring	Ceiling	Roofing	Location
X Insulation	□12'x12' Tile	☐ Textured	☐ Shingle	□Floor
□ Elbow	□ 9'x9'Tile	☐ Stucco	☐ Rolled	☐ Wall Orientation
☐ Fitting	□ Vinyl Sheet	□ Popcom	☐ Felt	☐ Ceiling
☐ Transite Pipe	☐ Mastic	□ DWJC	🗆 Таг	☐ Above Ceiling
☐ Gasket	Wall	☐ Plaster		X Other
☐ Tank Insulation	☐ Transite Panel	☐ Acoustic Tile (Dropped)		
☐ Pipe Wrap	□ Textured Wall	☐ Acoustic Tile (Glued-on)		
HVAC □ Plaster		☐ Mastic	☐ Mastic Miscellaneous: Inside ste	
☐ Insulation	□ DWJC	Structural	piping	
☐ Tape		☐ Steel F. P. ing	No. of Phases:	
☐ Paper Wrap		□ Deck F. P. ing	Colour:

- 1. Type III (high risk) asbestos abatement procedures should be carried out for the scheduled removal of greater than 1ft² of friable asbestos containing materials. Alternatively, Type II (moderate risk) glove bag abatement procedures may be applied where practical;
- 2. Type II (moderate risk) asbestos abatement procedures should be carried out for the scheduled repair or enclosure of friable ACMs or for the removal of less than 1ft² of material;

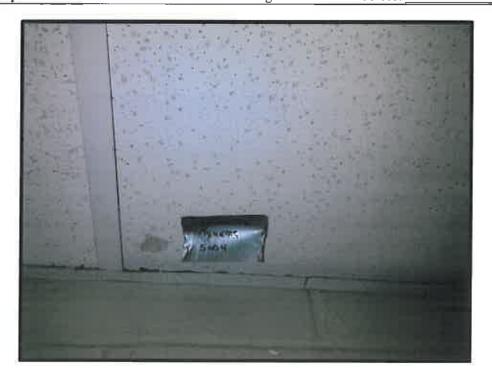
OMIATION									
Sample #:	S004	Date Sampled:	October 31, 2012						
Building:	Aquarena	Sampler:	Trent Hardy						
Location:	010, hallway 1S01	Analysis:	SAI - PLM						
MUN Project #:	02-02-900	Work Order #:							
	Bulk Sampling Parameters								
Pipe/Tank	Flooring	Ceiling	Roofing	Location					
☐ Insulation	□12'x12' Tile	☐ Textured	☐ Shingle	☐ Floor					
☐ Elbow	□ 9'x9'Tile	☐ Stucco	☐ Rolled	☐ Wall Orientation					
☐ Fitting	□ Vinyl Sheet	□ Popcorn	☐ Felt	X Ceiling					
☐ Transite Pipe	☐ Mastic	□ DWJC	☐ Tar	☐ Above Ceiling					
☐ Gasket	Wall	☐ Plaster		☐ Other					
☐ Tank Insulation	☐ Transite Panel	☐ Acoustic Tile (Dropped)							
☐ Pipe Wrap	☐ Textured Wall	X Acoustic Tile (Glued-on)							
HVAC □ Plaster		☐ Mastic	Miscellaneous:	2' x 2' pinhole fleck					
☐ Insulation	□ DWJC	Structural							
□ Tape		☐ Steel F. P. ing	No. of Phases:						
☐ Paper Wrap		☐ Deck F. P. ing	Colour:

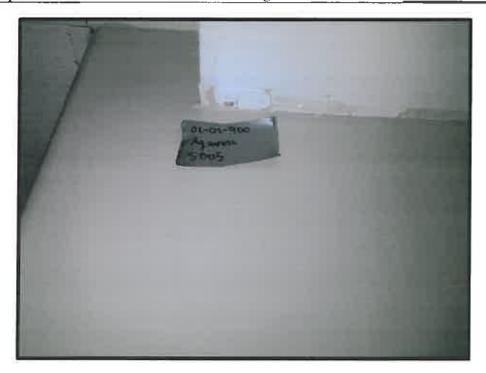
OMIATION					
Sample #:	S005		Date Sampled:	October 31, 2012	
Building:	Aquarena		Sampler:	Trent Hardy	
Location:	011, main lobby rooms 2000 and 2004		Analysis:	SAI - PLM	
MUN Project #:	02-02-900		Work Order #:		
		Bulk	Sampling Parameters		
Pipe/Tank	Flooring	Ceiling		Roofing	Location
☐ Insulation	□12'x12' Tile	☐ Textured		☐ Shingle	☐ Floor
□ Elbow	□ 9'x9'Tile	\square S	tucco	☐ Rolled	☐ Wall Orientation
☐ Fitting	□ Vinyl Sheet	\square P	орсогп	☐ Felt	X Ceiling
☐ Transite Pipe	☐ Mastic	ХD	WJC	☐ Tar	☐ Above Ceiling
☐ Gasket	Wall	□P	laster		☐ Other
☐ Tank Insulation	☐ Transite Panel	$\Box A$	coustic Tile (Dropped)		
☐ Pipe Wrap	☐ Textured Wall	$\Box A$	coustic Tile (Glued-on)		
HVAC	☐ Plaster	☐ Mastic		Miscellaneous:	
□ Insulation	□ DWJC		Structural		
☐ Tape		\square S	teel F. P. ing	No. of Phases:	
☐ Paper Wrap			eck F. P. ing	Colour:

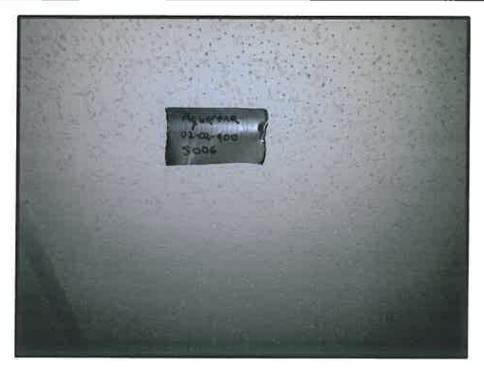
CIAIAEKSII	I				
Sample #:	S006		Date Sampled:	October 31, 201	12
Building:	Aquarena		Sampler:	Trent Hardy	
Location:	011, main lobby ro	oms	Analysis:	SAI - PLM	
	2000 and 2004				
MUN Project#:	02-02-900		Work Order#:		
		Bulk	Sampling Parameters		
Pipe/Tank	Flooring	Ceiling		Roofing	Location
☐ Insulation	□12'x12' Tile	\Box T	extured	☐ Shingle	□ Floor
☐ Elbow	☐ 9'x9'Tile	☐ Stucco		☐ Rolled	☐ Wall Orientation
☐ Fitting	□ Vinyl Sheet	□P	opcorn	☐ Felt	X Ceiling
☐ Transite Pipe	☐ Mastic		WJC	□ Tar	☐ Above Ceiling
☐ Gasket	Wall	\square P	laster		☐ Other
☐ Tank Insulation	☐ Transite Panel	ΧA	coustic Tile (Dropped)		
☐ Pipe Wrap	☐ Textured Wall		coustic Tile (Glued-on)		
HVAC	☐ Plaster	☐ Mastic Miscellaneous: 2' and pinhole		2' x 2' small fissure	
☐ Insulation	□ DWJC		Structural	· -— -	
☐ Tape		\square S	teel F. P. ing	No. of Phases:	
☐ Paper Wrap			eck F. P. ing	Colour:

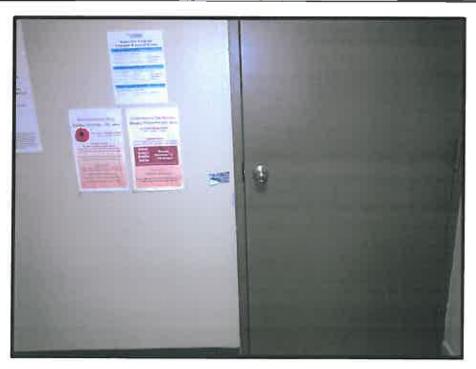
Sample #:	S007		Date Sampled:	October 31, 2012	
Building:	Aquarena		Sampler:	Trent Hardy	
Location:	011, main lobby ro	oms	Analysis:	SAI - PLM	
	2000 and 2004				
MUN Project #:	02-02-900	-	Work Order #:		
		Bulk	Sampling Parameters		
Pipe/Tank	Flooring		Ceiling	Roofing	Location
☐ Insulation	□12'x12' Tile	T	extured	☐ Shingle	☐ Floor
□ Elbow	□ 9'x9'Tile	\Box S	Stucco	□ Rolled	X Wall Orientation
☐ Fitting	□ Vinyl Sheet	\Box P	opcom	☐ Felt	☐ Ceiling
☐ Transite Pipe	☐ Mastic		DWJC	☐ Tar	☐ Above Ceiling
☐ Gasket	Wall	□P	laster		☐ Other
☐ Tank Insulation	☐ Transite Panel	\Box A	Acoustic Tile (Dropped)		
☐ Pipe Wrap	☐ Textured Wall	$\square A$	Acoustic Tile (Glued-on)		
HVAC	☐ Plaster	\square N	/astic	Miscellaneous:	
☐ Insulation	X DWJC		Structural		
☐ Tape		\square S	teel F. P. ing	No. of Phases:	
☐ Paper Wrap			Deck F. P. ing	Colour:

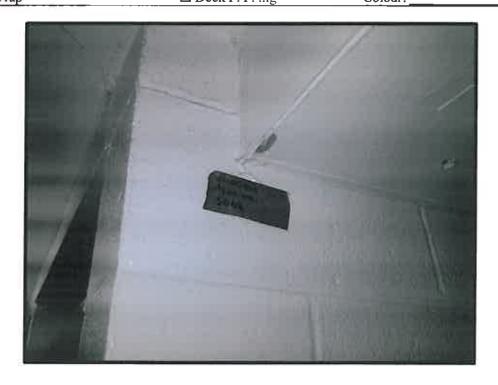
Nine (9) samples, in total, of drywall joint compound were collected in the site building. One (1) of the nine (9) of the samples contains 3% chrysotile asbestos (reference samples 02-02-900-S008).

O IA I A F I/ O I I					
Sample #:	S008		Date Sampled:	October 31, 201	2
Building:	Aquarena		Sampler:	Trent Hardy	
Location:	012, male change r 2007	oom	Analysis:	SAI - PLM	
MUN Project #:	02-02-900		Work Order#:	-	_
		Bulk	Sampling Parameters		
Pipe/Tank	Flooring		Ceiling	Roofing	Location
☐ Insulation	□12'x12' Tile	T	extured	☐ Shingle	☐ Floor
☐ Elbow	☐ 9'x9'Tile	\square S	tucco	☐ Rolled	X Wall Orientation
☐ Fitting	□ Vinyl Sheet	\square P	opcom	☐ Felt	☐ Ceiling
☐ Transite Pipe	□ Mastic		WJC	□ Tar	☐ Above Ceiling
☐ Gasket	Wall	\square P	laster		☐ Other
☐ Tank Insulation	□ Transite Panel		coustic Tile (Dropped)		
☐ Pipe Wrap	☐ Textured Wall	□A	coustic Tile (Glued-on)		
HVAC	□ Plaster	\square M	fastic	Miscellaneous:	
☐ Insulation	X DWJC		Structural		
☐ Tape			teel F. P. ing	No. of Phases:	
☐ Paper Wrap		Πр	eck F P ing	Colour

1. Under the NL guidance documents for moderate and low risk asbestos abatement procedures, quantities of these materials within an enclosure exceeding 100 ft² should be removed using Type III (high risk) asbestos abatement procedures. Quantities less than 100 ft² but exceeding 10ft² should be removed using Type II (moderate risk) asbestos abatement procedures, while quantities less than 10 ft² should be removed using Type I (low risk) asbestos abatement procedures.

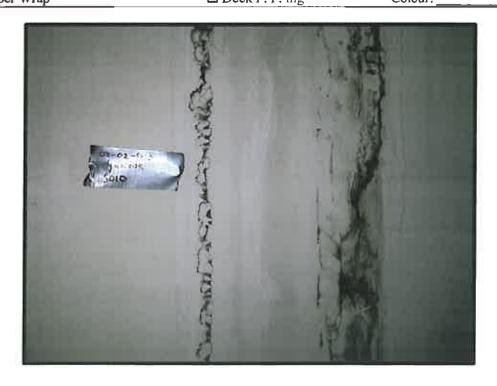
OIALATICALI				
Sample #:	S010	Date Sampled:	October 31, 201	2
Building:	Aquarena	Sampler:	Trent Hardy	
Location:	014, storage room	Analysis:	SAI - PLM	
MUN Project #:	02-02-900	Work Order #:		_
		Bulk Sampling Parameters		
Pipe/Tank	Flooring	Ceiling	Roofing	Location
☐ Insulation	□12'x12' Tile	☐ Textured	☐ Shingle	□ Floor
☐ Elbow	☐ 9'x9'Tile	☐ Stucco	☐ Rolled	X Wall Orientation
☐ Fitting	□ Vinyl Sheet	☐ Popcorn	☐ Felt	☐ Ceiling
☐ Transite Pipe	□ Mastic	□ DWJC	☐ Tar	☐ Above Ceiling
☐ Gasket	Wall	☐ Plaster		☐ Other
☐ Tank Insulation	☐ Transite Panel	☐ Acoustic Tile (Dropped)		
☐ Pipe Wrap	☐ Textured Wall	☐ Acoustic Tile (Glued-on)		
HVAC	☐ Plaster	☐ Mastic	Miscellaneous:	
☐ Insulation	X DWJC	Structural		
☐ Tape		☐ Steel F. P. ing	No. of Phases:	
☐ Paper Wran		□ Deck F P ing	Colour

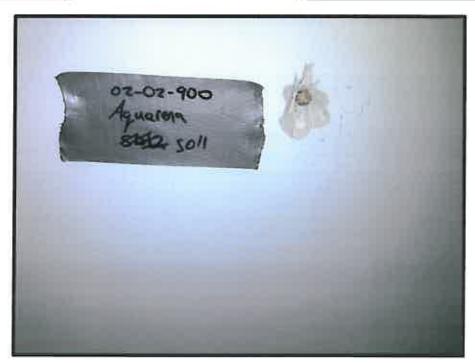
O I 4 I A E ICOLL	444				
Sample #:	S011	Date Sampled:	October 31, 201	2	
Building:	Aquarena	Sampler:	Trent Hardy		
Location:	022, rooms 2011 ar	nd Analysis:	SAI - PLM		
	2011A				
MUN Project#:	02-02-900	Work Order #:			
Bulk Sampling Parameters					
Pipe/Tank	Flooring	Ceiling	Roofing	Location	
☐ Insulation	□12'x12' Tile	☐ Textured	☐ Shingle	□ Floor	
☐ Elbow	□ 9'x9'Tile	☐ Stucco	☐ Rolled	X Wall Orientation	
☐ Fitting	□ Vinyl Sheet	☐ Popcom	☐ Felt	☐ Ceiling	
☐ Transite Pipe	☐ Mastic	□ DWJC	□ Tar	☐ Above Ceiling	
☐ Gasket	Wall	☐ Plaster		☐ Other	
☐ Tank Insulation	☐ Transite Panel	☐ Acoustic Tile (Dropped)			
☐ Pipe Wrap	□ Textured Wall	☐ Acoustic Tile (Glued-on)			
HVAC	☐ Plaster	☐ Mastic	Miscellaneous:		
☐ Insulation	X DWJC	Structural			
□ Tape		☐ Steel F. P. ing	No. of Phases:		
☐ Paper Wrap		□ Deck F. P. ing	Colour:

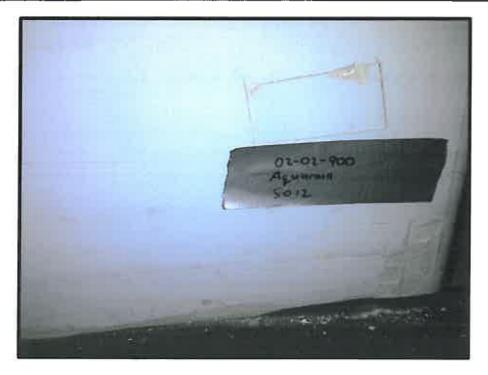
OMIATION	1				
Sample #:	S012	Date Sampled:	October 31, 201	2	
Building:	Aquarena	Sampler:	Trent Hardy		
Location:	023, rooms 2016, 2016A, and 2V02	Analysis:	SAI - PLM		
MUN Project #:	02-02-900	Work Order #:			
Bulk Sampling Parameters					
Pipe/Tank	Flooring	Ceiling	Roofing	Location	
☐ Insulation	□12'x12' Tile	☐ Textured	☐ Shingle	☐ Floor	
☐ Elbow	□ 9'x9'Tile	☐ Stucco	☐ Rolled	X Wall Orientation	
☐ Fitting	□ Vinyl Sheet	☐ Popcom	☐ Felt	☐ Ceiling	
☐ Transite Pipe	☐ Mastic	□ DWJC	□ Tar	☐ Above Ceiling	
☐ Gasket	Wall	☐ Plaster		□ Other	
☐ Tank Insulation	☐ Transite Panel	☐ Acoustic Tile (Dropped)			
☐ Pipe Wrap	☐ Textured Wall	☐ Acoustic Tile (Glued-on)			
HVAC	☐ Plaster	☐ Mastic	Miscellaneous:		
☐ Insulation	X DWJC	Structural			
□ Tape		☐ Steel F. P. ing	No. of Phases:		
☐ Paper Wrap		☐ Deck F. P. ing	Colour:

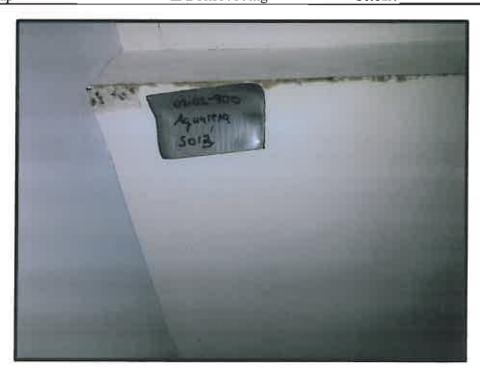
OMIAPICALI	1			
Sample #:	S013	Date Sampled:	October 31, 201	2
Building:	Aquarena	Sampler:	Trent Hardy	
Location:	023, rooms 2016,	Analysis:	SAI - PLM	
	2016A, and 2V02			
MUN Project #:	02-02-900	Work Order #:		
		Bulk Sampling Parameters		
Pipe/Tank	Flooring	Ceiling	Roofing	Location
☐ Insulation	□12'x12' Tile	☐ Textured	☐ Shingle	□ Floor
□ Elbow	□ 9'x9'Tile	☐ Stucco	☐ Rolled	☐ Wall Orientation
☐ Fitting	□ Vinyl Sheet	☐ Popcorn	☐ Felt	X Ceiling
☐ Transite Pipe	☐ Mastic	X DWJC	□ Tar	☐ Above Ceiling
☐ Gasket	Wall	☐ Plaster		☐ Other
☐ Tank Insulation	☐ Transite Panel	☐ Acoustic Tile (Dropped)		
☐ Pipe Wrap	□ Textured Wall	☐ Acoustic Tile (Glued-on)		
HVAC	☐ Plaster	☐ Mastic	Miscellaneous:	
☐ Insulation	□ DWJC	Structural		
☐ Tape		☐ Steel F. P. ing	No. of Phases:	
☐ Paper Wrap		Deck F. P. ing	Colour:

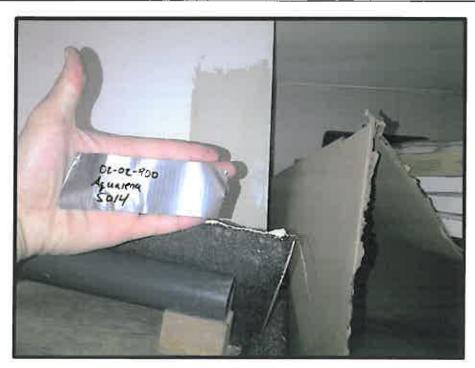
OMIAFICALI					
Sample #:	S014	Date Sampled:	October 31, 201	2	
Building:	Aquarena	Sampler:	Trent Hardy		
Location:	029, room 2020A	Analysis:	SAI - PLM		
MUN Project #:	02-02-900	Work Order #:			
Bulk Sampling Parameters					
Pipe/Tank	Flooring	Ceiling	Roofing	Location	
☐ Insulation	□12'x12' Tile	☐ Textured	☐ Shingle	Floor	
☐ Elbow	□ 9'x9'Tile	☐ Stucco	☐ Rolled	X Wall Orientation	
☐ Fitting	□ Vinyl Sheet	☐ Popcom	☐ Felt	☐ Ceiling	
☐ Transite Pipe	□ Mastic	□ DWJC	□ Tar	☐ Above Ceiling	
☐ Gasket	Wall	☐ Plaster		☐ Other	
☐ Tank Insulation	□ Transite Panel	☐ Acoustic Tile (Dropped)			
☐ Pipe Wrap	☐ Textured Wall	☐ Acoustic Tile (Glued-on)			
HVAC	☐ Plaster	☐ Mastic	Miscellaneous:		
☐ Insulation	X DWJC	Structural			
☐ Tape		☐ Steel F. P. ing	No. of Phases:		
□ Paper Wrap		Deck F. P. ing	Colour:

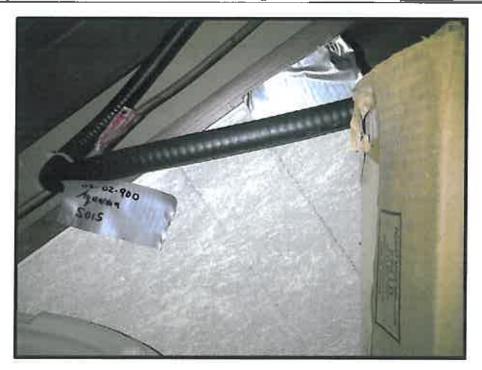
Cement board, commonly referred to "transite sheeting" was sampled from AQ 3025 and contains 20% chrysotile asbestos (reference sample 02-02-900-S015). For locations and conditions of this material at the time of the building survey refer to location & data excel document.

Sample #:	S015	Date Sampled:	October 31, 201	2
Building:	Aquarena	Sampler:	Trent Hardy	
Location:	032, room 3023	Analysis:	SAI - PLM	
MUN Project #:	02-02-900	Work Order #:		
		Bulk Sampling Parameters		
Pipe/Tank	Flooring	Ceiling	Roofing	Location
☐ Insulation	□12'x12' Tile	☐ Textured	☐ Shingle	□ Floor
☐ Elbow	□ 9'x9'Tile	☐ Stucco	☐ Rolled	X Wall Orientation
☐ Fitting	□ Vinyl Sheet	□ Popcom	☐ Felt	☐ Ceiling
☐ Transite Pipe	☐ Mastic	□ DWJC	☐ Tar	☐ Above Ceiling
☐ Gasket	Wall	☐ Plaster		☐ Other
☐ Tank Insulation	X Transite Panel	☐ Acoustic Tile (Dropped)		
☐ Pipe Wrap	☐ Textured Wall	☐ Acoustic Tile (Glued-on))	
HVAC	☐ Plaster	☐ Mastic	Miscellaneous:	
☐ Insulation	□ DWJC	Structural		
☐ Tape		☐ Steel F. P. ing	No. of Phases:	
☐ Paper Wrap		☐ Deck F. P. ing	Colour:

- 1. Type I (low risk) asbestos abatement procedures should be carried out for the scheduled disturbance of any non-friable materials provided the materials can be removed intact, and without the use of powered hand tools.
- 2. Should the use of powered hand tools or excessive breakage of the materials become necessary, Type II (moderate risk) asbestos abatement procedures should be adopted.

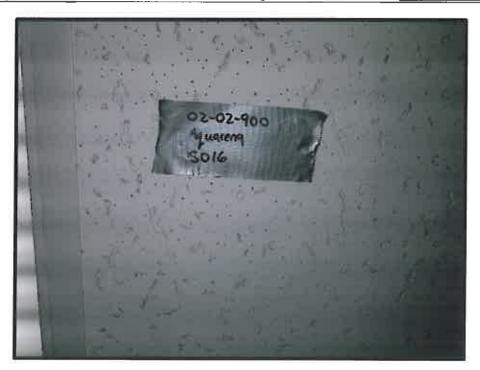
01414 PV 011				
Sample #:	S016	Date Sampled:	October 31, 201	2
Building:	Aquarena	Sampler:	Trent Hardy	
Location:	046, room 2022	Analysis:	SAI - PLM	
MUN Project #:	02-02-900	Work Order#:		
		Bulk Sampling Parameters		
Pipe/Tank	Flooring	Ceiling	Roofing	Location
☐ Insulation	□12'x12' Tile	☐ Textured	☐ Shingle	☐ Floor
□ Elbow	☐ 9'x9'Tile	☐ Stucco	□ Rolled	☐ Wall Orientation
☐ Fitting	□ Vinyl Sheet	☐ Popcom	☐ Felt	X Ceiling
☐ Transite Pipe	☐ Mastic	□DWJC	□ Таг	☐ Above Ceiling
☐ Gasket	Wall	☐ Plaster		☐ Other
☐ Tank Insulation	☐ Transite Panel	X Acoustic Tile (Dropped)		
☐ Pipe Wrap	☐ Textured Wall	☐ Acoustic Tile (Glued-on)		
HVAC	☐ Plaster	☐ Mastic	Miscellaneous:	
☐ Insulation	□ DWJC	Structural		
☐ Tape		☐ Steel F. P. ing	No. of Phases:	
□ Paper Wrap		□ Deck F. P. ing	Colour:

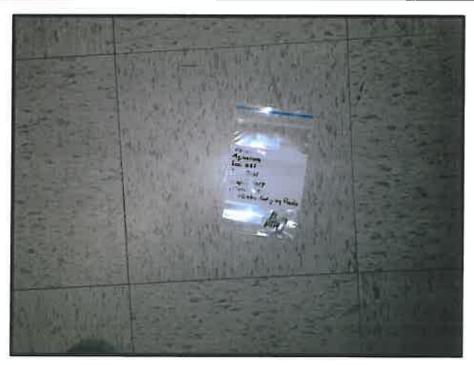
Grey with grey fleck, 12"x 12"vinyl floor tiles were sampled from AQ 3001. Analysis of this sample and associated tar mastic adhesive did not identify the presence of asbestos (reference sample 02-02-900-S017).

O MATA F K 2 L 1	1			
Sample #:	S017	Date Sampled:	October 31, 201	2
Building:	Aquarena	Sampler:	Trent Hardy	
Location:	051, room 3001	Analysis:	SAI - PLM	
MUN Project #:	02-02-900	Work Order#:		
		Bulk Sampling Parameters		
Pipe/Tank	Flooring	Ceiling	Roofing	Location
☐ Insulation	X12'x12' Tile	☐ Textured	☐ Shingle	X Floor
□ Elbow	□ 9'x9'Tile	☐ Stucco	□ Rolled	☐ Wall Orientation
☐ Fitting	□ Vinyl Sheet	□ Popcorn	☐ Felt	☐ Ceiling
☐ Transite Pipe	☐ Mastic	□ DWJC	☐ Tar	☐ Above Ceiling
☐ Gasket	Wall	☐ Plaster		☐ Other
☐ Tank Insulation	☐ Transite Panel	☐ Acoustic Tile (Dropped)		
☐ Pipe Wrap	☐ Textured Wall	☐ Acoustic Tile (Glued-on)		
HVAC	☐ Plaster	☐ Mastic	Miscellaneous:	
☐ Insulation	□ DWJC	Structural		
☐ Tape		☐ Steel F. P. ing	No. of Phases:	
☐ Paper Wrap		□ Deck F. P. ing	Colour: Grey w	rith abundant grey
