Project #: 13916

**ASBESTOS ASSESSMENT
Baltimore Court
Memorial University of Newfoundland
St. John's, NL**

SEPTEMBER 2011

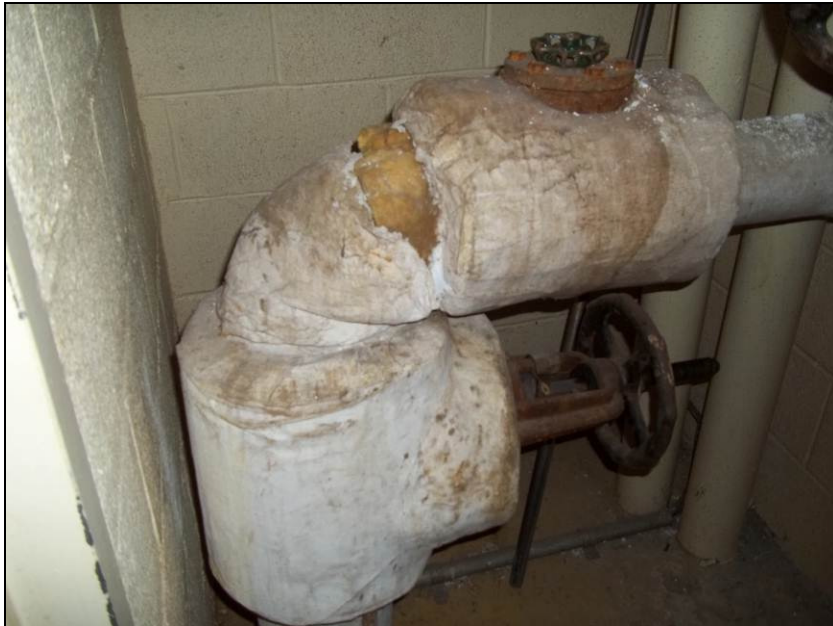
Pipe fitting insulation which could potentially contain asbestos was observed in Room BM106 during this assessment. Samples were collected and analyzed for asbestos content using the PLM method of detection and found to contain 10% Chrysotile asbestos (See sample BM-16 in Appendix II, Photographs 1, Appendix I)

Photographs 1: Room BM106. Pipe fitting insulation in poor condition

- All materials listed in fair and/or poor condition are to be repaired or removed immediately. See APPENDIX III – Asbestos Building Survey Information for materials condition and locations.

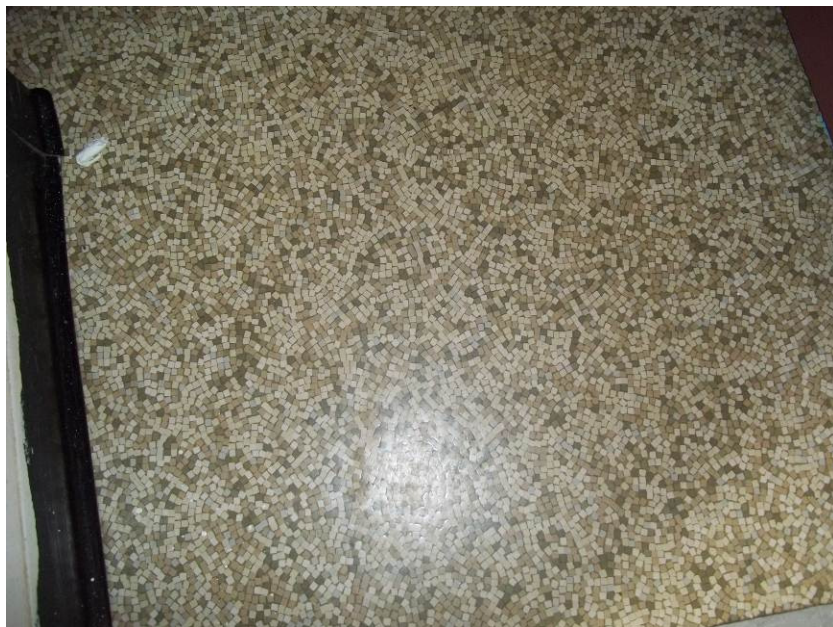
Vinyl sheet/linoleum flooring was identified during the assessment of the building. Three (3) samples were collected and analyzed for asbestos content using the PLM method of detection. Two (2) of the three (3) samples were identified as containing between 10 – 15% Chrysotile asbestos. (See samples BM-3, BM-4, BM-11 in Appendix II, Photographs 3, 4 in Appendix 1).

Photographs 2: Vinyl Sheet Flooring, containing 10% Chrysotile asbestos. Sample BM-3

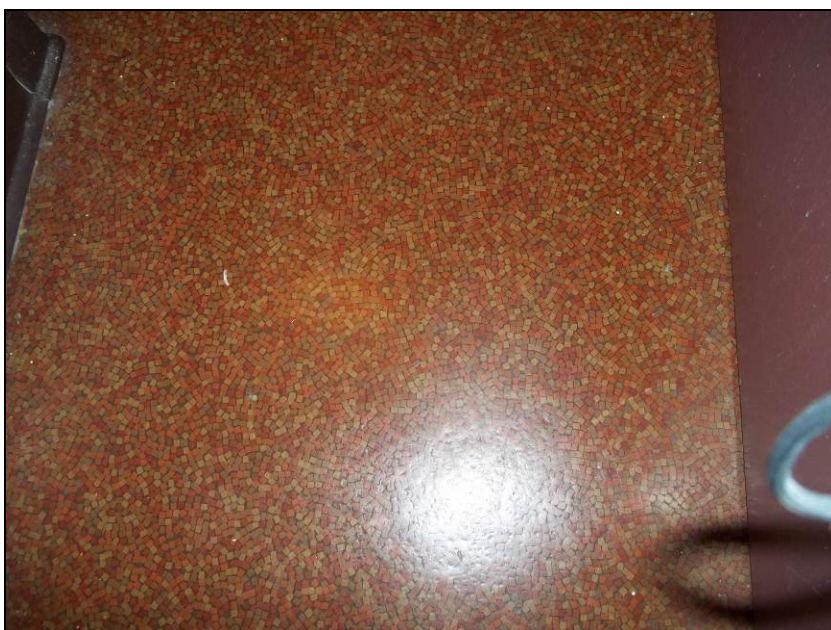
Photograph 3: Vinyl Sheet Flooring, containing 15% Chrysotile asbestos. Sample BM-4

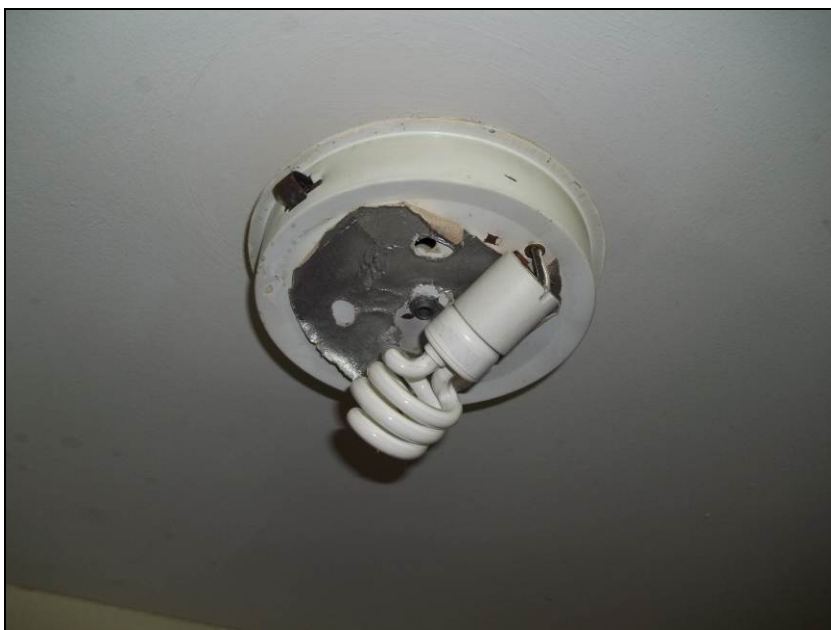
Two types of light fixture heat shields were observed throughout the building. Two (2) samples were collected and analyzed for asbestos content using the PLM method of detection. One (1) sample was found to contain 15% Chrysotile asbestos (See samples BM-9, BM-13 in Appendix II, photographs 4, 5 in Appendix I).

Photograph 4: Light fixture heat shield, containing 15% Chrysotile asbestos. Sample BM-9

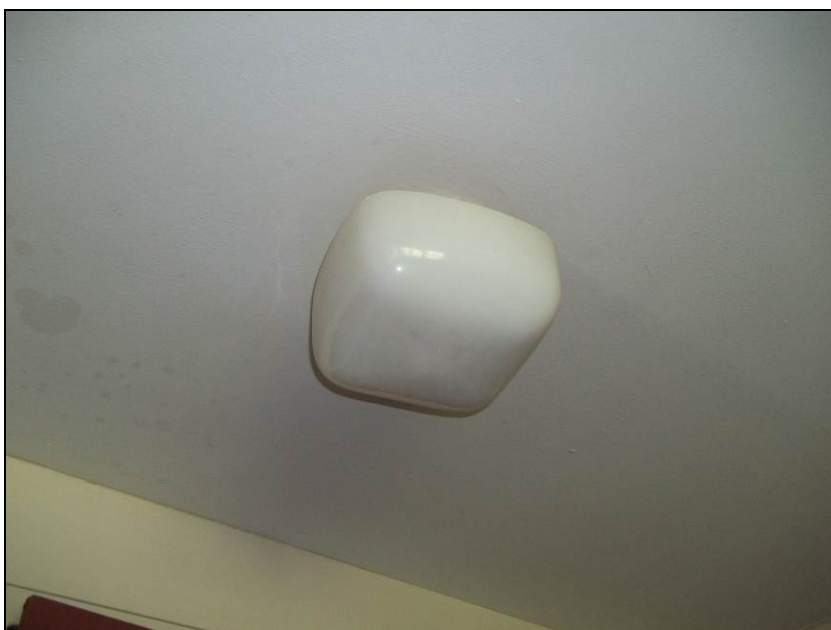
Photograph 5: Light fixture heat shield, containing 15% Chrysotile asbestos. Sample BM-9
