ASBESTOS AND LEAD PAINT BUILDING MATERIALS SURVEY FOR: C-CORE BUILDING MEMORIAL UNIVERSITY OF NEWFOUNDLAND

Pinchin LeBlanc Environmental Ltd Project No. 02-02-00900

June 19, 2013

BUILDING DESCRIPTION: C-CORE BUILDING

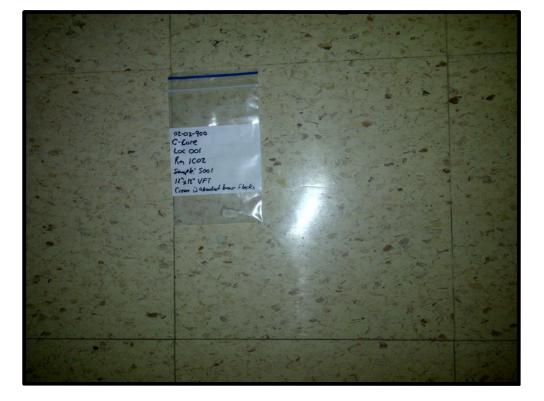
- The 12"x12" cream with abundant brown flecks vinyl floor tile were sampled in room K-1C02, and contain 3% chrysotile asbestos (reference sample 02-02-900-S001).
- The 12"x12" white with brown streaks vinyl floor tile, were sampled in room K-1009. Analysis of this sample and associated tar mastic adhesive did not detect the presence of asbestos (reference sample 02-02-900-S006).

MEMORIA UNIVERSIT		ASB	ESTOS BULK SA	MPLING FO	ORM		
Sample #:	S001		Date Sampled:				
Building :	C-Core		Sampler:	Trent Hardy			
Location:	001, room 1C02		Analysis:	SAI - PLM			
MUN Project #:	02-02-900		Work Order #:				
Bulk Sampling Parameters							
Pipe/Tank	Flooring		Ceiling	Roofing	Location		
□ Insulation	X12'x12' Tile	□ T	extured	□ Shingle	X Floor		
\Box Elbow	□ 9'x9'Tile	\Box S	tucco	□ Rolled	□ Wall Orientation		
□ Fitting	□ Vinyl Sheet	$\Box P$	opcorn	🗆 Felt	□ Ceiling		
□ Transite Pipe	□ Mastic	\Box D	WJC	🗆 Tar	□ Above Ceiling		
□ Gasket	Wall	$\Box P$	laster		□ Other		
□ Tank Insulation	□ Transite Panel	$\Box A$	coustic Tile (Dropped)				
□ Pipe Wrap	□ Textured Wall	$\Box A$	coustic Tile (Glued-on)				
HVAC	□ Plaster	$\Box M$	lastic	Miscellaneous:			
□ Insulation	DWJC		Structural				
□ Tape		\Box S	teel F. P. ing	No. of Phases:			
□ Paper Wrap			eck F. P. ing	Colour: <u>Cream</u> brown flecks	with abundant

- 1. Type I (low risk) asbestos abatement procedures should be carried out for the scheduled disturbance of any non-friable materials provided the materials can be removed intact, and without the use of powered hand tools.
- 2. Should the use of powered hand tools or excessive breakage of the materials become necessary, Type II (moderate risk) asbestos abatement procedures should be adopted.

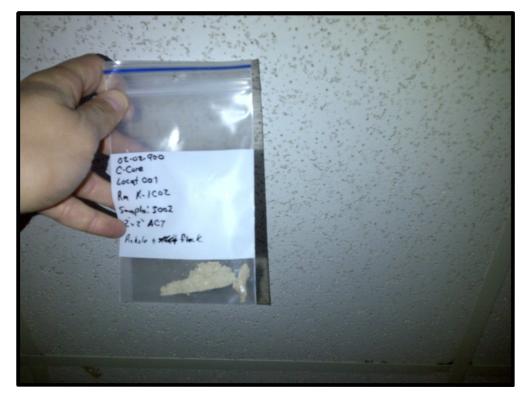
ASBESTOS BULK SAMPLING FORM							
Sample #:	S002		Date Sampled:				
Building :	C-Core		Sampler:	Trent Hardy			
Location:	001, room 1C02		Analysis:	SAI - PLM			
MUN Project #:	02-02-900		Work Order #:				
	Bulk Sampling Parameters						
Pipe/Tank	Flooring		Ceiling	Roofing	Location		
□ Insulation	□12'x12' Tile	ΠT	extured	□ Shingle	□ Floor		
□ Elbow	□ 9'x9'Tile	\Box S	tucco	□ Rolled	□ Wall Orientation		
□ Fitting	□ Vinyl Sheet	$\Box P$	opcorn	🗆 Felt	X Ceiling		
□ Transite Pipe	□ Mastic	ΠD	ŴJС	🗆 Tar	□ Above Ceiling		
□ Gasket	Wall	$\Box P$	laster		□ Other		
□ Tank Insulation	□ Transite Panel	ΧА	coustic Tile (Dropped)				
□ Pipe Wrap	□ Textured Wall	$\Box A$	coustic Tile (Glued-on)				
HVAC	□ Plaster	$\Box N$	lastic	Miscellaneous:	2' x 2' pinhole fleck		
□ Insulation	DWJC		Structural		-		
□ Tape		\Box S	teel F. P. ing	No. of Phases:			
Paper Wrap		\Box D	eck F. P. ing	Colour:

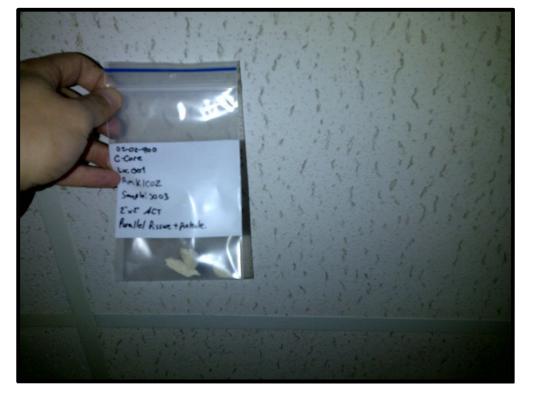
MEMORIA UNIVERSIT		ASB	ESTOS BULK SA	MPLING F	ORM		
Sample #:	S003		Date Sampled:				
Building :	C-Core		Sampler:	Trent Hardy			
Location:	001, room 1C02		Analysis:	SAI - PLM			
MUN Project #:	02-02-900		Work Order #:				
Bulk Sampling Parameters							
Pipe/Tank	Flooring		Ceiling	Roofing	Location		
\Box Insulation	□12'x12' Tile	П Т	extured	\Box Shingle	□ Floor		
□ Elbow	□ 9'x9'Tile	\Box S	tucco	\Box Rolled	□ Wall Orientation		
□ Fitting	□ Vinyl Sheet	$\Box P$	opcorn	□ Felt	X Ceiling		
□ Transite Pipe	□ Mastic	$\Box D$	WJC	🗖 Tar	□ Above Ceiling		
□ Gasket	Wall	$\square P$	laster		□ Other		
□ Tank Insulation	□ Transite Panel	X A	coustic Tile (Dropped)				
□ Pipe Wrap	□ Textured Wall	$\Box A$	coustic Tile (Glued-on)				
HVAC	□ Plaster	\Box Mastic Miscellaneous: <u>2' x 2' parallel</u> <u>fissure and pinhole</u>					
□ Insulation	DWJC		Structural				
□ Tape		\Box S	teel F. P. ing	No. of Phases:			
□ Paper Wrap		$\Box D$	eck F. P. ing	Colour:

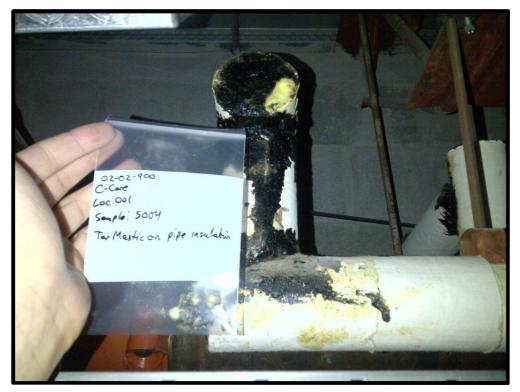
Tar mastic present on mitered elbows of fiberglass pipe insulation was sampled and analysis indicates the presence of 10% chrysotile asbestos (reference sample 02-02-900-S004). For locations and conditions of this material at the time of the building survey refer to location & data excel document.

MEMORIA UNIVERSIT		ASB	ESTOS BULK SA	MPLING F	ORM			
Sample #:	S004		Date Sampled:					
Building :	C-Core		Sampler:	Trent Hardy				
Location:	001, room 1C02		Analysis:	SAI - PLM				
MUN Project #:	02-02-900		Work Order #:					
	Bulk Sampling Parameters							
Pipe/Tank	Flooring		Ceiling	Roofing	Location			
□ Insulation	□12'x12' Tile	□ T	extured	□ Shingle	□ Floor			
X Elbow	□ 9'x9'Tile	\Box S	tucco	□ Rolled	□ Wall Orientation			
□ Fitting	□ Vinyl Sheet	$\Box P$	opcorn	🗆 Felt	□ Ceiling			
□ Transite Pipe	□ Mastic	ΠD	WJC	🗖 Tar	□ Above Ceiling			
□ Gasket	Wall	$\Box P$	laster		X Other			
□ Tank Insulation	□ Transite Panel	$\Box A$	coustic Tile (Dropped)					
□ Pipe Wrap	□ Textured Wall	$\Box A$	coustic Tile (Glued-on)					
HVAC	□ Plaster	$\Box M$	lastic	Miscellaneous	: <u>Tar mastic</u>			
\Box Insulation	DWJC		Structural					
□ Tape		$\Box S$	teel F. P. ing	No. of Phases:				
Paper Wrap		\Box D	eck F. P. ing	Colour:

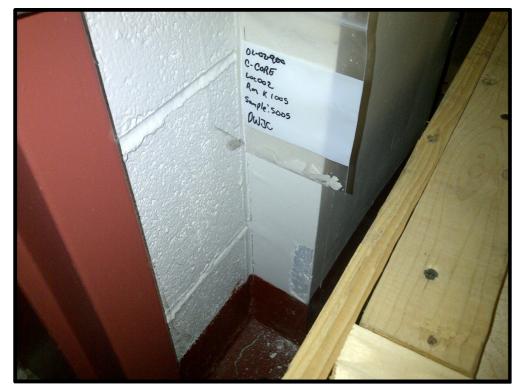
MEMORIA UNIVERSIT		ASB	ESTOS BULK SA	MPLING FO	ORM
Sample #:	S005		Date Sampled:		
Building :	C-Core		Sampler:	Trent Hardy	
Location:	002, room 1005	2, room 1005 Analysis:		SAI - PLM	
MUN Project #:	02-02-900		Work Order #:		
Bulk Sampling Parameters					
Pipe/Tank	Flooring		Ceiling	Roofing	Location
□ Insulation	□12'x12' Tile	ΠT	extured	□ Shingle	□ Floor
□ Elbow	□ 9'x9'Tile	\Box S	tucco	□ Rolled	X Wall Orientation
□ Fitting	□ Vinyl Sheet	$\Box P$	opcorn	🗆 Felt	□ Ceiling
□ Transite Pipe	□ Mastic	$\Box D$	WJC	🗆 Tar	□ Above Ceiling
□ Gasket	Wall	$\square P$	laster		□ Other
\Box Tank Insulation	□ Transite Panel	$\Box A$	coustic Tile (Dropped)		
□ Pipe Wrap	□ Textured Wall	$\Box A$	coustic Tile (Glued-on)		
HVAC	□ Plaster	$\Box M$	lastic	Miscellaneous:	
\Box Insulation	X DWJC		Structural		
□ Tape		\Box S	teel F. P. ing	No. of Phases:	
Paper Wrap		$\Box D$	eck F. P. ing	Colour:

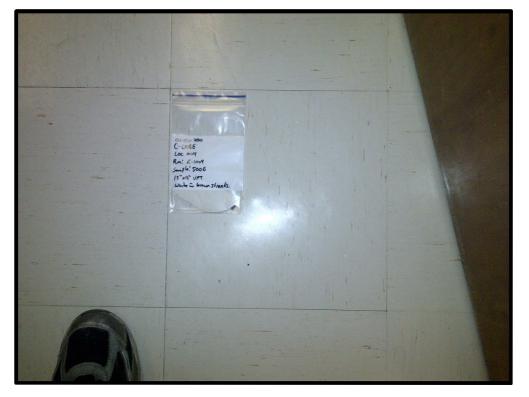
MEMORIA UNIVERSIT		ASB	ESTOS BULK SA	MPLING FO	ORM
Sample #:	S006		Date Sampled:		
Building :	C-Core		Sampler:	Trent Hardy	
Location:	004, room 1009	4, room 1009 Analysis:		SAI - PLM	
MUN Project #:	02-02-900		Work Order #:		
Bulk Sampling Parameters					
Pipe/Tank	Flooring		Ceiling	Roofing	Location
□ Insulation	X12'x12' Tile	ΠT	extured	□ Shingle	X Floor
□ Elbow	□ 9'x9'Tile	\Box S	tucco	□ Rolled	□ Wall Orientation
□ Fitting	□ Vinyl Sheet	$\Box P$	opcorn	🗆 Felt	□ Ceiling
□ Transite Pipe	□ Mastic	\Box D	WJC	🗆 Tar	□ Above Ceiling
□ Gasket	Wall	$\Box P$	laster		□ Other
□ Tank Insulation	□ Transite Panel	$\Box A$	coustic Tile (Dropped)		
□ Pipe Wrap	□ Textured Wall	$\Box A$	coustic Tile (Glued-on)		
HVAC	□ Plaster	$\Box M$	lastic	Miscellaneous:	
□ Insulation	DWJC		Structural		
□ Tape		\Box S	teel F. P. ing	No. of Phases:	
Paper Wrap		\Box D	eck F. P. ing	Colour: White	with brown streaks

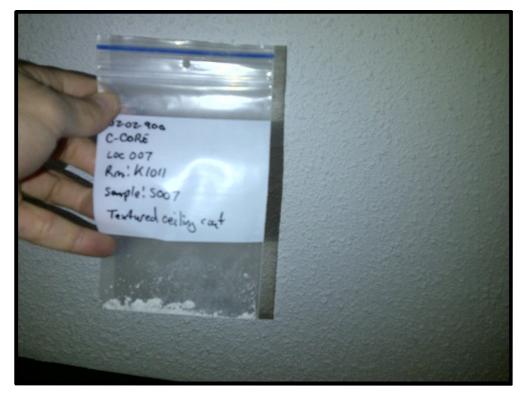
MEMORIA UNIVERSIT		ASB	ESTOS BULK SA	MPLING FO	ORM	
Sample #:	S007		Date Sampled:			
Building :	C-Core		Sampler:	Trent Hardy		
Location:	007, room 1011	room 1011 Analysis:		SAI - PLM		
MUN Project #:	02-02-900	2-900 Work Order #:				
Bulk Sampling Parameters						
Pipe/Tank	Flooring		Ceiling	Roofing	Location	
□ Insulation	□12'x12' Tile	ΧT	extured	□ Shingle	□ Floor	
□ Elbow	□ 9'x9'Tile	\Box S	tucco	□ Rolled	□ Wall Orientation	
□ Fitting	□ Vinyl Sheet	$\Box P$	opcorn	🗆 Felt	X Ceiling	
□ Transite Pipe	□ Mastic	\Box D	WJC	🗆 Tar	□ Above Ceiling	
□ Gasket	Wall	$\Box P$	laster		□ Other	
□ Tank Insulation	□ Transite Panel	$\Box A$	coustic Tile (Dropped)			
□ Pipe Wrap	□ Textured Wall	$\Box A$	coustic Tile (Glued-on)			
HVAC	□ Plaster	$\Box N$	lastic	Miscellaneous:		
□ Insulation	DWJC		Structural			
□ Tape		\Box S	teel F. P. ing	No. of Phases:		
Paper Wrap		\Box D	eck F. P. ing	Colour:

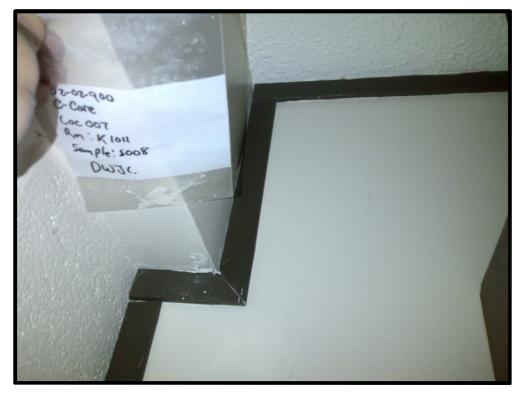
MEMORIA UNIVERSIT		ASB	ESTOS BULK SA	MPLING FO	ORM
Sample #:	S008		Date Sampled:		
Building :	C-Core		Sampler:	Trent Hardy	
Location:	007, room 1011		Analysis:	SAI - PLM	
MUN Project #:	02-02-900	2-900 Work Order #:			
Bulk Sampling Parameters					
Pipe/Tank	Flooring		Ceiling	Roofing	Location
□ Insulation	□12'x12' Tile	ΠT	extured	□ Shingle	□ Floor
□ Elbow	□ 9'x9'Tile	\Box S	tucco	□ Rolled	X Wall Orientation
□ Fitting	□ Vinyl Sheet	$\Box P$	opcorn	□ Felt	□ Ceiling
□ Transite Pipe	□ Mastic	\Box D	WJC	🗆 Tar	□ Above Ceiling
□ Gasket	Wall	$\Box P$	laster		□ Other
□ Tank Insulation	□ Transite Panel	$\Box A$	coustic Tile (Dropped)		
□ Pipe Wrap	□ Textured Wall	$\Box A$	coustic Tile (Glued-on)		
HVAC	□ Plaster	$\Box N$	lastic	Miscellaneous:	
\Box Insulation	X DWJC		Structural		
□ Tape		\Box S	teel F. P. ing	No. of Phases:	
Paper Wrap		\Box D	eck F. P. ing	Colour:

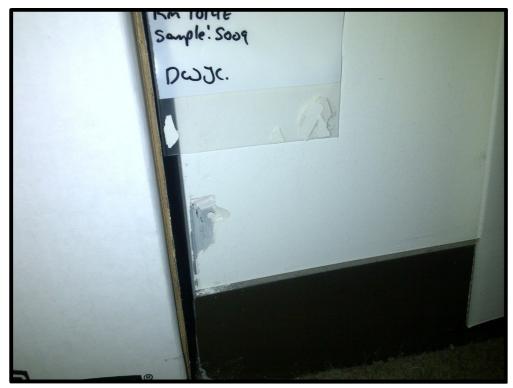
MEMORIA UNIVERSIT		ASBESTOS BULK SA	MPLING F(ORM		
Sample #:	S009	Date Sampled:				
Building :	C-Core	Sampler:	Trent Hardy			
Location:	Room 1014E	Analysis:	SAI - PLM			
MUN Project #:	02-02-900	Work Order #:				
Bulk Sampling Parameters						
Pipe/Tank	Flooring	Ceiling	Roofing	Location		
□ Insulation	□12'x12' Tile	□ Textured	□ Shingle	□ Floor		
\Box Elbow	□ 9'x9'Tile	□ Stucco	□ Rolled	X Wall Orientation		
□ Fitting	□ Vinyl Sheet	□ Popcorn	🗆 Felt	□ Ceiling		
□ Transite Pipe	□ Mastic	□ DWJC	🗆 Tar	□ Above Ceiling		
□ Gasket	Wall	□ Plaster		□ Other		
\Box Tank Insulation	□ Transite Panel	□ Acoustic Tile (Dropped)				
□ Pipe Wrap	□ Textured Wall	\Box Acoustic Tile (Glued-on)				
HVAC	□ Plaster	□ Mastic	Miscellaneous:			
□ Insulation	X DWJC	Structural				
□ Tape		□ Steel F. P. ing	No. of Phases:			
□ Paper Wrap		Deck F. P. ing	Colour:

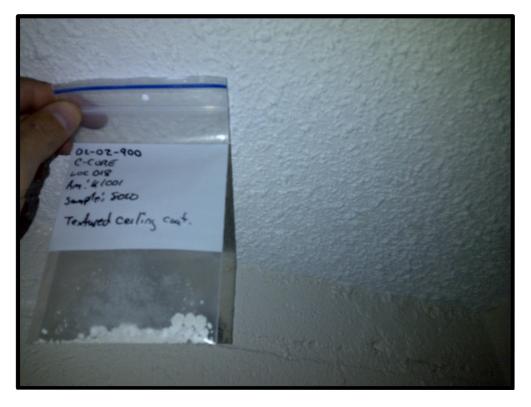
UNIVERSII	Y			
Sample #:	S010	Date Sampled:		
Building :	C-Core	Sampler:	Trent Hardy	
Location:	018, room 1001	Analysis:	SAI - PLM	
MUN Project #:	02-02-900	Work Order #:		
		Bulk Sampling Parameters		
Pipe/Tank	Flooring	Ceiling	Roofing	Location
□ Insulation	□12'x12' Tile	X Textured	□ Shingle	□ Floor
□ Elbow	□ 9'x9'Tile	□ Stucco	□ Rolled	□ Wall Orientation
□ Fitting	□ Vinyl Sheet	□ Popcorn	🗆 Felt	X Ceiling
□ Transite Pipe	□ Mastic	□ DWJC	🗆 Tar	□ Above Ceiling
□ Gasket	Wall	□ Plaster		□ Other
□ Tank Insulation	□ Transite Panel	□ Acoustic Tile (Dropped)		
□ Pipe Wrap	□ Textured Wall	□ Acoustic Tile (Glued-on)		
HVAC	□ Plaster	□ Mastic	Miscellaneous:	
□ Insulation	DWJC	Structural		
□ Tape		□ Steel F. P. ing	No. of Phases:	
□ Paper Wrap		Deck F. P. ing	Colour:

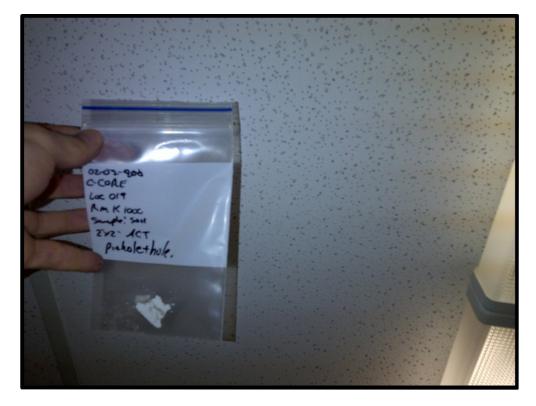
UNIVERSIT	Y				
Sample #:	S011		Date Sampled:		
Building :	C-Core		Sampler:	Trent Hardy	
Location:	019, room 1000		Analysis:	SAI - PLM	
MUN Project #:	02-02-900		Work Order #:		
		Bulk	Sampling Parameters		
Pipe/Tank	Flooring		Ceiling	Roofing	Location
□ Insulation	□12'x12' Tile	ΠT	extured	□ Shingle	□ Floor
□ Elbow	□ 9'x9'Tile	\Box S	tucco	□ Rolled	□ Wall Orientation
□ Fitting	\Box Vinyl Sheet \Box Popcorn		opcorn	🗆 Felt	X Ceiling
□ Transite Pipe	□ Mastic	\Box D	WJC	🗆 Tar	□ Above Ceiling
□ Gasket	Wall	$\Box P$	laster		□ Other
□ Tank Insulation	□ Transite Panel	ΧА	coustic Tile (Dropped)		
□ Pipe Wrap	□ Textured Wall	$\Box A$	coustic Tile (Glued-on)		
HVAC	□ Plaster	$\Box N$	lastic	Miscellaneous:	2' x 2' pinhole
\Box Insulation	□ DWJC		Structural		
□ Tape			teel F. P. ing	No. of Phases:	
□ Paper Wrap		\Box D	eck F. P. ing	Colour:

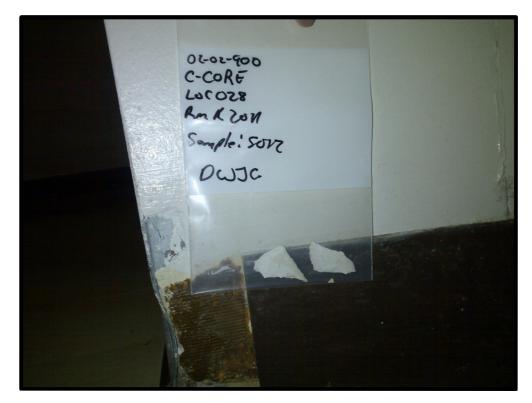
UNIVERSIT	Y			
Sample #:	S012	Date Sampled:		
Building :	C-Core	Sampler:	Trent Hardy	
Location:	028, room 2011	Analysis:	SAI - PLM	
MUN Project #:	02-02-900	Work Order #:		
		Bulk Sampling Parameters		
Pipe/Tank	Flooring	Ceiling	Roofing	Location
□ Insulation	□12'x12' Tile	□ Textured	□ Shingle	□ Floor
□ Elbow	□ 9'x9'Tile	□ Stucco	\Box Rolled	X Wall Orientation
□ Fitting	\Box Vinyl Sheet \Box Popcorn		□ Felt	□ Ceiling
□ Transite Pipe	□ Mastic	□ DWJC	🗖 Tar	□ Above Ceiling
□ Gasket	Wall	□ Plaster		□ Other
□ Tank Insulation	□ Transite Panel	□ Acoustic Tile (Dropped)		
□ Pipe Wrap	□ Textured Wall	□ Acoustic Tile (Glued-on)		
HVAC	□ Plaster	□ Mastic	Miscellaneous:	
□ Insulation	X DWJC	Structural		
□ Tape		□ Steel F. P. ing	No. of Phases:	
□ Paper Wrap		Deck F. P. ing	Colour:

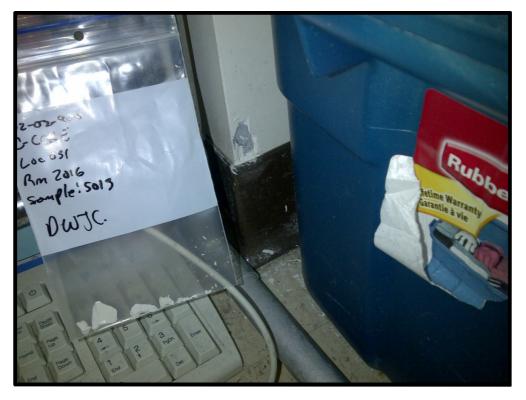
UNIVERSITY							
Sample #:	S013	Date Sampled:					
Building :	C-Core	Sampler:	Trent Hardy				
Location:	031, room 2016	Analysis:	SAI - PLM				
MUN Project #:	02-02-900	Work Order #:					
Bulk Sampling Parameters							
Pipe/Tank	Flooring	Ceiling	Roofing	Location			
□ Insulation	□12'x12' Tile	□ Textured	□ Shingle	□ Floor			
□ Elbow	□ 9'x9'Tile	□ Stucco	□ Rolled	X Wall Orientation			
□ Fitting	□ Vinyl Sheet	□ Popcorn	🗆 Felt	□ Ceiling			
□ Transite Pipe	□ Mastic	□ DWJC	🗆 Tar	□ Above Ceiling			
□ Gasket	Wall	□ Plaster		□ Other			
□ Tank Insulation	□ Transite Panel	□ Acoustic Tile (Dropped)					
□ Pipe Wrap	□ Textured Wall	\Box Acoustic Tile (Glued-on)					
HVAC	□ Plaster	□ Mastic	Miscellaneous:				
□ Insulation	X DWJC	Structural					
□ Tape		□ Steel F. P. ing	No. of Phases:				
□ Paper Wrap		Deck F. P. ing	Colour:

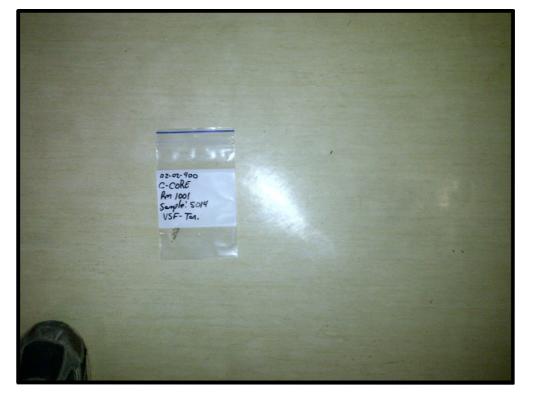
ASBESTOS BULK SAMPLING FORM							
Sample #:	S014	Ι	Date Sampled:	May 2, 2013			
Building :	C-Core Samp		Sampler:	Trent Hardy			
Location:	Room 1001		Analysis:	SAI - PLM			
MUN Project #:	02-02-900 W		Vork Order #:				
Bulk Sampling Parameters							
Pipe/Tank	Flooring	Ceiling		Roofing	Location		
□ Insulation	□12'x12' Tile	□ Textured		□ Shingle	X Floor		
\Box Elbow	□ 9'x9'Tile	□ Stucco		□ Rolled	□ Wall Orientation		
□ Fitting	X Vinyl Sheet	Popcorn		□ Felt	□ Ceiling		
□ Transite Pipe	□ Mastic	□ DWJC		🗆 Tar	□ Above Ceiling		
□ Gasket	Wall	🗆 Plas	ster		□ Other		
□ Tank Insulation	□ Transite Panel	\Box Acc	oustic Tile (Dropped)				
□ Pipe Wrap	□ Textured Wall	\Box Acc	oustic Tile (Glued-on)				
HVAC	□ Plaster	□ Mastic		Miscellaneous	: Tan		
\Box Insulation	DWJC		Structural				
□ Tape		□ Steel F. P. ing No. of Phases:					
□ Paper Wrap		Deck F. P. ing		Colour:

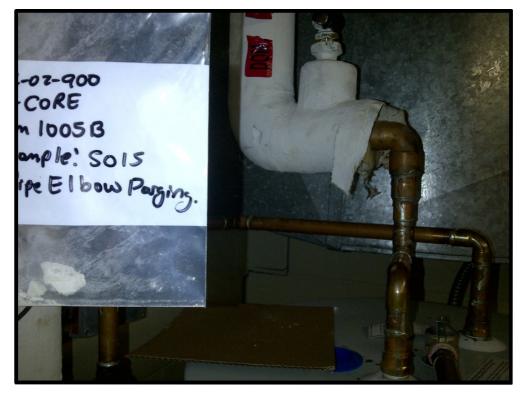
ASBESTOS BULK SAMPLING FORM							
Sample #:	S015	Date Sampled:	May 2, 2013	May 2, 2013			
Building :	C-Core Sampler:		Trent Hardy				
Location:	Room 1005B	Analysis:	SAI - PLM				
MUN Project #:	02-02-900 Work Order #:						
Bulk Sampling Parameters							
Pipe/Tank	Flooring	Ceiling	Roofing	Location			
\Box Insulation	□12'x12' Tile	□ Textured	\Box Shingle	□ Floor			
X Elbow	□ 9'x9'Tile	□ Stucco	□ Rolled	X Wall Orientation			
□ Fitting	□ Vinyl Sheet	□ Popcorn	🗆 Felt	□ Ceiling			
□ Transite Pipe	□ Mastic	□ DWJC	🗆 Tar	□ Above Ceiling			
□ Gasket	Wall	\Box Plaster \Box Other		□ Other			
□ Tank Insulation	□ Transite Panel	□ Acoustic Tile (Dropped)					
□ Pipe Wrap	□ Textured Wall	\Box Acoustic Tile (Glued-on)					
HVAC	□ Plaster	□ Mastic	Miscellaneous: Parging				
\Box Insulation	□ DWJC	Structural					
□ Tape		□ Steel F. P. ing	No. of Phases:				
□ Paper Wrap		Deck F. P. ing	Colour:

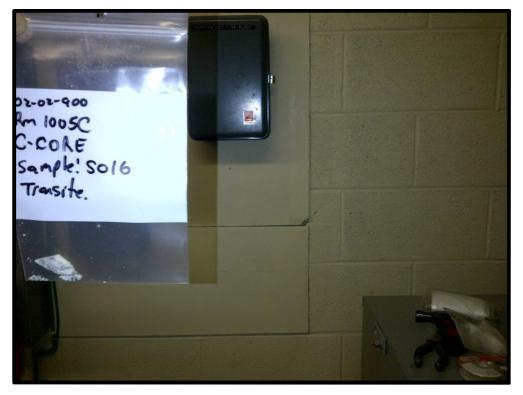
ASBESTOS BULK SAMPLING FORM							
Sample #:	S016		Date Sampled:	May 2, 2013			
Building :	C-Core	Core Sampler:		Trent Hardy			
Location:	Room 1005C	om 1005C Analysis:		SAI - PLM			
MUN Project #:	02-02-900	-02-900 Work Order #:					
Bulk Sampling Parameters							
Pipe/Tank	Flooring		Ceiling	Roofing	Location		
□ Insulation	□12'x12' Tile	□ Textured		□ Shingle	□ Floor		
\Box Elbow	□ 9'x9'Tile	□ Stucco		□ Rolled	X Wall Orientation		
□ Fitting	□ Vinyl Sheet	□ Popcorn		□ Felt	□ Ceiling		
□ Transite Pipe	□ Mastic	□ DWJC		🗆 Tar	□ Above Ceiling		
□ Gasket	Wall	□ Plaster			□ Other		
□ Tank Insulation	X Transite Panel	$\Box A$	coustic Tile (Dropped)				
□ Pipe Wrap	□ Textured Wall	$\Box A$	coustic Tile (Glued-on)				
HVAC	□ Plaster	□ Mastic		Miscellaneous:			
□ Insulation	DWJC		Structural				
□ Tape		\Box S	teel F. P. ing	No. of Phases:			
Paper Wrap		\Box D	eck F. P. ing	Colour:
