Project #: 13916

**ASBESTOS ASSESSMENT
Cabot Court
Memorial University of Newfoundland
St. John's, NL**

September 2011

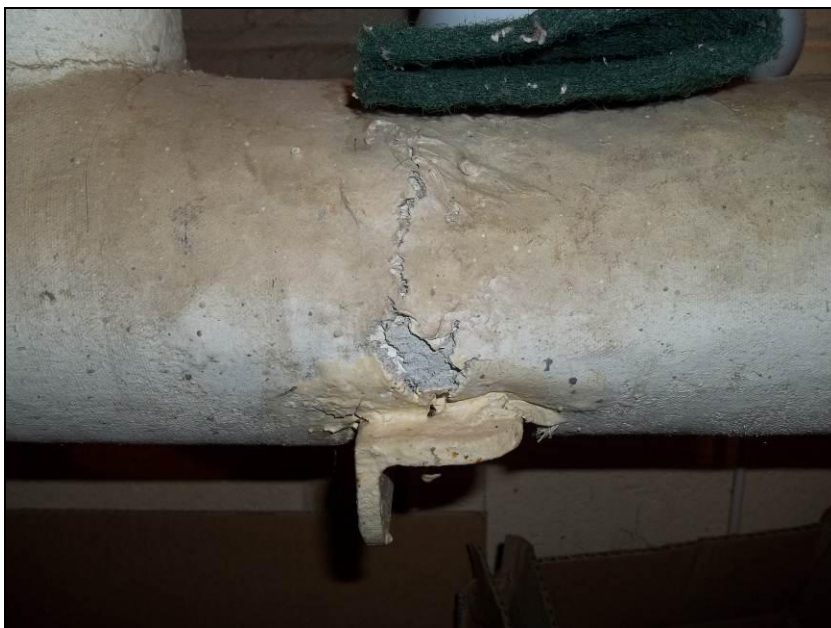
Two types of pipe fitting insulation which could potentially contain asbestos were observed in select areas throughout the building during this assessment. Samples were collected of fitting insulation in the hallways and analyzed for asbestos content using the PLM method of detection. These samples were identified as non-asbestos containing. The fittings identified in closets of the residence rooms and the mechanical room is visually distinguishable and appears to be older than those in the hallway. Those fittings must be considered to be asbestos containing until proven otherwise (see sample CT-1 in Appendix II, Photographs 1, 2, Appendix I)

Photograph 1: Suspect asbestos containing pipe fitting insulation in Room CT112, mechanical room, in poor condition.

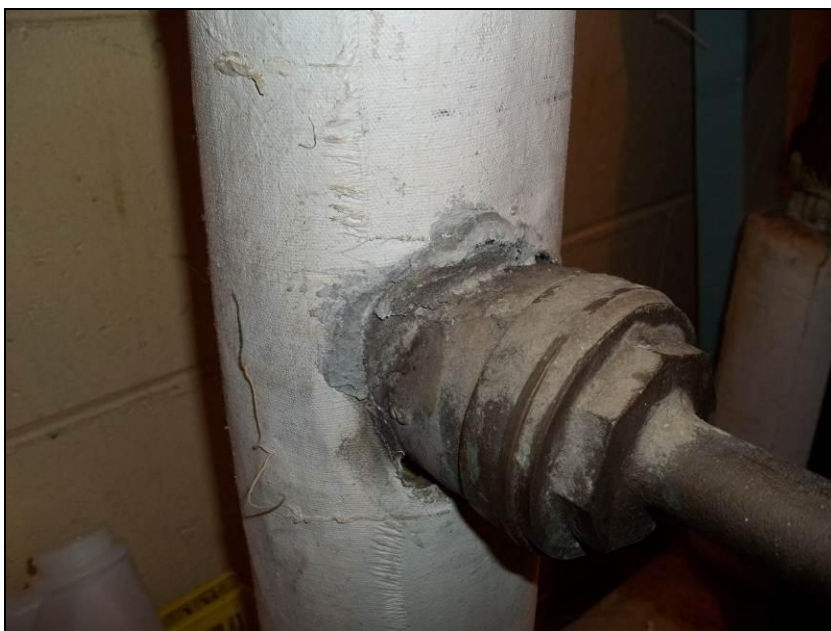
Photograph 2: Suspect asbestos containing pipe fitting insulation in Room CT112, mechanical room, in poor condition.

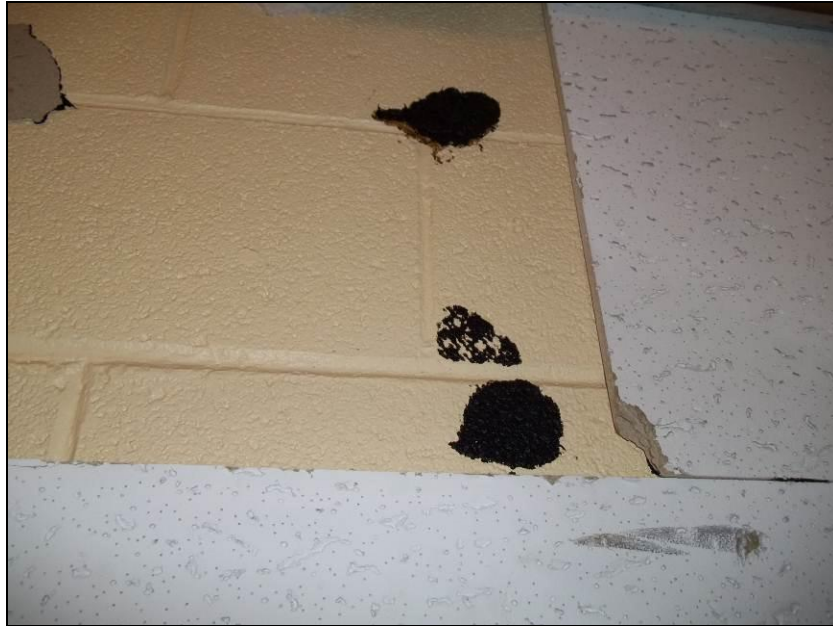
Ceiling tile adhesive associated with the above mentioned ceiling tiles was sampled and analyzed for asbestos content using the PLM method of detection. The sample was found to contain 10% Chrysotile asbestos. (see sample CT-16 in Appendix II, Photograph 3 in Appendix I)

Photograph 3: Sample CT-16. Asbestos containing ceiling tile adhesive on the walls of Room CT312.

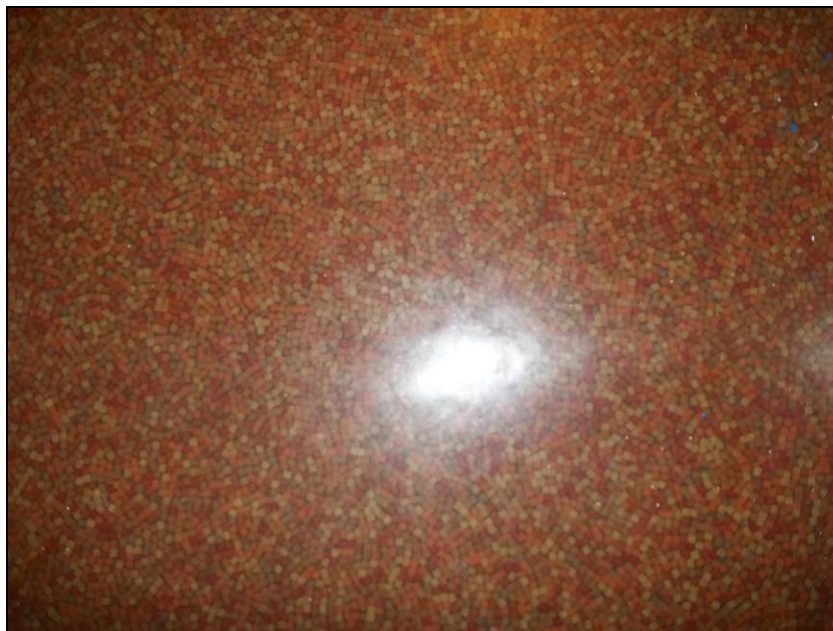
Photograph 4: Sample CT-6. The flooring was found to contain 20% Chrysotile asbestos.

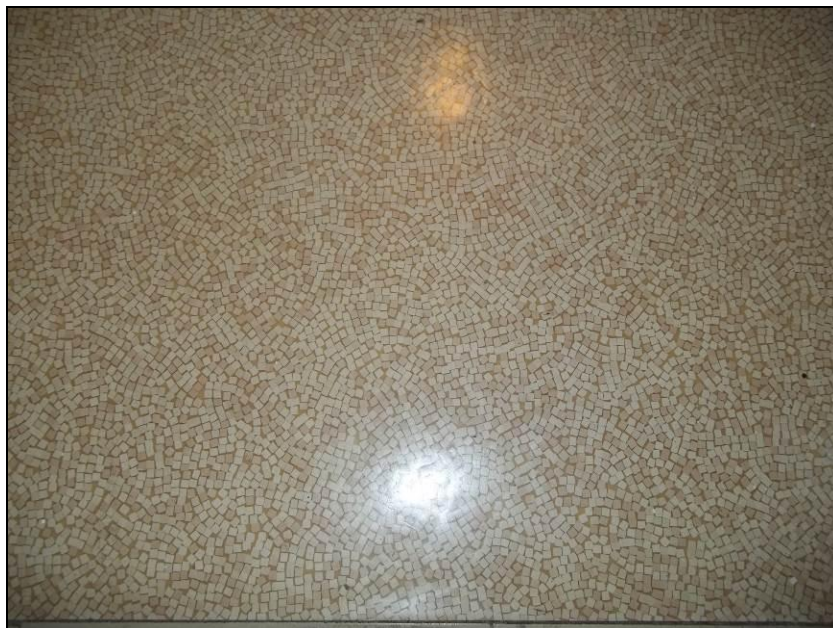
Photograph 5: Sample CT-8. The flooring was found to contain 20% Chrysotile asbestos.

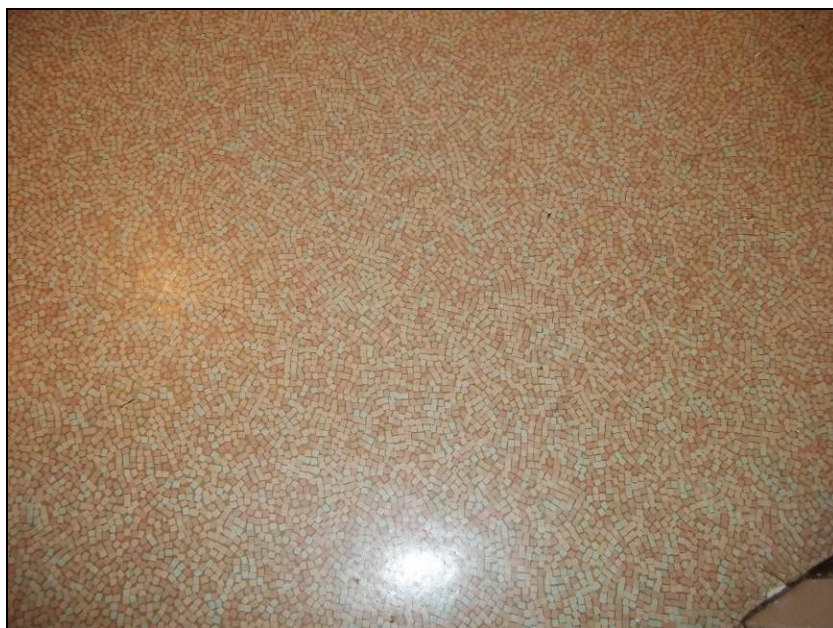
Photograph 6: Sample CT-10. The flooring was found to contain 20% Chrysotile asbestos.

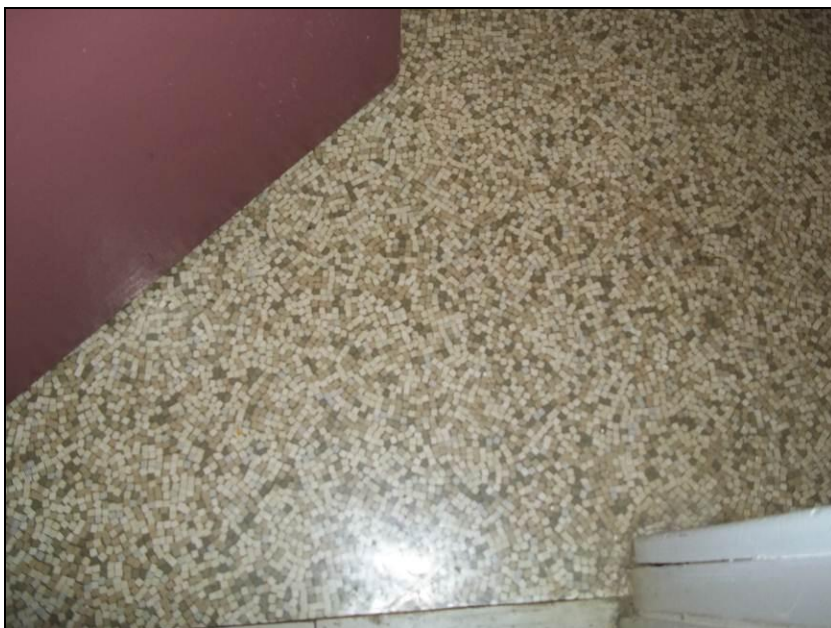
Photograph 7: Sample CT-18. The flooring was found to contain 20% Chrysotile asbestos.

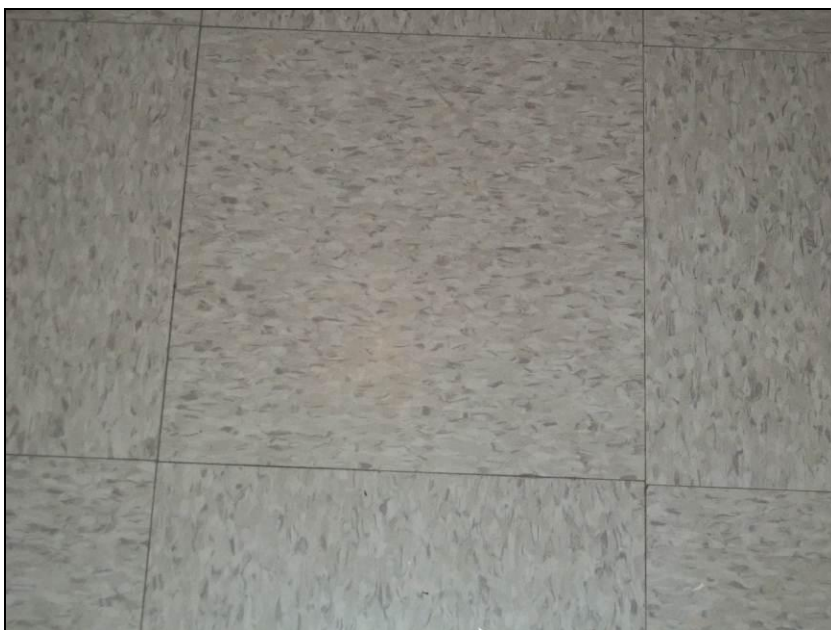
Photograph 8: Sample CT-2. The vinyl floor tile was identified as non-asbestos containing. The mastic was found to contain 5% Chrysotile asbestos.

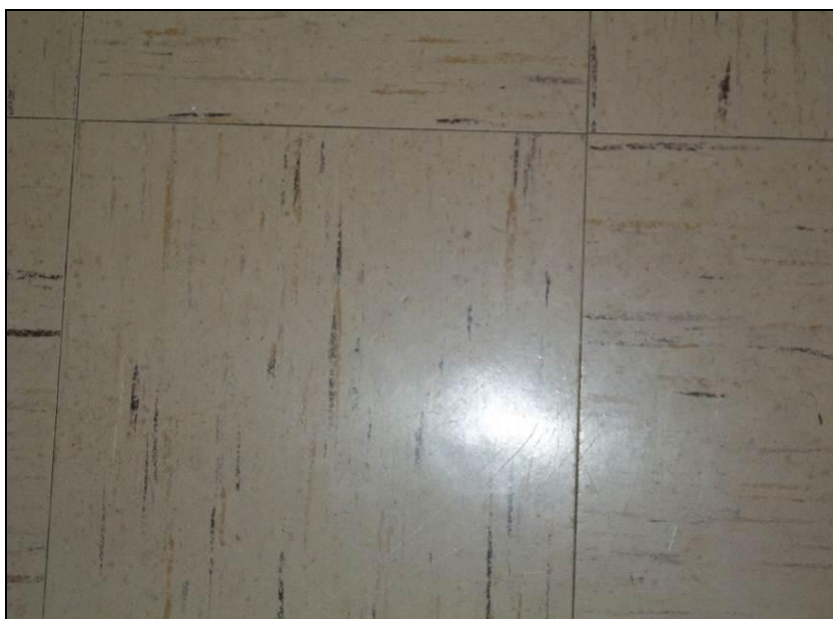
Photograph 9: Sample CT-3. The vinyl floor tile was found to contain 5% Chrysotile asbestos.

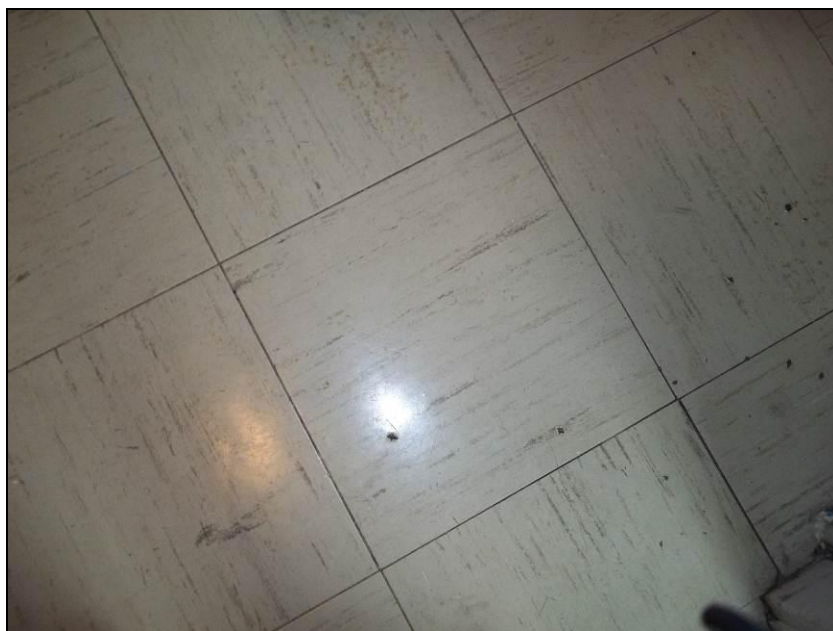
Photograph 10: Sample CT-7. The vinyl floor tile was found to contain 5% Chrysotile asbestos.

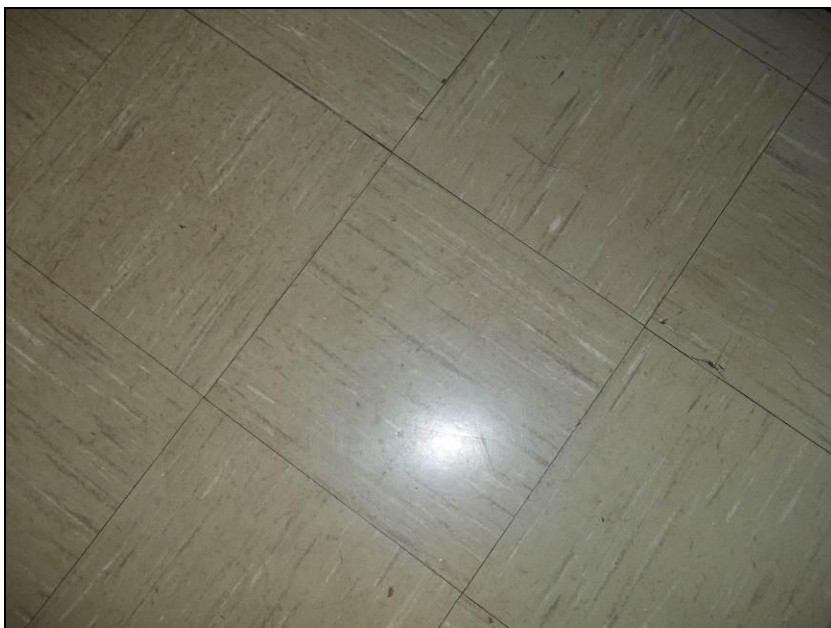
Photograph 11: Sample CT-9. The vinyl floor tile was found to contain 5% Chrysotile asbestos, and the mastic was found to contain 3% Chrysotile asbestos.

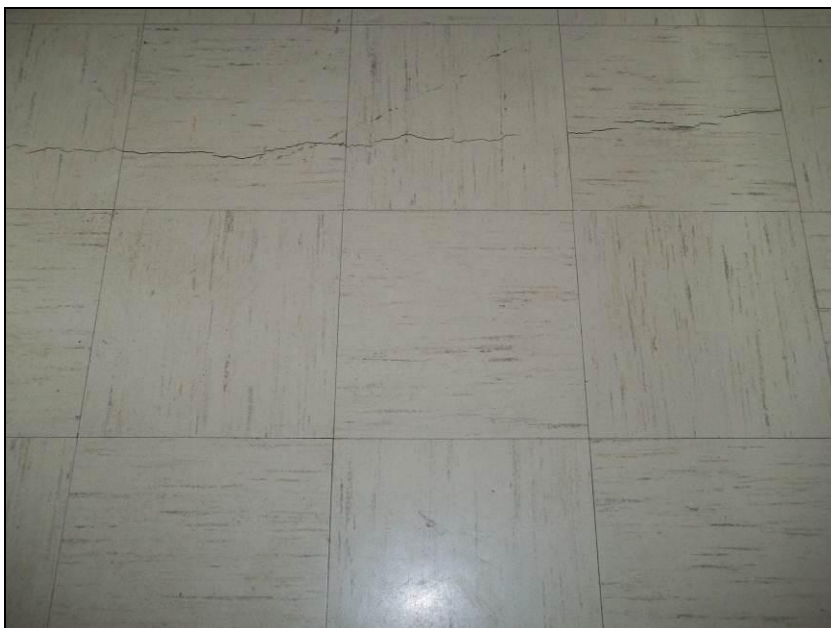
Photograph 12: Sample CT-13. The vinyl floor tile was found to contain 8% Chrysotile asbestos.

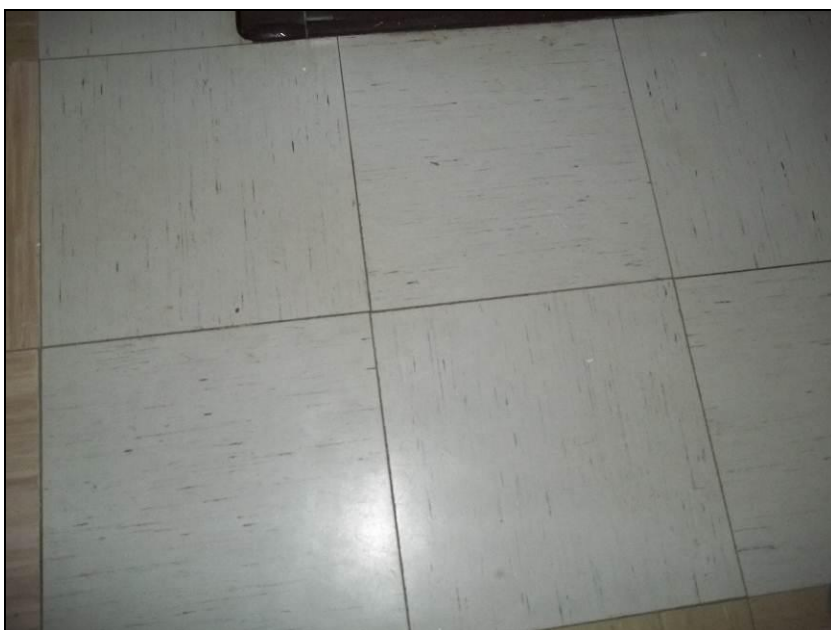
Photograph 13: Sample CT-20. The vinyl floor tile was identified as non-asbestos containing. The mastic was found to contain 3% Chrysotile asbestos.

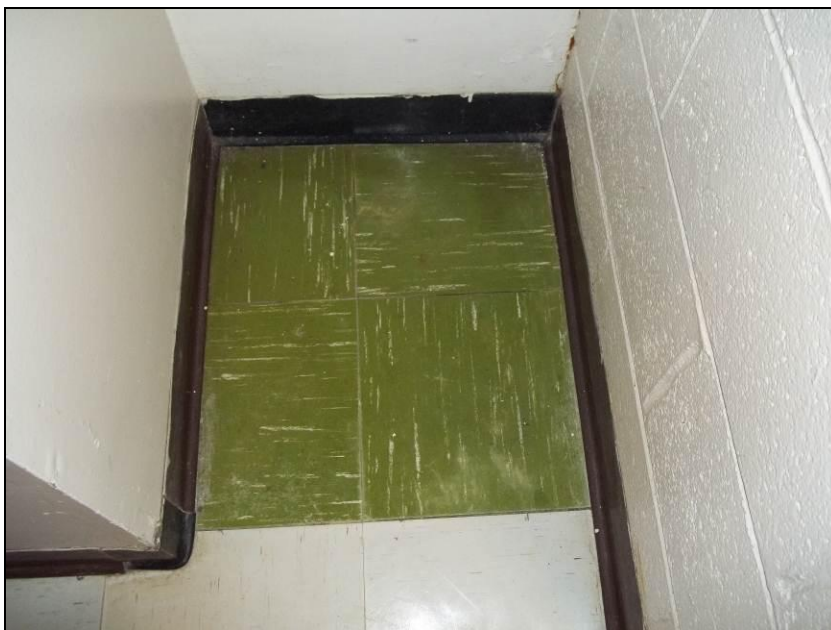
Photograph 14: Sample CT-23. The vinyl floor tile was found to contain 8% Chrysotile asbestos, and the mastic was found to contain 3% Chrysotile asbestos.

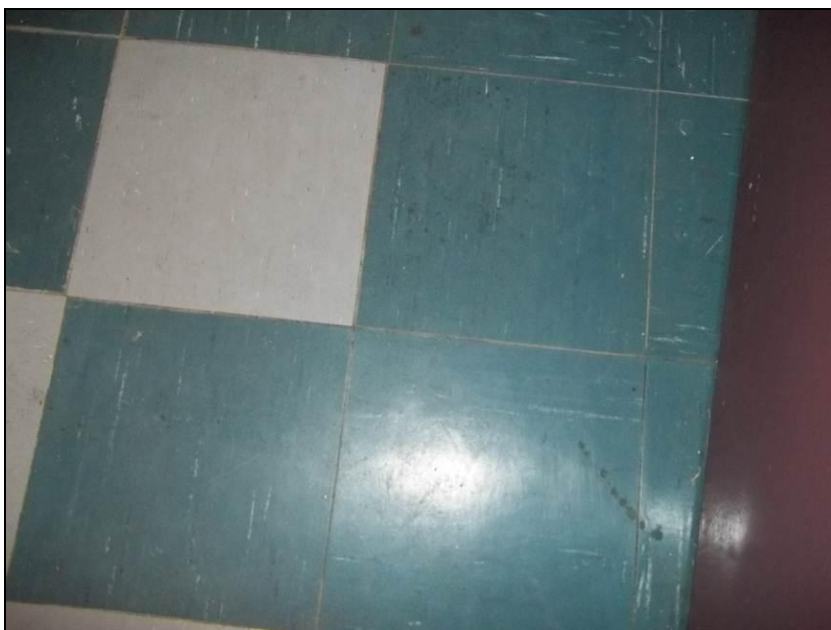
Photograph 15: Sample CT-27. The vinyl floor tile was found to contain 2% Chrysotile asbestos, and the mastic was found to contain 5% Chrysotile asbestos.

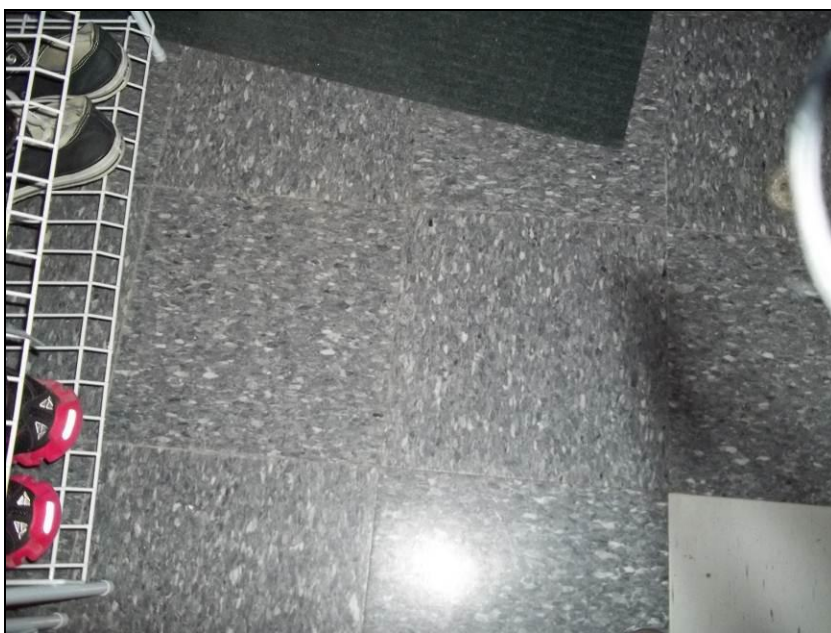
Photograph 16: Sample CT-29. The vinyl floor tile was identified as non-asbestos containing. The mastic was found to contain 2% Chrysotile asbestos.

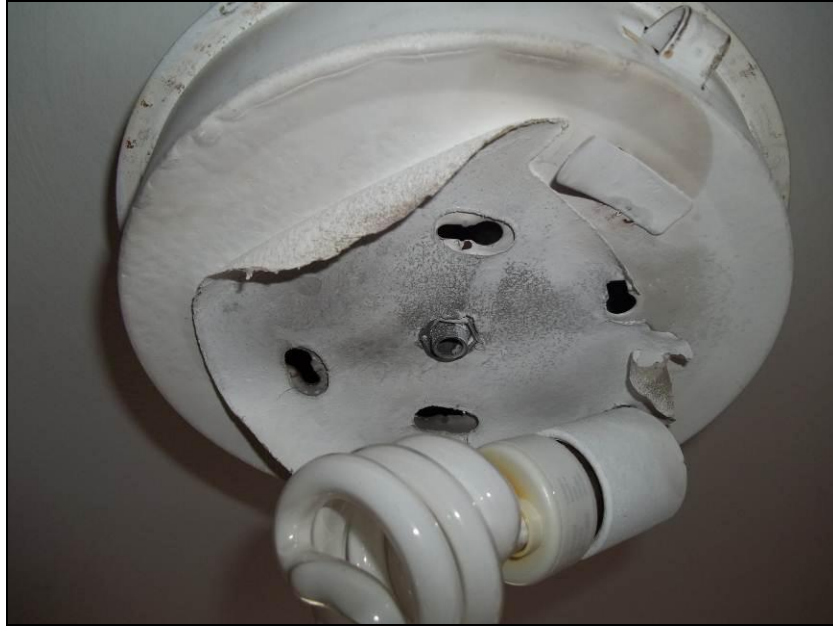
Three (3) types of light fixture heat shields were observed throughout the building. Samples were collected and analyzed for asbestos content using the PLM method of detection. One (1) of the three (3) samples was found to contain 20% Chrysotile asbestos (see samples CT-5, CT-11, CT-12 in Appendix II, see Photographs 17, 18 in Appendix I).

Photograph 17: Sample CT-12. Asbestos containing light fixture heat shield.

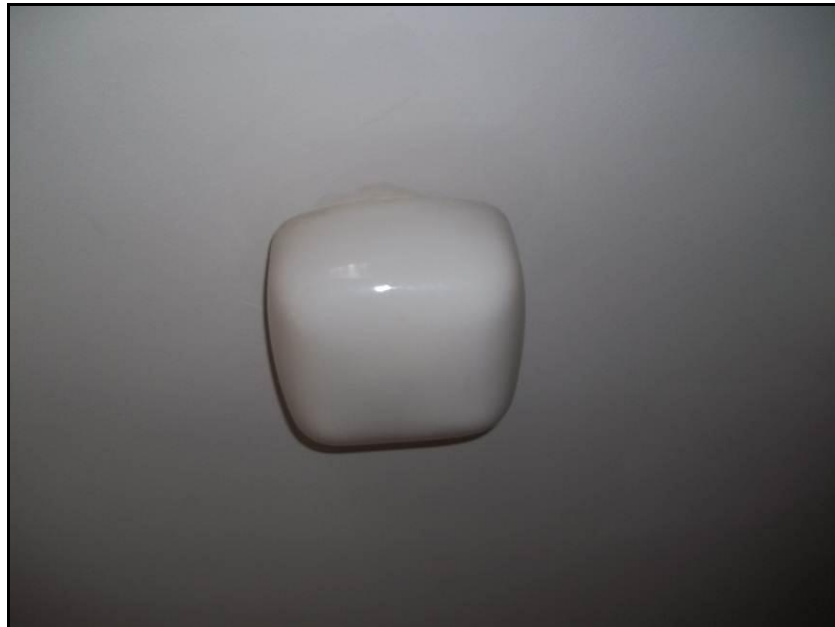
Photograph 18: Sample CT-12. Globe associated with asbestos containing light fixture heat shield.
