Project #: 13916

**ASBESTOS ASSESSMENT
Cartier Court
Memorial University of Newfoundland
St. John's, NL**

September 2011

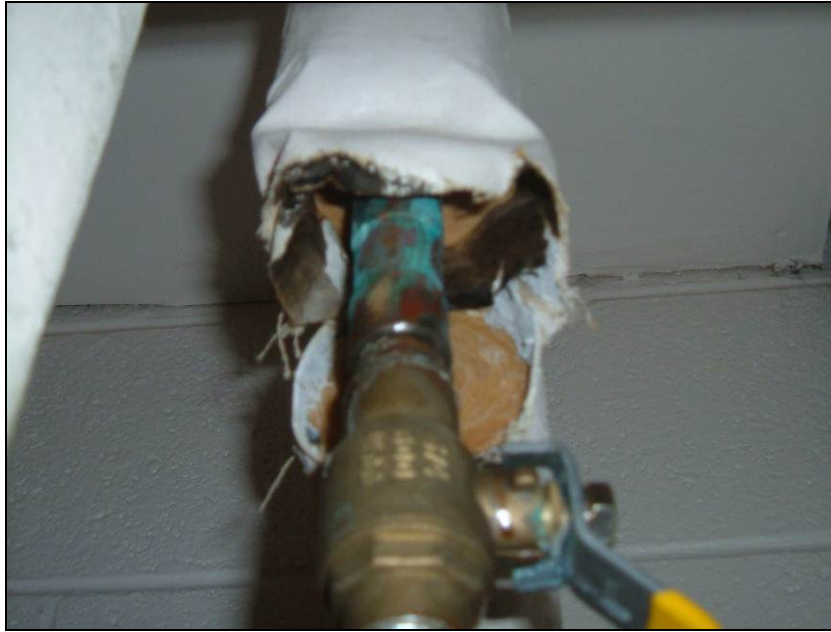
Pipe fitting insulation which could potentially contain asbestos was observed in select areas throughout the building during this assessment. Samples collected from the hallways and from the closets were analyzed for asbestos content using the PLM method of detection. The sample from the hallway was identified as non-asbestos containing. The sample from the closet was found to contain 25% Chrysotile asbestos (see samples CR-15, CR-23 in Appendix II, Photographs 1 - 3, Appendix I)

Photograph 1: Pipe fitting insulation debris in the closet of Room CR209, in poor condition.

- All materials listed in fair and/or poor condition are to be repaired or removed immediately. See APPENDIX III – Asbestos Building Survey Information for materials condition and locations.

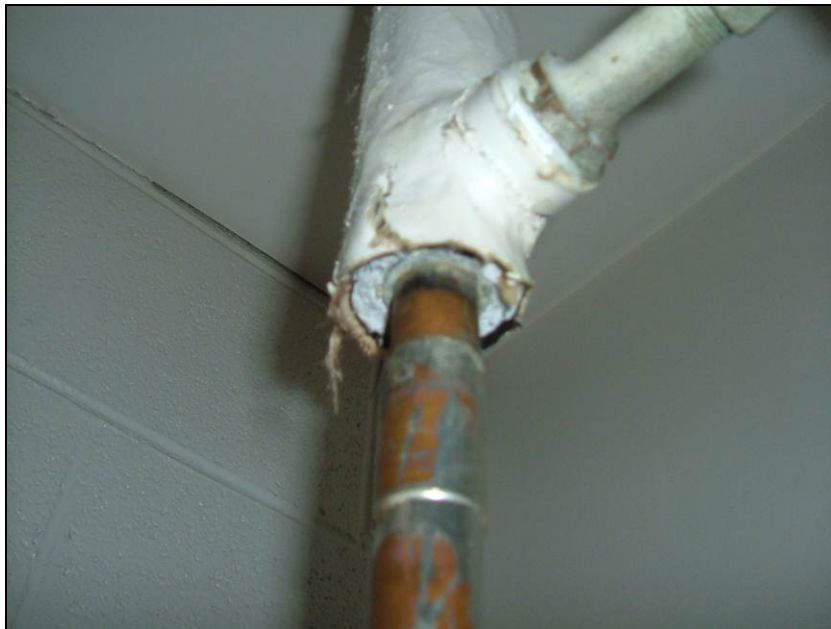
Photograph 2: Pipe fitting insulation debris in the closet of Room CR210, in poor condition.

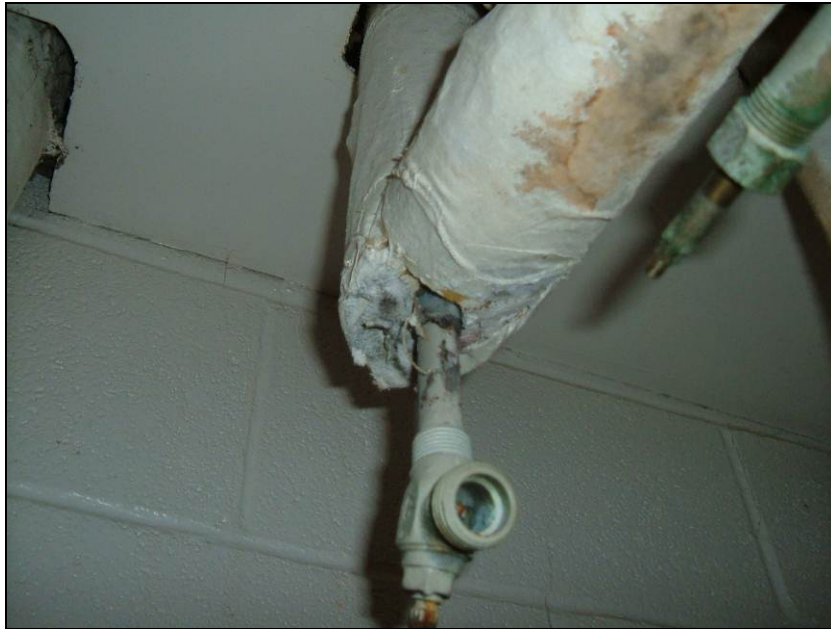
Photograph 3: Pipe fitting insulation debris in the closet of Room CR108, in poor condition.

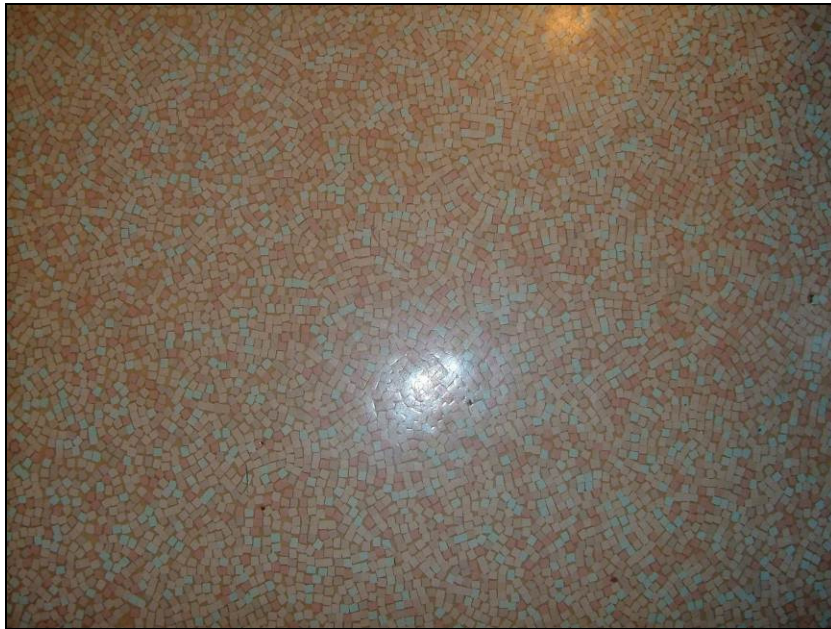
Various vinyl sheet floorings which could potentially contain asbestos were identified in the building during the assessment. Five (5) samples of this flooring were sampled and analyzed for asbestos content using the PLM method of detection. Three (3) of the samples were found to contain between 15 – 20% Chrysotile asbestos. (see samples CR-4, CR-9, CR-13, CR-26, CR-20 in Appendix II, Photographs 4 – 6 in Appendix I)

Photograph 4: Sample CR-4, asbestos containing vinyl sheet flooring.

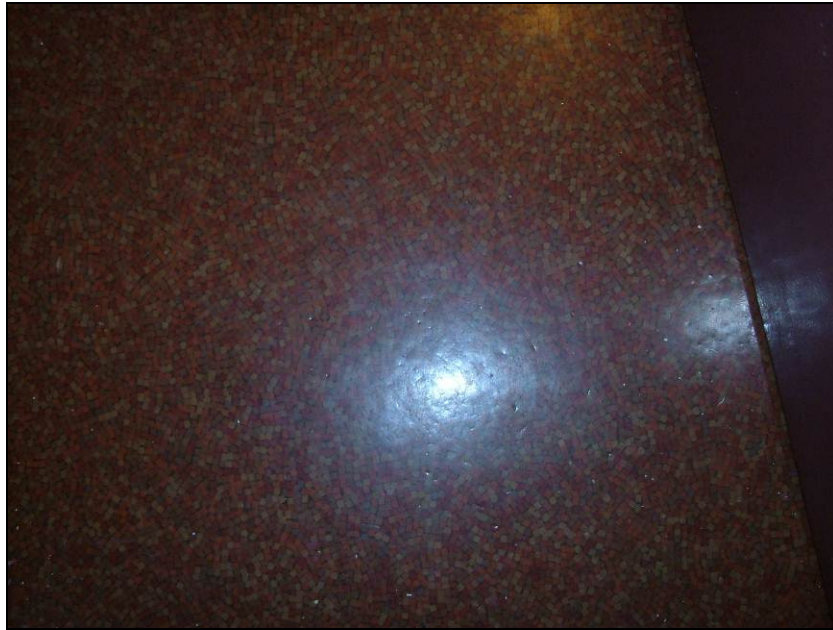
Photograph 5: Sample CR-9, asbestos containing vinyl sheet flooring.

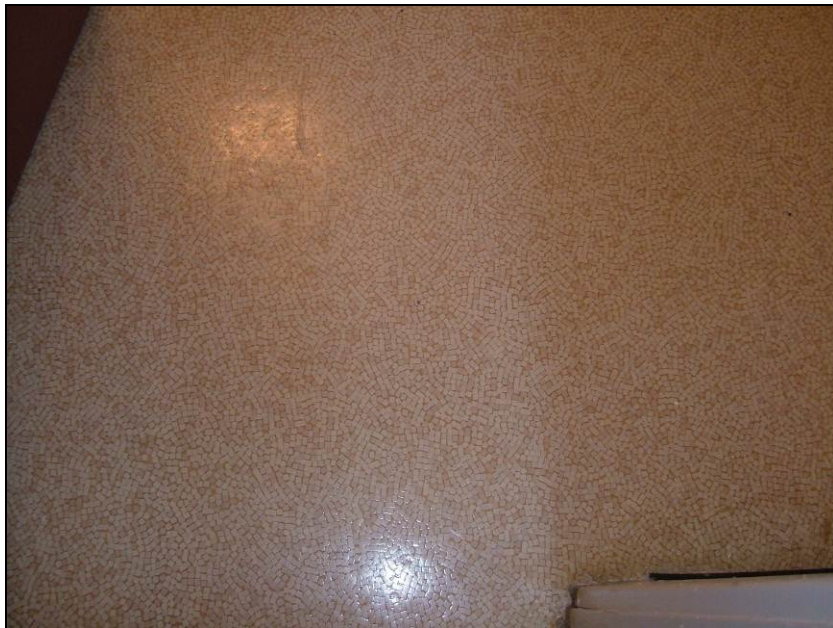
Photograph 6: Sample CR-20, asbestos containing vinyl sheet flooring.

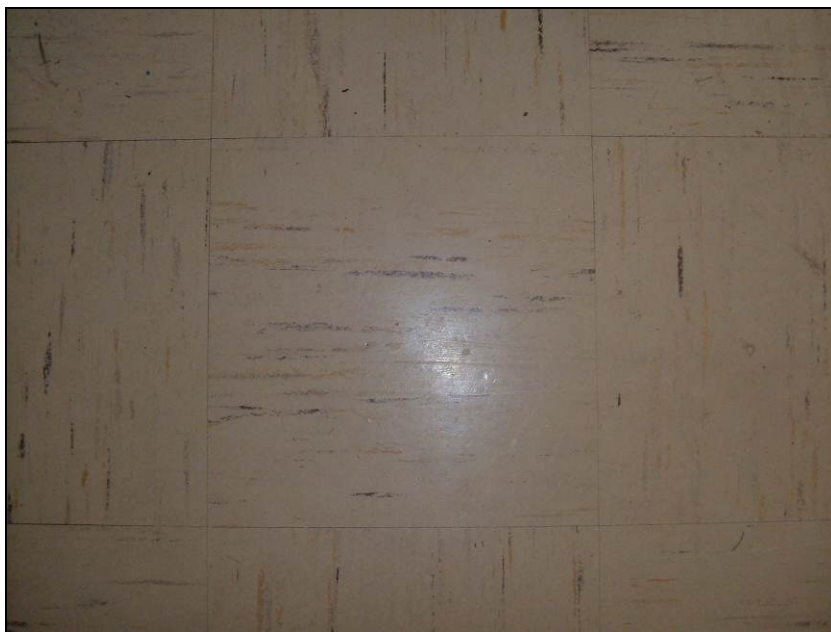
Vinyl floor tiles which could potentially contain asbestos were identified during the assessment. Sixteen (16) samples of 1' x 1' vinyl floor tiles were sampled and analyzed for asbestos content using the PLM method of detection. Eight (8) tiles and / or their associated mastics were found to contain between 3 – 8% Chrysotile asbestos. One tile, sample CR-11, was analyzed and its mastic was found to contain <1% Chrysotile asbestos. As such, in accordance with the *Newfoundland Asbestos Abatement Regulations 111/98*, it is not considered to be asbestos containing. (see samples CR-1, CR-2, CR-3, CR-5, CR-6, CR-7, CR-8, CR-10, CR-11, CR-12, CR-22, CR-27, CR-28, CR-30, CR-31, CR-33 in Appendix II, see Photographs 7 - 14 Appendix I)

Photograph 7: Sample CR-1 asbestos containing vinyl floor tile and mastic.

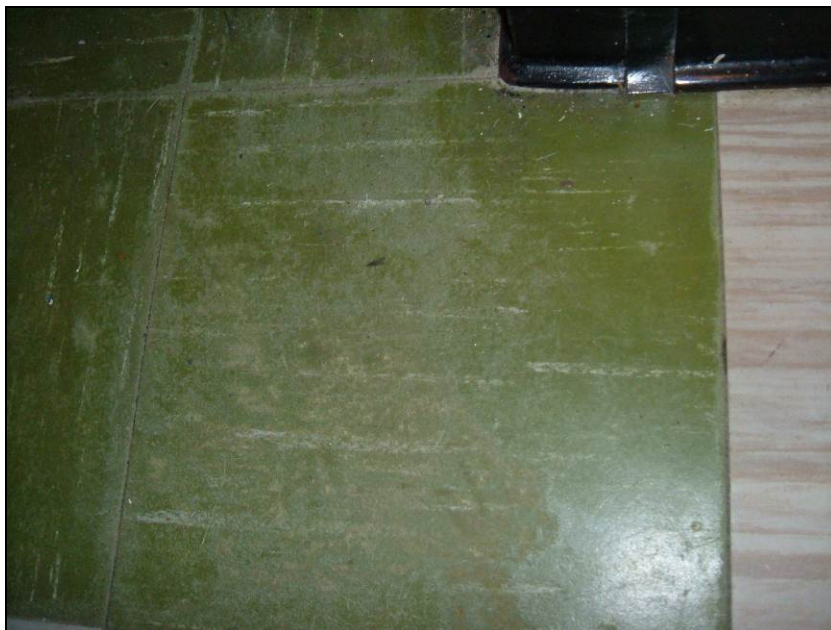
Photograph 8: Sample CR-5 asbestos containing vinyl floor tile and mastic.

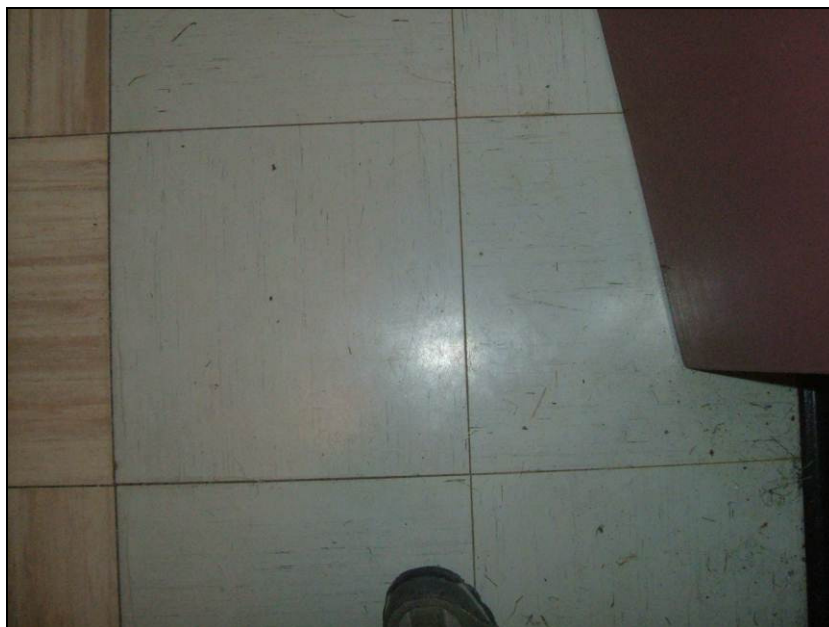
Photograph 9: Sample CR-7 asbestos containing mastic associated with the non-asbestos containing tile.

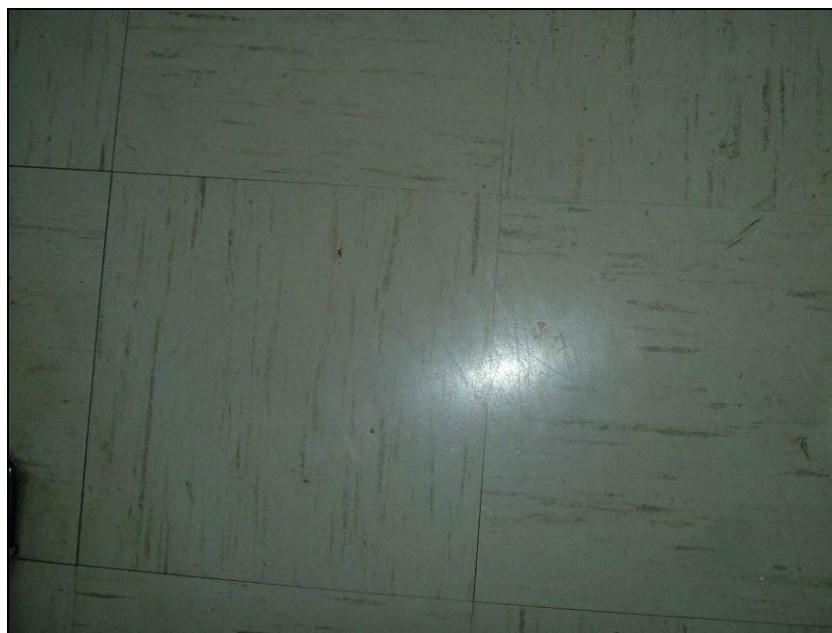
Photograph 10: Sample CR-8 asbestos containing vinyl floor tile.

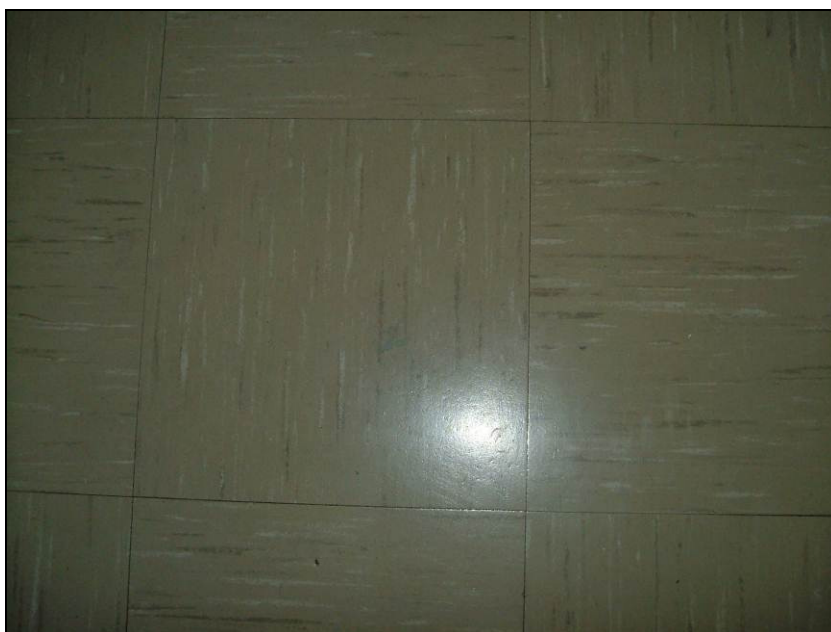
Photograph 11: Sample CR-10 asbestos containing vinyl floor tile.

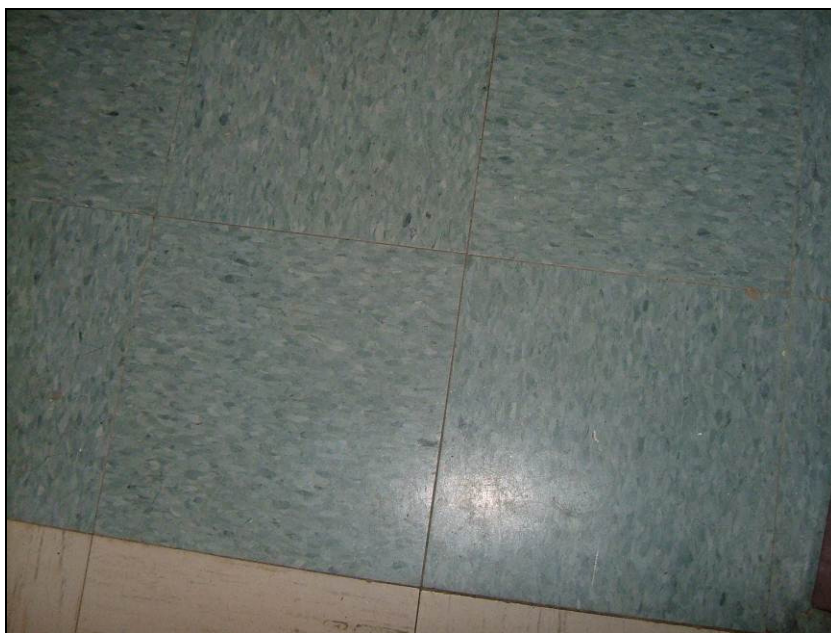
Photograph 12: Sample CR-22 asbestos containing mastic associated with the non-asbestos containing tile.

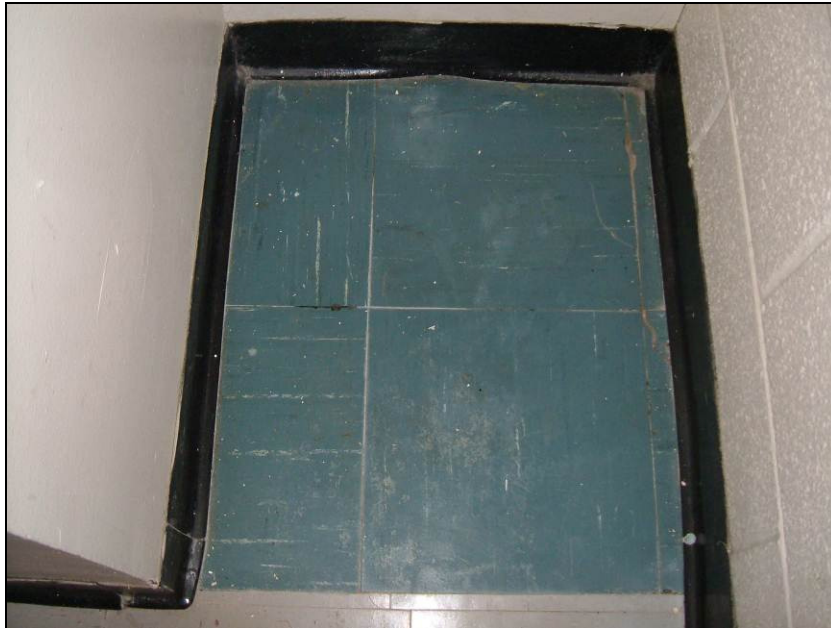
Photograph 13: Sample CR-28 asbestos containing vinyl floor tile and mastic.

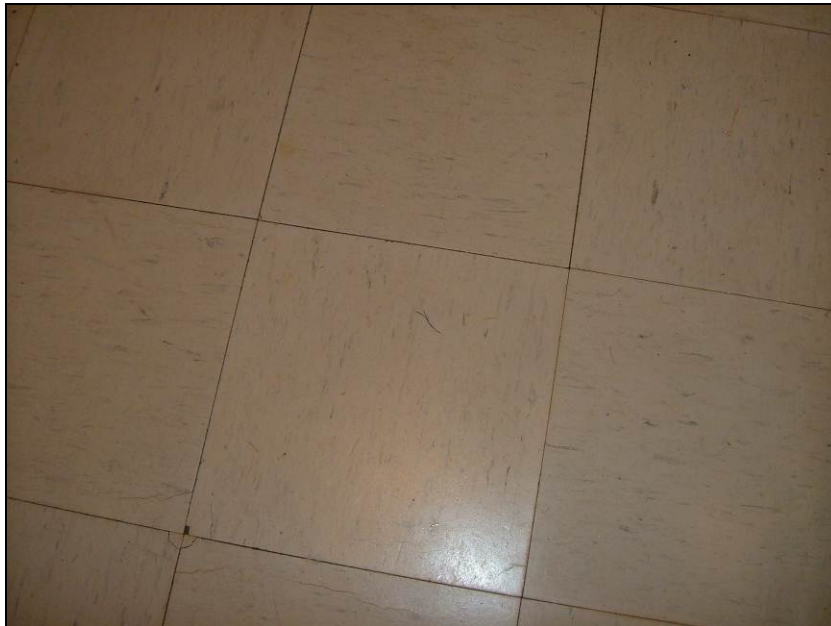
Photograph 14: Sample CR-33 asbestos containing mastic associated with the non-asbestos containing tile.

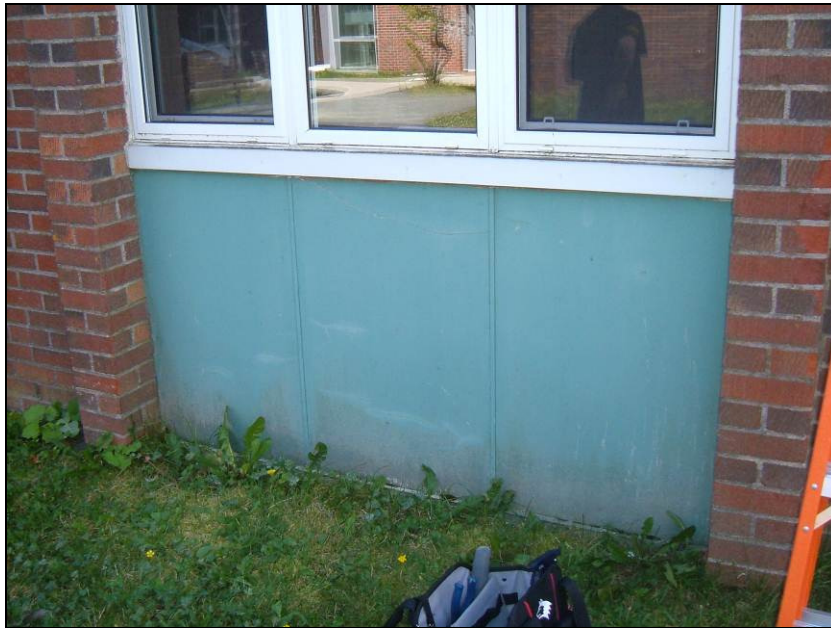
Suspect asbestos containing transite paneling was observed on the exterior widows panels. One (1) sample was collected and analyzed for asbestos content using the PLM method of detection. The sample was found to contain 25% Chrysotile asbestos. As such, based on the composition and similarity of the construction of these residences, it is suspected that the panels at the other residences of Burton's Pond are also asbestos containing. (see sample CR-34 in Appendix II, Photographs 15 of Appendix I)

Photograph 15: Sample CR-34. Asbestos containing transite panels at the exterior of the building. Suspected to be similar material on all exteriors of Burtons Pond residences.

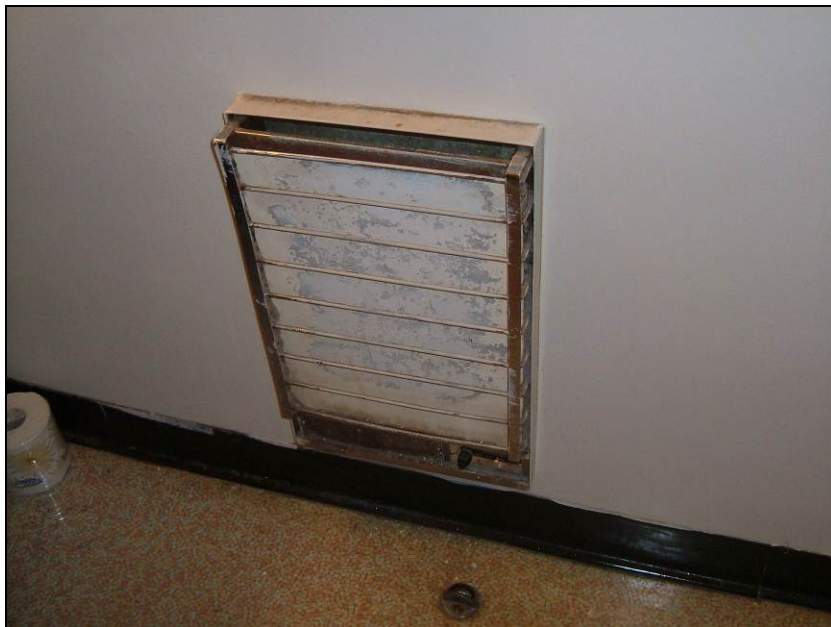
Suspect asbestos containing transite paneling on washroom heaters was also observed during the assessment. One (1) sample was collected and analyzed for asbestos content using the PLM method of detection. The sample was found to contain 25% Chrysotile asbestos. (see sample CR-16 in Appendix II, Photograph 16 of Appendix I)

Photograph 16: Sample CR-16. Asbestos containing transite on heaters in washrooms.

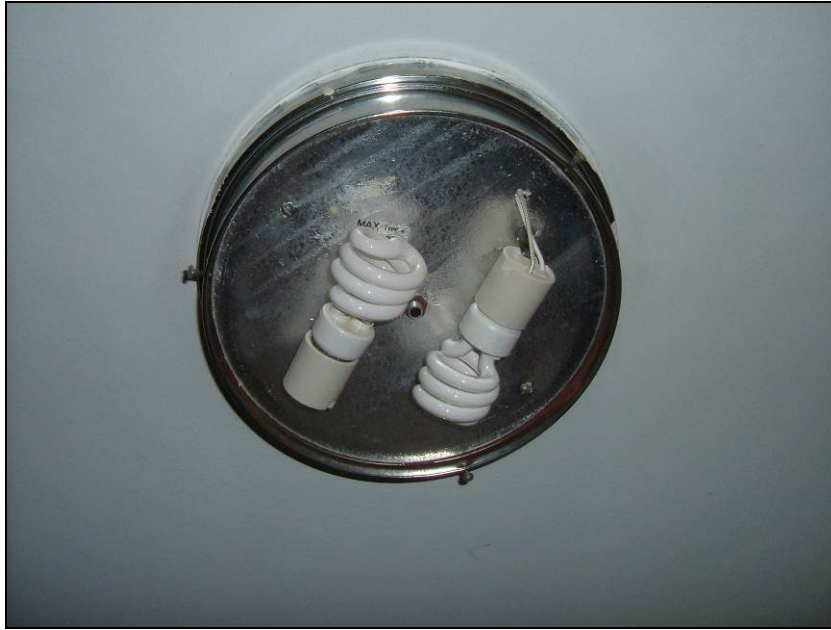
Four (4) types of light fixture heat shields were observed throughout the building. Samples were collected and analyzed for asbestos content using the PLM method of detection. One (1) sample was found to contain 80% Chrysotile asbestos (see samples CR-14, CR-17, CR-25, CR-29 in Appendix II, see Photographs 17 - 18 in Appendix I).

Photograph 17: Sample CR-29. Asbestos containing light fixture heat shield.

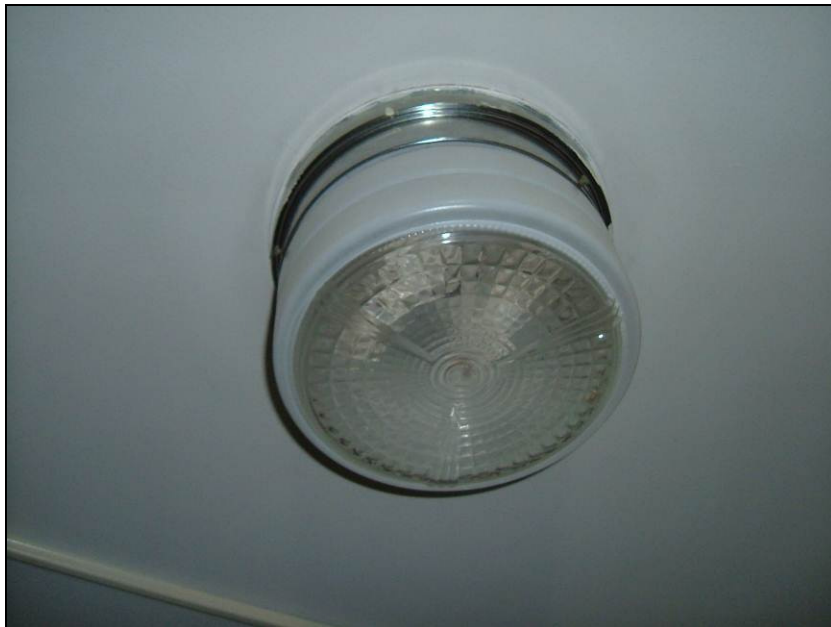
Photograph 18: Sample CR-29. Light globe associated with asbestos containing light fixture heat shield.
