# ASBESTOS AND LEAD PAINT BUILDING MATERIALS SURVEY FOR: COMPUTING SERVICES MEMORIAL UNIVERSITY OF NEWFOUNDLAND

Pinchin LeBlanc Environmental Ltd Project No. 02-02-00900

March 27, 2013

**BUILDING DESCRIPTION:** COMPUTING SERVICES COLLEGE

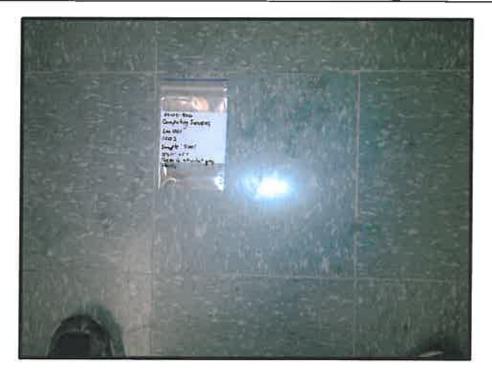
Green with abundant grey fleck, 12"x 12" vinyl floor tiles were sampled in room 1C02.
 Analysis of this sample and the associated tar mastic adhesive and leveling compound did not identify the presence of asbestos (reference sample 02-02-900-S001).

Sample #:	S001		Date Sampled:	March 19, 2013	-	
Building:	Computing Services		Sampler:	Trent Hardy		
Location:	001, room 1002		Analysis:	SAI - PLM		
MUN Project #:	02-02-900		Work Order #:			
		Bulk S	Sampling Parameters	-		
Pipe/Tank	Flooring		Ceiling	Roofing	Location	
☐ Insulation	X 12'x12' Tile	□Те	extured	☐ Shingle	X Floor	
☐ Elbow	□ 9'x9'Tile	□ St	иссо	☐ Rolled	☐ Wall Orientation	
☐ Fitting	□ Vinyl Sheet	☐ Popcorn		☐ Felt	☐ Ceiling	
☐ Transite Pipe	☐ Mastic	□ D'	ŴJC	□ Tar	☐ Above Ceiling	
☐ Gasket	Wall	□ Pla	aster		☐ Other	
☐ Tank Insulation	☐ Transite Panel		coustic Tile (Dropped)			
☐ Pipe Wrap	□ Textured Wall		coustic Tile (Glued-on)			
HVAC	☐ Plaster		astic	Miscellaneous:		
☐ Insulation	□ DWJC		Structural			
☐ Tape		□ Ste	eel F. P. ing	No. of Phases:		
☐ Paper Wrap		□ De	eck F. P. ing	Colour: Green flecks	with abundant grey

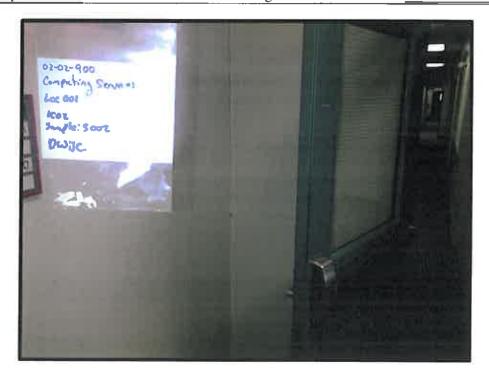
ONIVERSITY									
Sample #:	Sample #: S002		Date Sampled:	March 19, 2013					
Building: Computing Services		Sampler:	Trent Hardy						
Location:	001, hallway 1C02		Analysis:	SAI - PLM					
MUN Project #:	02-02-900		Work Order #:						
		Bulk	Sampling Parameters						
Pipe/Tank	Flooring		Ceiling	Roofing	Location				
☐ Insulation	□12'x12' Tile	$\square$ T	extured	☐ Shingle	☐ Floor				
☐ Elbow	□ 9'x9'Tile	☐ Stucco		☐ Rolled	XWall Orientation				
☐ Fitting	□ Vinyl Sheet	$\square$ P	opcom	☐ Felt	☐ Ceiling				
☐ Transite Pipe	☐ Mastic		WJC	□ Таг	☐ Above Ceiling				
☐ Gasket	Wall	$\square$ P	laster		☐ Other				
☐ Tank Insulation	□ Transite Panel	$\Box$ A	coustic Tile (Dropped)						
☐ Pipe Wrap	☐ Textured Wall	$\Box$ A	coustic Tile (Glued-on)						
HVAC	☐ Plaster	☐ Mastic		Miscellaneous:					
☐ Insulation	X DWJC		Structural						
□ Tape		$\square$ S	teel F. P. ing	No. of Phases:	_				
☐ Paper Wrap		☐ Deck F. P. ing		Colour:

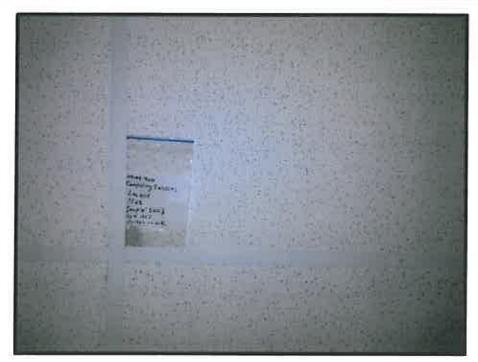
- One (1) sample of 2'x 4' acoustic ceiling tiles distinguished with a pinhole and fleck pattern was collected from room 1C02. Analysis of this sample did not identify the presence of asbestos (reference sample 02-02-900-S003).
- One (1) sample of 2'x 4' acoustic ceiling tiles distinguished with a pinhole, hole, and small fissure pattern was collected from room 1010. Analysis of this sample did not identify the presence of asbestos (reference sample 02-02-900-S007).

ONIVERSITY								
Sample #:	S003		Date Sampled:	March 19, 2013				
Building:	Computing Services		Sampler:	Trent Hardy				
Location:	001, hallway 1C02		Analysis:	SAI - PLM				
MUN Project #:	02-02-900		Work Order #:					
Bulk Sampling Parameters								
Pipe/Tank Flooring		Ceiling	Roofing	Location				
☐ Insulation	□12'x12' Tile	$\Box$ T	extured	☐ Shingle	□ Floor			
□ Elbow	□ 9'x9'Tile	☐ Stucco		☐ Rolled	☐ Wall Orientation			
☐ Fitting	□ Vinyl Sheet	☐ Popcom		□ Felt	X Ceiling			
☐ Transite Pipe	□ Mastic		WJC	☐ Tar	☐ Above Ceiling			
☐ Gasket	Wall	$\Box$ P	laster		□ Other			
☐ Tank Insulation	Transite Panel	XAc	oustic Tile (Dropped)					
☐ Pipe Wrap	□ Textured Wall		coustic Tile (Glued-on)					
HVAC	☐ Plaster	☐ Plaster ☐ Mastic		Miscellaneous:	2' x 4' pinhole fleck			
☐ Insulation	□ DWJC		Structural		_			
☐ Tape		$\square$ S	teel F. P. ing	No. of Phases:				
☐ Paper Wrap			eck F. P. ing	Colour:

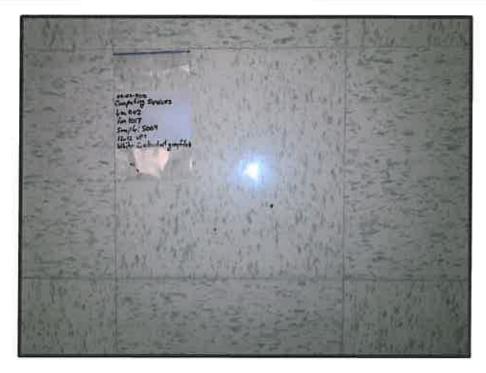
- White with abundant grey fleck, 12"x 12" vinyl floor tiles were sampled in room 1017. Analysis of this sample and the associated tar mastic adhesive did not identify the presence of asbestos (reference sample 02-02-900-S004).
- White with black streak, 12"x 12" vinyl floor tiles were sampled in room 1C02. Analysis of this sample and the associated tar mastic adhesive did not identify the presence of asbestos (reference sample 02-02-900-S005).
- Light brown with abundant brown fleck, 12"x 12" vinyl floor tiles were sampled in room 1V01. Analysis of this sample and the associated tar mastic adhesive and leveling compound did not identify the presence of asbestos (reference sample 02-02-900-S011).

Sample #:	S004	Date Sampled:	March 19, 2013	larch 19, 2013				
Building: Computing Services		es Sampler:	Trent Hardy					
Location:	002, room 1017	Analysis:	SAI - PLM					
MUN Project #:	02-02-900	Work Order #:						
		<b>Bulk Sampling Parameters</b>						
Pipe/Tank	Flooring	Ceiling	Roofing	Location				
☐ Insulation	X12'x12' Tile	☐ Textured	☐ Shingle	X Floor				
☐ Elbow	□ 9'x9'Tile	☐ Stucco	☐ Rolled	■ Wall Orientation				
☐ Fitting	□ Vinyl Sheet	□ Popcom	☐ Felt	☐ Ceiling				
☐ Transite Pipe	☐ Mastic	□ DWJC	☐ Tar	☐ Above Ceiling				
☐ Gasket	Wall	☐ Plaster		☐ Other				
☐ Tank Insulation	☐ Transite Panel	☐ Acoustic Tile (Dropped)						
☐ Pipe Wrap	☐ Textured Wall	☐ Acoustic Tile (Glued-on)						
HVAC	☐ Plaster	☐ Mastic	Miscellaneous: White with					
HVAC □ Plaster		□ IVIastic	abundant grey flecks					
☐ Insulation	□ DWJC	Structural						
☐ Tape		☐ Steel F. P. ing	No. of Phases:					
☐ Paper Wrap		□ Deck F. P. ing	Colour:

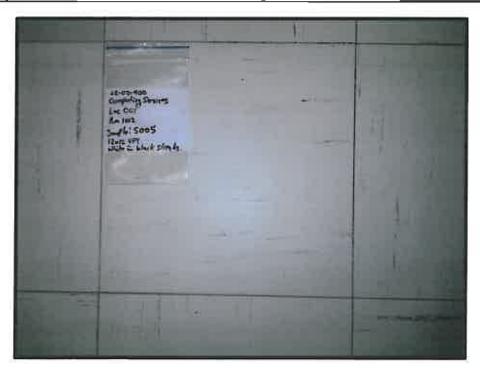
VIII EIVOIT I									
Sample #:	S005		Date Sampled:	March 19, 2013					
Building: Computing Service		es	Sampler:	Trent Hardy					
Location:	007, room 1012		Analysis:	SAI - PLM					
MUN Project#:	02-02-900		Work Order#:						
		Bulk	Sampling Parameters						
Pipe/Tank	Flooring		Ceiling	Roofing	Location				
☐ Insulation	X12'x12' Tile	$\Box$ T	extured	☐ Shingle	X Floor				
□ Elbow	☐ 9'x9'Tile		tucco	☐ Rolled	☐ Wall Orientation				
☐ Fitting	□ Vinyl Sheet	□ Po	opcorn	☐ Felt	☐ Ceiling				
☐ Transite Pipe	☐ Mastic	$\Box$ D	WJC	□ Tar	☐ Above Ceiling				
☐ Gasket	Wall	□ P:	laster		☐ Other				
☐ Tank Insulation	□ Transite Panel		coustic Tile (Dropped)						
☐ Pipe Wrap	☐ Textured Wall	$\Box$ A	coustic Tile (Glued-on)						
HVAC	□ Plaster		lastic	Miscellaneous: streaks	White with black				
☐ Insulation	□ DWJC		Structural						
☐ Tape			teel F. P. ing	No. of Phases:					
☐ Paper Wrap		$\Box$ D	eck F. P. ing	Colour:

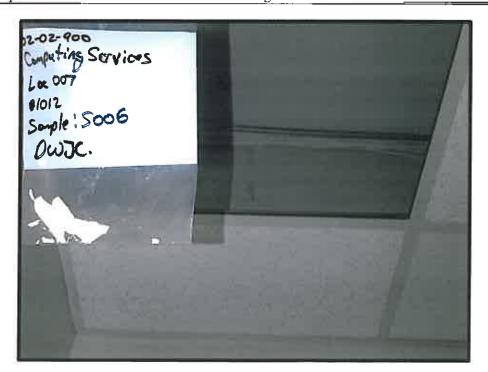
Five (5) samples, in total, of drywall joint compound were collected in the Site Building. Results from three (3) of the five (5) samples collected contain 3% chrysotile asbestos (reference samples, 02-02-900-S006, S010, S013, S002, and S014).

Sample #:	S006		Date Sampled:	March 19, 2013	
Building:	Computing Service	s	Sampler:	Trent Hardy	
Location:	007, room 1012		Analysis:	SAI - PLM	
MUN Project #:	02-02-900		Work Order#:		
		Bulk	Sampling Parameters		
Pipe/Tank	Flooring		Ceiling	Roofing	Location
☐ Insulation	□12'x12' Tile	T	extured	☐ Shingle	□ Floor
□ Elbow	□ 9'x9'Tile	☐ Stucco		☐ Rolled	X Wall Orientation
☐ Fitting	□ Vinyl Sheet	□ Popcom		☐ Felt	☐ Ceiling
☐ Transite Pipe	□ Mastic	□ DWJC		☐ Tar	☐ Above Ceiling
☐ Gasket	Wall	$\square$ P	laster		☐ Other
☐ Tank Insulation	☐ Transite Panel	$\Box A$	coustic Tile (Dropped)		
☐ Pipe Wrap	□ Textured Wall	$\Box$ A	coustic Tile (Glued-on)		
HVAC	☐ Plaster	☐ Mastic		Miscellaneous:	
☐ Insulation	X DWJC		Structural		
☐ Tape		$\square$ S	teel F. P. ing	No. of Phases:	
☐ Paper Wrap			eck F. P. ing	Colour:

1. Under the NL guidance documents for moderate and low risk asbestos abatement procedures, quantities of these materials within an enclosure exceeding 100 ft<sup>2</sup> should be removed using Type III (high risk) asbestos abatement procedures. Quantities less than 100 ft<sup>2</sup> but exceeding 10ft<sup>2</sup> should be removed using Type II (moderate risk) asbestos abatement procedures, while quantities less than 10 ft<sup>2</sup> should be removed using Type I (low risk) asbestos abatement procedures.

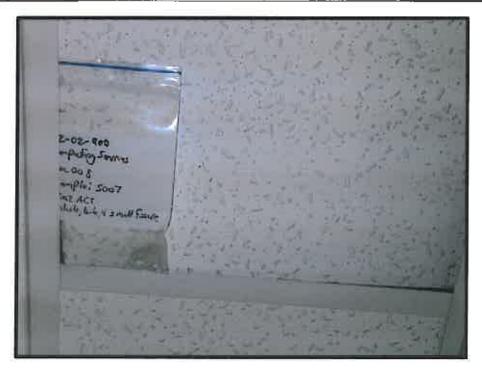
OHITEKSII				
Sample #:	S007	Date Sampled:	March 19, 2013	
Building:	Computing Service	es Sampler:	Trent Hardy	
Location:	008, room 1019	Analysis:	SAI - PLM	
MUN Project #:	02-02-900	Work Order #:		
		<b>Bulk Sampling Parameters</b>	-	
Pipe/Tank	Flooring	Ceiling	Roofing	Location
☐ Insulation	□12'x12' Tile	☐ Textured	☐ Shingle	☐ Floor
☐ Elbow	□ 9'x9'Tile	☐ Stucco	□ Rolled	☐ Wall Orientation
☐ Fitting	□ Vinyl Sheet	☐ Popcom	☐ Felt	X Ceiling
☐ Transite Pipe	☐ Mastic	□ DWJC	□ Tar	☐ Above Ceiling
☐ Gasket	Wall	☐ Plaster		☐ Other
☐ Tank Insulation	☐ Transite Panel	X Acoustic Tile (Dropped)		
☐ Pipe Wrap	□ Textured Wall	☐ Acoustic Tile (Glued-on)		
HVAC	☐ Plaster	☐ Mastic	Miscellaneous:	2' x 2' pinhole,
HVAC	□ Flaster	□ Iviastic	hole, and small	fissure
☐ Insulation	□ DWJC	Structural		
☐ Tape		☐ Steel F. P. ing	No. of Phases:	
☐ Paper Wrap		☐ Deck F. P. ing	Colour:

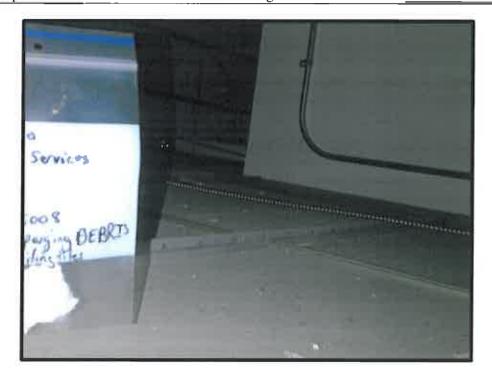
OMIACION				
Sample #:	S008	Date Sampled:	March 19, 2013	
Building:	Computing Service	es Sampler:	Trent Hardy	
Location:	009, hallway 1C01	Analysis:	SAI - PLM	
MUN Project #:	02-02-900	Work Order#:		·
		<b>Bulk Sampling Parameters</b>		
Pipe/Tank	Flooring	Ceiling	Roofing	Location
☐ Insulation	□12'x12' Tile	☐ Textured	☐ Shingle	☐ Floor
X Elbow	☐ 9'x9'Tile	☐ Stucco	☐ Rolled	☐ Wall Orientation
☐ Fitting	□ Vinyl Sheet	☐ Popcorn	☐ Felt	☐ Ceiling
☐ Transite Pipe	☐ Mastic	□ DWJC	☐ Tar	X Above Ceiling
☐ Gasket	Wall	☐ Plaster		☐ Other
☐ Tank Insulation	□ Transite Panel	☐ Acoustic Tile (Dropped)		
☐ Pipe Wrap	☐ Textured Wall	☐ Acoustic Tile (Glued-on)		
HVAC	☐ Plaster	☐ Mastic	Miscellaneous:	Parging debris
☐ Insulation	□ DWJC	Structural		
☐ Tape		☐ Steel F. P. ing	No. of Phases:	
☐ Paper Wrap		□ Deck F. P. ing	Colour:

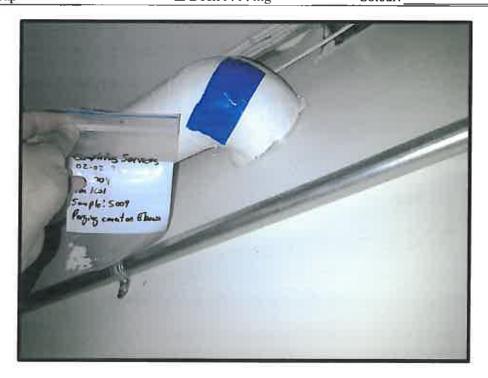
ONIVERSII	I				
Sample #:	S009	Date Sampled:	March 19, 2013		
Building:	Computing Service	s Sampler:	Trent Hardy		
Location:	009, hallway 1C01	Analysis:	SAI - PLM		
MUN Project #:	02-02-900	Work Order #:			
		<b>Bulk Sampling Parameters</b>			
Pipe/Tank	Flooring	Ceiling	Roofing	Location	
☐ Insulation	□12'x12' Tile	☐ Textured	☐ Shingle	☐ Floor	
X Elbow	□ 9'x9'Tile	☐ Stucco	☐ Rolled	☐ Wall Orientation	
☐ Fitting	□Vinyl Sheet	□ Popcom	☐ Felt	☐ Ceiling	
☐ Transite Pipe	☐ Mastic	□ DWJC	☐ Tar	X Above Ceiling	
☐ Gasket	Wall	☐ Plaster		☐ Other	
☐ Tank Insulation	☐ Transite Panel	☐ Acoustic Tile (Dropped)			
🗖 Pipe Wrap	☐ Textured Wall	☐ Acoustic Tile (Glued-on)			
HVAC	☐ Plaster	☐ Mastic	Miscellaneous: Parging cement		
☐ Insulation	□ DWJC	Structural			
☐ Tape		☐ Steel F. P. ing	No. of Phases:		
☐ Paper Wrap		Deck F. P. ing	Colour:

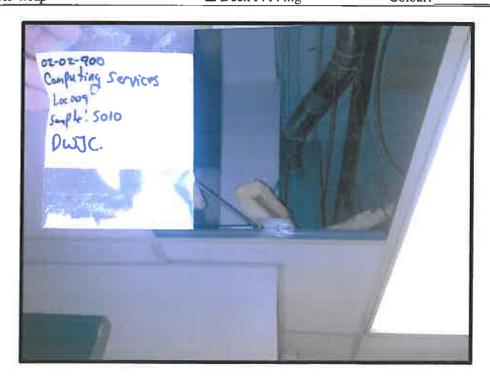
1				
Sample #:	S010	Date Sampled:	March 19, 2013		
Building:	Computing Service	s Sampler:	Trent Hardy	Trent Hardy	
Location:	009, hallway 1C01	Analysis:	SAI - PLM		
MUN Project #:	02-02-900	Work Order#:			
		<b>Bulk Sampling Parameters</b>			
Pipe/Tank	Flooring	Ceiling	Roofing	Location	
☐ Insulation	□12'x12' Tile	☐ Textured	☐ Shingle	☐ Floor	
☐ Elbow	☐ 9'x9'Tile	☐ Stucco	□ Rolled	X Wall Orientation	
☐ Fitting	□ Vinyl Sheet	☐ Popcorn	☐ Felt	☐ Ceiling	
☐ Transite Pipe	☐ Mastic	□ DWJC	□ Таг	☐ Above Ceiling	
☐ Gasket	Wall	☐ Plaster		☐ Other	
☐ Tank Insulation	□ Transite Panel	☐ Acoustic Tile (Dropped)			
☐ Pipe Wrap	□ Textured Wall	☐ Acoustic Tile (Glued-on)			
HVAC	☐ Plaster	☐ Mastic	Miscellaneous:		
☐ Insulation	X DWJC	Structural			
☐ Tape		☐ Steel F. P. ing	No. of Phases:		
☐ Paper Wrap		□ Deck F. P. ing	Colour

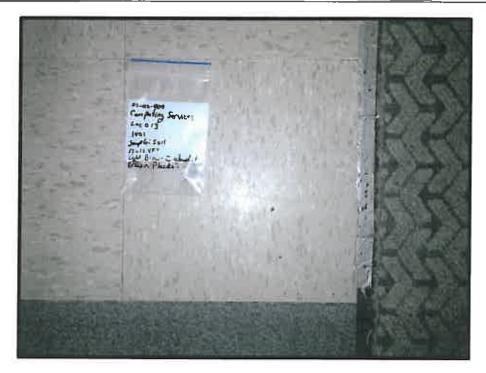
O IAI A FIX O I			<u> </u>		
Sample #:	S011		Date Sampled:	March 19, 2013	
Building:	Computing Services		Sampler:	Trent Hardy	
Location:	013, corridor 1V01		Analysis:	SAI - PLM	
MUN Project #:	02-02-900		Work Order #:		
		Bulk	Sampling Parameters		-
Pipe/Tank	Flooring		Ceiling	Roofing	Location
☐ Insulation	X12'x12' Tile	ПТ	extured	☐ Shingle	X Floor
☐ Elbow	□ 9'x9'Tile	☐ Stucco		☐ Rolled	☐ Wall Orientation
☐ Fitting	□ Vinyl Sheet	☐ Popcom		☐ Felt	☐ Ceiling
☐ Transite Pipe	☐ Mastic	□ DWJC		🗆 Таг	☐ Above Ceiling
☐ Gasket	Wall	□P	laster		□ Other
☐ Tank Insulation	☐ Transite Panel	$\Box$ A	coustic Tile (Dropped)		
☐ Pipe Wrap	☐ Textured Wall	$\Box$ A	coustic Tile (Glued-on)		
HVAC	☐ Plaster	☐ Mastic		Miscellaneous:	
□ Insulation	□ DWJC		Structural		
☐ Tape		$\square$ S	teel F. P. ing	No. of Phases:	
☐ Paper Wrap			eck F. P. ing	Colour: Brown brown flecks	with abundant

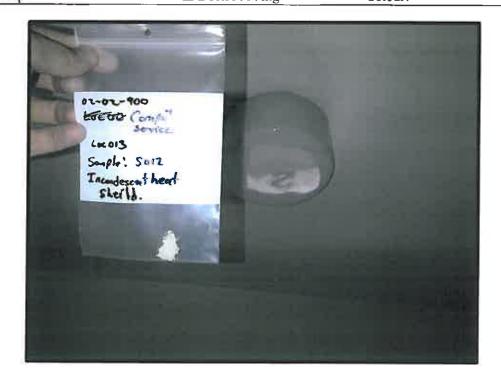
An incandescent heat shield was sampled from a light fixture in room 1V01, and contains 60% chrysotile asbestos (reference sample 02-02-900-S012). For locations and conditions of these materials at the time of the building survey refer to location & data excel document.

ONIVERSII	Y					
Sample #:	S012	Date Sampled:	March 19, 2013	March 19, 2013		
Building:	Computing Service	s Sampler:	Trent Hardy	Trent Hardy		
Location:	013, comidor 1V01	Analysis:	SAI - PLM			
MUN Project #:	02-02-900	Work Order #:	-			
		<b>Bulk Sampling Parameters</b>				
Pipe/Tank	Flooring	Ceiling	Roofing	Location		
☐ Insulation	□12'x12' Tile	☐ Textured	☐ Shingle	□ Floor		
☐ Elbow	□ 9'x9'Tile	☐ Stucco	☐ Rolled	☐ Wall Orientation		
☐ Fitting	□ Vinyl Sheet	☐ Popcom	☐ Felt	☐ Ceiling		
☐ Transite Pipe	☐ Mastic	□ DWJC	🗆 Таг	☐ Above Ceiling		
☐ Gasket	Wall	□ Plaster		X Other (Light Fixture)		
☐ Tank Insulation ☐ Pipe Wrap	☐ Transite Panel☐ Textured Wall	☐ Acoustic Tile (Dropped) ☐ Acoustic Tile (Glued-on)		1 ixtuic)		
HVAC	☐ Plaster	☐ Mastic	Miscellaneous: shield	Incandescent heat		
☐ Insulation	□ DWJC	Structural				
☐ Tape		☐ Steel F. P. ing	No. of Phases:			
☐ Paper Wrap		□ Deck F P ing	Colour

- 1. Type I (low risk) asbestos abatement procedures should be carried out for the scheduled disturbance of any non-friable materials provided the materials can be removed intact, and without the use of powered hand tools.
- 2. Should the use of powered hand tools or excessive breakage of the materials become necessary, Type II (moderate risk) asbestos abatement procedures should be adopted.

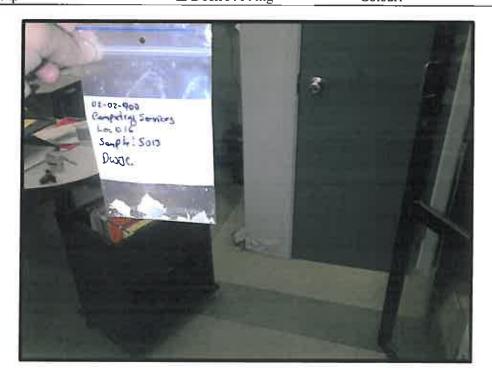
OIAIAEKSII				
Sample #:	S013	Date Sampled:	March 19, 2013	
Building:	Computing Service	es Sampler:	Trent Hardy	
Location:	016, room 1000	Analysis:	SAI - PLM	
MUN Project #:	02-02-900	Work Order #:		
		<b>Bulk Sampling Parameters</b>		
Pipe/Tank	Flooring	Ceiling	Roofing	Location
☐ Insulation	□12'x12' Tile	☐ Textured	☐ Shingle	☐ Floor
□ Elbow	□ 9'x9'Tile	☐ Stucco	□ Rolled	X Wall Orientation
☐ Fitting	Vinyl Sheet	☐ Popcorn	□ Felt	☐ Ceiling
☐ Transite Pipe	☐ Mastic	□ DWJC	□ Tar	☐ Above Ceiling
☐ Gasket	Wall	☐ Plaster		□ Other
☐ Tank Insulation	☐ Transite Panel	☐ Acoustic Tile (Dropped)		
☐ Pipe Wrap	☐ Textured Wall	☐ Acoustic Tile (Glued-on)		
HVAC	☐ Plaster	☐ Mastic	Miscellaneous:	
☐ Insulation	X DWJC	Structural		
☐ Tape		☐ Steel F. P. ing	No. of Phases:	
☐ Paper Wrap		□ Deck F. P. ing	Colour:
