Project #: 13916

**ASBESTOS ASSESSMENT
Corte Real Building
Memorial University of Newfoundland
St. John's, NL**

August 2011

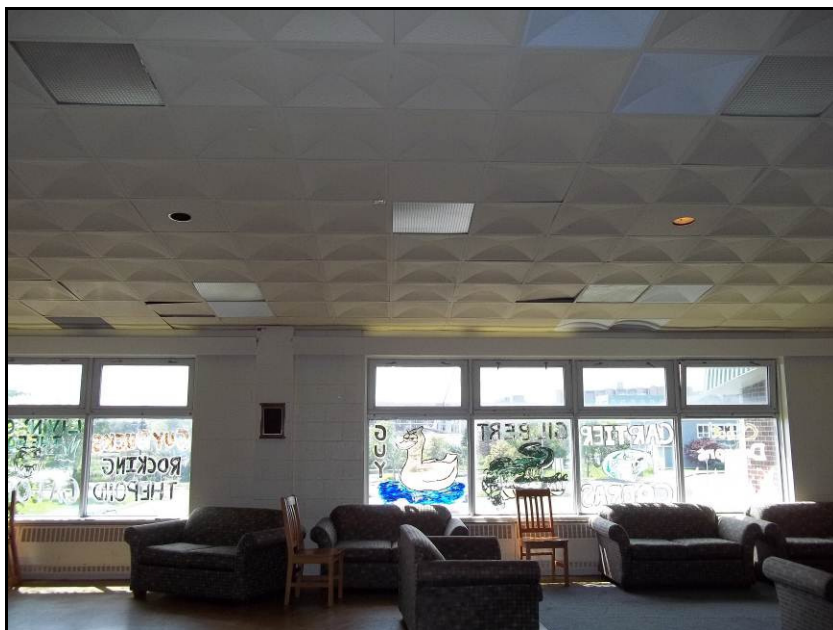
Ceiling tiles observed in Room CA2000 were identified as a cardboard-based tile. (see Photograph 1, Appendix I)

Photograph 1: Ceiling tiles of Room CA2000 were visually identified as a cardboard based tile.

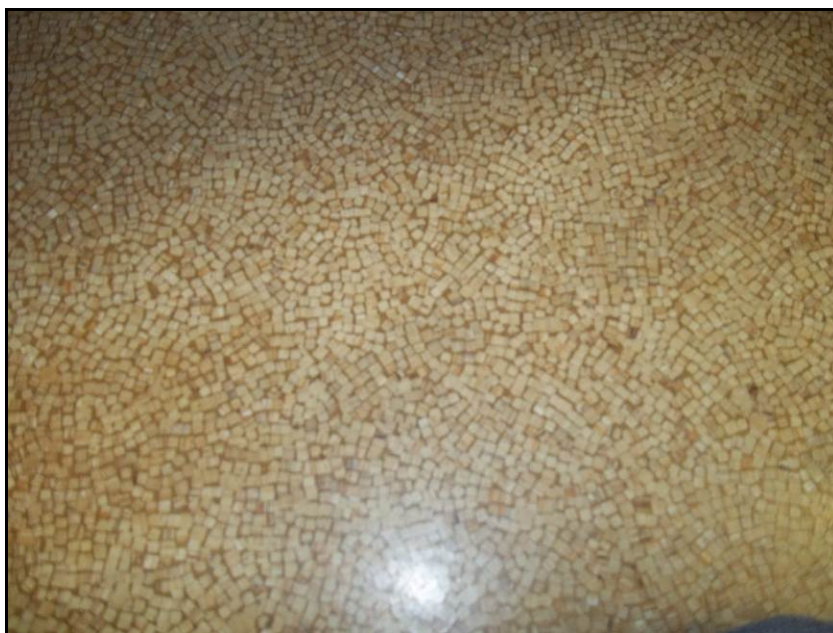
Various vinyl sheet floorings which could potentially contain asbestos were identified in the building during the assessment. Two (2) samples of this flooring were sampled and analyzed for asbestos content using the PLM method of detection. Sample CA-5, collected from Room 2011, was identified as non-asbestos containing. Sample CA-12 was found to contain 15% Chrysotile asbestos. Its associated mastic was identified as non-asbestos containing. (see samples CA-5, CA-12, in Appendix II, see Photograph 2 in Appendix I)

Photograph 2: Asbestos containing vinyl sheet flooring (sample CA-12).

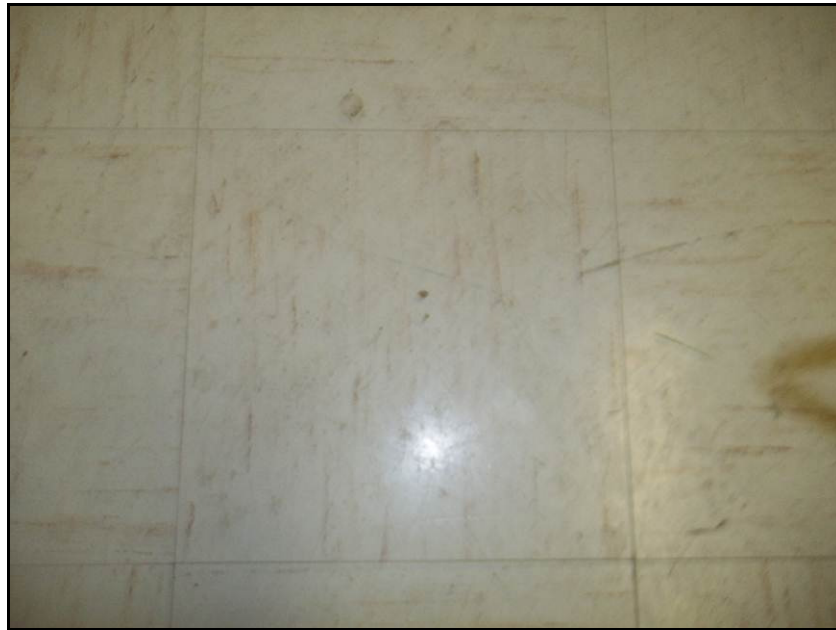
Vinyl floor tiles which could potentially contain asbestos were identified during the assessment. Six (6) samples of 1' x 1' vinyl floor tiles were sampled and analyzed for asbestos content using the PLM method of detection. Three (3) tiles were found to contain between 2 and 3% Chrysotile asbestos. One (1) of the associated mastics was found to contain <1% Chrysotile asbestos. As such, in accordance with the *Newfoundland Asbestos Abatement Regulations 111/98*, it is not considered to be asbestos containing. (See samples CA-1, CA-4, CA-6, CA-9, CA-10, CA-11, in Appendix II, see Photographs 3 - 5, Appendix I)

Photograph 3: Asbestos containing 1' x 1' vinyl floor tile (Sample CA-1).

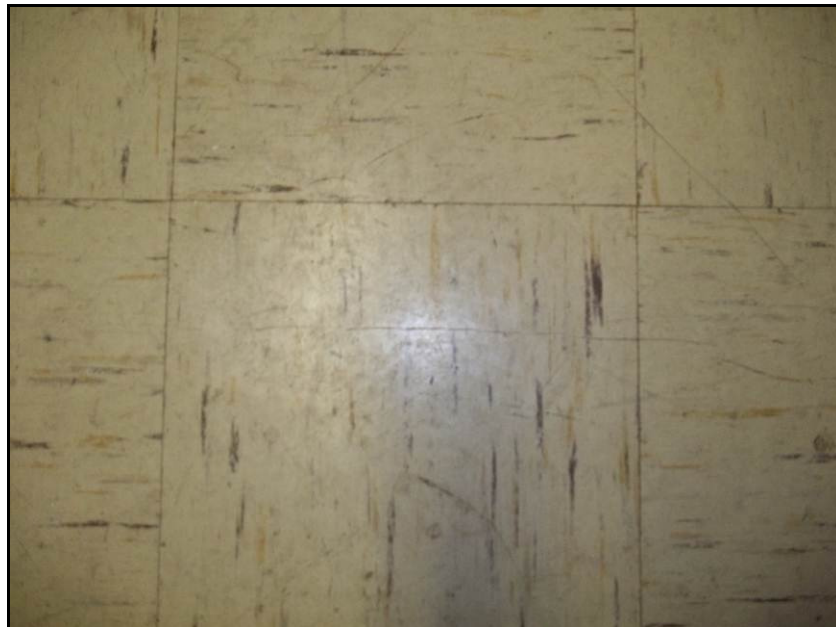
Photograph 4: Asbestos containing 1' x 1' vinyl floor tile (Sample CA-6).

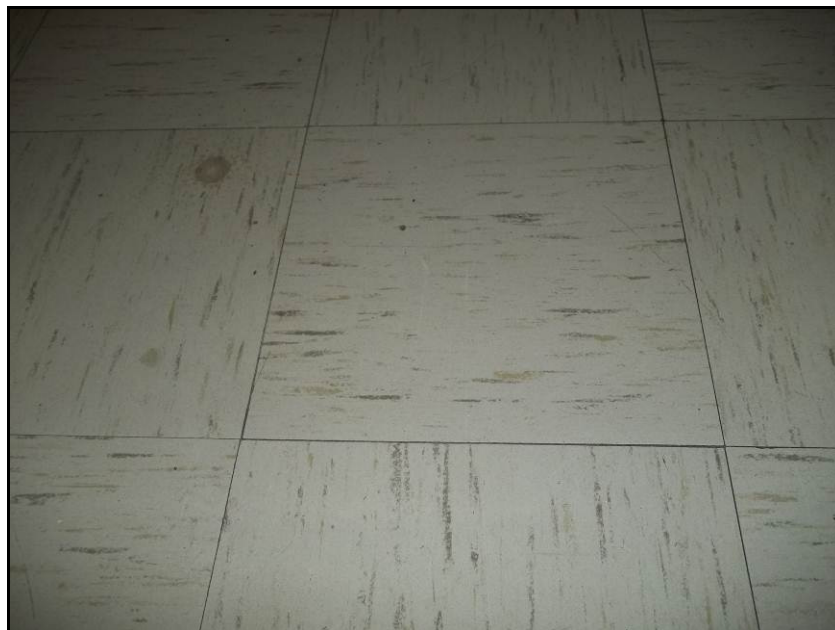
Photograph 5: Asbestos containing 1' x 1' vinyl floor tile (Sample CA-11).
