ASBESTOS AND LEAD PAINT BUILDING MATERIALS SURVEY FOR: COUGHLAN COLLEGE MEMORIAL UNIVERSITY OF NEWFOUNDLAND

Pinchin LeBlanc Environmental Ltd Project No. 02-02-00900

June 19, 2013

BUILDING DESCRIPTION: COUGHLAN COLLEGE

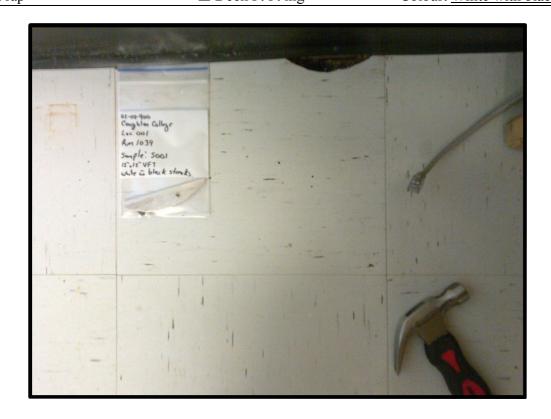
Sample #:	S001	Date Sampled:	January 18, 201	3
Building:	Coughlan College	Sampler:	Trent Hardy	
Location:	001, room 1039	Analysis:	SAI - PLM	
MUN Project #:	02-02-900	Work Order #:		
		Bulk Sampling Parameters	•	
Pipe/Tank	Flooring	Ceiling	Roofing	Location
☐ Insulation	X12'x12' Tile	☐ Textured	☐ Shingle	X Floor
□ Elbow	☐ 9'x9'Tile	☐ Stucco	□ Rolled	☐ Wall Orientation
☐ Fitting	☐ Vinyl Sheet	□ Popcorn	□ Felt	☐ Ceiling
☐ Transite Pipe	☐ Mastic	□ DWJC	□ Tar	☐ Above Ceiling
☐ Gasket	Wall	☐ Plaster		□ Other
☐ Tank Insulation	☐ Transite Panel	☐ Acoustic Tile (Dropped)		
☐ Pipe Wrap	☐ Textured Wall	☐ Acoustic Tile (Glued-on)		
HVAC	☐ Plaster	☐ Mastic	Miscellaneous:	·
☐ Insulation	\square DWJC	Structural		
□ Tape		☐ Steel F. P. ing	No. of Phases:	
☐ Paper Wrap		☐ Deck F. P. ing	Colour: White	with black streaks

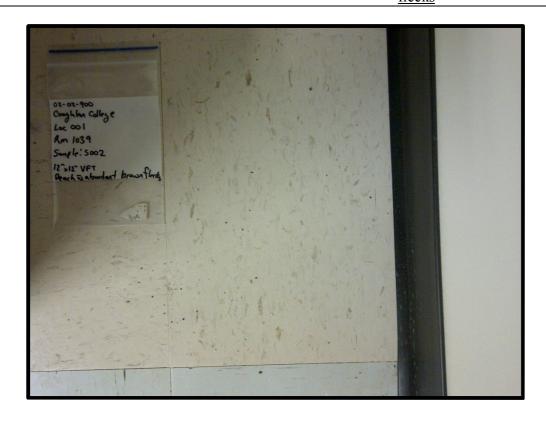
Sample #:	S002	Date Sampled:	January 18, 201	3
Building:	Coughlan College	Sampler:	Trent Hardy	
Location:	001, room 1039	Analysis:	SAI - PLM	
MUN Project #:	02-02-900	Work Order #:		
		Bulk Sampling Parameters	•	
Pipe/Tank	Flooring	Ceiling	Roofing	Location
☐ Insulation	X12'x12' Tile	☐ Textured	☐ Shingle	X Floor
□ Elbow	☐ 9'x9'Tile	☐ Stucco	☐ Rolled	☐ Wall Orientation
☐ Fitting	☐ Vinyl Sheet	□ Popcorn	□ Felt	☐ Ceiling
☐ Transite Pipe	☐ Mastic	□ DWJC	□ Tar	☐ Above Ceiling
☐ Gasket	Wall	☐ Plaster		☐ Other
☐ Tank Insulation	☐ Transite Panel	☐ Acoustic Tile (Dropped)		
☐ Pipe Wrap	☐ Textured Wall	☐ Acoustic Tile (Glued-on)		
HVAC	☐ Plaster	☐ Mastic	Miscellaneous:	
☐ Insulation	□ DWJC	Structural		
☐ Tape		☐ Steel F. P. ing	No. of Phases:	
☐ Paper Wrap		□ Deck F. P. ing	Colour: Peach v	with abundant brown

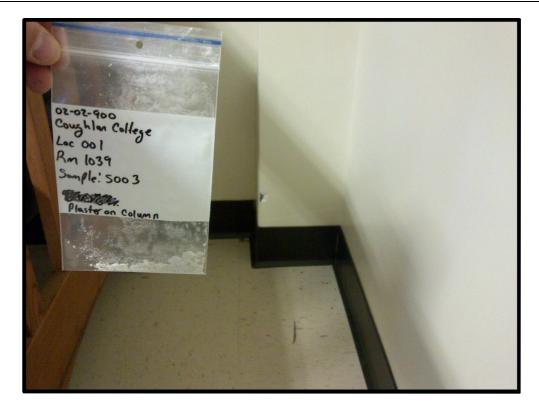
Sample #:	S003		Date Sampled:	January 18, 2013	3
Building:	Coughlan College		Sampler:	Trent Hardy	
Location:	001, room 1039		Analysis:	SAI - PLM	
MUN Project #:	02-02-900		Work Order #:		
		Bulk	Sampling Parameters		
Pipe/Tank	Flooring		Ceiling	Roofing	Location
☐ Insulation	□12'x12' Tile	\Box T	extured	☐ Shingle	□ Floor
□ Elbow	□ 9'x9'Tile	\square S	tucco	□ Rolled	X Wall Orientation
☐ Fitting	☐ Vinyl Sheet	\square P	opcorn	□ Felt	☐ Ceiling
☐ Transite Pipe	☐ Mastic	\square D	WJC	□ Tar	☐ Above Ceiling
☐ Gasket	Wall	\square P	laster		X Other (column)
☐ Tank Insulation	☐ Transite Panel	\Box A	coustic Tile (Dropped)		
☐ Pipe Wrap	☐ Textured Wall	\Box A	coustic Tile (Glued-on)		
HVAC	X Plaster	\square N	f astic	Miscellaneous:	
☐ Insulation	□ DWJC		Structural		
☐ Tape		\square S	teel F. P. ing	No. of Phases:	
☐ Paper Wrap		\square D	eck F. P. ing	Colour:

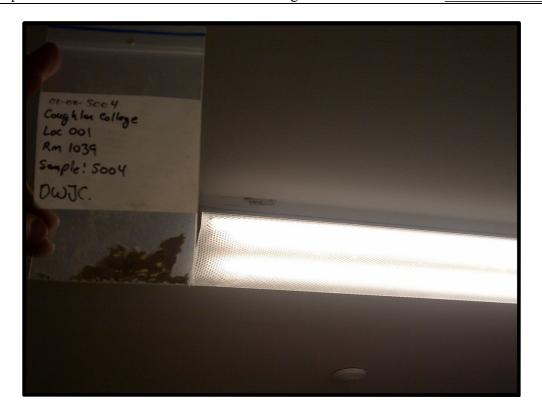
Sample #:	S004	Date Sampled:	January 18, 201	3
Building:	Coughlan College	Sampler:	Trent Hardy	
Location:	001, room 1039	Analysis:	SAI - PLM	
MUN Project #:	02-02-900	Work Order #:		
		Bulk Sampling Parameters		
Pipe/Tank	Flooring	Ceiling	Roofing	Location
☐ Insulation	□12'x12' Tile	☐ Textured	☐ Shingle	□ Floor
□ Elbow	□ 9'x9'Tile	☐ Stucco	☐ Rolled	☐ Wall Orientation
☐ Fitting	☐ Vinyl Sheet	□ Popcorn	□ Felt	X Ceiling
☐ Transite Pipe	☐ Mastic	□ DWJC	□ Tar	☐ Above Ceiling
☐ Gasket	Wall	☐ Plaster		□ Other
☐ Tank Insulation	☐ Transite Panel	☐ Acoustic Tile (Dropped)		
☐ Pipe Wrap	☐ Textured Wall	☐ Acoustic Tile (Glued-on)		
HVAC	☐ Plaster	☐ Mastic	Miscellaneous:	
☐ Insulation	X DWJC	Structural		
☐ Tape		☐ Steel F. P. ing	No. of Phases:	
☐ Paper Wrap		□ Deck F. P. ing	Colour:

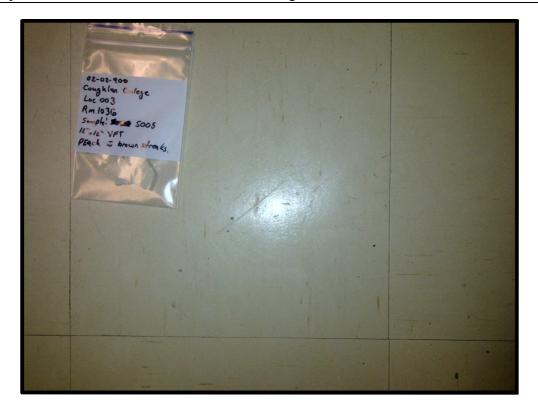
Sample #:	S005	Date Sampled:	January 18, 2013	3
Building:	Coughlan College	Sampler:	Trent Hardy	
Location:	003, room 1036	Analysis:	SAI - PLM	
MUN Project #:	02-02-900	Work Order #:		
		Bulk Sampling Paramet	ters	
Pipe/Tank	Flooring	Ceiling	Roofing	Location
☐ Insulation	X12'x12' Tile	☐ Textured	☐ Shingle	X Floor
□ Elbow	□ 9'x9'Tile	☐ Stucco	□ Rolled	☐ Wall Orientation
☐ Fitting	☐ Vinyl Sheet	□ Popcorn	□ Felt	☐ Ceiling
☐ Transite Pipe	☐ Mastic	□ DWJC	□ Tar	☐ Above Ceiling
☐ Gasket	Wall	☐ Plaster		□ Other
☐ Tank Insulation	☐ Transite Panel	☐ Acoustic Tile (Droppe	ed)	
☐ Pipe Wrap	☐ Textured Wall	☐ Acoustic Tile (Glued-	-on)	
HVAC	☐ Plaster	☐ Mastic	Miscellaneous:	
☐ Insulation	□ DWJC	Structural		
☐ Tape		☐ Steel F. P. ing	No. of Phases:	
☐ Paper Wrap		☐ Deck F. P. ing	Colour: Peach v	with brown streaks

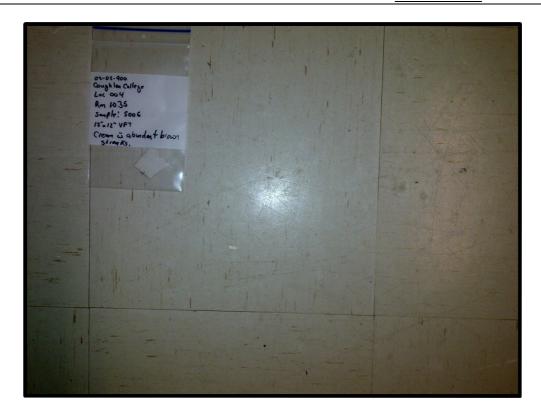
Sample #:	S006	Date Sampled:	January 18, 201	3
Building:	Coughlan College	Sampler:	Trent Hardy	
Location:	004, room 1035	Analysis:	SAI - PLM	
MUN Project #:	02-02-900	Work Order #:		
		Bulk Sampling Parameters		
Pipe/Tank	Flooring	Ceiling	Roofing	Location
☐ Insulation	X12'x12' Tile	☐ Textured	☐ Shingle	X Floor
□ Elbow	□ 9'x9'Tile	☐ Stucco	☐ Rolled	☐ Wall Orientation
☐ Fitting	☐ Vinyl Sheet	□ Popcorn	□ Felt	☐ Ceiling
☐ Transite Pipe	☐ Mastic	□ DWJC	□ Tar	☐ Above Ceiling
☐ Gasket	Wall	☐ Plaster		☐ Other
☐ Tank Insulation	☐ Transite Panel	☐ Acoustic Tile (Dropped)		
☐ Pipe Wrap	☐ Textured Wall	☐ Acoustic Tile (Glued-on)		
HVAC	☐ Plaster	☐ Mastic	Miscellaneous:	
☐ Insulation	□ DWJC	Structural		
☐ Tape		☐ Steel F. P. ing	No. of Phases:	
☐ Paper Wrap		□ Deck F. P. ing	Colour: Cream brown streaks	with abundant

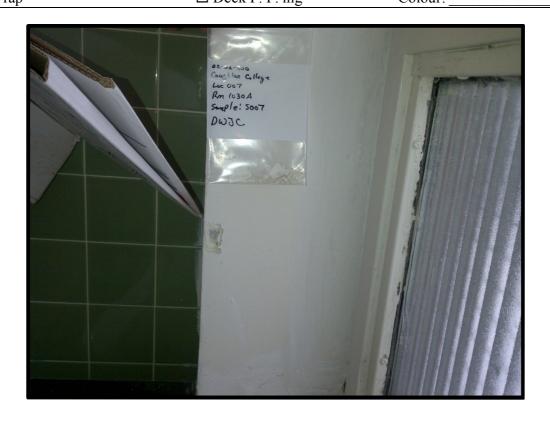
Sample #:	S007	Date Sam	ipled:	January 18, 2013	3
Building:	Coughlan College	Sampler:		Trent Hardy	
Location:	007, room 1030A	Analysis:		SAI - PLM	
MUN Project #:	02-02-900	Work Or	der #:		
		Bulk Sampling	Parameters		
Pipe/Tank	Flooring	Ceil	ling	Roofing	Location
☐ Insulation	□12'x12' Tile	☐ Textured		☐ Shingle	□ Floor
□ Elbow	☐ 9'x9'Tile	☐ Stucco		□ Rolled	X Wall Orientation
☐ Fitting	☐ Vinyl Sheet	□ Popcorn		□ Felt	☐ Ceiling
☐ Transite Pipe	☐ Mastic	\square DWJC		□ Tar	☐ Above Ceiling
☐ Gasket	Wall	☐ Plaster			□ Other
☐ Tank Insulation	☐ Transite Panel	☐ Acoustic Til	e (Dropped)		
☐ Pipe Wrap	☐ Textured Wall	☐ Acoustic Til	e (Glued-on)		
HVAC	☐ Plaster	☐ Mastic		Miscellaneous:	
☐ Insulation	X DWJC	Struc	tural		
□ Tape		☐ Steel F. P. in	ıg	No. of Phases:	
☐ Paper Wrap		□ Deck F. P. ir	ng	Colour:

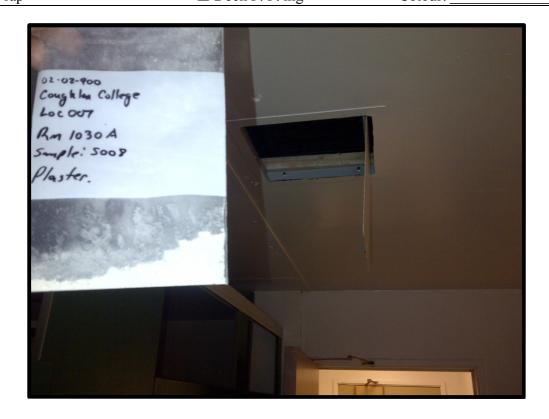
Sample #:	S008	Date Sampled:	January 18, 201	3
Building:	Coughlan College	Sampler:	Trent Hardy	
Location:	007, room 1030A	Analysis:	SAI - PLM	
MUN Project #:	02-02-900	Work Order #:		
		Bulk Sampling Parameters		
Pipe/Tank	Flooring	Ceiling	Roofing	Location
☐ Insulation	□12'x12' Tile	☐ Textured	☐ Shingle	□ Floor
□ Elbow	□ 9'x9'Tile	☐ Stucco	☐ Rolled	☐ Wall Orientation
☐ Fitting	☐ Vinyl Sheet	□ Popcorn	□ Felt	X Ceiling
☐ Transite Pipe	☐ Mastic	□ DWJC	□ Tar	☐ Above Ceiling
☐ Gasket	Wall	X Plaster		□ Other
☐ Tank Insulation	☐ Transite Panel	☐ Acoustic Tile (Dropped)		
☐ Pipe Wrap	☐ Textured Wall	☐ Acoustic Tile (Glued-on)		
HVAC	☐ Plaster	☐ Mastic	Miscellaneous:	
☐ Insulation	□ DWJC	Structural		
☐ Tape		☐ Steel F. P. ing	No. of Phases:	
□ Paper Wrap		□ Deck F P ing	Colour:

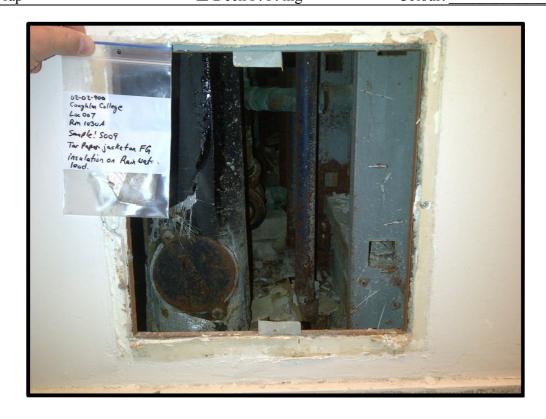
Sample #:	S009	Date Sampled:	January 18, 201	3				
Building:	Coughlan College	Sampler:	Trent Hardy					
Location:	007, room 1030A	Analysis:	SAI - PLM					
MUN Project #:	02-02-900	Work Order #:						
	Bulk Sampling Parameters							
Pipe/Tank	Flooring	Ceiling	Roofing	Location				
☐ Insulation	□12'x12' Tile	☐ Textured	☐ Shingle	□ Floor				
□ Elbow	□ 9'x9'Tile	☐ Stucco	☐ Rolled	☐ Wall Orientation				
☐ Fitting	☐ Vinyl Sheet	□ Popcorn	☐ Felt	☐ Ceiling				
☐ Transite Pipe	☐ Mastic	□ DWJC	□ Tar	☐ Above Ceiling				
☐ Gasket	Wall	☐ Plaster		X Other				
☐ Tank Insulation	☐ Transite Panel	☐ Acoustic Tile (Dropped)						
X Pipe Wrap	☐ Textured Wall	☐ Acoustic Tile (Glued-on)						
HVAC	□ Plaster	☐ Mastic	Miscellaneous: mastic jacket or	<u>Tar paper and</u> n rain water lead				
☐ Insulation	□ DWJC	Structural						
☐ Tape		☐ Steel F. P. ing	No. of Phases:					
☐ Paper Wrap		□ Deck F P ing	Colour:

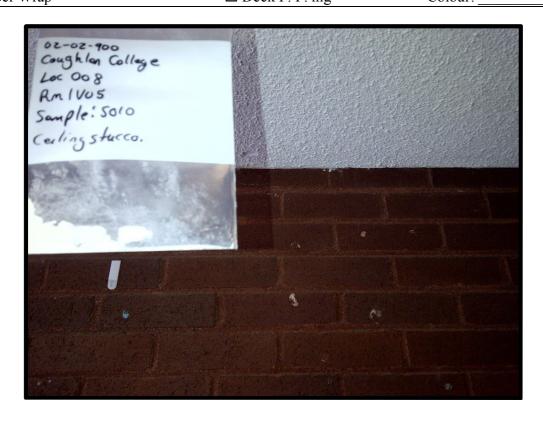
Friable stucco ceiling finish was collected from the Site Building and contains 4% chrysotile asbestos (reference samples 02-02-900-S010, SS017, and S031). For locations and conditions of this material at the time of the building survey refer to location & data excel document.

Sample #:	S010	Date Sampled:	January 18, 201	3
Building:	Coughlan College	Sampler:	Trent Hardy	
Location:	008, room 1V05	Analysis:	SAI - PLM	
MUN Project #:	02-02-900	Work Order #:		
		Bulk Sampling Parameters		
Pipe/Tank	Flooring	Ceiling	Roofing	Location
☐ Insulation	□12'x12' Tile	☐ Textured	☐ Shingle	□ Floor
□ Elbow	□ 9'x9'Tile	X Stucco	\square Rolled	☐ Wall Orientation
☐ Fitting	☐ Vinyl Sheet	□ Popcorn	☐ Felt	X Ceiling
☐ Transite Pipe	☐ Mastic	□ DWJC	□ Tar	☐ Above Ceiling
☐ Gasket	Wall	☐ Plaster		□ Other
☐ Tank Insulation	☐ Transite Panel	☐ Acoustic Tile (Dropped)		
☐ Pipe Wrap	☐ Textured Wall	☐ Acoustic Tile (Glued-on)		
HVAC	☐ Plaster	☐ Mastic	Miscellaneous:	
☐ Insulation	□ DWJC	Structural		
☐ Tape		☐ Steel F. P. ing	No. of Phases:	
☐ Paper Wran		□ Deck F P ing	Colour:

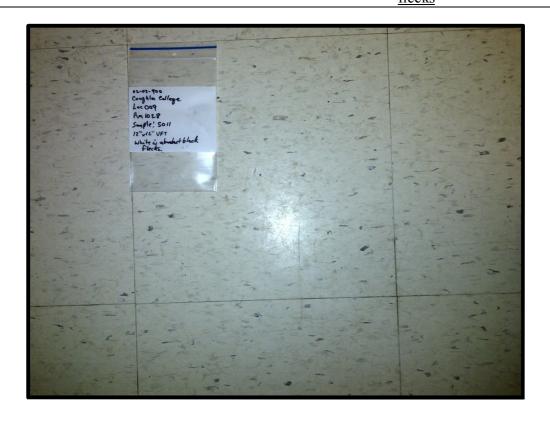
01111					
Sample #:	S011		Date Sampled:	January 18, 2013	3
Building:	Coughlan College		Sampler:	Trent Hardy	
Location:	009, room 1028		Analysis:	SAI - PLM	
MUN Project #:	02-02-900		Work Order #:		
		Bulk	Sampling Parameters		
Pipe/Tank	Flooring		Ceiling	Roofing	Location
☐ Insulation	X12'x12' Tile	□Т	extured	☐ Shingle	X Floor
□ Elbow	□ 9'x9'Tile	☐ Stucco		□ Rolled	☐ Wall Orientation
☐ Fitting	☐ Vinyl Sheet	□ Popcorn		□ Felt	☐ Ceiling
☐ Transite Pipe	☐ Mastic	□ DWJC		□ Tar	☐ Above Ceiling
☐ Gasket	Wall	□ P1	aster		☐ Other
☐ Tank Insulation	☐ Transite Panel	\Box A	coustic Tile (Dropped)		
☐ Pipe Wrap	☐ Textured Wall	\Box A	coustic Tile (Glued-on)		
HVAC	☐ Plaster	\square M	astic	Miscellaneous:	
☐ Insulation	□ DWJC		Structural		
□ Tape		□ St	eel F. P. ing	No. of Phases:	
☐ Paper Wrap		\square D	eck F. P. ing	Colour: White v	with abundant black

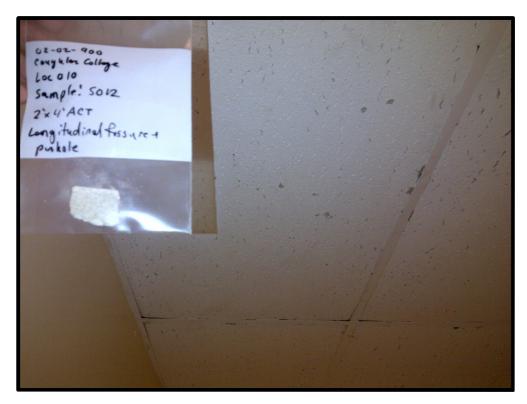
- One (1) sample of 2'x 4' acoustic ceiling tiles distinguished with a longitudinal fissure and pinhole pattern was collected from room C-1C03. Analysis of this sample did not identify the presence of asbestos (reference sample 02-02-900-S012).

Sample #:	S012	Date Sampled:	January 18, 2013	3			
Building:	Coughlan College	Sampler:	Trent Hardy				
Location:	011, room 1C03	Analysis:	SAI - PLM				
MUN Project #:	02-02-900	Work Order #:					
Bulk Sampling Parameters							
Pipe/Tank	Flooring	Ceiling	Roofing	Location			
☐ Insulation	□12'x12' Tile	☐ Textured	☐ Shingle	☐ Floor			
□ Elbow	☐ 9'x9'Tile	☐ Stucco	☐ Rolled	☐ Wall Orientation			
☐ Fitting	☐ Vinyl Sheet	□ Popcorn	☐ Felt	X Ceiling			
☐ Transite Pipe	☐ Mastic	□ DWJC	□ Tar	☐ Above Ceiling			
☐ Gasket	Wall	□ Plaster		□ Other			
☐ Tank Insulation	☐ Transite Panel	X Acoustic Tile (Dropped)					
☐ Pipe Wrap	☐ Textured Wall	☐ Acoustic Tile (Glued-on)					
HVAC	□ Plaster	☐ Mastic	Miscellaneous: fissure and pinh	2' x 4' longitudinal ole			
☐ Insulation	□ DWJC	Structural					
☐ Tape		☐ Steel F. P. ing	No. of Phases:				
☐ Paper Wrap		□ Deck F. P. ing	Colour:

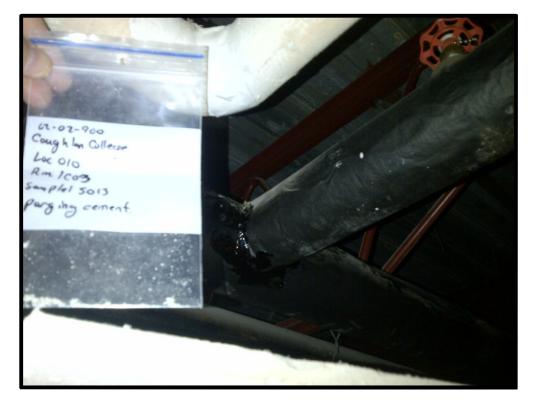
G 1 "	0012	D . C . I I	T 10.201				
Sample #:	S013	Date Sampled:	January 18, 2013	3			
Building:	Coughlan College	Sampler:	Trent Hardy				
Location:	011, room 1C03	Analysis:	SAI - PLM				
MUN Project #:	02-02-900	Work Order #:					
Bulk Sampling Parameters							
Pipe/Tank	Flooring	Ceiling	Roofing	Location			
☐ Insulation	□12'x12' Tile	☐ Textured	☐ Shingle	□ Floor			
X Elbow	☐ 9'x9'Tile	□ Stucco	☐ Rolled	☐ Wall Orientation			
☐ Fitting	☐ Vinyl Sheet	□ Popcorn	☐ Felt	☐ Ceiling			
☐ Transite Pipe	☐ Mastic	□ DWJC	□ Tar	X Above Ceiling			
☐ Gasket	Wall	□ Plaster		□ Other			
☐ Tank Insulation	☐ Transite Panel	☐ Acoustic Tile (Dropped)					
☐ Pipe Wrap	☐ Textured Wall	☐ Acoustic Tile (Glued-on)					
HVAC	□ Plaster	☐ Mastic	Miscellaneous: wrapped water	Parging on canvas lines			
☐ Insulation	□ DWJC	Structural					
☐ Tape		☐ Steel F. P. ing	No. of Phases:				
☐ Paper Wrap		☐ Deck F. P. ing	Colour:

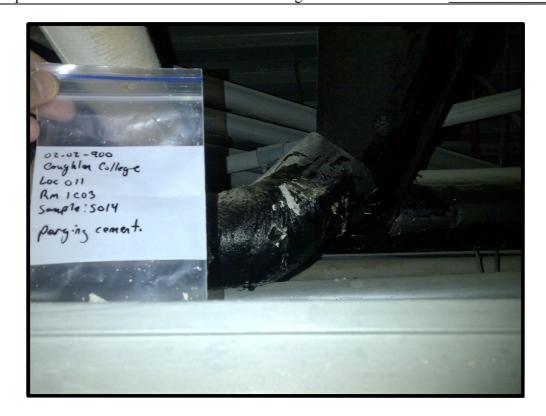
Sample #:	S014	Date Sampled:	January 18, 2013	3			
Building:	Coughlan College	Sampler:	Trent Hardy				
Location:	011, room 1C03	Analysis:	SAI - PLM				
MUN Project #:	02-02-900	Work Order #:					
Bulk Sampling Parameters							
Pipe/Tank	Flooring	Ceiling	Roofing	Location			
☐ Insulation	□12'x12' Tile	☐ Textured	☐ Shingle	☐ Floor			
X Elbow	□ 9'x9'Tile	☐ Stucco	□ Rolled	☐ Wall Orientation			
☐ Fitting	☐ Vinyl Sheet	□ Popcorn	□ Felt	☐ Ceiling			
☐ Transite Pipe	☐ Mastic	□ DWJC	□ Tar	☐ Above Ceiling			
☐ Gasket	Wall	□ Plaster		X Other (water line			
☐ Tank Insulation	☐ Transite Panel	☐ Acoustic Tile (Dropped)		exhaust)			
☐ Pipe Wrap	☐ Textured Wall	☐ Acoustic Tile (Glued-on)					
1 1		☐ Mastic	Migaallanaaya	Darrain a comont			
HVAC	□ Plaster		Miscerianeous.	Parging cement			
☐ Insulation	□ DWJC	Structural					
☐ Tape		☐ Steel F. P. ing	No. of Phases:				
☐ Paper Wrap		□ Deck F. P. ing	Colour:

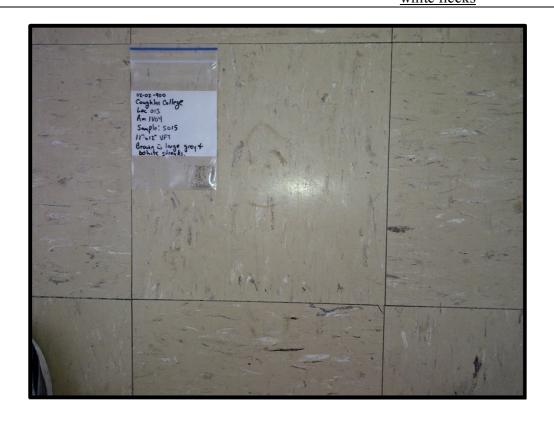
01111 = 11011					
Sample #:	S015		Date Sampled:	January 18, 2013	3
Building:	Coughlan College		Sampler:	Trent Hardy	
Location:	013, room 1V04		Analysis:	SAI - PLM	
MUN Project #:	02-02-900		Work Order #:		
		Bulk	Sampling Parameters		
Pipe/Tank	Flooring		Ceiling	Roofing	Location
☐ Insulation	X12'x12' Tile	\Box T	extured	☐ Shingle	X Floor
□ Elbow	□ 9'x9'Tile	☐ Stucco		□ Rolled	☐ Wall Orientation
☐ Fitting	☐ Vinyl Sheet	□ Popcorn		□ Felt	☐ Ceiling
☐ Transite Pipe	☐ Mastic	□ DWJC		□ Tar	☐ Above Ceiling
☐ Gasket	Wall	\square P	laster		□ Other
☐ Tank Insulation	☐ Transite Panel	\Box A	coustic Tile (Dropped)		
☐ Pipe Wrap	☐ Textured Wall	\Box A	coustic Tile (Glued-on)		
HVAC	☐ Plaster	\square N	Iastic	Miscellaneous:	
☐ Insulation	□ DWJC		Structural		
□ Tape		\square S	teel F. P. ing	No. of Phases:	
☐ Paper Wrap		\Box D	eck F. P. ing	Colour: Brown	with large grey and

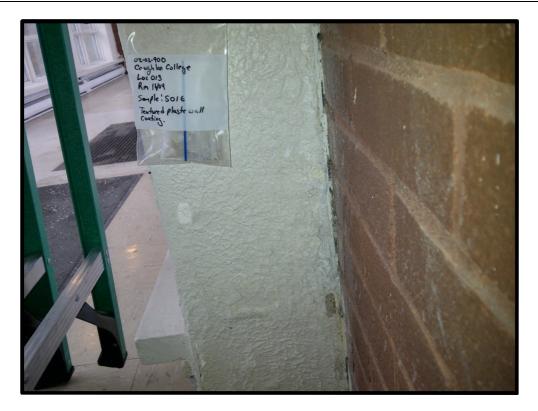
Two (2) samples of textured wall coating were collected from the Site Building. Results from one (1) of the two (2) samples collected contain 2% chrysotile asbestos (reference sample 02-02-900-S016, and 02-02-900-S030). Due to the nature of the addition of asbestos to this type of a material all textured wall coatings in the Site Building is considered asbestos-containing. For locations and conditions of this material at the time of the building survey refer to location & data excel document.

Sample #:	S016		Date Sampled:	January 18, 201	3
Building:	Coughlan College		Sampler:	Trent Hardy	
Location:	013, room 1V04		Analysis:	SAI - PLM	
MUN Project #:	02-02-900		Work Order #:		
		Bulk	Sampling Parameters		
Pipe/Tank	Flooring		Ceiling	Roofing	Location
☐ Insulation	□12'x12' Tile	\Box T	extured	☐ Shingle	□ Floor
□ Elbow	□ 9'x9'Tile	\square S	tucco	□ Rolled	X Wall Orientation
☐ Fitting	☐ Vinyl Sheet	\square P	opcorn	□ Felt	☐ Ceiling
☐ Transite Pipe	☐ Mastic	\square D	OWJC	□ Tar	☐ Above Ceiling
☐ Gasket	Wall	\square P	laster		☐ Other
☐ Tank Insulation	☐ Transite Panel	\square A	coustic Tile (Dropped)		
☐ Pipe Wrap	X Textured Wall	\square A	coustic Tile (Glued-on)		
HVAC	☐ Plaster	\square N	lastic	Miscellaneous:	
☐ Insulation	□ DWJC		Structural		
☐ Tape		\square S	teel F. P. ing	No. of Phases:	
☐ Paper Wrap		\square D	eck F. P. ing	Colour:

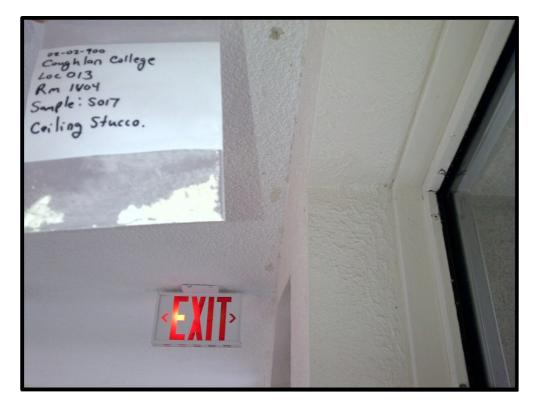
Sample #:	S017	Date Sampled:	January 18, 201	3
Building:	Coughlan College	Sampler:	Trent Hardy	
Location:	013, room 1V04	Analysis:	SAI - PLM	
MUN Project #:	02-02-900	Work Order #:		
		Bulk Sampling Parameters		
Pipe/Tank	Flooring	Ceiling	Roofing	Location
☐ Insulation	□12'x12' Tile	☐ Textured	☐ Shingle	□ Floor
□ Elbow	☐ 9'x9'Tile	X Stucco	☐ Rolled	☐ Wall Orientation
☐ Fitting	☐ Vinyl Sheet	□ Popcorn	☐ Felt	X Ceiling
☐ Transite Pipe	☐ Mastic	□ DWJC	□ Tar	☐ Above Ceiling
☐ Gasket	Wall	☐ Plaster		□ Other
☐ Tank Insulation	☐ Transite Panel	☐ Acoustic Tile (Dropped)		
☐ Pipe Wrap	☐ Textured Wall	☐ Acoustic Tile (Glued-on)		
HVAC	☐ Plaster	☐ Mastic	Miscellaneous:	
☐ Insulation	□ DWJC	Structural		
☐ Tape		☐ Steel F. P. ing	No. of Phases:	
☐ Paper Wrap		☐ Deck F. P. ing	Colour:

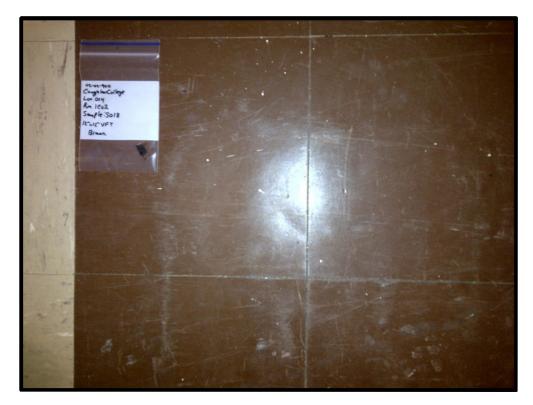
Sample #:	S018		Date Sampled:	January 18, 2013	3
Building:	Coughlan College		Sampler:	Trent Hardy	
Location:	014, room 1C02		Analysis:	SAI - PLM	
MUN Project #:	02-02-900		Work Order #:		
		Bulk	Sampling Parameters		
Pipe/Tank	Flooring		Ceiling	Roofing	Location
☐ Insulation	X12'x12' Tile	\Box T	extured	☐ Shingle	X Floor
□ Elbow	□ 9'x9'Tile	\square St	tucco	□ Rolled	☐ Wall Orientation
☐ Fitting	☐ Vinyl Sheet	□ P	opcorn	□ Felt	☐ Ceiling
☐ Transite Pipe	☐ Mastic	\square D	WJC	□ Tar	☐ Above Ceiling
☐ Gasket	Wall	\square P	laster		□ Other
☐ Tank Insulation	☐ Transite Panel	\Box A	coustic Tile (Dropped)		
☐ Pipe Wrap	☐ Textured Wall	\Box A	coustic Tile (Glued-on)		
HVAC	☐ Plaster	\square M	lastic	Miscellaneous:	
☐ Insulation	□ DWJC		Structural		
☐ Tape		\square St	teel F. P. ing	No. of Phases:	
☐ Paper Wrap		\square D	eck F. P. ing	Colour: Brown

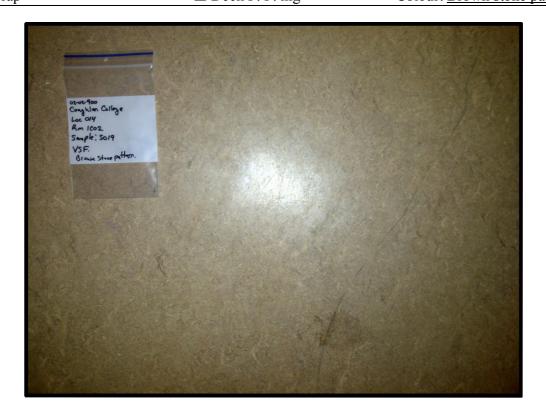
Sample #:	S019	Date Sampled:	January 18, 2013	3			
Building:	Coughlan College	Sampler:	Trent Hardy				
Location:	014, room 1C02	Analysis:	SAI - PLM				
MUN Project #:	02-02-900	Work Order #:					
	Bulk Sampling Parameters						
Pipe/Tank	Flooring	Ceiling	Roofing	Location			
☐ Insulation	□12'x12' Tile	☐ Textured	☐ Shingle	X Floor			
□ Elbow	□ 9'x9'Tile	☐ Stucco	☐ Rolled	☐ Wall Orientation			
☐ Fitting	X Vinyl Sheet	□ Popcorn	☐ Felt	☐ Ceiling			
☐ Transite Pipe	☐ Mastic	□ DWJC	□ Tar	☐ Above Ceiling			
☐ Gasket	Wall	☐ Plaster		□ Other			
☐ Tank Insulation	☐ Transite Panel	☐ Acoustic Tile (Dropped	1)				
☐ Pipe Wrap	☐ Textured Wall	☐ Acoustic Tile (Glued-or	n)				
HVAC	☐ Plaster	☐ Mastic	Miscellaneous:				
☐ Insulation	□ DWJC	Structural					
□ Tape		☐ Steel F. P. ing	No. of Phases:				
☐ Paper Wrap		□ Deck F. P. ing	Colour: Brown	stone pattern

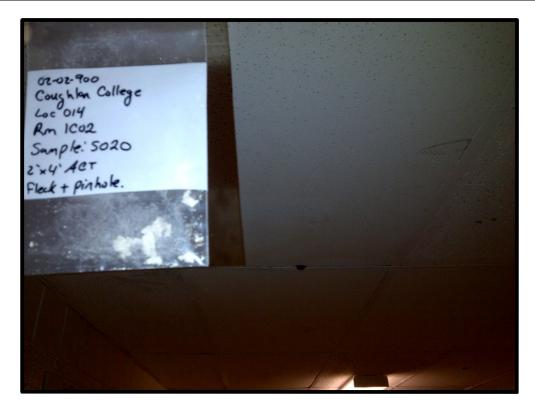
Sample #:	S020	Date Sampled:	January 18, 2013	3	
Building:	Coughlan College	Sampler:	Trent Hardy		
Location:	014, room 1C02	Analysis:	SAI - PLM		
MUN Project #:	02-02-900	Work Order #:			
Bulk Sampling Parameters					
Pipe/Tank	Flooring	Ceiling	Roofing	Location	
☐ Insulation	□12'x12' Tile	☐ Textured	☐ Shingle	☐ Floor	
□ Elbow	□ 9'x9'Tile	☐ Stucco	□ Rolled	☐ Wall Orientation	
☐ Fitting	☐ Vinyl Sheet	□ Popcorn	□ Felt	X Ceiling	
☐ Transite Pipe	☐ Mastic	□ DWJC	□ Tar	☐ Above Ceiling	
☐ Gasket	Wall	☐ Plaster		□ Other	
☐ Tank Insulation	☐ Transite Panel	X Acoustic Tile (Dropped)			
☐ Pipe Wrap	☐ Textured Wall	☐ Acoustic Tile (Glued-on)			
HVAC	□ Plaster	☐ Mastic	Miscellaneous: pinhole	2' x 4' fleck and	
☐ Insulation	□ DWJC	Structural			
☐ Tape		☐ Steel F. P. ing	No. of Phases:		
☐ Paper Wrap		☐ Deck F. P. ing	Colour:

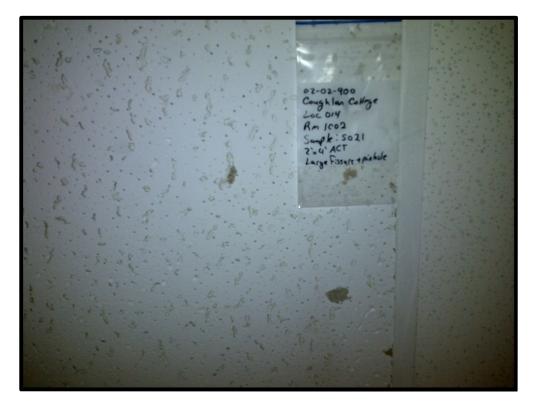
- One (1) sample of 2'x 4' acoustic ceiling tiles distinguished with a large fissure and pinhole fleck pattern was collected from room C-1010. Analysis of this sample did not identify the presence of asbestos (reference sample 02-02-900-S021).

Sample #:	S021	Date Sampled:	January 18, 201	3	
Building:	Coughlan College	Sampler:	Trent Hardy		
Location:	014, room 1C02	Analysis:	SAI - PLM		
MUN Project #:	02-02-900	Work Order #:			
Bulk Sampling Parameters					
Pipe/Tank	Flooring	Ceiling	Roofing	Location	
☐ Insulation	□12'x12' Tile	☐ Textured	☐ Shingle	□ Floor	
□ Elbow	□ 9'x9'Tile	☐ Stucco	☐ Rolled	☐ Wall Orientation	
☐ Fitting	☐ Vinyl Sheet	□ Popcorn	□ Felt	X Ceiling	
☐ Transite Pipe	☐ Mastic	□ DWJC	□ Tar	☐ Above Ceiling	
☐ Gasket	Wall	☐ Plaster		□ Other	
☐ Tank Insulation	☐ Transite Panel	X Acoustic Tile (Dropped)			
☐ Pipe Wrap	☐ Textured Wall	☐ Acoustic Tile (Glued-on)			
HVAC	□ Plaster	☐ Mastic	Miscellaneous: and pinhole	2' x 4' large fissure	
☐ Insulation	□ DWJC	Structural			
☐ Tape		☐ Steel F. P. ing	No. of Phases:		
☐ Paper Wrap		☐ Deck F. P. ing	Colour:

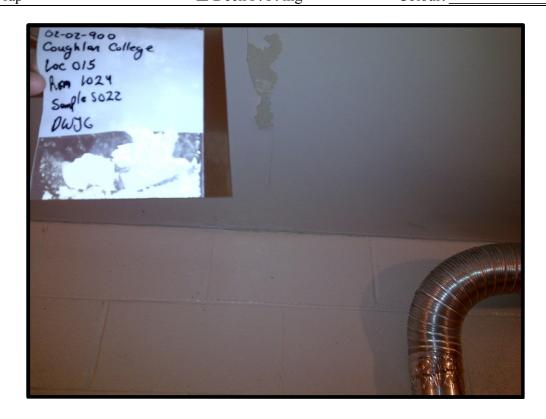
Sample #:	S022	Date Sampled:	January 18, 201	3
Building:	Coughlan College	Sampler:	Trent Hardy	
Location:	015, room 1024	Analysis:	SAI - PLM	
MUN Project #:	02-02-900	Work Order #:		
		Bulk Sampling Parameters		
Pipe/Tank	Flooring	Ceiling	Roofing	Location
☐ Insulation	□12'x12' Tile	☐ Textured	☐ Shingle	□ Floor
□ Elbow	□ 9'x9'Tile	☐ Stucco	□ Rolled	☐ Wall Orientation
☐ Fitting	☐ Vinyl Sheet	□ Popcorn	□ Felt	X Ceiling
☐ Transite Pipe	☐ Mastic	X DWJC	□ Tar	☐ Above Ceiling
☐ Gasket	Wall	☐ Plaster		□ Other
☐ Tank Insulation	☐ Transite Panel	☐ Acoustic Tile (Dropped)		
☐ Pipe Wrap	☐ Textured Wall	☐ Acoustic Tile (Glued-on)		
HVAC	☐ Plaster	☐ Mastic	Miscellaneous:	
☐ Insulation	□ DWJC	Structural		
☐ Tape		☐ Steel F. P. ing	No. of Phases:	
☐ Paper Wrap		□ Deck F. P. ing	Colour:

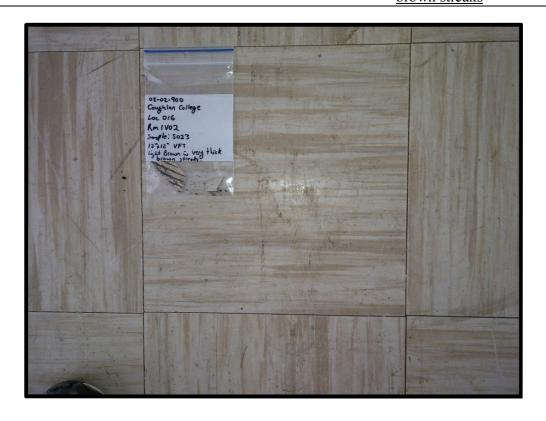
Sample #:	S023	Date Sampled:	January 18, 201	3
Building:	Coughlan College	Sampler:	Trent Hardy	
Location:	015, room 1V02	Analysis:	SAI - PLM	
MUN Project #:	02-02-900	Work Order #:		
		Bulk Sampling Parameters		
Pipe/Tank	Flooring	Ceiling	Roofing	Location
☐ Insulation	X12'x12' Tile	☐ Textured	☐ Shingle	X Floor
□ Elbow	☐ 9'x9'Tile	☐ Stucco	□ Rolled	☐ Wall Orientation
☐ Fitting	☐ Vinyl Sheet	□ Popcorn	☐ Felt	☐ Ceiling
☐ Transite Pipe	☐ Mastic	□ DWJC	□ Tar	☐ Above Ceiling
☐ Gasket	Wall	□ Plaster		☐ Other
☐ Tank Insulation	☐ Transite Panel	☐ Acoustic Tile (Dropped)		
☐ Pipe Wrap	☐ Textured Wall	☐ Acoustic Tile (Glued-on)		
HVAC	☐ Plaster	☐ Mastic	Miscellaneous:	
☐ Insulation	□ DWJC	Structural		
☐ Tape		☐ Steel F. P. ing	No. of Phases:	
☐ Paper Wrap		□ Deck F. P. ing	Colour: <u>Light b</u>	rown with large

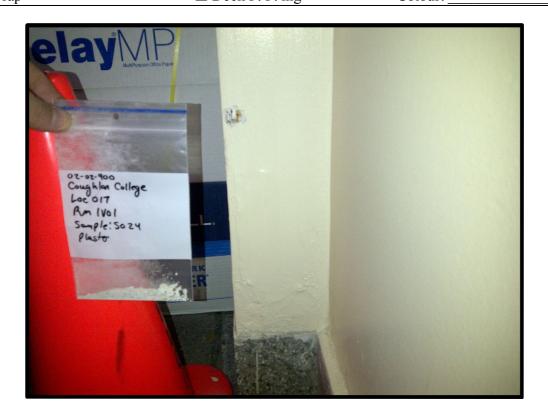
Sample #:	S024	Date Sampled:	January 18, 201	3
Building:	Coughlan College	Sampler:	Trent Hardy	
Location:	017, room 1V01	Analysis:	SAI - PLM	
MUN Project #:	02-02-900	Work Order #:		
		Bulk Sampling Parameters		
Pipe/Tank	Flooring	Ceiling	Roofing	Location
☐ Insulation	□12'x12' Tile	☐ Textured	☐ Shingle	□ Floor
□ Elbow	□ 9'x9'Tile	☐ Stucco	□ Rolled	X Wall Orientation
☐ Fitting	☐ Vinyl Sheet	□ Popcorn	□ Felt	☐ Ceiling
☐ Transite Pipe	☐ Mastic	□ DWJC	□ Tar	☐ Above Ceiling
☐ Gasket	Wall	☐ Plaster		X Other (column)
☐ Tank Insulation	☐ Transite Panel	☐ Acoustic Tile (Dropped)		
☐ Pipe Wrap	☐ Textured Wall	☐ Acoustic Tile (Glued-on)		
HVAC	X Plaster	☐ Mastic	Miscellaneous:	
☐ Insulation	□ DWJC	Structural		
☐ Tape		☐ Steel F. P. ing	No. of Phases:	
□ Paner Wran		□ Deck F P ing	Colour

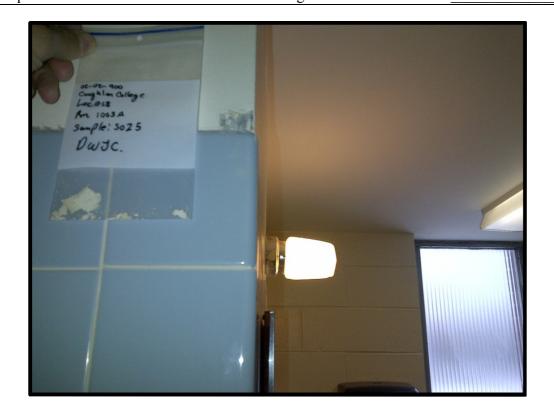
Sample #:	S025	Date Sampled:	January 18, 2013	3	
Building:	Coughlan College	Sampler:	Trent Hardy		
Location:	018, room 1003A	Analysis:	SAI - PLM		
MUN Project #:	02-02-900	Work Order #:			
Bulk Sampling Parameters					
Pipe/Tank	Flooring	Ceiling	Roofing	Location	
☐ Insulation	□12'x12' Tile	☐ Textured	☐ Shingle	☐ Floor	
□ Elbow	☐ 9'x9'Tile	☐ Stucco	□ Rolled	X Wall Orientation	
☐ Fitting	☐ Vinyl Sheet	□ Popcorn	□ Felt	☐ Ceiling	
☐ Transite Pipe	☐ Mastic	□ DWJC	□ Tar	☐ Above Ceiling	
☐ Gasket	Wall	□ Plaster		□ Other	
☐ Tank Insulation	☐ Transite Panel	☐ Acoustic Tile (Dropped)			
☐ Pipe Wrap	☐ Textured Wall	☐ Acoustic Tile (Glued-on)			
HVAC	☐ Plaster	☐ Mastic	Miscellaneous:		
☐ Insulation	X DWJC	Structural			
☐ Tape		☐ Steel F. P. ing	No. of Phases:		
☐ Paper Wrap		□ Deck F. P. ing	Colour:

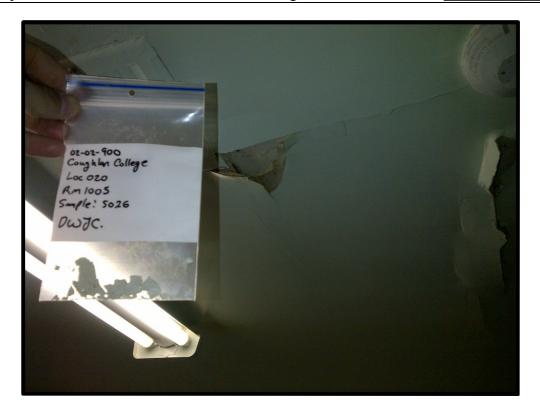
Sample #:	S026	Date Sampled:	January 18, 2013	3		
Building:	Coughlan College	Sampler:	Trent Hardy			
Location:	026, room 1005	Analysis:	SAI - PLM			
MUN Project #:	02-02-900	Work Order #:				
Bulk Sampling Parameters						
Pipe/Tank	Flooring	Ceiling	Roofing	Location		
☐ Insulation	□12'x12' Tile	☐ Textured	☐ Shingle	☐ Floor		
□ Elbow	□ 9'x9'Tile	☐ Stucco	□ Rolled	☐ Wall Orientation		
☐ Fitting	☐ Vinyl Sheet	□ Popcorn	□ Felt	X Ceiling		
☐ Transite Pipe	☐ Mastic	X DWJC	□ Tar	☐ Above Ceiling		
☐ Gasket	Wall	☐ Plaster		□ Other		
☐ Tank Insulation	☐ Transite Panel	☐ Acoustic Tile (Dropped)				
☐ Pipe Wrap	☐ Textured Wall	☐ Acoustic Tile (Glued-on)				
HVAC	☐ Plaster	☐ Mastic	Miscellaneous:			
☐ Insulation	□ DWJC	Structural				
☐ Tape		☐ Steel F. P. ing	No. of Phases:			
☐ Paper Wrap		☐ Deck F. P. ing	Colour:

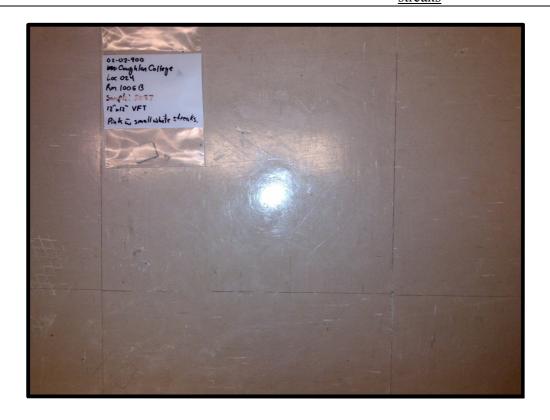
Sample #:	S027	Dat	te Sampled:	January 18, 2013	3
Building:	Coughlan College	San	npler:	Trent Hardy	
Location:	024, room 1006B	Ana	alysis:	SAI - PLM	
MUN Project #:	02-02-900	Wo	rk Order #:		
		Bulk Sam	pling Parameters		
Pipe/Tank	Flooring		Ceiling	Roofing	Location
☐ Insulation	X12'x12' Tile	☐ Textur	red	☐ Shingle	X Floor
□ Elbow	□ 9'x9'Tile	☐ Stucco)	□ Rolled	☐ Wall Orientation
☐ Fitting	☐ Vinyl Sheet	☐ Popcoi	rn	□ Felt	☐ Ceiling
☐ Transite Pipe	☐ Mastic	□ DWJC		□ Tar	☐ Above Ceiling
☐ Gasket	Wall	☐ Plaster	r		□ Other
☐ Tank Insulation	☐ Transite Panel	☐ Acous	tic Tile (Dropped)		
☐ Pipe Wrap	☐ Textured Wall	☐ Acous	tic Tile (Glued-on)		
HVAC	☐ Plaster	☐ Mastic		Miscellaneous:	
☐ Insulation	□ DWJC		Structural		
☐ Tape		☐ Steel F	F. P. ing	No. of Phases:	
☐ Paper Wrap		□ Deck I	F. P. ing	Colour: Pink wi	th small white

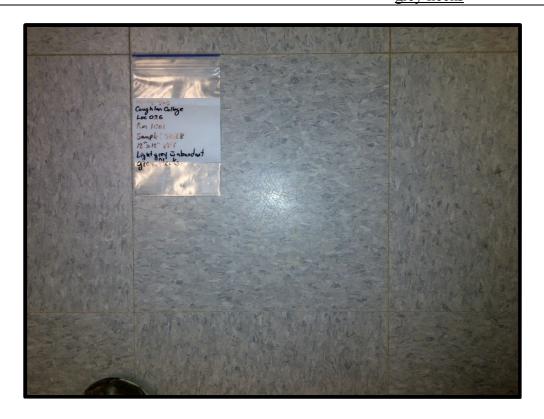
•						
Sample #:	S028		Date Sampled:	January 18, 2013	3		
Building:	Coughlan College		Sampler:	Trent Hardy			
Location:	026, room 1C01		Analysis:	SAI - PLM			
MUN Project #:	02-02-900		Work Order #:				
		Bulk	Sampling Parameters				
Pipe/Tank	Flooring		Ceiling	Roofing	Location		
☐ Insulation	X12'x12' Tile	□ Te	extured	☐ Shingle	X Floor		
□ Elbow	☐ 9'x9'Tile	\square St	ucco	☐ Rolled	☐ Wall Orientation		
☐ Fitting	☐ Vinyl Sheet	□ Pc	opcorn	□ Felt	☐ Ceiling		
☐ Transite Pipe	☐ Mastic	\square D	WJC	□ Tar	☐ Above Ceiling		
☐ Gasket	Wall	□ P1	aster		☐ Other		
☐ Tank Insulation	☐ Transite Panel	\square A	coustic Tile (Dropped)				
☐ Pipe Wrap	☐ Textured Wall	\Box A	coustic Tile (Glued-on)				
HVAC	☐ Plaster	\square M	astic	Miscellaneous:			
☐ Insulation	□ DWJC		Structural				
☐ Tape		\square St	eel F. P. ing	No. of Phases:			
☐ Paper Wrap			eck F. P. ing	Colour: <u>Light g</u>	rey with abundant

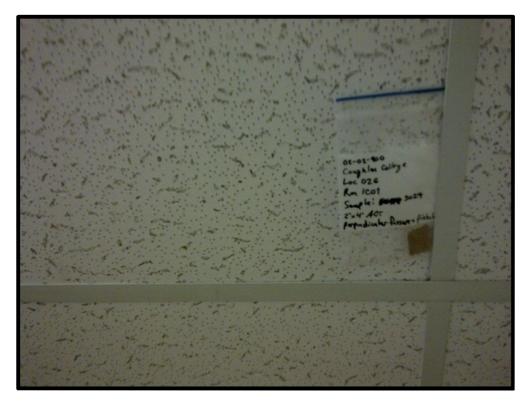
- One (1) sample of 2'x 4' acoustic ceiling tiles distinguished with a perpendicular fissure and pinhole pattern was collected from room C-1C01. Analysis of this sample did not identify the presence of asbestos (reference sample 02-02-900-S029).

Sample #:	S029	Date Sampled:	January 18, 2013	3		
Building:	Coughlan College	Sampler:	Trent Hardy			
Location:	027, room 1V02	Analysis:	SAI - PLM			
MUN Project #:	02-02-900	Work Order #:				
	Bulk Sampling Parameters					
Pipe/Tank	Flooring	Ceiling	Roofing	Location		
☐ Insulation	□12'x12' Tile	☐ Textured	☐ Shingle	□ Floor		
□ Elbow	☐ 9'x9'Tile	☐ Stucco	☐ Rolled	☐ Wall Orientation		
☐ Fitting	☐ Vinyl Sheet	□ Popcorn	☐ Felt	X Ceiling		
☐ Transite Pipe	☐ Mastic	□ DWJC	□ Tar	☐ Above Ceiling		
☐ Gasket	Wall	□ Plaster		□ Other		
☐ Tank Insulation	☐ Transite Panel	X Acoustic Tile (Dropped)				
☐ Pipe Wrap	☐ Textured Wall	☐ Acoustic Tile (Glued-on)				
HVAC	□ Plaster	☐ Mastic	Miscellaneous: perpendicular fi	2' x 4' ssure and pinhole		
☐ Insulation	□ DWJC	Structural				
☐ Tape		☐ Steel F. P. ing	No. of Phases: _			
☐ Paper Wrap		□ Deck F. P. ing	Colour:

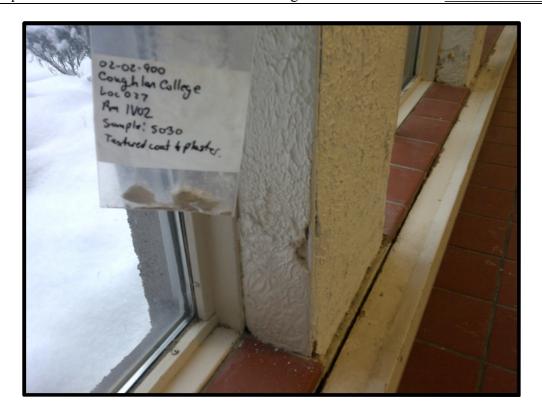
Sample #:	S030	Date Sampled:	January 18, 2013	3
Building:	Coughlan College	Sampler:	Trent Hardy	
Location:	027, room 1V02	Analysis:	SAI - PLM	
MUN Project #:	02-02-900	Work Order #:		
		Bulk Sampling Parameters		
Pipe/Tank	Flooring	Ceiling	Roofing	Location
☐ Insulation	□12'x12' Tile	☐ Textured	☐ Shingle	☐ Floor
□ Elbow	□ 9'x9'Tile	☐ Stucco	□ Rolled	X Wall Orientation
☐ Fitting	☐ Vinyl Sheet	□ Popcorn	□ Felt	☐ Ceiling
☐ Transite Pipe	☐ Mastic	□ DWJC	□ Tar	☐ Above Ceiling
☐ Gasket	Wall	☐ Plaster		□ Other
☐ Tank Insulation	☐ Transite Panel	☐ Acoustic Tile (Dropped)		
☐ Pipe Wrap	X Textured Wall	☐ Acoustic Tile (Glued-on)		
HVAC	☐ Plaster	☐ Mastic	Miscellaneous:	
☐ Insulation	□ DWJC	Structural		
☐ Tape		☐ Steel F. P. ing	No. of Phases:	
☐ Paper Wrap		□ Deck F. P. ing	Colour:

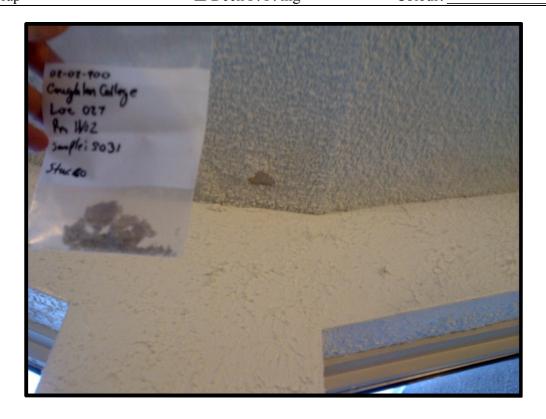
Sample #:	S031	Date Sampled:	January 18, 201	3
Building:	Coughlan College	Sampler:	Trent Hardy	
Location:	027, room 1V02	Analysis:	SAI - PLM	
MUN Project #:	02-02-900	Work Order #:		
		Bulk Sampling Parameters		
Pipe/Tank	Flooring	Ceiling	Roofing	Location
☐ Insulation	□12'x12' Tile	☐ Textured	☐ Shingle	□ Floor
□ Elbow	□ 9'x9'Tile	X Stucco	☐ Rolled	☐ Wall Orientation
☐ Fitting	☐ Vinyl Sheet	□ Popcorn	□ Felt	X Ceiling
☐ Transite Pipe	☐ Mastic	□ DWJC	□ Tar	☐ Above Ceiling
☐ Gasket	Wall	☐ Plaster		□ Other
☐ Tank Insulation	☐ Transite Panel	☐ Acoustic Tile (Dropped)		
☐ Pipe Wrap	☐ Textured Wall	☐ Acoustic Tile (Glued-on)		
HVAC	☐ Plaster	☐ Mastic	Miscellaneous:	
☐ Insulation	□ DWJC	Structural		
☐ Tape		☐ Steel F. P. ing	No. of Phases:	
☐ Paper Wrap		□ Deck F. P. ing	Colour:

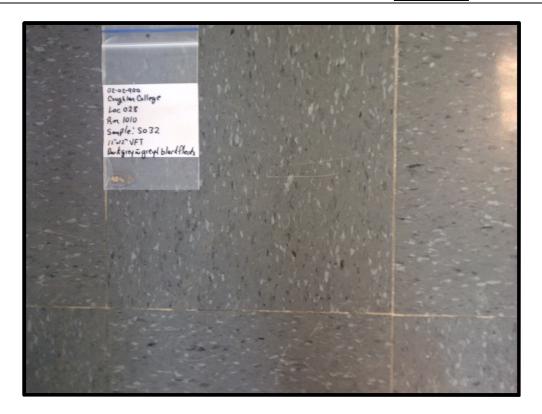
Sample #:	S032	Date Sampled:	January 21, 2013	3		
Building:	Coughlan College	Sampler:	Trent Hardy			
Location:	028, room 1010	Analysis:	SAI - PLM			
MUN Project #:	02-02-900	Work Order #:				
Bulk Sampling Parameters						
Pipe/Tank	Flooring	Ceiling	Roofing	Location		
☐ Insulation	X12'x12' Tile	☐ Textured	☐ Shingle	X Floor		
□ Elbow	□ 9'x9'Tile	□ Stucco	□ Rolled	☐ Wall Orientation		
☐ Fitting	☐ Vinyl Sheet	□ Popcorn	□ Felt	☐ Ceiling		
☐ Transite Pipe	☐ Mastic	□ DWJC	□ Tar	☐ Above Ceiling		
☐ Gasket	Wall	□ Plaster		□ Other		
☐ Tank Insulation	☐ Transite Panel	☐ Acoustic Tile (Dropped)				
☐ Pipe Wrap	☐ Textured Wall	☐ Acoustic Tile (Glued-on)				
HVAC	□ Plaster	☐ Mastic	Miscellaneous:			
☐ Insulation	□ DWJC	Structural				
☐ Tape		☐ Steel F. P. ing	No. of Phases:			
☐ Paper Wrap		□ Deck F. P. ing	Colour: Dark gr black flecks	rey with grey and

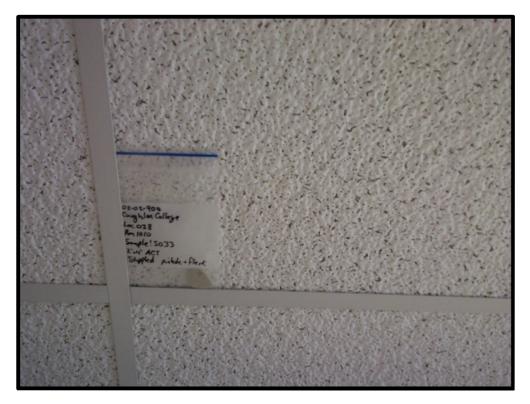
Sample #:	S033	Date Sampled:	January 21, 201	3			
Building:	Coughlan College	Sampler:	Trent Hardy				
Location:	028, room 1010	Analysis:	SAI - PLM				
MUN Project #:	02-02-900	Work Order #:					
	Bulk Sampling Parameters						
Pipe/Tank	Flooring	Ceiling	Roofing	Location			
☐ Insulation	\Box 12'x12' Tile	☐ Textured	☐ Shingle	□ Floor			
□ Elbow	☐ 9'x9'Tile	☐ Stucco	☐ Rolled	☐ Wall Orientation			
☐ Fitting	☐ Vinyl Sheet	□ Popcorn	□ Felt	X Ceiling			
☐ Transite Pipe	☐ Mastic	□ DWJC	□ Tar	☐ Above Ceiling			
☐ Gasket	Wall	☐ Plaster		□ Other			
☐ Tank Insulation	☐ Transite Panel	X Acoustic Tile (Dropped)					
☐ Pipe Wrap	☐ Textured Wall	☐ Acoustic Tile (Glued-on)					
HVAC	□ Plaster	☐ Mastic	Miscellaneous: pinhole and flee	2' x 4' stippled ck			
☐ Insulation	□ DWJC	Structural					
☐ Tape		☐ Steel F. P. ing	No. of Phases:				
☐ Paper Wrap		□ Deck F. P. ing	Colour:

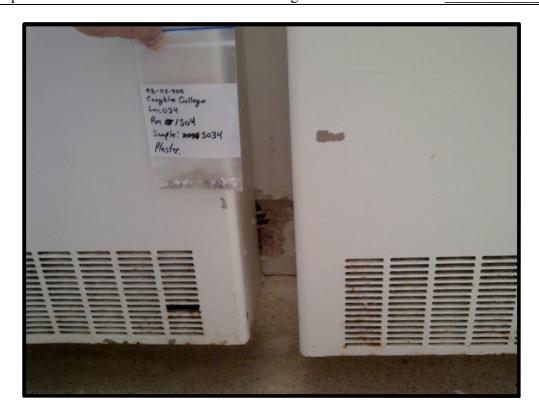
Sample #:	S034	Date Sampled:	January 21, 201	3
Building:	Coughlan College	Sampler:	Trent Hardy	
Location:	034, room 1S04	Analysis:	SAI - PLM	
MUN Project #:	02-02-900	Work Order #:		
		Bulk Sampling Parameters		
Pipe/Tank	Flooring	Ceiling	Roofing	Location
☐ Insulation	□12'x12' Tile	☐ Textured	☐ Shingle	☐ Floor
□ Elbow	□ 9'x9'Tile	☐ Stucco	\square Rolled	X Wall Orientation
☐ Fitting	☐ Vinyl Sheet	□ Popcorn	☐ Felt	☐ Ceiling
☐ Transite Pipe	☐ Mastic	□ DWJC	□ Tar	☐ Above Ceiling
☐ Gasket	Wall	☐ Plaster		□ Other
☐ Tank Insulation	☐ Transite Panel	☐ Acoustic Tile (Dropped)		
☐ Pipe Wrap	☐ Textured Wall	☐ Acoustic Tile (Glued-on))	
HVAC	X Plaster	☐ Mastic	Miscellaneous:	
☐ Insulation	□ DWJC	Structural		
☐ Tape		☐ Steel F. P. ing	No. of Phases:	
☐ Paper Wrap		□ Deck F. P. ing	Colour:

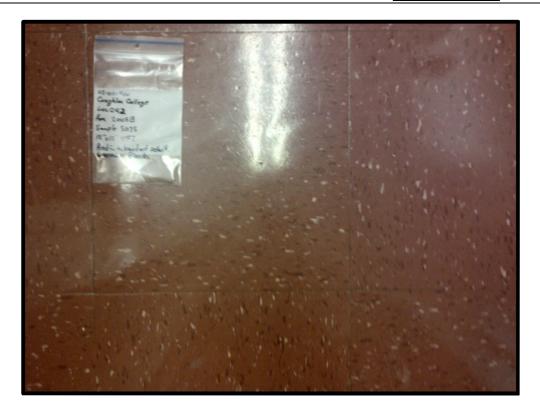
Sample #:	S035	Date Sampled:	January 21, 201	3				
Building:	Coughlan College	Sampler:	Trent Hardy					
Location:	042, room 2005B	Analysis:	SAI - PLM					
MUN Project #:	02-02-900	Work Order #:						
	Bulk Sampling Parameters							
Pipe/Tank	Flooring	Ceiling	Roofing	Location				
☐ Insulation	X12'x12' Tile	☐ Textured	☐ Shingle	X Floor				
□ Elbow	☐ 9'x9'Tile	☐ Stucco	☐ Rolled	☐ Wall Orientation				
☐ Fitting	☐ Vinyl Sheet	□ Popcorn	□ Felt	☐ Ceiling				
☐ Transite Pipe	☐ Mastic	□ DWJC	□ Tar	☐ Above Ceiling				
☐ Gasket	Wall	□ Plaster		□ Other				
☐ Tank Insulation	☐ Transite Panel	☐ Acoustic Tile (Dropped)						
☐ Pipe Wrap	☐ Textured Wall	☐ Acoustic Tile (Glued-on)						
HVAC	☐ Plaster	☐ Mastic	Miscellaneous:					
☐ Insulation	□ DWJC	Structural						
□ Tape		☐ Steel F. P. ing	No. of Phases:					
☐ Paper Wrap		□ Deck F. P. ing	Colour: Red wi	th abundant white ks

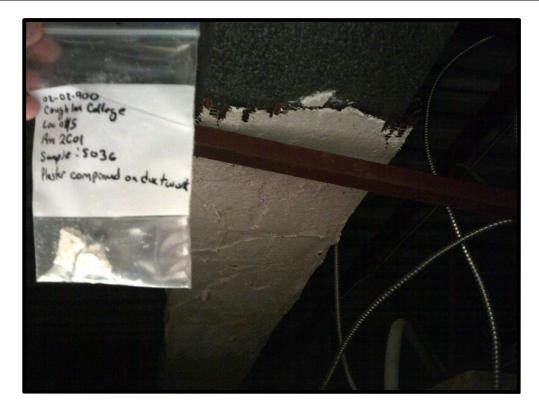
Seven (7) samples of plaster were collected throughout the Site Building. Results from two (2) of the seven (7) samples collected contain <1% Libby amphibole asbestos (reference samples 02-02-900-S036, and 02-02-900-S039). Due to the nature of the addition of asbestos to this type of a material, all plaster in the Site Building is considered asbestos-containing. For locations and conditions of this material at the time of the building survey refer to location & data excel document.

Sample #:	S036	Date Sampled:	January 21, 2013	3			
Building:	Coughlan College	Sampler:	Trent Hardy				
Location:	044, room 2C01	Analysis:	SAI - PLM				
MUN Project #:	02-02-900	Work Order #:					
Bulk Sampling Parameters							
Pipe/Tank	Flooring	Ceiling	Roofing	Location			
☐ Insulation	□12'x12' Tile	☐ Textured	☐ Shingle	☐ Floor			
□ Elbow	☐ 9'x9'Tile	☐ Stucco	☐ Rolled	☐ Wall Orientation			
☐ Fitting	☐ Vinyl Sheet	□ Popcorn	□ Felt	☐ Ceiling			
☐ Transite Pipe	☐ Mastic	□ DWJC	□ Tar	X Above Ceiling			
☐ Gasket	Wall	□ Plaster		□ Other			
☐ Tank Insulation	☐ Transite Panel	☐ Acoustic Tile (Dropped)					
☐ Pipe Wrap	☐ Textured Wall	☐ Acoustic Tile (Glued-on)					
HVAC	□ Plaster	☐ Mastic	Miscellaneous: above the kitche	Plaster on ductwork en			
☐ Insulation	□ DWJC	Structural					
☐ Tape		☐ Steel F. P. ing	No. of Phases:				
☐ Paper Wrap		□ Deck F. P. ing	Colour:

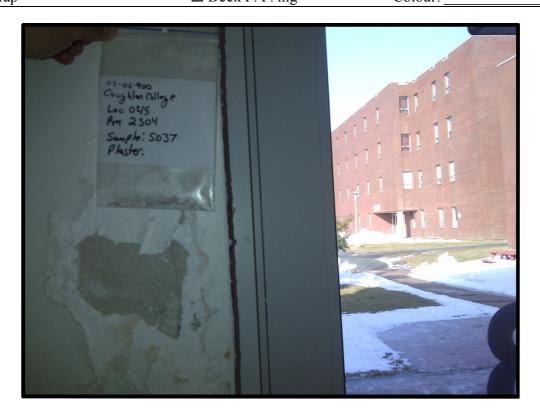
Sample #:	S037	Date Sampled:	January 21, 201	3
Building:	Coughlan College	Sampler:	Trent Hardy	
Location:	045, room 1S04	Analysis:	SAI - PLM	
MUN Project #:	02-02-900	Work Order #:		
		Bulk Sampling Parameters		
Pipe/Tank	Flooring	Ceiling	Roofing	Location
☐ Insulation	□12'x12' Tile	☐ Textured	☐ Shingle	□ Floor
□ Elbow	□ 9'x9'Tile	☐ Stucco	□ Rolled	X Wall Orientation
☐ Fitting	☐ Vinyl Sheet	□ Popcorn	□ Felt	☐ Ceiling
☐ Transite Pipe	☐ Mastic	□ DWJC	□ Tar	☐ Above Ceiling
☐ Gasket	Wall	☐ Plaster		□ Other
☐ Tank Insulation	☐ Transite Panel	☐ Acoustic Tile (Dropped)		
☐ Pipe Wrap	☐ Textured Wall	☐ Acoustic Tile (Glued-on)		
HVAC	X Plaster	☐ Mastic	Miscellaneous:	
☐ Insulation	□ DWJC	Structural		
☐ Tape		☐ Steel F. P. ing	No. of Phases:	
☐ Paner Wran		□ Deck F P ing	Colour:

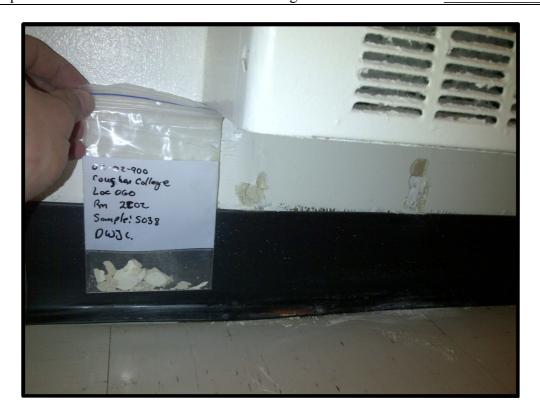
Sample #:	S038		Date Sampled:	January 21, 201	3
Building:	Coughlan College	• 5	Sampler:	Trent Hardy	
Location:	060, room 2C03		Analysis:	SAI - PLM	
MUN Project #:	02-02-900	7	Work Order #:		
		Bulk S	ampling Parameters		
Pipe/Tank	Flooring		Ceiling	Roofing	Location
☐ Insulation	□12'x12' Tile	□ Te	xtured	☐ Shingle	☐ Floor
□ Elbow	□ 9'x9'Tile	☐ Stu	icco	☐ Rolled	X Wall Orientation
☐ Fitting	☐ Vinyl Sheet	□ Poj	pcorn	□ Felt	☐ Ceiling
☐ Transite Pipe	☐ Mastic	\square DV	VJC	□ Tar	☐ Above Ceiling
☐ Gasket	Wall	□ Pla	ster		□ Other
☐ Tank Insulation	☐ Transite Panel	\square Ac	oustic Tile (Dropped)		
☐ Pipe Wrap	☐ Textured Wall	\square Ac	oustic Tile (Glued-on)		
HVAC	☐ Plaster	□ Ma	istic	Miscellaneous:	
☐ Insulation	X DWJC		Structural		
☐ Tape		☐ Ste	eel F. P. ing	No. of Phases:	
☐ Paper Wrap		\square De	ck F. P. ing	Colour:

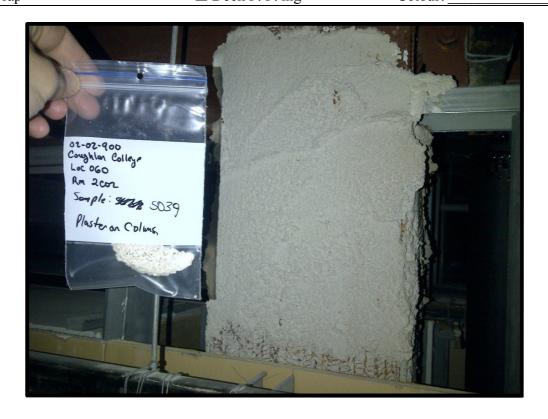
Sample #:	S039	Date Sampled:	January 21, 201	3
Building:	Coughlan College	Sampler:	Trent Hardy	
Location:	060, room 2C03	Analysis:	SAI - PLM	
MUN Project #:	02-02-900	Work Order #:		
		Bulk Sampling Parameters		
Pipe/Tank	Flooring	Ceiling	Roofing	Location
☐ Insulation	□12'x12' Tile	☐ Textured	☐ Shingle	□ Floor
□ Elbow	□ 9'x9'Tile	☐ Stucco	□ Rolled	☐ Wall Orientation
☐ Fitting	☐ Vinyl Sheet	□ Popcorn	□ Felt	☐ Ceiling
☐ Transite Pipe	☐ Mastic	□ DWJC	□ Tar	X Above Ceiling
☐ Gasket	Wall	X Plaster		□ Other
☐ Tank Insulation	☐ Transite Panel	☐ Acoustic Tile (Dropped)		
☐ Pipe Wrap	☐ Textured Wall	☐ Acoustic Tile (Glued-on)		
HVAC	☐ Plaster	☐ Mastic	Miscellaneous:	
☐ Insulation	□ DWJC	Structural		
☐ Tape		☐ Steel F. P. ing	No. of Phases:	
□ Paner Wran		□ Deck F P ing	Colour

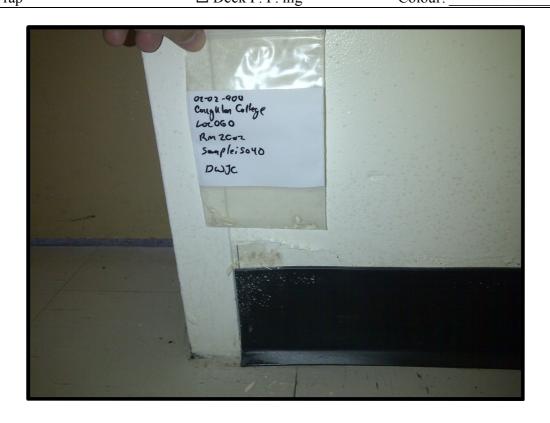
Sample #:	S040		Date Sampled:	January 21, 2013	3
Building:	Coughlan College		Sampler:	Trent Hardy	
Location:	060, room 2C03		Analysis:	SAI - PLM	
MUN Project #:	02-02-900		Work Order #:		
		Bulk S	Sampling Parameters		
Pipe/Tank	Flooring		Ceiling	Roofing	Location
☐ Insulation	□12'x12' Tile	□Те	extured	☐ Shingle	□ Floor
□ Elbow	☐ 9'x9'Tile	☐ St	ucco	☐ Rolled	X Wall Orientation
☐ Fitting	☐ Vinyl Sheet	□ Po	pcorn	☐ Felt	☐ Ceiling
☐ Transite Pipe	☐ Mastic	\square D	WJC	□ Tar	☐ Above Ceiling
☐ Gasket	Wall	□ Pla	aster		□ Other
☐ Tank Insulation	☐ Transite Panel	\Box Ac	coustic Tile (Dropped)		
☐ Pipe Wrap	☐ Textured Wall	\Box Ac	coustic Tile (Glued-on)		
HVAC	☐ Plaster	\square M	astic	Miscellaneous:	
☐ Insulation	X DWJC		Structural		
□ Tape		\square Ste	eel F. P. ing	No. of Phases:	
☐ Paper Wrap		\Box De	eck F. P. ing	Colour:

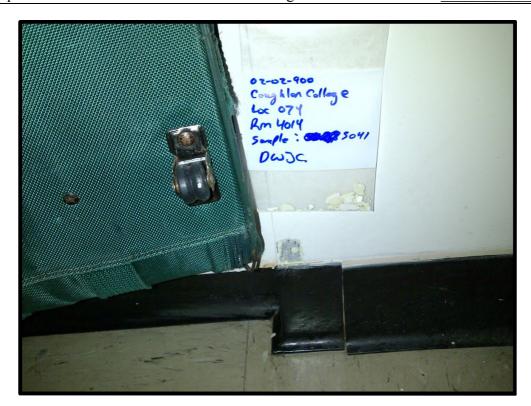
Sample #:	S041	I	Date Sampled:	January 25, 2013	3
Building:	Coughlan College	S	Sampler:	Trent Hardy	
Location:	074, room 4014	A	Analysis:	SAI - PLM	
MUN Project #:	02-02-900	1	Work Order #:		
		Bulk Sa	ampling Parameters		
Pipe/Tank	Flooring		Ceiling	Roofing	Location
☐ Insulation	□12'x12' Tile	□ Tex	tured	☐ Shingle	☐ Floor
□ Elbow	□ 9'x9'Tile	□ Stu	cco	□ Rolled	X Wall Orientation
☐ Fitting	☐ Vinyl Sheet	□ Popcorn		□ Felt	☐ Ceiling
☐ Transite Pipe	☐ Mastic	\square DW	/JC	□ Tar	☐ Above Ceiling
☐ Gasket	Wall	□ Plas	ster		☐ Other
☐ Tank Insulation	☐ Transite Panel	\Box Acc	oustic Tile (Dropped)		
☐ Pipe Wrap	☐ Textured Wall	\Box Acc	oustic Tile (Glued-on)		
HVAC	☐ Plaster	□ Mas	stic	Miscellaneous:	
☐ Insulation	X DWJC		Structural		
☐ Tape		☐ Stee	el F. P. ing	No. of Phases:	
☐ Paper Wrap		\square Dec	ck F. P. ing	Colour:

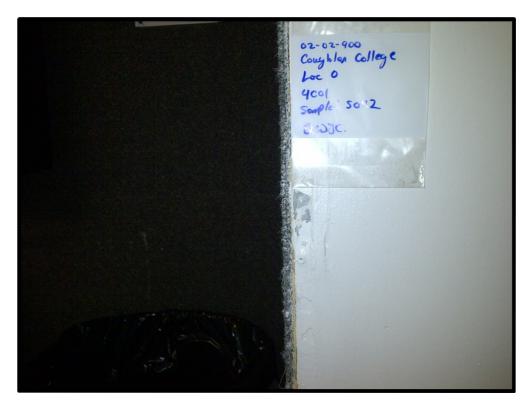
01111 = 11011							
Sample #:	S042	Date Sampl	ed:	January 25, 2013	3		
Building:	Coughlan College	Sampler:		Trent Hardy			
Location:	079, room 4C01	Analysis:		SAI - PLM			
MUN Project #:	02-02-900	Work Orde	r#:				
	Bulk Sampling Parameters						
Pipe/Tank	Flooring	Ceilin	9	Roofing	Location		
☐ Insulation	□12'x12' Tile	☐ Textured		☐ Shingle	□ Floor		
□ Elbow	☐ 9'x9'Tile	☐ Stucco		☐ Rolled	X Wall Orientation		
☐ Fitting	☐ Vinyl Sheet	□ Popcorn		☐ Felt	☐ Ceiling		
☐ Transite Pipe	☐ Mastic	□ DWJC		□ Tar	☐ Above Ceiling		
☐ Gasket	Wall	□ Plaster			□ Other		
☐ Tank Insulation	☐ Transite Panel	☐ Acoustic Tile (Dropped)				
☐ Pipe Wrap	☐ Textured Wall	☐ Acoustic Tile (Glued-on)				
HVAC	☐ Plaster	☐ Mastic		Miscellaneous:			
☐ Insulation	X DWJC	Structu	ral				
□ Tape		☐ Steel F. P. ing		No. of Phases:			
☐ Paper Wrap		☐ Deck F. P. ing		Colour:

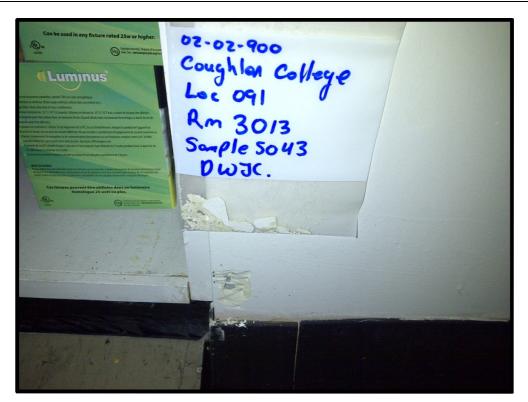
Sample #:	S043		Date Sampled:	January 25, 2013	3		
Building:	Coughlan College		Sampler:	Trent Hardy			
Location:	091, room 3013		Analysis:	SAI - PLM			
MUN Project #:	02-02-900		Work Order #:				
	Bulk Sampling Parameters						
Pipe/Tank	Flooring		Ceiling	Roofing	Location		
☐ Insulation	□12'x12' Tile	\Box T	extured	☐ Shingle	□ Floor		
□ Elbow	☐ 9'x9'Tile	\square S	tucco	□ Rolled	X Wall Orientation		
☐ Fitting	☐ Vinyl Sheet	\square P	opcorn	□ Felt	☐ Ceiling		
☐ Transite Pipe	☐ Mastic	\square D	OWJC	□ Tar	☐ Above Ceiling		
☐ Gasket	Wall	\square P	laster		□ Other		
☐ Tank Insulation	☐ Transite Panel	\Box A	coustic Tile (Dropped)				
☐ Pipe Wrap	☐ Textured Wall	\Box A	coustic Tile (Glued-on)				
HVAC	☐ Plaster	\square N	lastic	Miscellaneous:			
☐ Insulation	X DWJC		Structural				
□ Tape		\square S	teel F. P. ing	No. of Phases:			
☐ Paper Wrap		\square D	eck F. P. ing	Colour:

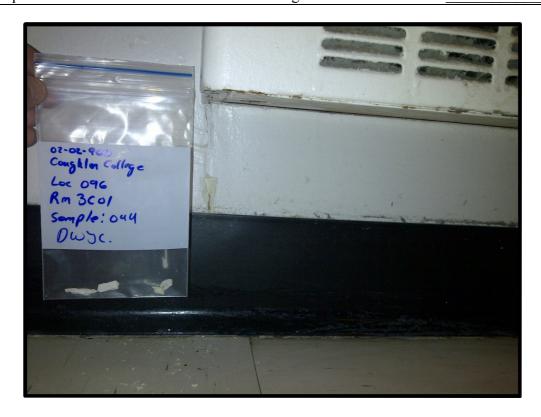
Sample #:	S044	Date Sampled:	January 25, 201	3
Building:	Coughlan College	Sampler:	Trent Hardy	
Location:	096, room 3C01	Analysis:	SAI - PLM	
MUN Project #:	02-02-900	Work Order #:		
		Bulk Sampling Parameters		
Pipe/Tank	Flooring	Ceiling	Roofing	Location
☐ Insulation	□12'x12' Tile	☐ Textured	☐ Shingle	□ Floor
□ Elbow	□ 9'x9'Tile	☐ Stucco	☐ Rolled	X Wall Orientation
☐ Fitting	☐ Vinyl Sheet	□ Popcorn	□ Felt	☐ Ceiling
☐ Transite Pipe	☐ Mastic	□ DWJC	□ Tar	☐ Above Ceiling
☐ Gasket	Wall	☐ Plaster		□ Other
☐ Tank Insulation	☐ Transite Panel	☐ Acoustic Tile (Dropped)		
☐ Pipe Wrap	☐ Textured Wall	☐ Acoustic Tile (Glued-on)		
HVAC	☐ Plaster	☐ Mastic	Miscellaneous:	
☐ Insulation	X DWJC	Structural		
☐ Tape		☐ Steel F. P. ing	No. of Phases:	
☐ Paper Wrap		□ Deck F. P. ing	Colour:

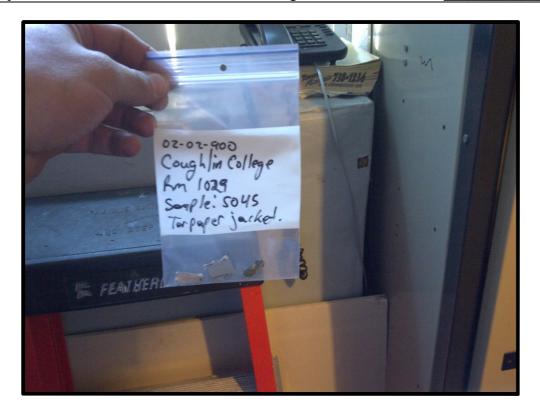
Sample #:	S045	Date Sampled:	May 2, 2103			
Building:	Coughlan College	Sampler:	Trent Hardy			
Location:	Room 1029	Analysis:	SAI - PLM			
MUN Project #:	02-02-900	Work Order #:				
Bulk Sampling Parameters						
Pipe/Tank	Flooring	Ceiling	Roofing	Location		
☐ Insulation	□12'x12' Tile	☐ Textured	☐ Shingle	□ Floor		
□ Elbow	☐ 9'x9'Tile	□ Stucco	□ Rolled	X Wall Orientation		
☐ Fitting	☐ Vinyl Sheet	□ Popcorn	□ Felt	☐ Ceiling		
☐ Transite Pipe	☐ Mastic	□ DWJC	□ Tar	☐ Above Ceiling		
☐ Gasket	Wall	□ Plaster		□ Other		
☐ Tank Insulation	☐ Transite Panel	☐ Acoustic Tile (Dropped)				
☐ Pipe Wrap	☐ Textured Wall	☐ Acoustic Tile (Glued-on)				
	□ Plaster	☐ Mastic	Miscellaneous:	_Tar Paper wrap on		
HVAC		□ Iviastic	Ductwork			
☐ Insulation	□ DWJC	Structural				
☐ Tape		☐ Steel F. P. ing	No. of Phases:			
X Paper Wrap		□ Deck F. P. ing	Colour:

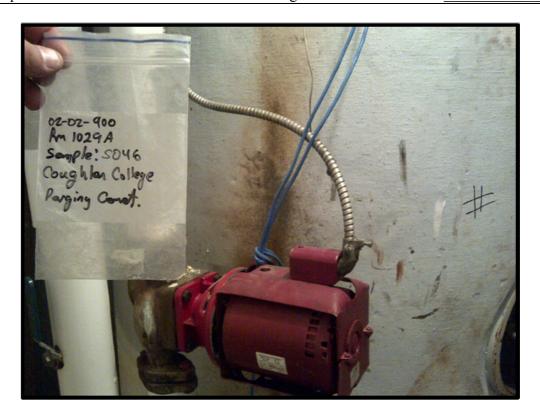
Sample #:	S046		Date Sampled:	May 2, 2103	
Building:	Coughlan College		Sampler:	Trent Hardy	
Location:	Room 1029A		Analysis:	SAI - PLM	
MUN Project #:	02-02-900		Work Order #:		
		Bulk S	Sampling Parameters		
Pipe/Tank	Flooring		Ceiling	Roofing	Location
☐ Insulation	□12'x12' Tile	□ Te	extured	☐ Shingle	☐ Floor
□ Elbow	□ 9'x9'Tile	☐ Stı	ucco	☐ Rolled	X Wall Orientation
☐ Fitting	☐ Vinyl Sheet	□ Po	pcorn	□ Felt	☐ Ceiling
☐ Transite Pipe	☐ Mastic	\square DV	WJC	□ Tar	☐ Above Ceiling
☐ Gasket	Wall	□ Pla	aster		□ Other
X Tank Insulation	☐ Transite Panel	\Box Ac	coustic Tile (Dropped)		
☐ Pipe Wrap	☐ Textured Wall	\Box Ac	coustic Tile (Glued-on)		
HVAC	☐ Plaster	☐ Mastic		Miscellaneous:	
☐ Insulation	□ DWJC		Structural		
☐ Tape		□ Ste	eel F. P. ing	No. of Phases:	
☐ Paper Wrap		\Box De	eck F. P. ing	Colour:

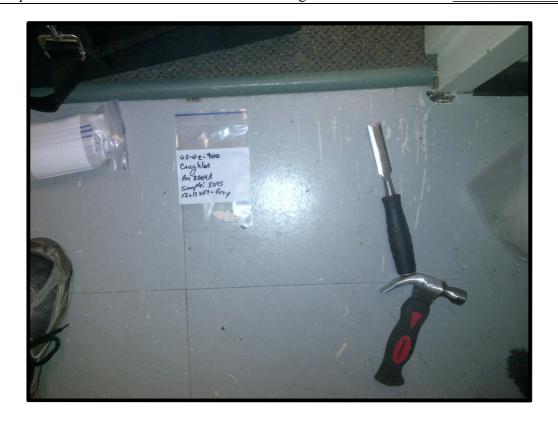
Sample #:	S047	Date Sampled:	May 2, 2103	
Building:	Coughlan College	Sampler:	Trent Hardy	
Location:	Room 2004A	Analysis:	SAI - PLM	
MUN Project #:	02-02-900	Work Order #:		
		Bulk Sampling Parameters		
Pipe/Tank	Flooring	Ceiling	Roofing	Location
☐ Insulation	X 12'x12' Tile	☐ Textured	☐ Shingle	X Floor
□ Elbow	☐ 9'x9'Tile	☐ Stucco	☐ Rolled	☐ Wall Orientation
☐ Fitting	☐ Vinyl Sheet	□ Popcorn	□ Felt	☐ Ceiling
☐ Transite Pipe	☐ Mastic	□ DWJC	□ Tar	☐ Above Ceiling
☐ Gasket	Wall	☐ Plaster		□ Other
☐ Tank Insulation	☐ Transite Panel	☐ Acoustic Tile (Dropped)		
☐ Pipe Wrap	☐ Textured Wall	☐ Acoustic Tile (Glued-on)		
HVAC	□ Plaster	☐ Mastic	Miscellaneous:	Grey
☐ Insulation	□ DWJC	Structural		
☐ Tape		☐ Steel F. P. ing	No. of Phases:	
☐ Paper Wran		□ Deck F P ing	Colour:	-
