Project #: 13916

**ASBESTOS ASSESSMENT
Curtis House
Memorial University of Newfoundland
St. John's, NL**

AUGUST 2011

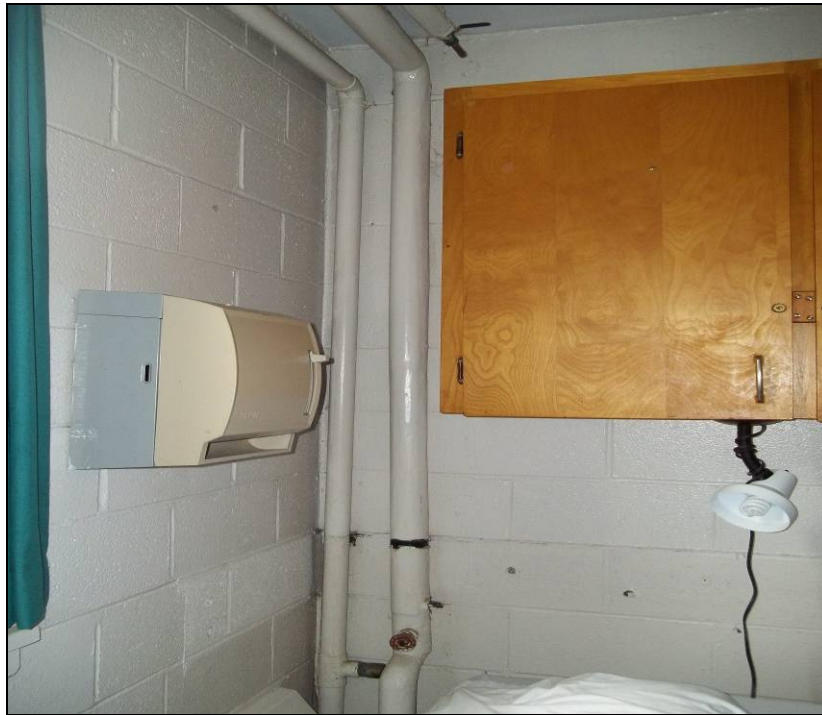
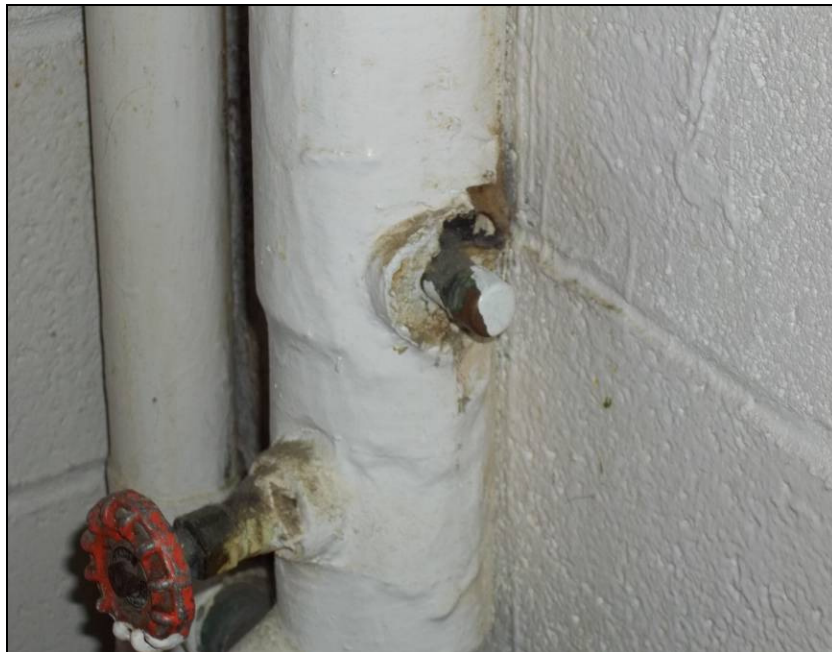
Pipe fitting insulation which could potentially contain asbestos was observed in select areas throughout the building during this assessment. Samples were collected and analyzed for asbestos content using the PLM method of detection and found to contain 7% Chrysotile asbestos (see sample CU-8 in Appendix II, Photographs 1, 2, Appendix I)

Photographs 1, 2: Room CU106. Pipe fitting insulation in poor condition

- All materials listed in fair and/or poor condition are to be repaired or removed immediately. See APPENDIX III – Asbestos Building Survey Information for materials condition and locations.

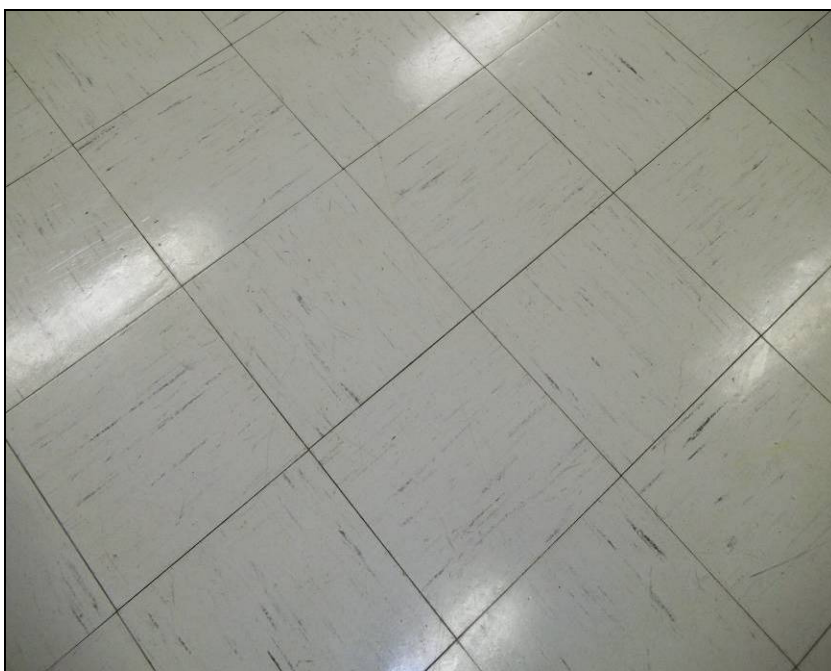
Vinyl floor tiles which could potentially contain asbestos were identified during the assessment. Six (6) samples of 1' x 1' vinyl floor tiles were sampled and analyzed for asbestos content using the PLM method of detection. One (1) of the six (6) samples was identified as containing 2% Chrysotile asbestos. Its associated mastic was identified as non-asbestos containing. The blue and white vinyl floor tiles in Room CU105 were not sampled due to difficulty of sample collection. As such, these tiles should be considered to be asbestos containing until proven otherwise. (See samples CU-1, CU-6, CU-18, CU-23, CU-25, CU-26 in Appendix II, Photographs 3, 4, Appendix I)

Photograph 3: Sample CU-1, grey with black 1 x 1' vinyl floor tile.

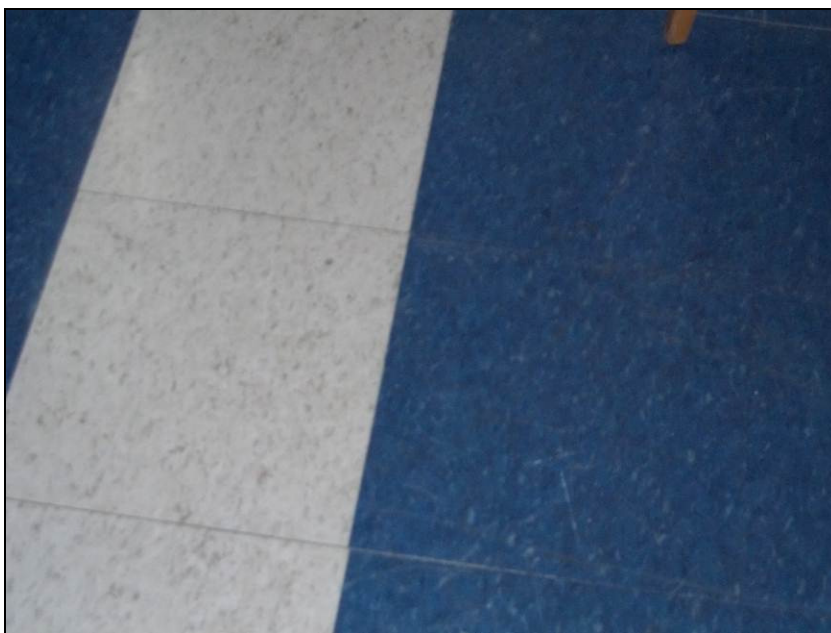
Photograph 4: Blue and white vinyl floor tiles in Room CU105 were not sampled due to sample collection difficulty. These tiles must be considered to be asbestos containing until proven otherwise.

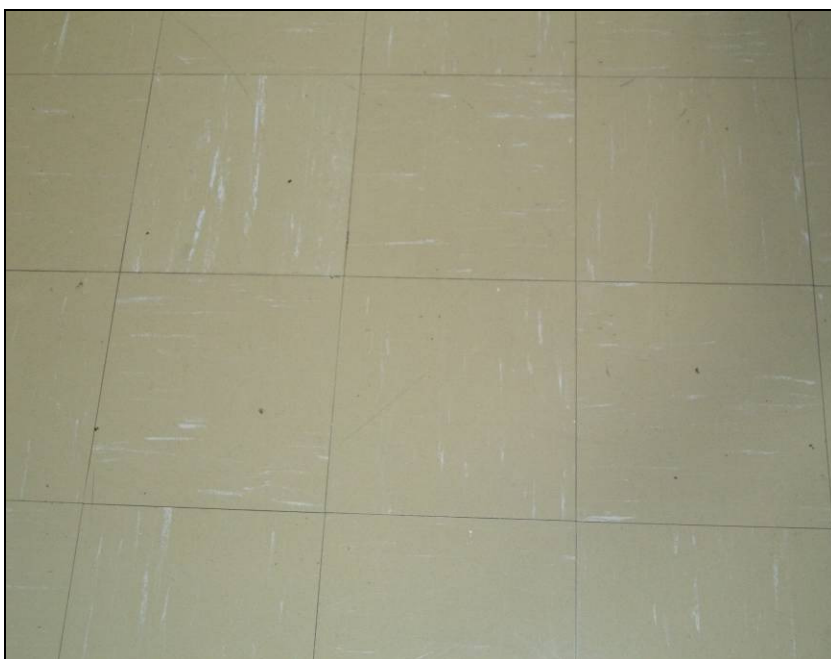
Six (6) samples of 9" x 9" vinyl floor tiles were sampled and analyzed for asbestos content using the PLM method of detection. Three (3) of the six (6) samples were identified as containing 2 – 3% Chrysotile asbestos. Their associated mastics were identified as non-asbestos containing. (See samples CU-2, CU-9, CU-13, CU-14, CU-15, CU-16 in Appendix II, Photographs 5 - 7, Appendix I)

Photograph 5: Sample CU-13, yellow with white 9" x 9" vinyl floor tile.

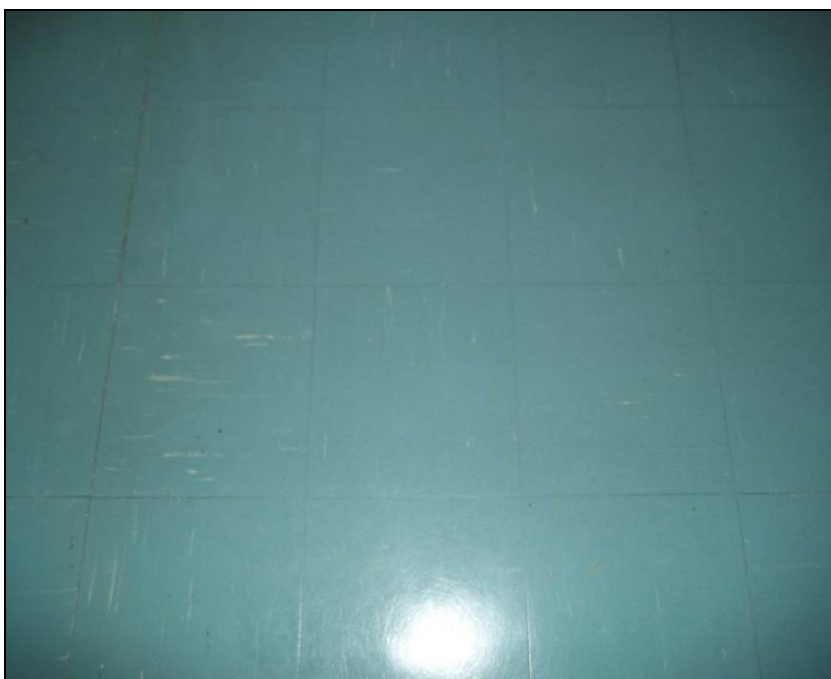
Photograph 6: Sample CU-15, blue with white 9" x 9" vinyl floor tile.

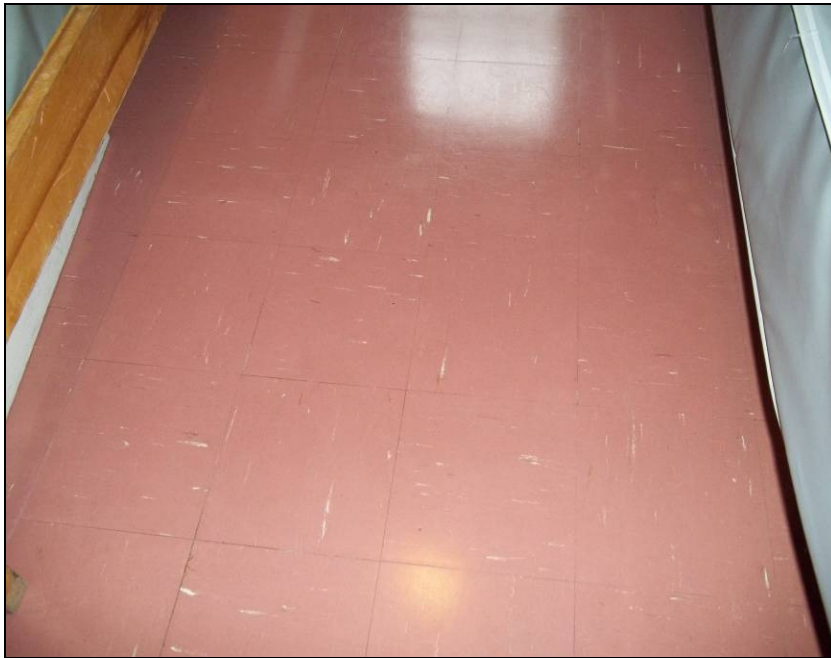
Photograph 7: Sample CU-16, red with white 9" x 9" vinyl floor tile.

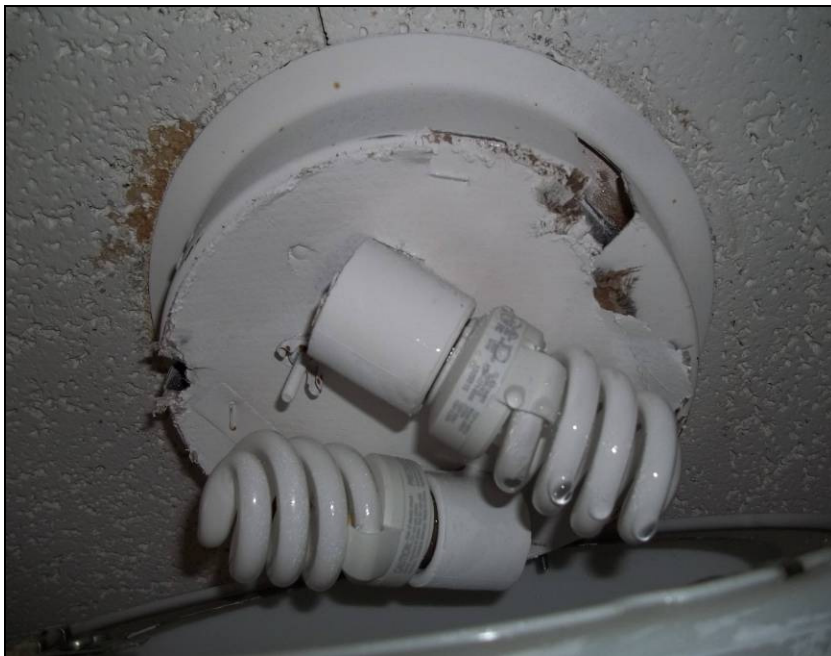
Two types of light fixture heat shields were observed throughout the building. Two (2) samples were collected and analyzed for asbestos content using the PLM method of detection and found to contain 20% and 35% Chrysotile asbestos (see samples CU-7 and CU-10 in Appendix II, see photographs 8, 9 in Appendix I).

Photograph 8: Sample CU-7, damaged light fixture heat shield.

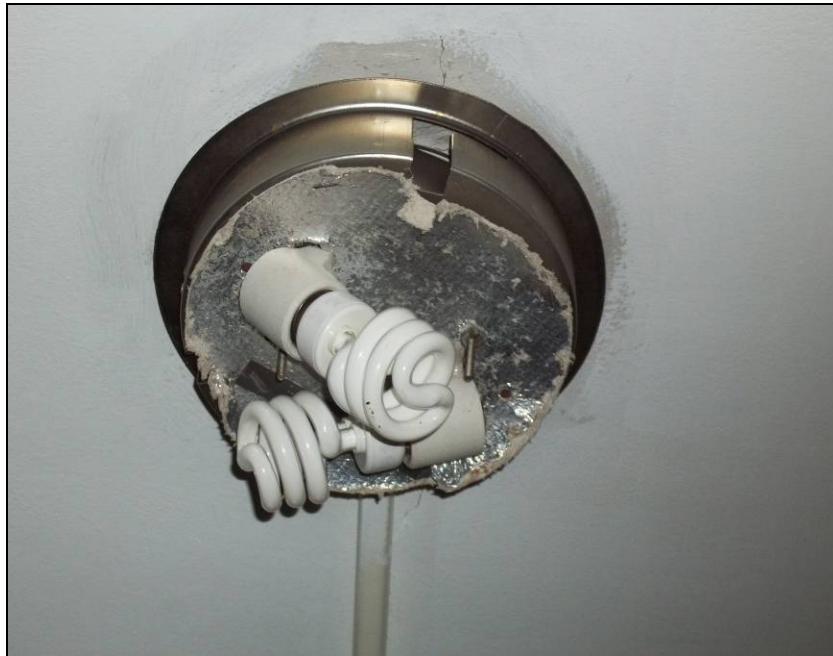
Photograph 9: Sample CU-10, damaged light fixture heat shield.

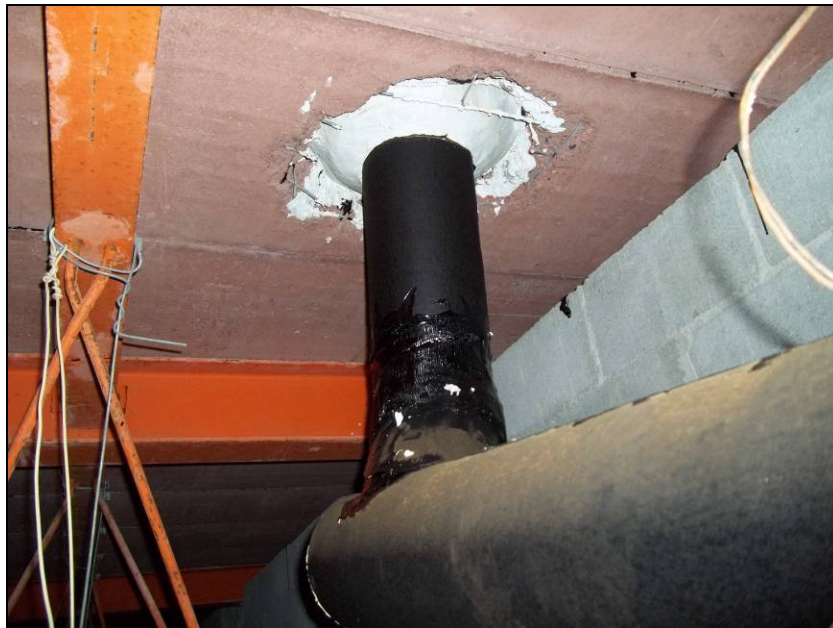
In addition, three rain water leaders were observed above ceiling tiles in the corridors on the 4th floor. These materials were too high to access, thus they were not sampled. As such, they must be considered to be asbestos containing until proven otherwise. (see Photograph 10, Appendix I)

Photograph 10: One of three rain water leaders observed in the building. These were too high to access for sampling. As such, they must be considered to be asbestos containing until proven otherwise.
