ASBESTOS AND LEAD PAINT BUILDING MATERIALS SURVEY FOR: FIELD HALL MEMORIAL UNIVERSITY OF NEWFOUNDLAND

Pinchin LeBlanc Environmental Ltd Project No. 02-02-00900

June 19, 2013

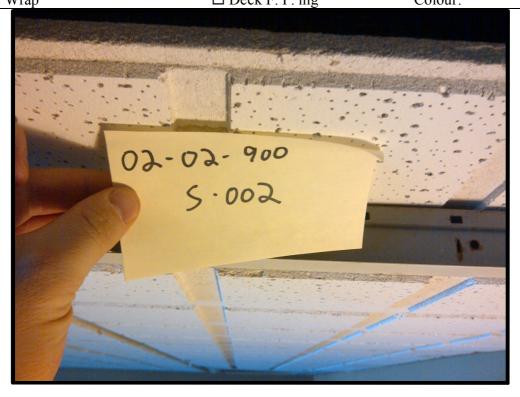
01414 11311					
Sample #:	S002	D	ate Sampled:	August 8, 2012	
Building:	Field Hall	S	ampler:	Trent Hardy	
Location:	001, room 1000	A	nalysis:	SAI - PLM	
MUN Project #:	02-02-900	V	Vork Order #:		
-		Bulk Sa	mpling Parameters		
Pipe/Tank	Flooring		Ceiling	Roofing	Location
☐ Insulation	□12'x12' Tile	□Tex	tured	☐ Shingle	□ Floor
□ Elbow	□ 9'x9'Tile	☐ Stuc	cco	□ Rolled	☐ Wall Orientation
☐ Fitting	☐ Vinyl Sheet	□ Pop	corn	☐ Felt	X Ceiling
☐ Transite Pipe	☐ Mastic	\square DW	JC	□ Tar	☐ Above Ceiling
☐ Gasket	Wall	□ Plas	ter		□ Other
☐ Tank Insulation	☐ Transite Panel	X Acou	ustic Tile (Dropped)		
☐ Pipe Wrap	☐ Textured Wall	□ Aco	ustic Tile (Glued-on)		
HVAC	□ Plaster	□ Mas	stic	Miscellaneous: square	2' x 4' pinhole
☐ Insulation	□ DWJC		Structural	-	
☐ Tape		☐ Stee	el F. P. ing	No. of Phases:	
□ Paper Wran		\Box Dec	k F D ing	Colour

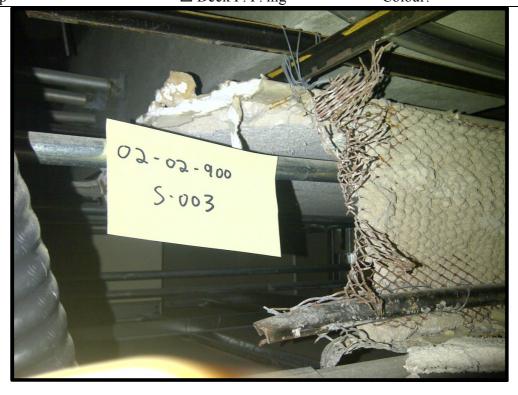
Sample #:	S003	Date Sampled:	August 8, 2012	
Building:	Field Hall	Sampler:	Trent Hardy	
Location:	001, room 1000	Analysis:	SAI - PLM	
MUN Project #:	02-02-900	Work Order #:		
		Bulk Sampling Parameters		
Pipe/Tank	Flooring	Ceiling	Roofing	Location
☐ Insulation	□12'x12' Tile	☐ Textured	☐ Shingle	□ Floor
□ Elbow	☐ 9'x9'Tile	☐ Stucco	☐ Rolled	☐ Wall Orientation
☐ Fitting	☐ Vinyl Sheet	□ Popcorn	□ Felt	☐ Ceiling
☐ Transite Pipe	☐ Mastic	□ DWJC	□ Tar	X Above Ceiling
☐ Gasket	Wall	☐ Plaster		□ Other
☐ Tank Insulation	☐ Transite Panel	☐ Acoustic Tile (Dropped)		
☐ Pipe Wrap	☐ Textured Wall	☐ Acoustic Tile (Glued-on)		
HVAC	☐ Plaster	☐ Mastic	Miscellaneous:	Textured cement
☐ Insulation	□ DWJC	Structural		
□ Tape		☐ Steel F. P. ing	No. of Phases:	
□ Paper Wran		□ Deck F P ing	Colour:

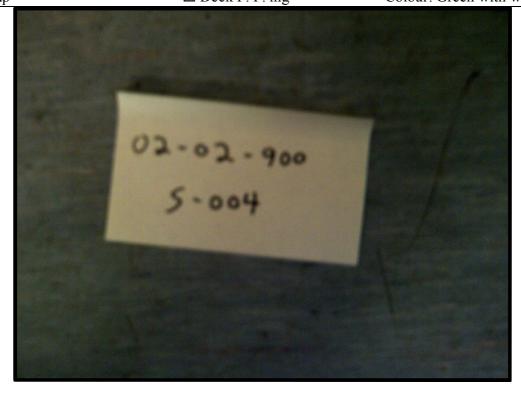
Sample #:	S004	Date Sampled:	August 8, 2012	
Building:	Field Hall	Sampler:	Trent Hardy	
Location:	001, room 1000	Analysis:	SAI - PLM	
MUN Project #:	02-02-900	Work Order #:		
		Bulk Sampling Parameters		
Pipe/Tank	Flooring	Ceiling	Roofing	Location
☐ Insulation	□12'x12' Tile	☐ Textured	☐ Shingle	X Floor
□ Elbow	☐ 9'x9'Tile	☐ Stucco	☐ Rolled	☐ Wall Orientation
☐ Fitting	X Vinyl Sheet	□ Popcorn	☐ Felt	☐ Ceiling
☐ Transite Pipe	☐ Mastic	□ DWJC	□ Tar	☐ Above Ceiling
☐ Gasket	Wall	☐ Plaster		□ Other
☐ Tank Insulation	☐ Transite Panel	☐ Acoustic Tile (Dropped)		
☐ Pipe Wrap	☐ Textured Wall	☐ Acoustic Tile (Glued-on)		
HVAC	☐ Plaster	☐ Mastic	Miscellaneous:	
☐ Insulation	□ DWJC	Structural		
☐ Tape		☐ Steel F. P. ing	No. of Phases:	
☐ Paper Wrap		□ Deck F P ing	Colour: Green	with white streaks

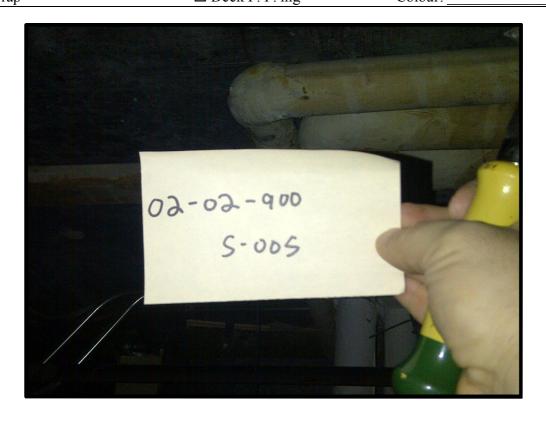
Insulating cement, also referred to as "parging cement", present on pipe elbows and fittings was sampled in the site building and contains 30% Chrysotile asbestos (reference sample 02-02-900-S005). For locations and conditions of this material at the time of the building survey refer to location & data excel document.

Sample #:	S005	Date Sampled:	August 8, 2012	
Building:	Field Hall	Sampler:	Trent Hardy	
Location:	002, room 1003	Analysis:	SAI - PLM	
MUN Project #:	02-02-900	Work Order #:		
		Bulk Sampling Parameters		
Pipe/Tank	Flooring	Ceiling	Roofing	Location
☐ Insulation	□12'x12' Tile	☐ Textured	☐ Shingle	□ Floor
X Elbow	□ 9'x9'Tile	☐ Stucco	☐ Rolled	☐ Wall Orientation
☐ Fitting	☐ Vinyl Sheet	□ Popcorn	□ Felt	☐ Ceiling
☐ Transite Pipe	☐ Mastic	□ DWJC	□ Tar	X Above Ceiling
☐ Gasket	Wall	☐ Plaster		□ Other
☐ Tank Insulation	☐ Transite Panel	☐ Acoustic Tile (Dropped)		
☐ Pipe Wrap	☐ Textured Wall	☐ Acoustic Tile (Glued-on)		
HVAC	☐ Plaster	☐ Mastic	Miscellaneous:	
☐ Insulation	\square DWJC	Structural		
☐ Tape		☐ Steel F. P. ing	No. of Phases:	
☐ Paper Wrap		□ Deck F P ing	Colour:

- 1. Type III (high risk) asbestos abatement procedures should be carried out for the scheduled removal of greater than 1 ft² of friable asbestos containing materials. Alternatively, Type II (moderate risk) glove bag abatement procedures may be applied where practical.
- 2. Type II (moderate risk) asbestos abatement procedures should be carried out for the scheduled repair or enclosure of friable ACMs or for the removal of less than 1 ft² of material.

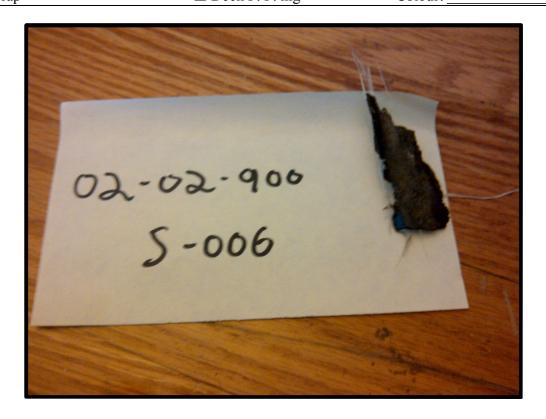
Tar paper used on insulation was collected in the site building. Analysis of the sample did not identify the presence of asbestos (reference sample 02-02-900-S006).

Sample #:	S006	Date Sampled:	August 8, 2012		
Building:	Field Hall	Sampler:	Trent Hardy		
Location:	006, room 1008	Analysis:	SAI - PLM		
MUN Project #:	02-02-900	Work Order #:			
Bulk Sampling Parameters					
Pipe/Tank	Flooring	Ceiling	Roofing	Location	
☐ Insulation	□12'x12' Tile	☐ Textured	☐ Shingle	☐ Floor	
□ Elbow	□ 9'x9'Tile	☐ Stucco	☐ Rolled	☐ Wall Orientation	
☐ Fitting	☐ Vinyl Sheet	□ Popcorn	□ Felt	☐ Ceiling	
☐ Transite Pipe	☐ Mastic	□ DWJC	□ Tar	X Above Ceiling	
☐ Gasket	Wall	☐ Plaster		□ Other	
☐ Tank Insulation	☐ Transite Panel	☐ Acoustic Tile (Dropped)			
☐ Pipe Wrap	☐ Textured Wall	☐ Acoustic Tile (Glued-on)			
HVAC	☐ Plaster	☐ Mastic	Miscellaneous:	Tar Paper	
☐ Insulation	□ DWJC	Structural			
☐ Tape		☐ Steel F. P. ing	No. of Phases:		
☐ Paper Wrap		□ Deck F. P. ing	Colour:

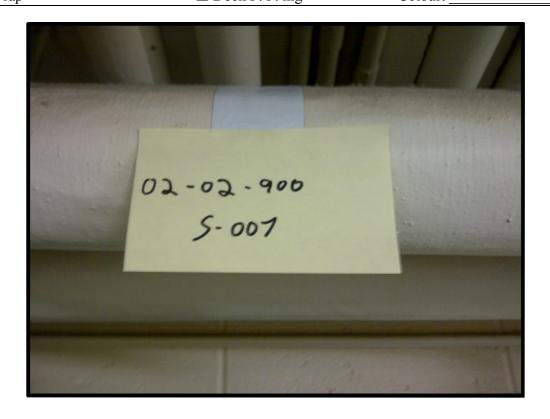
Insulating insulation, also referred to as "Aircell" was collected from the basement (Room GH-001). Analysis of the sample did not identify the presence of asbestos (reference samples 02-02-900-S007-A and 02-02-900-S007-B).

01414 [1311	1					
Sample #:	S007	Date Sampled:	August 8, 2012			
Building:	Field Hall	Sampler:	Trent Hardy			
Location:	008, room 001	Analysis:	SAI - PLM			
MUN Project #:	02-02-900	Work Order #:				
Bulk Sampling Parameters						
Pipe/Tank	Flooring	Ceiling	Roofing	Location		
X Insulation	□12'x12' Tile	☐ Textured	☐ Shingle	□ Floor		
□ Elbow	□ 9'x9'Tile	☐ Stucco	☐ Rolled	☐ Wall Orientation		
☐ Fitting	☐ Vinyl Sheet	□ Popcorn	□ Felt	☐ Ceiling		
☐ Transite Pipe	☐ Mastic	□ DWJC	□ Tar	X Above Ceiling		
☐ Gasket	Wall	☐ Plaster		□ Other		
☐ Tank Insulation	☐ Transite Panel	☐ Acoustic Tile (Dropped)				
☐ Pipe Wrap	☐ Textured Wall	☐ Acoustic Tile (Glued-on)				
HVAC	☐ Plaster	☐ Mastic	Miscellaneous:	Air Cell		
☐ Insulation	\square DWJC	Structural				
☐ Tape		☐ Steel F. P. ing	No. of Phases:			
□ Paper Wran		□ Deck F P ing	Colour:

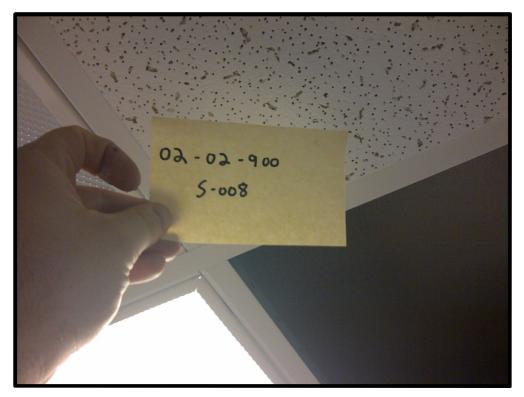
S008		Date Sampled:	August 8, 2012	
Field Hall		Sampler:	Trent Hardy	
010, room 2019		Analysis:	SAI - PLM	
02-02-900		Work Order #:		
Bulk Sampling Parameters				
Flooring		Ceiling	Roofing	Location
□12'x12' Tile	\Box T	extured	☐ Shingle	□ Floor
☐ 9'x9'Tile	\square S	tucco	□ Rolled	☐ Wall Orientation
☐ Vinyl Sheet	\square P	opcorn	□ Felt	X Ceiling
☐ Mastic	\square D	OWJC	□ Tar	☐ Above Ceiling
Wall	\square P	laster		□ Other
☐ Transite Panel	ΧA	coustic Tile (Dropped)		
☐ Textured Wall	\Box A	coustic Tile (Glued-on)		
☐ Plaster	\square N	lastic	Miscellaneous:	2' x 2' pinhole fleck
□ DWJC		Structural		
	\square S	teel F. P. ing	No. of Phases: _	
		eck F. P. ing	Colour:	
	Field Hall 010, room 2019 02-02-900 Flooring 12'x12' Tile 9'x9'Tile Vinyl Sheet Mastic Wall Transite Panel Textured Wall Plaster	Field Hall 010, room 2019 02-02-900 Bulk Flooring □12'x12' Tile □ T □9'x9'Tile □ S □Vinyl Sheet □ P □ Mastic □ P □ Wall □ P □ Transite Panel X A □ Textured Wall □ A □ Plaster □ M □ DWJC □ S	Field Hall Sampler: 010, room 2019 Analysis: 02-02-900 Work Order #: Bulk Sampling Parameters Flooring Ceiling □ 12'x12' Tile □ Textured □ 9'x9'Tile □ Stucco □ Vinyl Sheet □ Popcorn □ Mastic □ DWJC Wall □ Plaster □ Textured Wall □ Acoustic Tile (Dropped) □ Textured Wall □ Acoustic Tile (Glued-on) □ Plaster □ Mastic	Field Hall Sampler: Trent Hardy 010, room 2019 Analysis: SAI - PLM 02-02-900 Work Order #: Bulk Sampling Parameters Flooring Roofing □ 12'x12' Tile □ Textured □ Shingle □ 9'x9'Tile □ Stucco □ Rolled □ Vinyl Sheet □ Popcorn □ Felt □ Mastic □ DWJC □ Tar □ Plaster □ Acoustic Tile (Dropped) □ Textured Wall □ Plaster □ Mastic Miscellaneous: □ DWJC Structural □ DWJC Structural □ Steel F. P. ing No. of Phases:

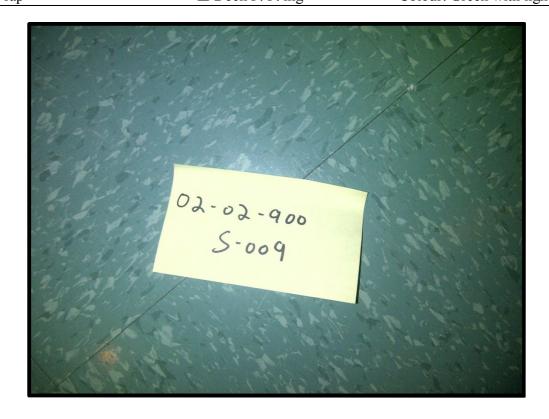
Sample #:	S009	Date Sampled:	August 8, 2012			
Building:	Field Hall	Sampler:	Trent Hardy			
Location:	027, room 2012	Analysis:	SAI - PLM			
MUN Project #:	02-02-900	Work Order #:				
	Bulk Sampling Parameters					
Pipe/Tank	Flooring	Ceiling	Roofing	Location		
☐ Insulation	X12'x12' Tile	☐ Textured	☐ Shingle	X Floor		
□ Elbow	☐ 9'x9'Tile	☐ Stucco	☐ Rolled	☐ Wall Orientation		
☐ Fitting	☐ Vinyl Sheet	□ Popcorn	☐ Felt	☐ Ceiling		
☐ Transite Pipe	☐ Mastic	□ DWJC	□ Tar	☐ Above Ceiling		
☐ Gasket	Wall	☐ Plaster		□ Other		
☐ Tank Insulation	☐ Transite Panel	☐ Acoustic Tile (Dropped)				
☐ Pipe Wrap	☐ Textured Wall	☐ Acoustic Tile (Glued-on)				
HVAC	☐ Plaster	☐ Mastic	Miscellaneous:			
☐ Insulation	\square DWJC	Structural				
☐ Tape		☐ Steel F. P. ing	No. of Phases:			
☐ Paper Wrap		□ Deck F P ing	Colour: Green	with light fleck

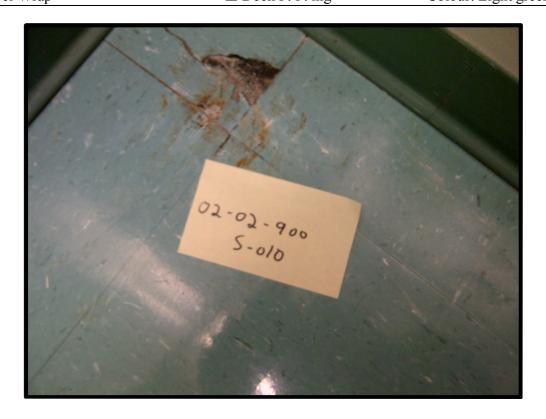
Sample #:	S010	Date Sampled:	August 8, 2012			
Building:	Field Hall	Sampler:	Trent Hardy			
Location:	028, room 1C01	Analysis:	SAI - PLM			
MUN Project #:	02-02-900	Work Order #:				
	Bulk Sampling Parameters					
Pipe/Tank	Flooring	Ceiling	Roofing	Location		
☐ Insulation	X12'x12' Tile	☐ Textured	☐ Shingle	X Floor		
□ Elbow	□ 9'x9'Tile	☐ Stucco	☐ Rolled	☐ Wall Orientation		
☐ Fitting	☐ Vinyl Sheet	□ Popcorn	☐ Felt	☐ Ceiling		
☐ Transite Pipe	☐ Mastic	□ DWJC	□ Tar	☐ Above Ceiling		
☐ Gasket	Wall	☐ Plaster		□ Other		
☐ Tank Insulation	☐ Transite Panel	☐ Acoustic Tile (Dropped)				
☐ Pipe Wrap	☐ Textured Wall	☐ Acoustic Tile (Glued-on)				
HVAC	☐ Plaster	☐ Mastic	Miscellaneous:			
☐ Insulation	□ DWJC	Structural				
☐ Tape		☐ Steel F. P. ing	No. of Phases:			
☐ Paper Wrap		□ Deck F P ing	Colour Light g	reen with light fleck

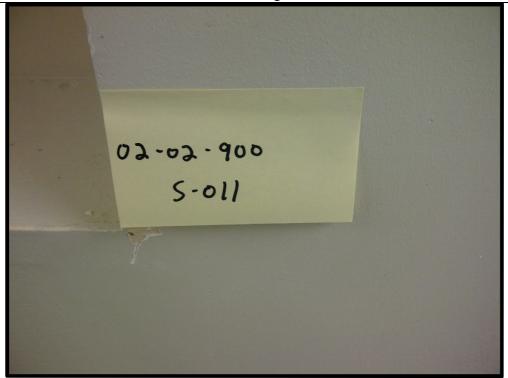
Sample #:	S011	Date Sampled:	August 8, 2012	
Building:	Field Hall	Sampler:	Trent Hardy	
Location:	028, room 2C01	Analysis:	SAI - PLM	
MUN Project #:	02-02-900	Work Order #:		
		Bulk Sampling Parameters		
Pipe/Tank	Flooring	Ceiling	Roofing	Location
☐ Insulation	□12'x12' Tile	☐ Textured	☐ Shingle	☐ Floor
□ Elbow	☐ 9'x9'Tile	☐ Stucco	□ Rolled	X Wall Orientation
☐ Fitting	☐ Vinyl Sheet	□ Popcorn	□ Felt	☐ Ceiling
☐ Transite Pipe	☐ Mastic	□ DWJC	□ Tar	☐ Above Ceiling
☐ Gasket	Wall	☐ Plaster		☐ Other
☐ Tank Insulation	☐ Transite Panel	☐ Acoustic Tile (Dropped)		
☐ Pipe Wrap	☐ Textured Wall	☐ Acoustic Tile (Glued-on)		
HVAC	☐ Plaster	☐ Mastic	Miscellaneous:	
☐ Insulation	X DWJC	Structural		
☐ Tape		☐ Steel F. P. ing	No. of Phases:	
☐ Paper Wrap		□ Deck F. P. ing	Colour:

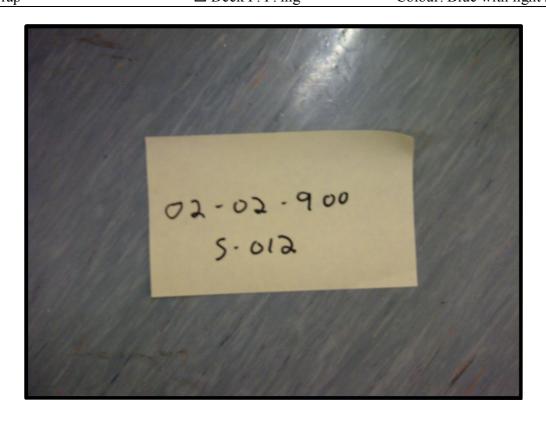
Sample #:	S012	Date Sampled:	August 8, 2012			
Building:	Field Hall	Sampler:	Trent Hardy			
Location:	029, hallway 2005	Analysis:	SAI - PLM			
MUN Project #:	02-02-900	Work Order #:				
Bulk Sampling Parameters						
Pipe/Tank	Flooring	Ceiling	Roofing	Location		
☐ Insulation	□12'x12' Tile	☐ Textured	☐ Shingle	X Floor		
□ Elbow	☐ 9'x9'Tile	☐ Stucco	□ Rolled	☐ Wall Orientation		
☐ Fitting	X Vinyl Sheet	□ Popcorn	□ Felt	☐ Ceiling		
☐ Transite Pipe	☐ Mastic	□ DWJC	□ Tar	☐ Above Ceiling		
☐ Gasket	Wall	☐ Plaster		□ Other		
☐ Tank Insulation	☐ Transite Panel	☐ Acoustic Tile (Dropped)				
☐ Pipe Wrap	☐ Textured Wall	☐ Acoustic Tile (Glued-on)				
HVAC	☐ Plaster	☐ Mastic	Miscellaneous:			
☐ Insulation	□ DWJC	Structural				
☐ Tape		☐ Steel F. P. ing	No. of Phases:			
☐ Paper Wran		□ Deck F P ing	Colour: Blue w	ith light streaks

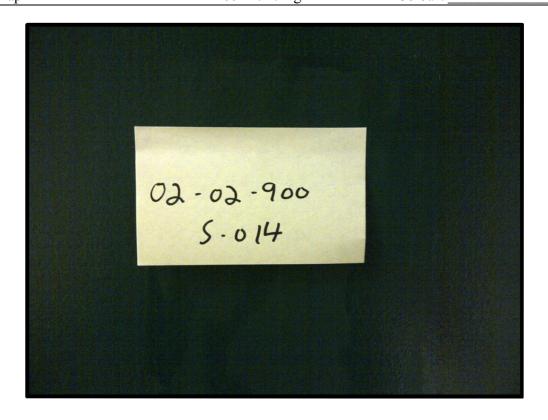
Sample #:	S014	Date Sampled:	August 8, 2012	
Building:	Field Hall	Sampler:	Trent Hardy	
Location:	078, room 4S02	Analysis:	SAI - PLM	
MUN Project #:	02-02-900	Work Order #:		
		Bulk Sampling Parameters		
Pipe/Tank	Flooring	Ceiling	Roofing	Location
☐ Insulation	□12'x12' Tile	☐ Textured	☐ Shingle	☐ Floor
□ Elbow	□ 9'x9'Tile	☐ Stucco	□ Rolled	X Wall Orientation
☐ Fitting	☐ Vinyl Sheet	□ Popcorn	□ Felt	☐ Ceiling
☐ Transite Pipe	☐ Mastic	□ DWJC	□ Tar	☐ Above Ceiling
☐ Gasket	Wall	☐ Plaster		□ Other
☐ Tank Insulation	☐ Transite Panel	☐ Acoustic Tile (Dropped)		
☐ Pipe Wrap	☐ Textured Wall	☐ Acoustic Tile (Glued-on)		
HVAC	☐ Plaster	☐ Mastic	Miscellaneous:	
☐ Insulation	X DWJC	Structural		
☐ Tape		☐ Steel F. P. ing	No. of Phases:	
☐ Paper Wrap		□ Deck F. P. ing	Colour:

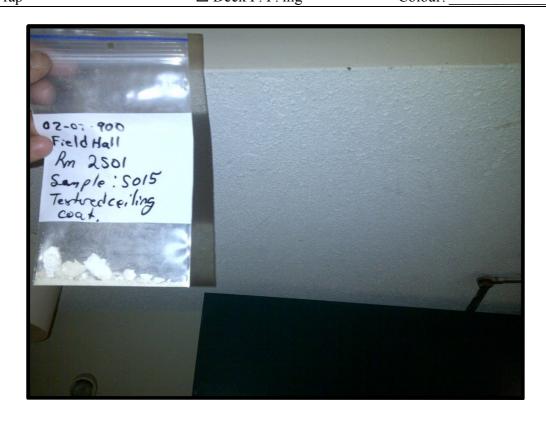
Two (2) samples of friable textured ceiling stucco were collected from Room GH-1000 and GH-2S01. Multiple phases within the first sample were analyzed independently, as a result, a total of two (2) analyses were performed. Results identified the presence of 6% chrysotile asbestos (reference sample 02-02-900-S003-A) in the texture coat and 3% chrysotile asbestos (reference sample 02-02-900-S015). Analysis of the sample did not identify the presence of asbestos in the base portion of the sample. For locations and conditions of this material at the time of the building survey refer to location & data excel document.

Sample #:	S015	Date Sampled:	May 2, 2013				
Building:	Field Hall	Sampler:	Trent Hardy				
Location:	Room 2S01	Analysis:	SAI - PLM				
MUN Project #:	02-02-900	Work Order #:					
	Bulk Sampling Parameters						
Pipe/Tank	Flooring	Ceiling	Roofing	Location			
☐ Insulation	□12'x12' Tile	X Textured	☐ Shingle	□ Floor			
□ Elbow	□ 9'x9'Tile	☐ Stucco	☐ Rolled	☐ Wall Orientation			
☐ Fitting	☐ Vinyl Sheet	□ Popcorn	□ Felt	X Ceiling			
☐ Transite Pipe	☐ Mastic	□ DWJC	□ Tar	☐ Above Ceiling			
☐ Gasket	Wall	☐ Plaster		□ Other			
☐ Tank Insulation	☐ Transite Panel	☐ Acoustic Tile (Dropped)					
☐ Pipe Wrap	☐ Textured Wall	☐ Acoustic Tile (Glued-on)					
HVAC	☐ Plaster	☐ Mastic	Miscellaneous:				
☐ Insulation	\square DWJC	Structural					
☐ Tape		☐ Steel F. P. ing	No. of Phases:				
☐ Paper Wrap		□ Deck F P ing	Colour:

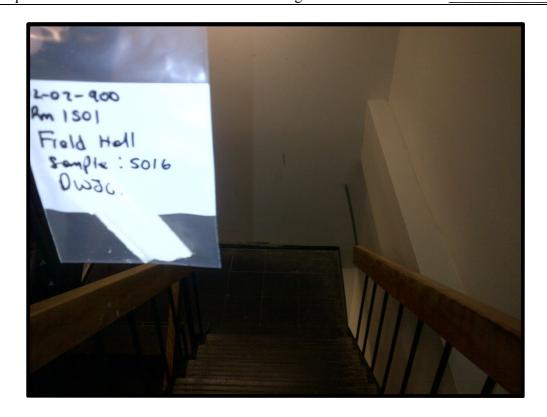
Sample #:	S016	Date Sampled:	May 2, 2013			
Building:	Field Hall	Sampler:	Trent Hardy			
Location:	1S01	Analysis:	SAI - PLM			
MUN Project #:	02-02-900	Work Order #:				
	Bulk Sampling Parameters					
Pipe/Tank	Flooring	Ceiling	Roofing	Location		
☐ Insulation	□12'x12' Tile	☐ Textured	☐ Shingle	□ Floor		
□ Elbow	□ 9'x9'Tile	☐ Stucco	☐ Rolled	X Wall Orientation		
☐ Fitting	☐ Vinyl Sheet	□ Popcorn	□ Felt	☐ Ceiling		
☐ Transite Pipe	☐ Mastic	□ DWJC	□ Tar	☐ Above Ceiling		
☐ Gasket	Wall	☐ Plaster		□ Other		
☐ Tank Insulation	☐ Transite Panel	☐ Acoustic Tile (Dropped)				
☐ Pipe Wrap	☐ Textured Wall	☐ Acoustic Tile (Glued-on)				
HVAC	☐ Plaster	☐ Mastic	Miscellaneous:			
☐ Insulation	X DWJC	Structural				
☐ Tape		☐ Steel F. P. ing	No. of Phases:			
☐ Paper Wrap		□ Deck F. P. ing	Colour:

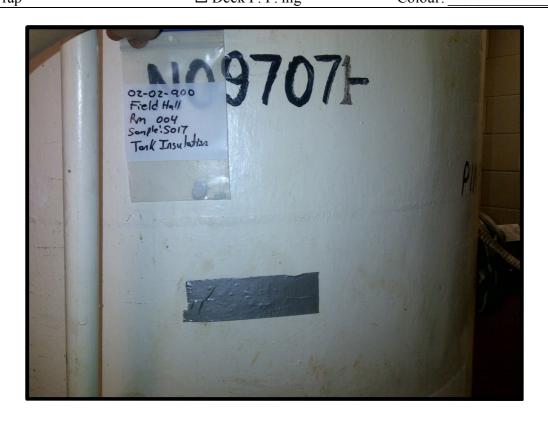
Insulating cement, also referred to as "mag block", present on tanks was sampled in the site building and contains 20% chrysotile and 5% amosite asbestos (reference sample 02-02-900-S017). For locations and conditions of this material at the time of the building survey refer to location & data excel document.

Sample #:	S017	Date Sampled:	May 2, 2013	
Building:	Field Hall	Sampler:	Trent Hardy	
Location:	Room 004	Analysis:	SAI - PLM	
MUN Project #:	02-02-900	Work Order #:		
		Bulk Sampling Parameters		
Pipe/Tank	Flooring	Ceiling	Roofing	Location
☐ Insulation	□12'x12' Tile	☐ Textured	☐ Shingle	□ Floor
□ Elbow	☐ 9'x9'Tile	☐ Stucco	□ Rolled	X Wall Orientation
☐ Fitting	☐ Vinyl Sheet	□ Popcorn	□ Felt	☐ Ceiling
☐ Transite Pipe	☐ Mastic	□ DWJC	□ Tar	☐ Above Ceiling
☐ Gasket	Wall	☐ Plaster		□ Other
X Tank Insulation	☐ Transite Panel	☐ Acoustic Tile (Dropped)		
☐ Pipe Wrap	☐ Textured Wall	☐ Acoustic Tile (Glued-on)		
HVAC	☐ Plaster	☐ Mastic	Miscellaneous:	
☐ Insulation	□ DWJC	Structural		
☐ Tape		☐ Steel F. P. ing	No. of Phases:	
☐ Paper Wrap		☐ Deck F. P. ing	Colour:
