**Project #: 13916**

**ASBESTOS ASSESSMENT  
Gilbert Court  
Memorial University of Newfoundland  
St. John's, NL**

**September 2011**

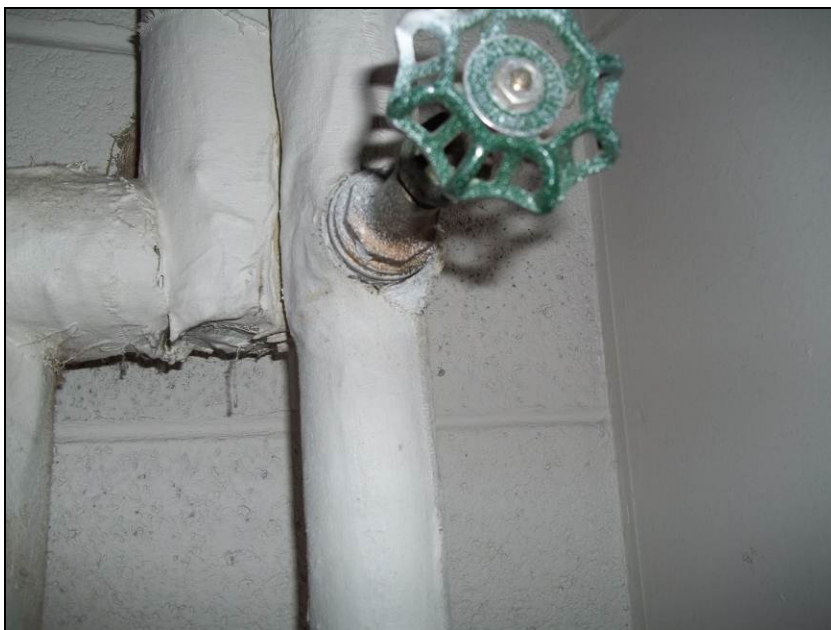
Two types of pipe fitting insulation which could potentially contain asbestos were observed in select areas throughout the building during this assessment. Samples were collected of fitting insulation in the hallways and analyzed for asbestos content using the PLM method of detection. These samples were identified as non-asbestos containing. The fittings identified in closets of the residence rooms and the mechanical room is visually distinguishable and appears to be older than those in the hallway. Those fittings must be considered to be asbestos containing until proven otherwise (see sample GB-17 in Appendix II, Photograph 1, Appendix I)

**Photograph 1: Suspect asbestos containing pipe fitting insulation in Room GB202, in poor condition.**

- All materials listed in fair and/or poor condition are to be repaired or removed immediately. See APPENDIX III – Asbestos Building Survey Information for materials condition and locations.

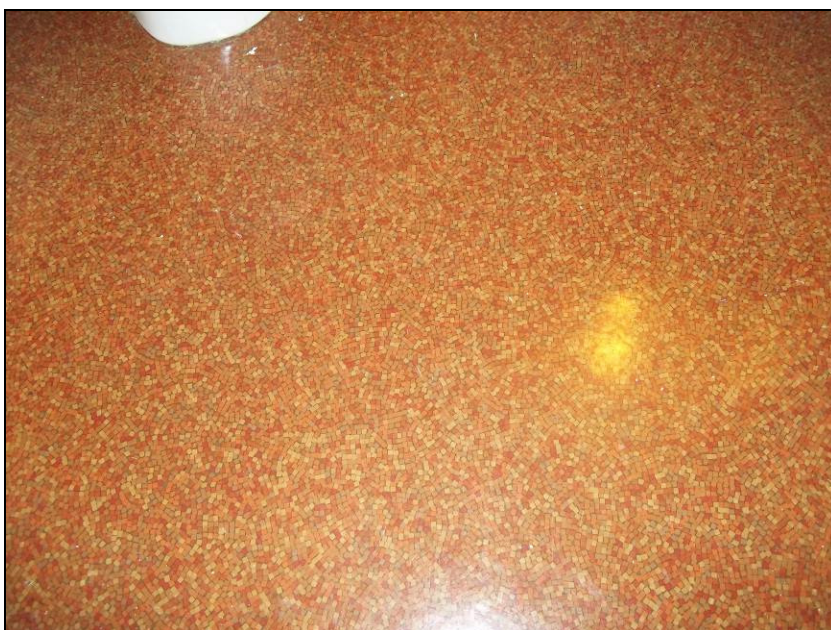
Various vinyl sheet floorings which could potentially contain asbestos were identified in the building during the assessment. Six (6) samples of this flooring were sampled and analyzed for asbestos content using the PLM method of detection. Three (3) samples of the flooring were each found to contain 20% Chrysotile asbestos. (see samples GB-4, GB-7, GB-10, GB-12, GB-19, GB-27 in Appendix II, Photographs 2 - 4 in Appendix I)

**Photograph 2: Sample GB-4. Asbestos containing vinyl sheet flooring.**

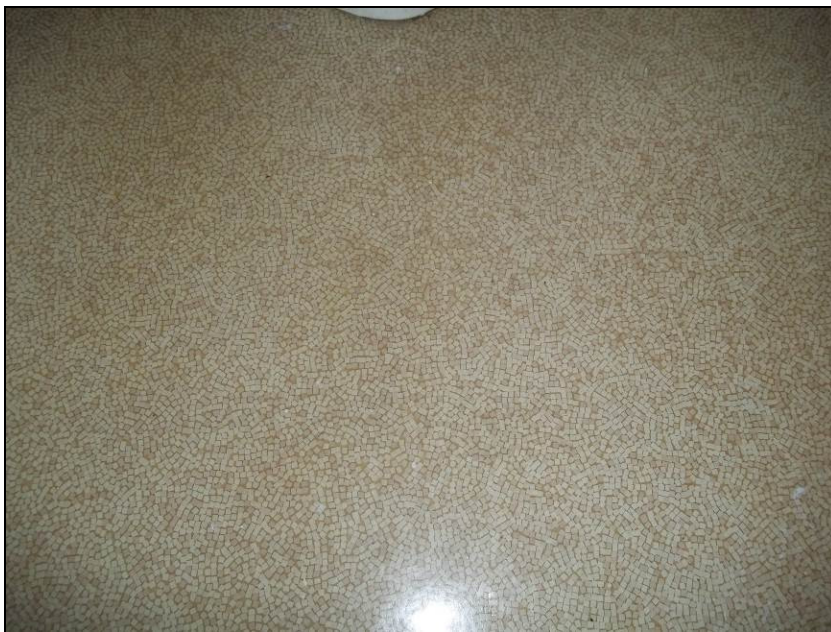
**Photograph 3: Sample GB-7. Asbestos containing vinyl sheet flooring.**

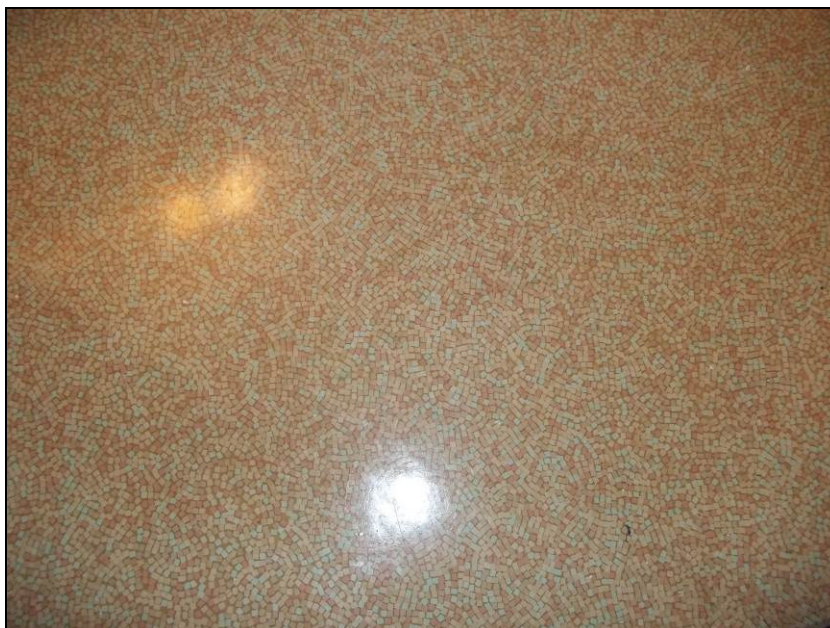
**Photograph 4: Sample GB-10. Asbestos containing vinyl sheet flooring.**

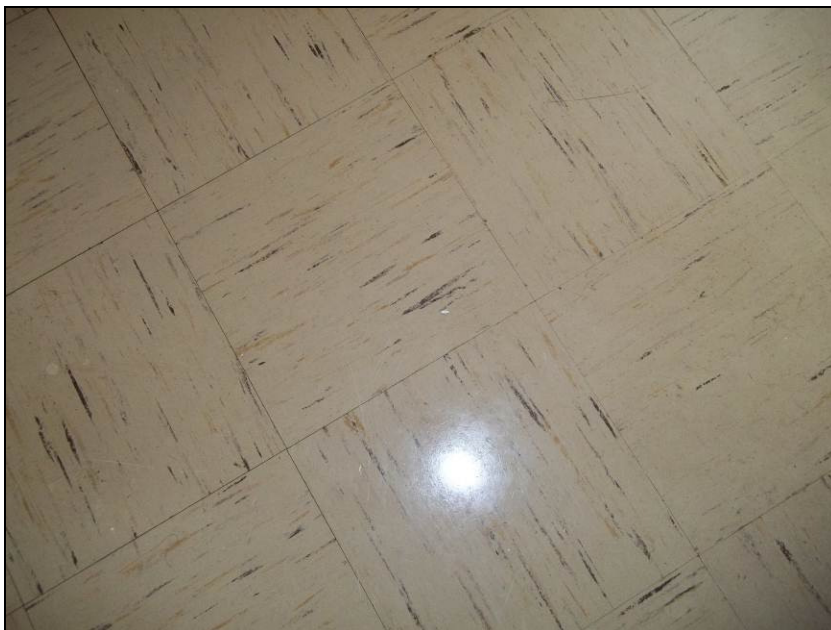
Vinyl floor tiles which could potentially contain asbestos were identified during the assessment. Twelve (12) samples of 1' x 1' vinyl floor tiles were sampled and analyzed for asbestos content using the PLM method of detection. Six (6) tiles and/or their associated mastics were found to contain between 2 – 7% Chrysotile asbestos. (see samples GB-1, GB-2, GB-3, GB-6, GB-8, GB-9, GB-13, GB-18, GB-20, GB-22, GB-24, GB-25 in Appendix II, see Photographs 5 - 10, Appendix I)

**Photograph 5: Sample GB-1. Asbestos containing vinyl floor tile.**

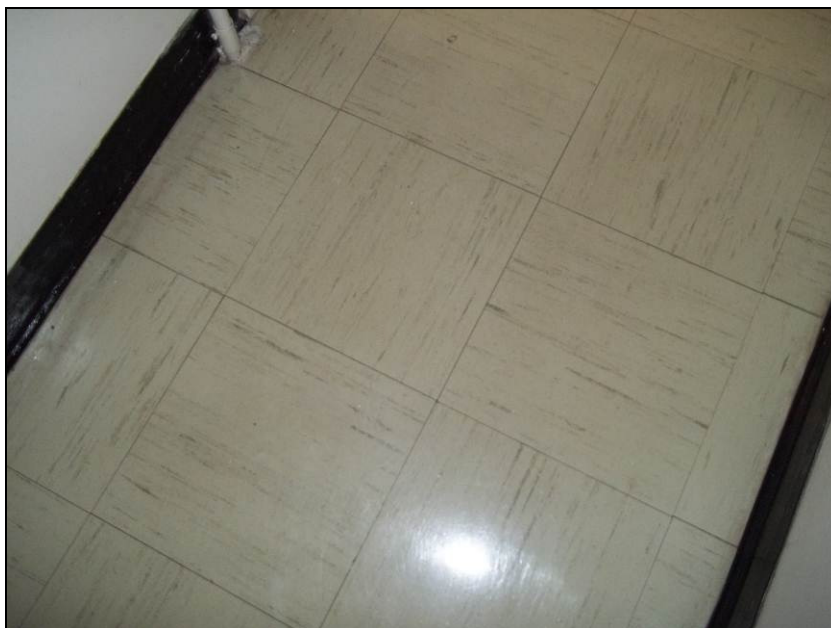
**Photograph 6: Sample GB-6. Asbestos containing vinyl floor tile.**

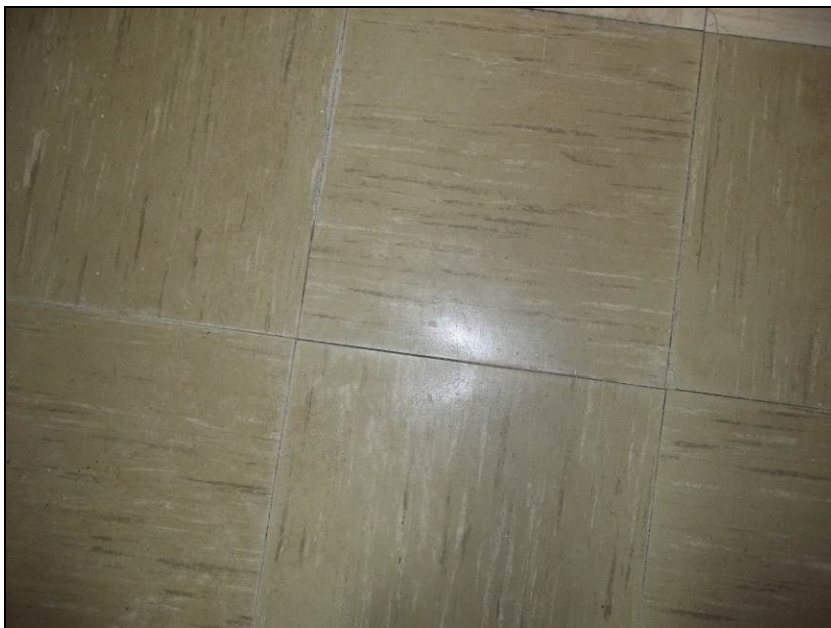
**Photograph 7: Sample GB-8. Asbestos containing vinyl floor tile.**

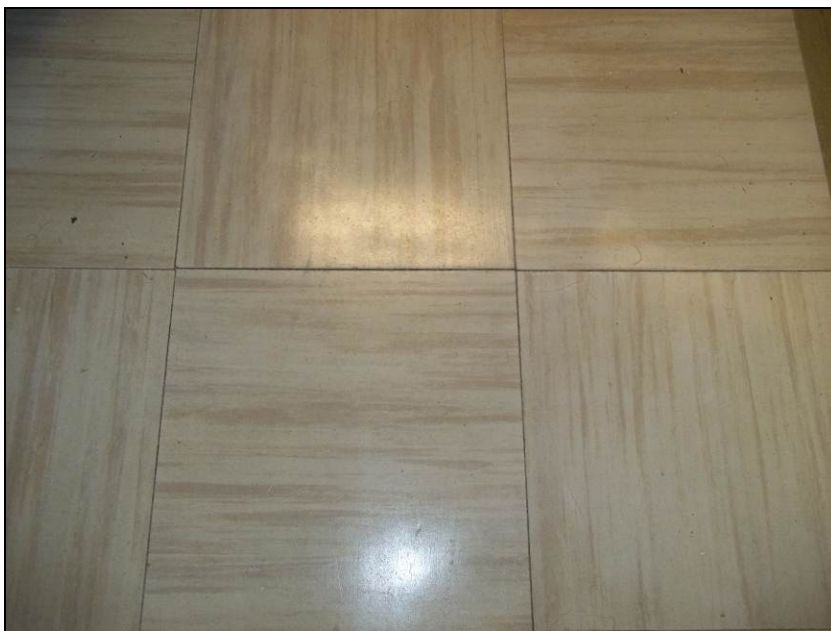
**Photograph 8: Sample GB-9. The vinyl floor tile was identified as non-asbestos containing.  
The mastic was found to contain 4% Chrysotile asbestos.**

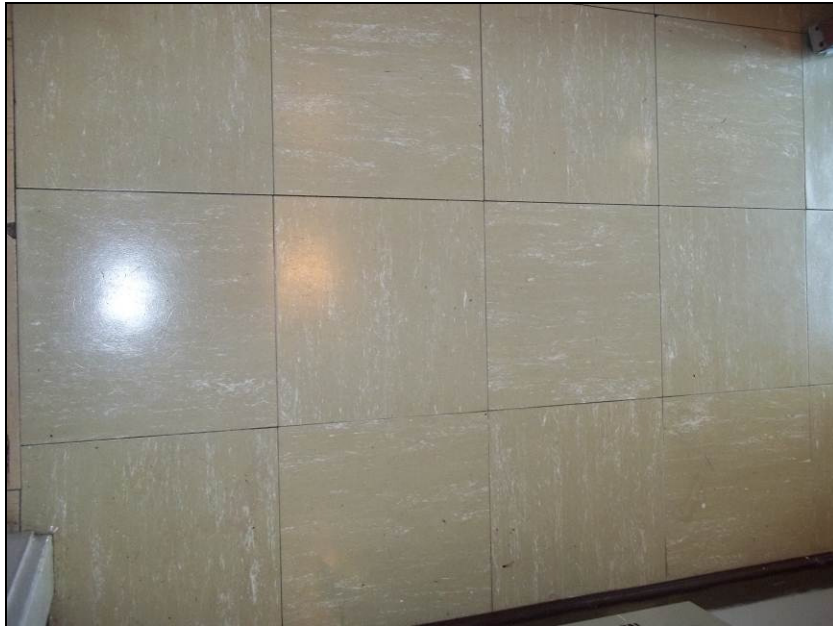
**Photograph 9: Sample GB-24. Asbestos containing vinyl floor tile.**

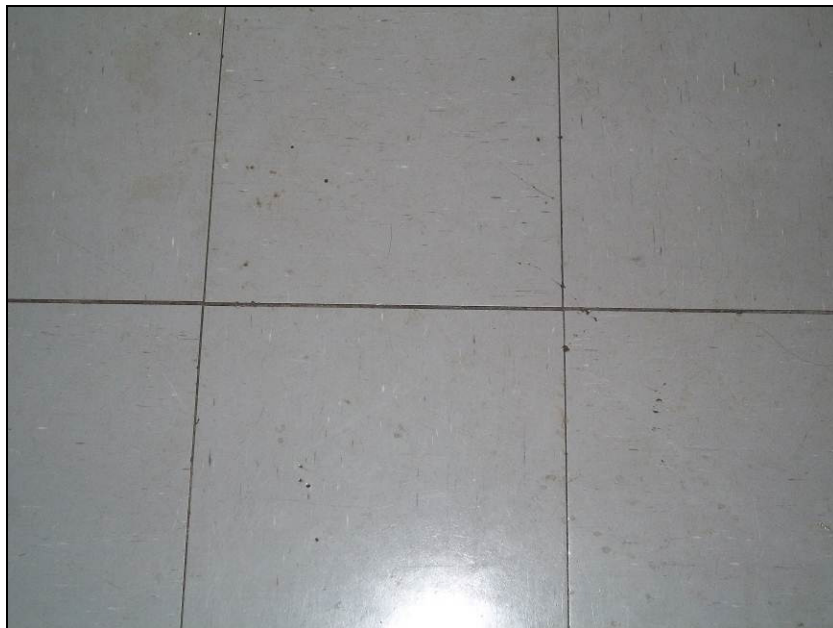
**Photograph 10: Sample GB-25. The vinyl floor tile was identified as non-asbestos containing. The mastic was found to contain 2% Chrysotile asbestos.**

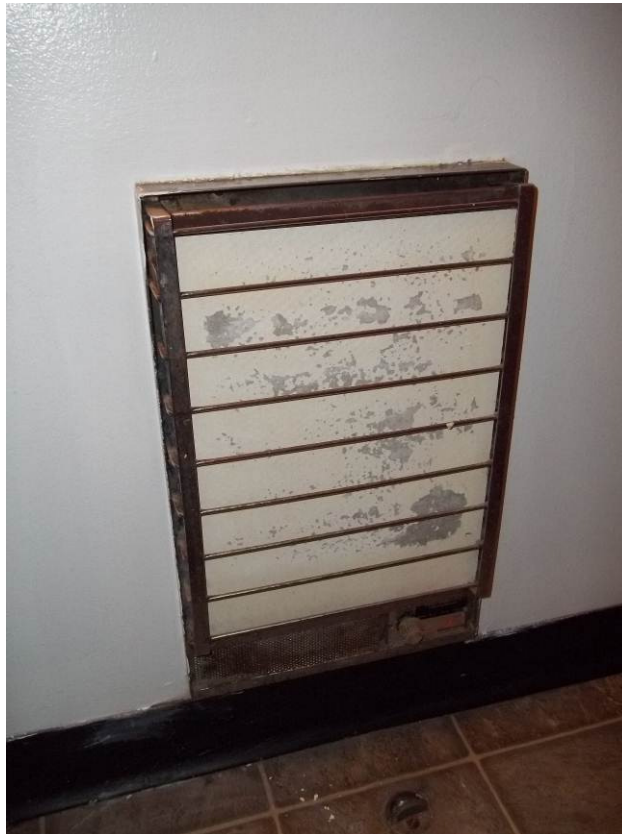
Suspect asbestos containing transite paneling on washroom heaters was also observed during the assessment. One (1) sample was collected and analyzed for asbestos content

using the PLM method of detection. The sample was found to contain 20% Chrysotile asbestos. (see sample GB-11 in Appendix II, Photograph 11 of Appendix I)

**Photograph 11: Sample GB-11. The asbestos containing transite heater panel was found on select washroom walls.**
