**Project #: 13916**

**ASBESTOS ASSESSMENT  
Hatcher House  
Memorial University of Newfoundland  
St. John's, NL**

**August 2011**

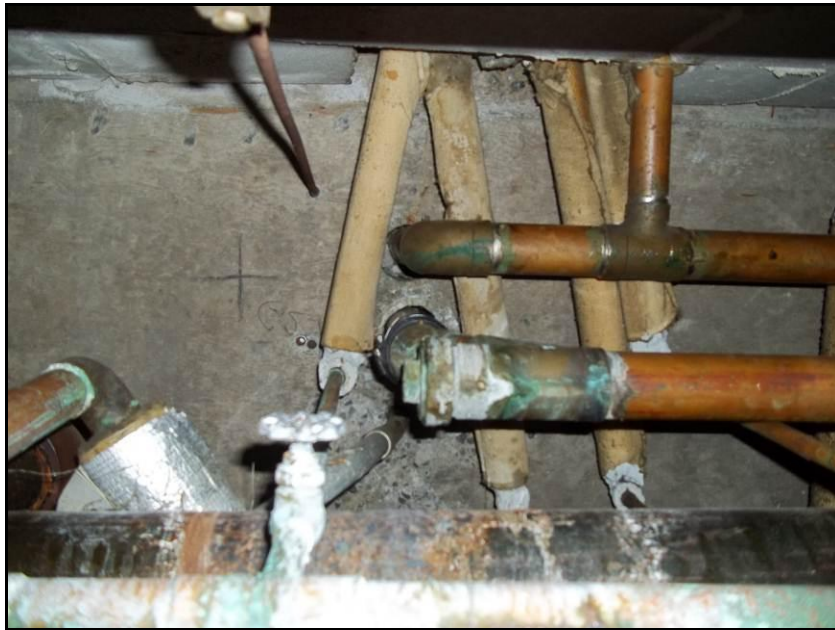
Pipe fitting insulation which could potentially contain asbestos was observed in select areas throughout the building during this assessment. Samples were collected and analyzed for asbestos content using the PLM method of detection and found to contain 60% Chrysotile asbestos (see sample HA-11 in Appendix II, Photographs 1-8, Appendix I)

**Photograph 1: Pipe fitting insulation in the Corridor HA1C03, in poor condition. Limited viewing was available above the ceiling tiles.**

- All materials listed in fair and/or poor condition are to be repaired or removed immediately. See APPENDIX III – Asbestos Building Survey Information for materials condition and locations.

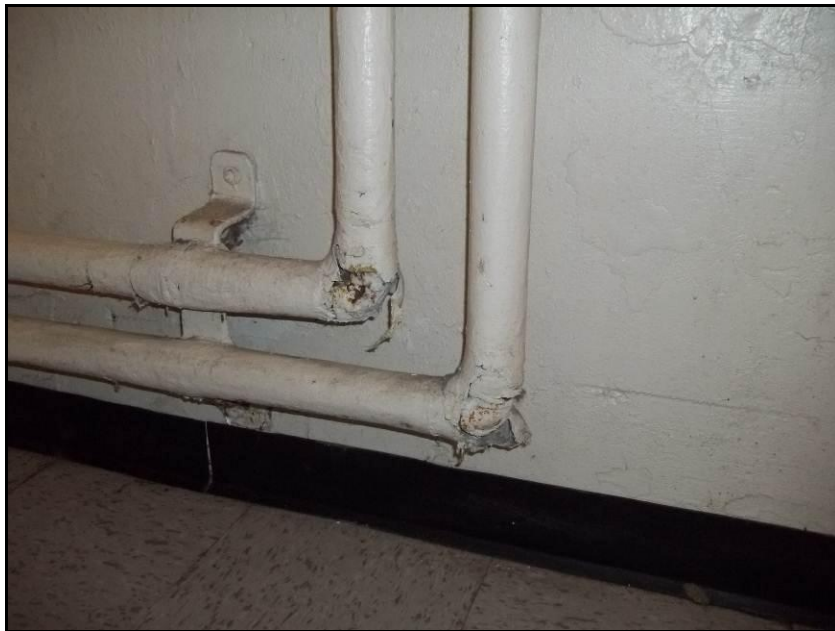
**Photograph 2: Pipe fitting insulation in Stairway HA1S03, in poor condition.**

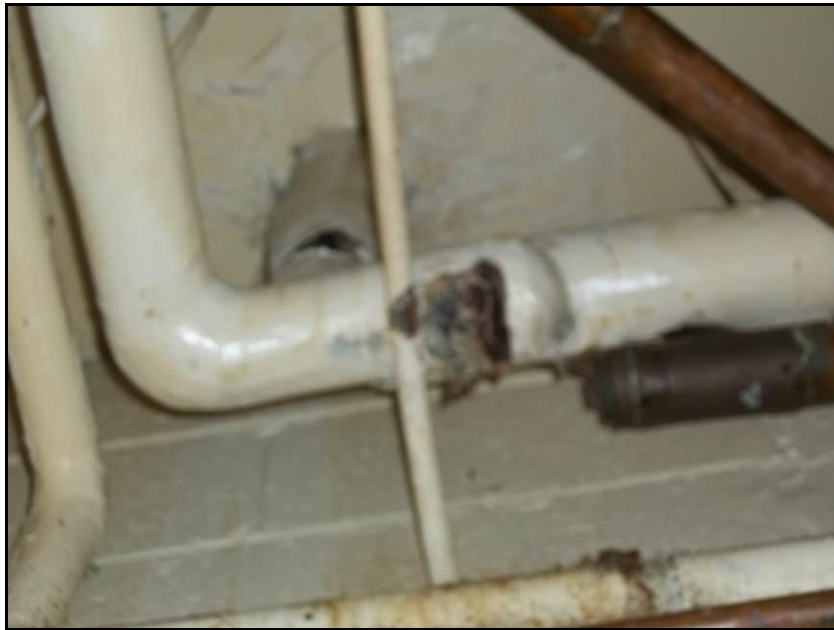
**Photograph 3: Pipe fitting insulation in Room HA101, in poor condition.**

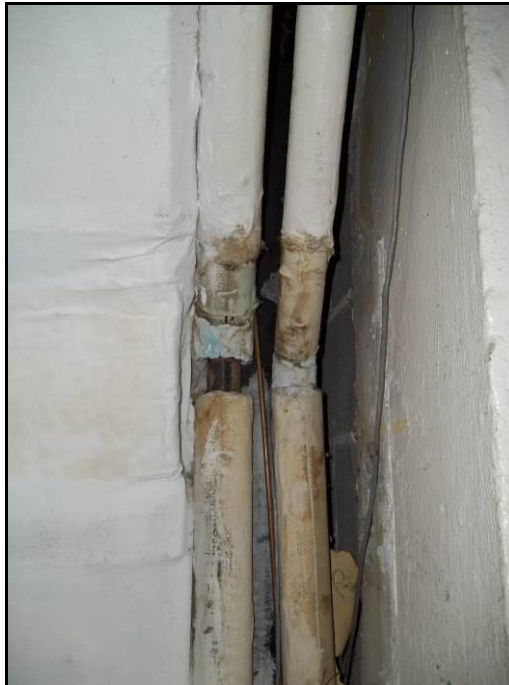
**Photograph 4: Pipe fitting insulation in Room HA208, in poor condition.**

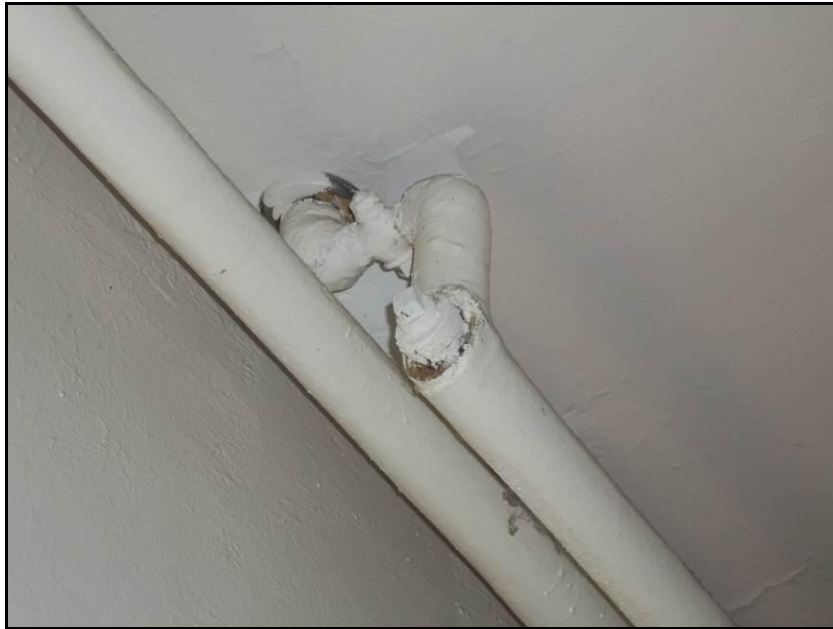
**Photograph 5: Pipe fitting insulation in Stairway HA3S03, in poor condition.**

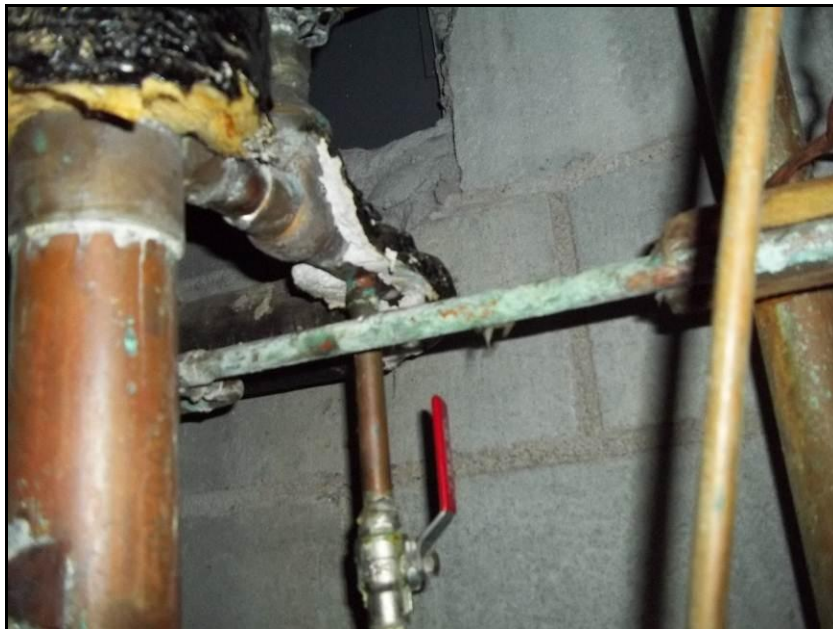
**Photograph 6: Pipe fitting insulation in the access hatch in Room HA321, in poor condition.**

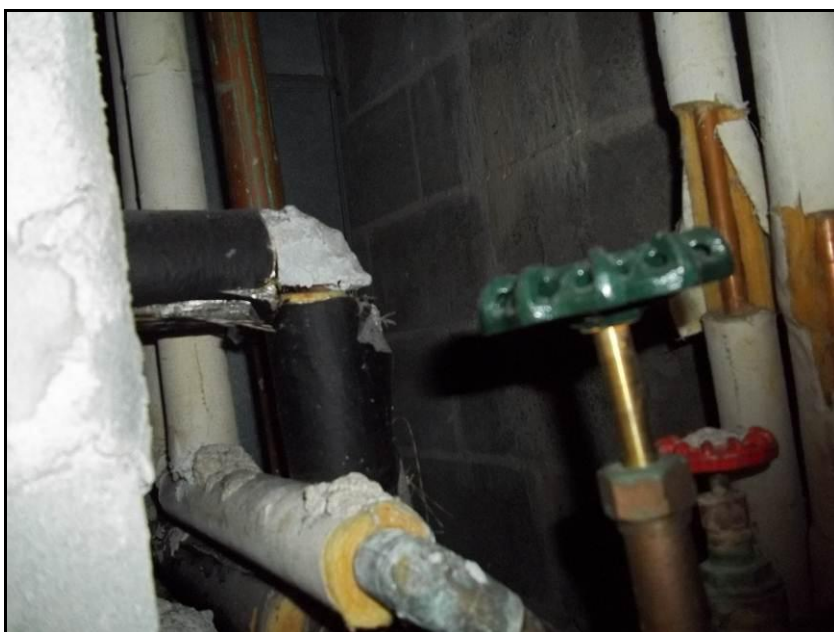
**Photograph 7: Pipe fitting insulation in the access hatch in Room HA422 in poor condition.**

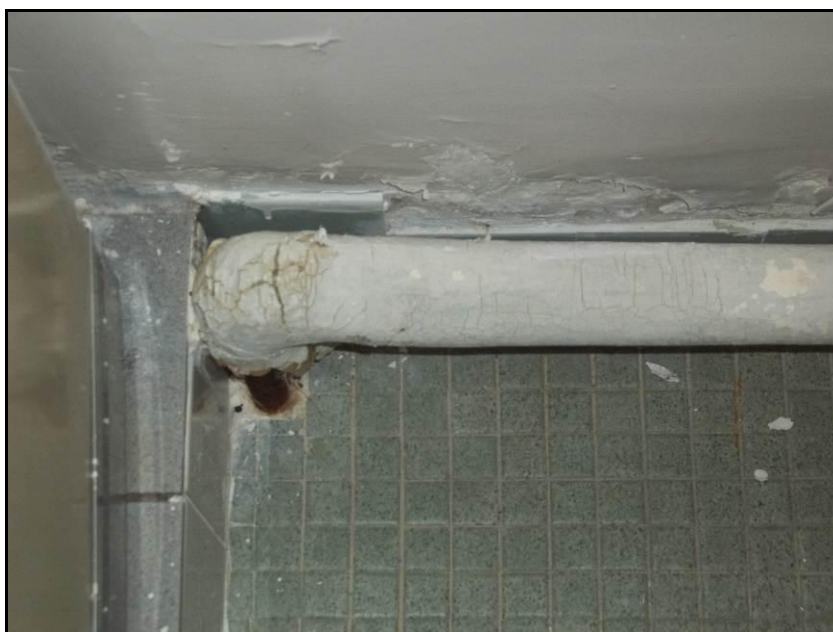
| <b>HA-11</b> | <b>Pipe Fitting Insulation – HA507</b> | <b>60% Chrysotile</b> |

**Photograph 8: Pipe fitting insulation in the shower of Room HA507 in poor condition..**

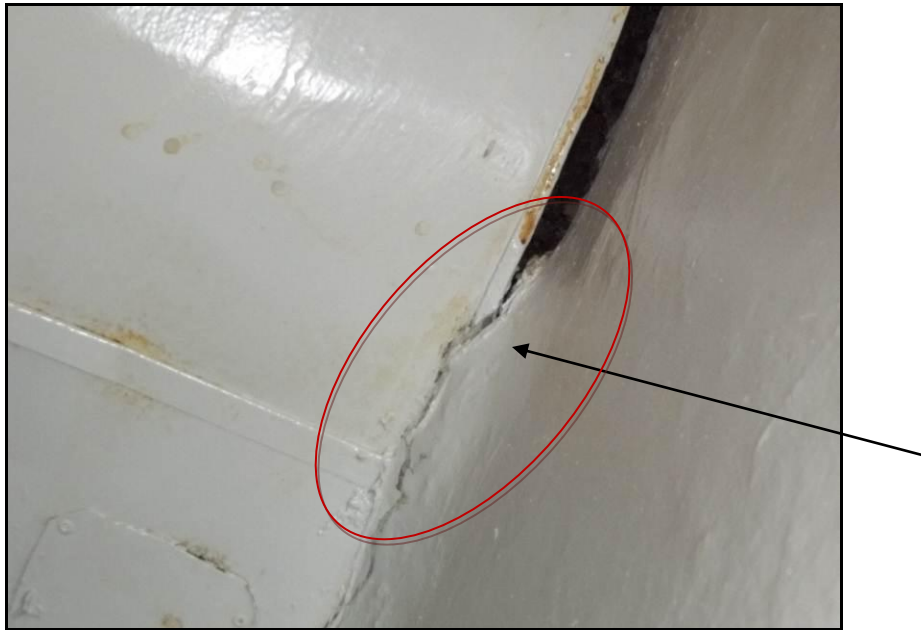
Duct insulation observed in Room HA-218 was too high to access for visual inspection or sample collection, thus it must be considered to be asbestos containing until proven otherwise. (see Photograph 9, Appendix I)

**Photograph 9: Duct in Room HA208, too high to assess. As such it must be considered to be asbestos containing until proven otherwise.**

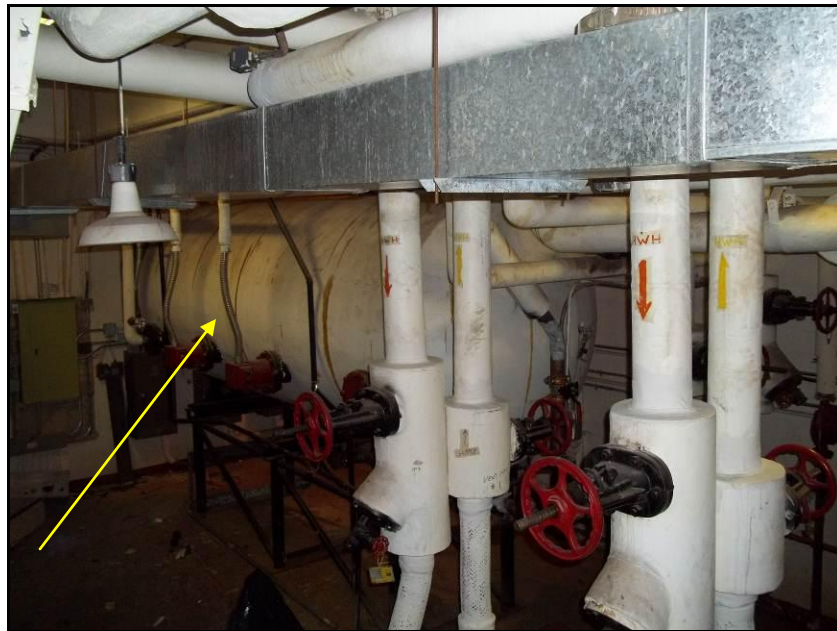
Tank insulation observed in Room HA-114 was sampled and analyzed for asbestos content using the PLM method of detection. The sample was found to contain 35% Chrysotile asbestos. The insulation was observed to be in good condition. (see sample HA-34 in Appendix II, Photograph 10, Appendix I)

**Photograph 10: Asbestos containing tank insulation in Room HA114.**

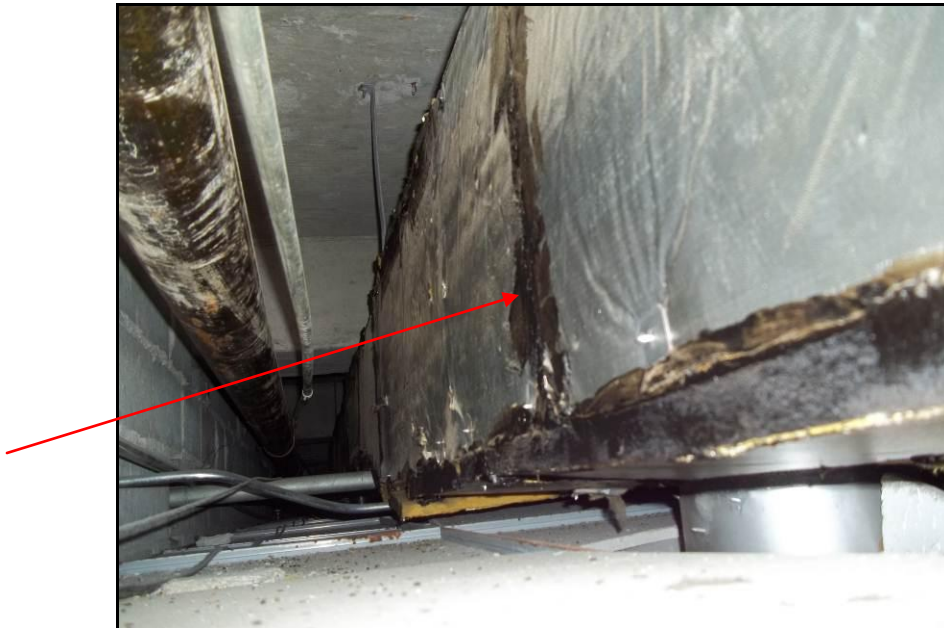
Two tar sealants were observed during the building assessment. One (1) sample of the sealant was observed on linear fiberglass pipe above the ceiling tiles located in HA5C01. The tar sealant was collected and analyzed for asbestos content using the PLM method of detection. The sample was identified as non-asbestos containing. One (1) sample of tar sealant was observed on foil on duct insulation found above the ceiling tiles located in HA1C02. The tar sealant was collected and analyzed for asbestos content using the PLM method of detection. The sample was found to contain 10% Chrysotile asbestos. Tar sealants throughout the building must be considered to be asbestos containing (see samples HA-9 and HA-33 in Appendix II, Photograph 11, Appendix I,)

**Photograph 11: Asbestos containing tar sealant on fiberglass duct above the ceiling tiles in Corridor HA1C02.**

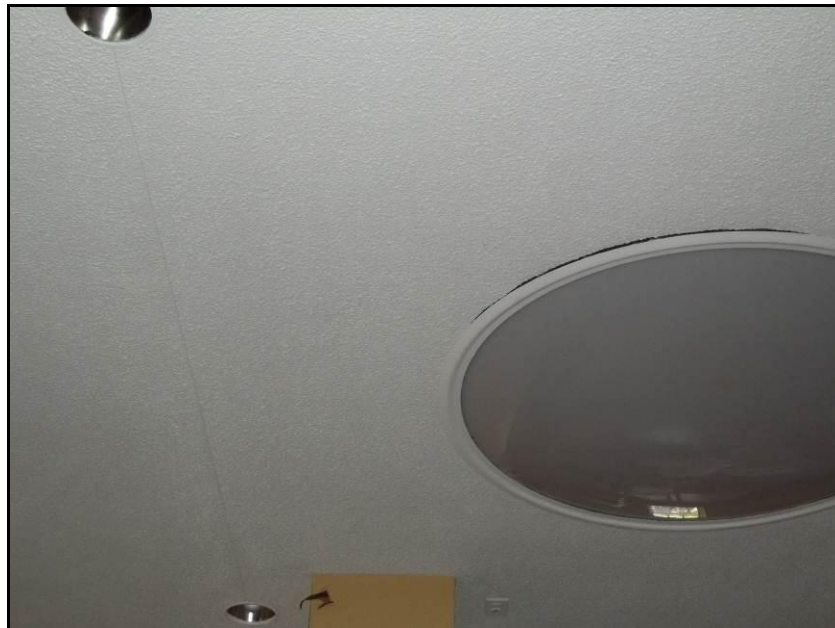
Texture coating on ceilings were observed in select locations within the building during the assessment. One (1) sample was collected and analyzed for asbestos content using the PLM method of detection. The sample was found to contain 3% Chrysotile asbestos. (see sample HA-31 in Appendix II, Photograph 12 in Appendix I).

*It should be noted that due to the uncertainty of when and where a specific type of texture coating was used, it is to be assumed that texture coating present in the building contains asbestos.*

**Photograph 12: Asbestos containing texture coat on the ceilings of HA210 and HA211.**

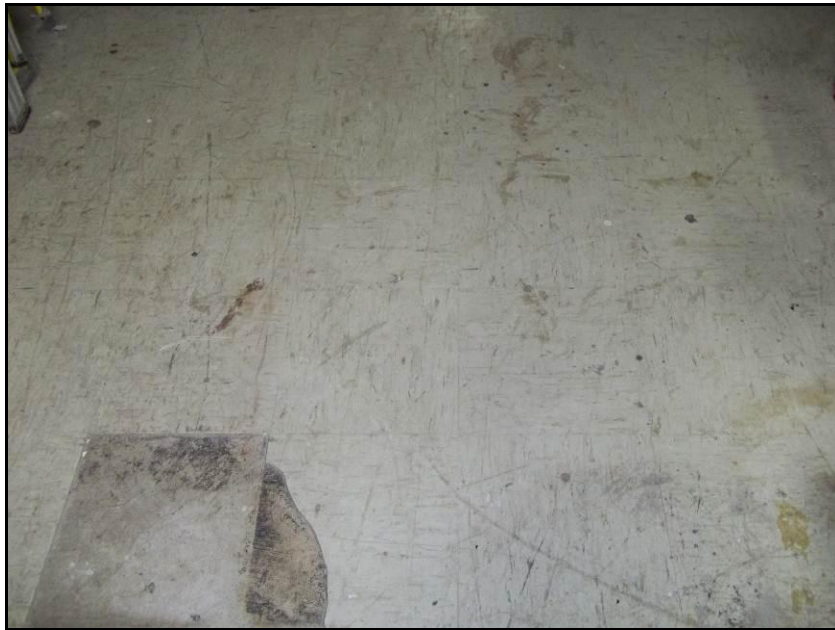
Vinyl floor tiles which could potentially contain asbestos were identified during the assessment. Nine (9) samples of 1' x 1' vinyl floor tiles were sampled and analyzed for asbestos content using the PLM method of detection. One (1) tile was found to contain 2% Chrysotile asbestos. Two (2) of the associated mastics were identified as containing 3% Chrysotile asbestos (See samples HA-8, HA-15, HA-16, HA-18, HA-20, HA-23, HA-25, HA-28, HA-32, HA-36 in Appendix II, see Photograph 13, Appendix I)

**Photograph 13: Asbestos containing 1' x 1' vinyl floor tile.**

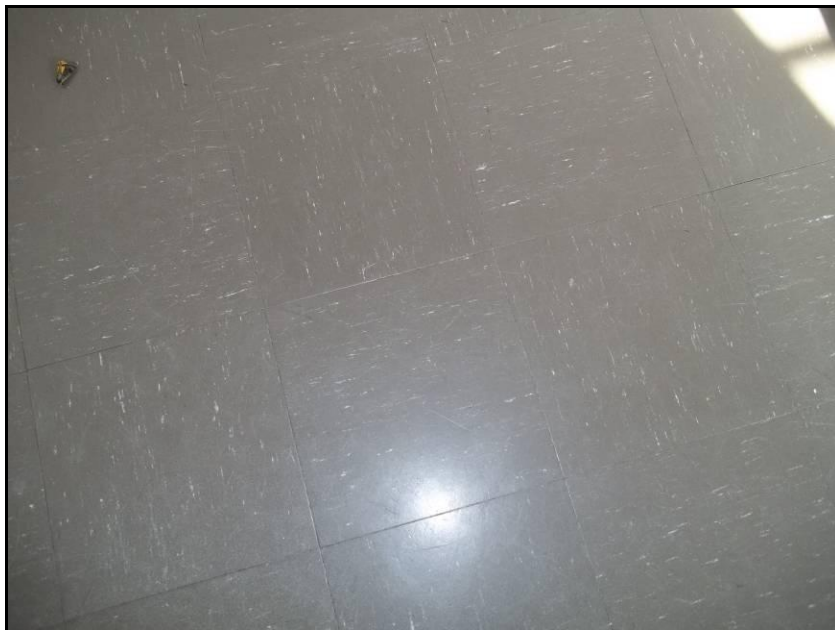
| Sample No. | Sample Description and Location | Asbestos Results |
|---|--|---|
| HA-1 | 9" x 9" Vinyl Floor Tile – dark grey with white – HA5S03 | 8% Chrysotile |
| | Mastic | 5% Chrysotile |

**Photograph 14: Asbestos containing 9" x 9" vinyl floor tile, sample HA-1.**

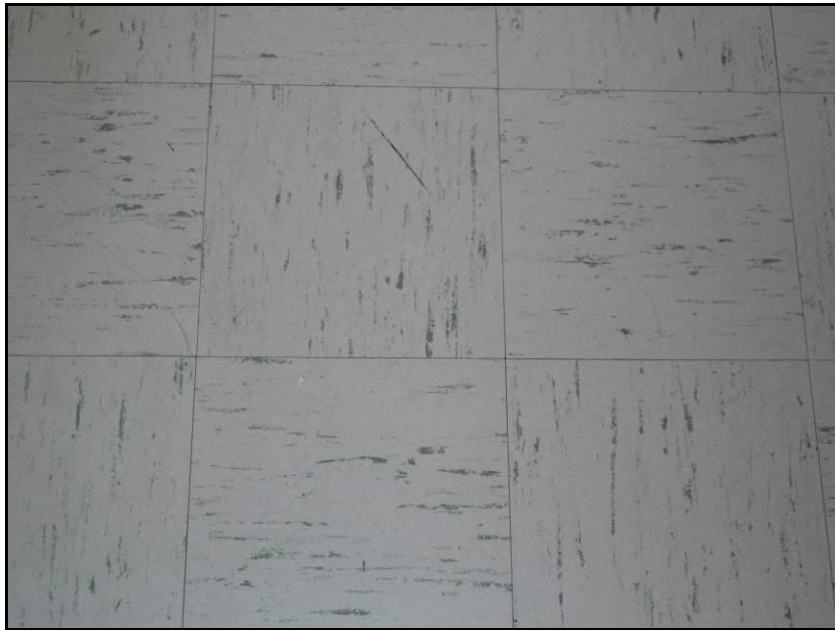
| Sample No. | Sample Description and Location | Asbestos Results |
|---|--|---|
| HA-4 | 9" x 9" Vinyl Floor Tile – white with green – HA537 | 6% Chrysotile |
| | Mastic | 3% Chrysotile |

**Photograph 15: Asbestos containing 9" x 9" vinyl floor tile, sample HA-4.**

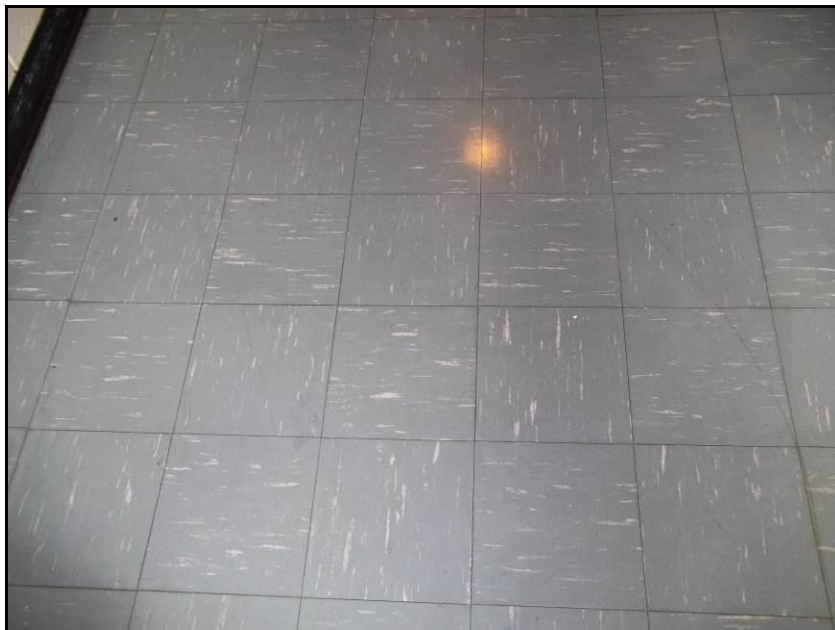
| <b>HA-13</b> | <b>9" x 9" Vinyl Floor Tile – blue with white – HA4C03</b> | <b>8% Chrysotile</b> |
| | <b>Mastic</b> | <b>3% Chrysotile</b> |

**Photograph 16: Asbestos containing 9" x 9" vinyl floor tile, sample HA-13**

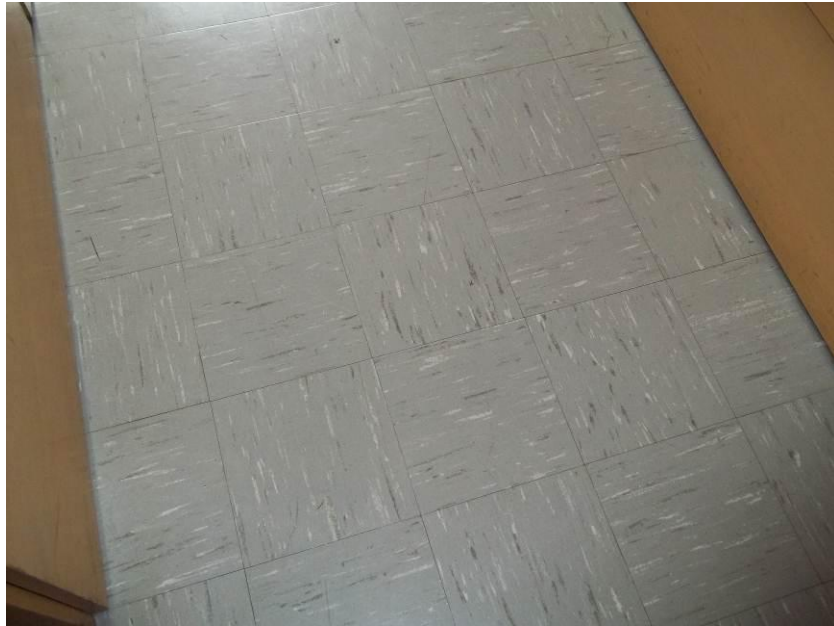
| <b>HA-15A</b> | <b>9" x 9" Vinyl Floor Tile – medium grey with white, dark grey – HA403</b> | <b>10% Chrysotile</b> |

**Photograph 17: Asbestos containing 9" x 9" vinyl floor tile, sample HA-15A**

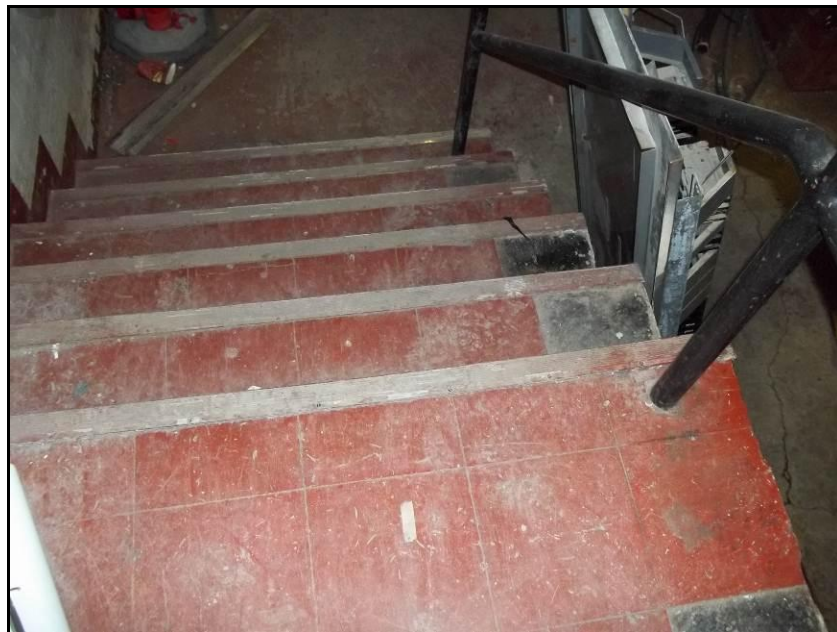
**Photograph 18: Asbestos containing 9" x 9" vinyl floor tile, sample HA-35.**

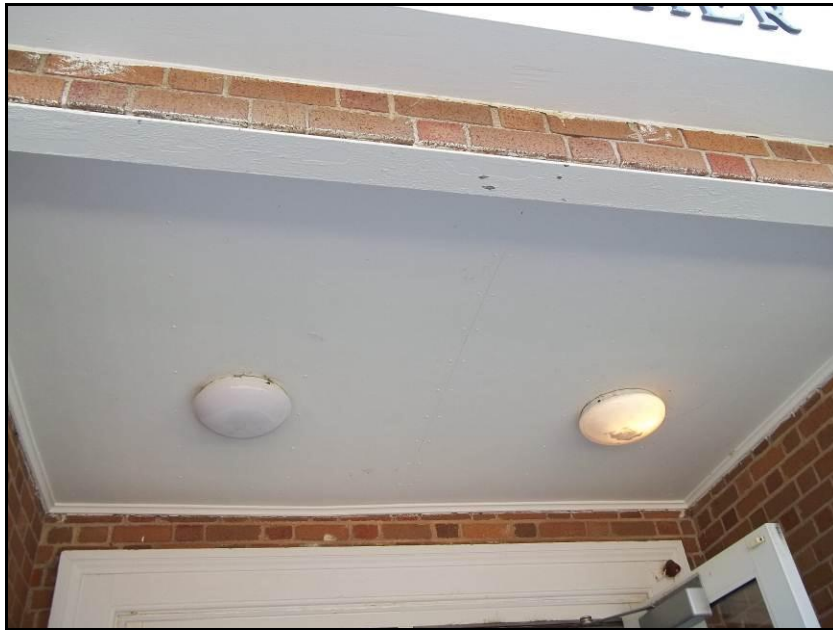
Suspect asbestos containing transite paneling was observed on the exterior overhang and the main entrance of the building. This material was not sampled, as doing so would compromise the integrity of the material. As such, it must be considered to be asbestos containing until proven otherwise. (see Photograph 19, Appendix I)

**Photograph 19: Suspect asbestos containing transite ceiling panel (and asbestos containing light fixture heat shields, HA-6) exterior of the main entrance to the building.**

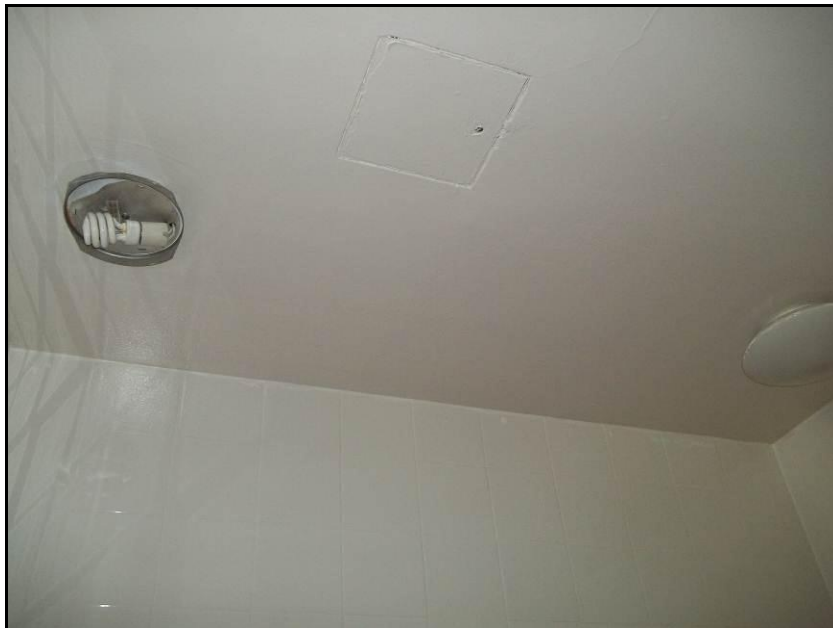
| Sample No. | Sample Description and Location | Asbestos Results |
|---|--|---|
| HA-6 | Light Fixture Heat Shield – HA532 | 40% Chrysotile |

Three (3) types of light fixture heat shields were observed throughout the building. Samples were collected and analyzed for asbestos content using the PLM method of detection, and were found to contain 40 - 50% Chrysotile asbestos (see samples HA-5, HA-6, HA-24 in Appendix II, see Photograph 19 - 21 in Appendix I).

**Photograph 20: Asbestos containing light fixture heat shields, HA-6.**

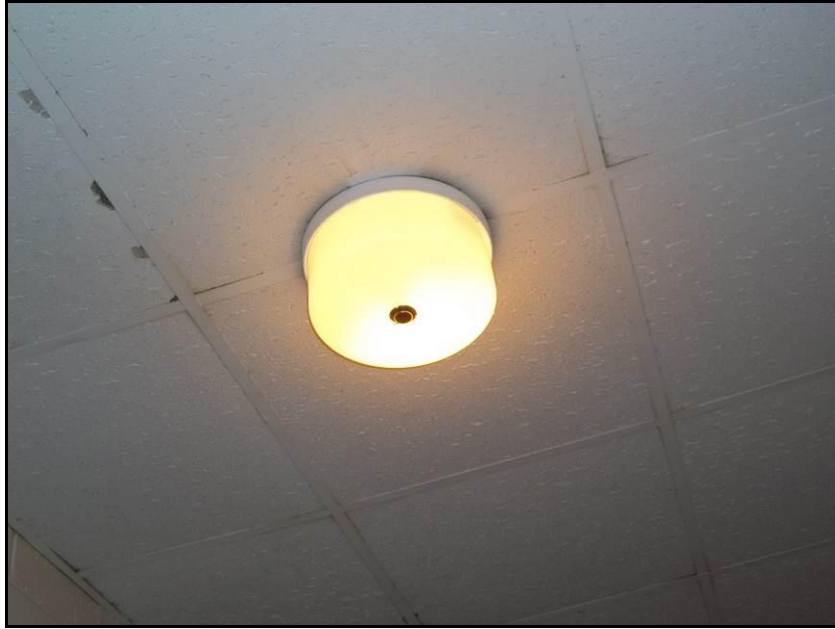
**Photograph 21: Asbestos containing light fixture heat shields, HA-24.**
