ASBESTOS AND LEAD PAINT BUILDING MATERIALS SURVEY FOR: BOTANICAL GARDENS GREENHOUSE MEMORIAL UNIVERSITY OF NEWFOUNDLAND

Pinchin LeBlanc Environmental Ltd Project No. 02-02-00900

March 26, 2013

BUILDING DESCRIPTION: BOTANICAL GARDENS GREENHOUSE

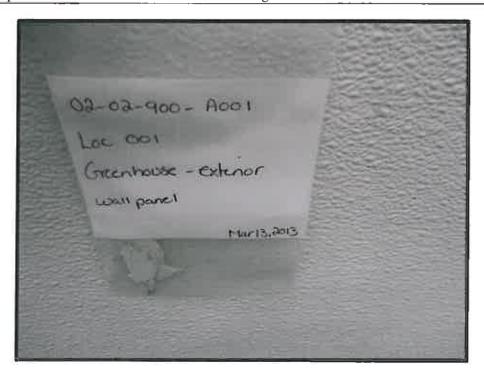
One (1) sample of an exterior wall panel was sampled on the Site Building. Analysis of the sample did not identify the presence of asbestos (reference sample 02-02-900-S001).

Alitable							
Sample #:	S001	Date Sampled:	December 14, 2	012			
Building:	Exterior	Sampler:	Trent Hardy				
Location:	003, room 1000E	Analysis:	SAI - PLM				
MUN Project #:	02-02-900	Work Order #:					
		Bulk Sampling Parameter	rs				
Pipe/Tank	Flooring	Ceiling	Roofing	Location			
	□12'x12' Tile	☐ Textured	☐ Shingle	□ Floor			
☐ Elbow	□ 9'x9'Tile	☐ Stucco	□ Rolled	X Wall Orientation			
☐ Fitting	□ Vinyl Sheet	☐ Popcorn	☐ Felt	☐ Ceiling			
☐ Transite Pipe	☐ Mastic	□ DWJC	□ Tar	☐ Above Ceiling			
☐ Gasket	Wall	☐ Plaster		☐ Other			
☐ Tank Insulation	□ Transite Panel	☐ Acoustic Tile (Dropped	1)				
☐ Pipe Wrap	☐ Textured Wall	☐ Acoustic Tile (Glued-o	n)				
HVAC	☐ Plaster	☐ Mastic	Miscellaneous:	Panel			
☐ Insulation	□ DWJC	Structural					
□ Tape		☐ Steel F. P. ing	No. of Phases:	No. of Phases:			
□ Paper Wrap		☐ Deck F. P. ing	Colour:

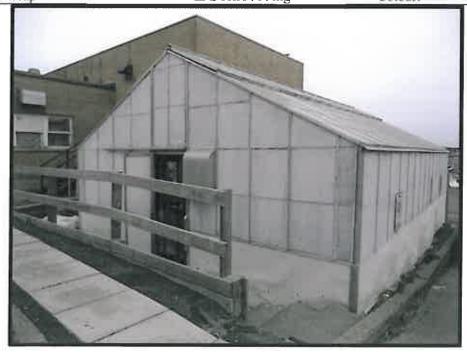
One (1) sample of exterior caulking was sampled from the Site Building. Analysis of the sample did not identify the presence of asbestos (reference sample 02-02-900-S002).

Sample #:	S002	Date Sampled:	December 14,	2012
Building:	Mechanical Greenhouse	Sampler:	Trent Hardy	
Location:	Exterior	Analysis:	SAI - PLM	
MUN Project#:	02-02-900	Work Order #:		
		Bulk Sampling Parameters	-	
Pipe/Tank	Flooring	Ceiling	Roofing	Location
☐ Insulation	□12'x12' Tile	☐ Textured	☐ Shingle	☐ Floor
□ Elbow	□ 9'x9'Tile	☐ Stucco	☐ Rolled	☐ Wall Orientation
☐ Fitting	□ Vinyl Sheet	□ Popcom	☐ Felt	□ Ceiling
☐ Transite Pipe	☐ Mastic	□ DWJC	□ Таг	☐ Above Ceiling
☐ Gasket	Wall	☐ Plaster		☐ Other
☐ Tank Insulation	☐ Transite Panel	☐ Acoustic Tile (Dropped)		
☐ Pipe Wrap	☐ Textured Wall	☐ Acoustic Tile (Glued-on)		
HVAC	☐ Plaster	☐ Mastic	Miscellaneous	: Window Caulking
☐ Insulation	□ DWJC	Structural		J
☐ Tape		☐ Steel F. P. ing	No. of Phases:	
Paper Wrap		□ Deck F. P. ing	Colour:

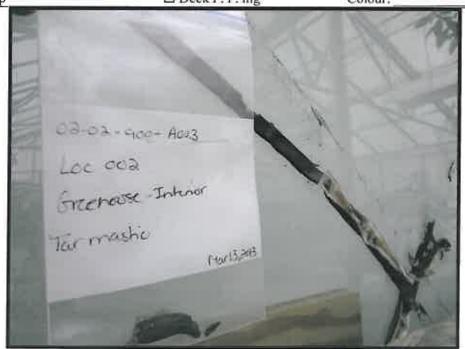
Tar mastic used on the surface of interior windows was sampled from the Site Building, and contains 1-5% chrysotile asbestos (reference sample 02-02-900-S003).

ONIVERSIIT							
Sample #:	S003	Date Sampled:	December 14, 2	2012			
Building:	Mechanical	Sampler:	Trent Hardy				
_	Greenhouse		20000000000				
Location:	002, interior	Analysis:	SAI - PLM				
MUN Project #:	02-02-900	Work Order #:					
		Bulk Sampling Parameters					
Pipe/Tank	Flooring	Ceiling	Roofing	Location			
☐ Insulation	□12'x12' Tile	☐ Textured	☐ Shingle	☐ Floor			
☐ Elbow	□ 9'x9'Tile	☐ Stucco	□ Rolled	X Wall Orientation			
☐ Fitting	□ Vinyl Sheet	□ Popcom	☐ Felt	☐ Ceiling			
☐ Transite Pipe	☐ Mastic	□ DWJC	□ Tar	☐ Above Ceiling			
☐ Gasket	Wall	☐ Plaster		☐ Other			
☐ Tank Insulation	□ Transite Panel	☐ Acoustic Tile (Dropped)					
☐ Pipe Wrap	☐ Textured Wall	☐ Acoustic Tile (Glued-on)					
HVAC	☐ Plaster	☐ Mastic	Miscellaneous: Tar Mastic				
☐ Insulation	□ DWJC	Structural					
☐ Tape		☐ Steel F. P. ing	No. of Phases:				
☐ Paper Wrap		☐ Deck F. P. ing	Colour:

- 1. Type I (low risk) asbestos abatement procedures should be carried out for the scheduled disturbance of any non-friable materials provided the materials can be removed intact, and without the use of powered hand tools.
- 2. Should the use of powered hand tools or excessive breakage of the materials become necessary, Type II (moderate risk) asbestos abatement procedures should be adopted.
