ASBESTOS AND LEAD PAINT BUILDING MATERIALS SURVEY FOR: RESEARCH LAB – 297 MOUNT SCIO ROAD MEMORIAL UNIVERSITY OF NEWFOUNDLAND

Pinchin LeBlanc Environmental Ltd Project No. 02-02-00900

March 20, 2013

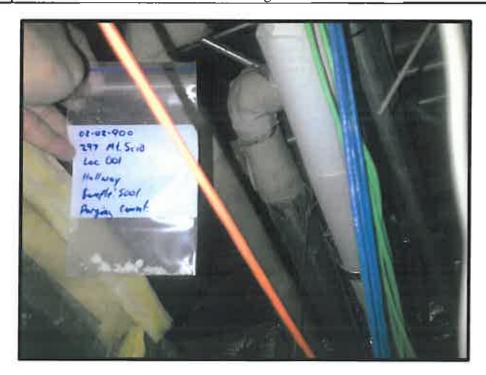
Insulating cement, also referred to as "parging cement", present on pipe elbows and straight sections, was sampled in room MS-1C01 and contains 30% Chrysotile asbestos (reference sample 02-02-900-S001). For locations and conditions of this material at the time of the building survey refer to location & data excel document.

OMIAEK2II	I all				
Sample #:	S001		Date Sampled:	January 16, 2013	
Building:	Mount Scio Resear	ch	Sampler:	Trent Hardy	
_	Lab		·		
Location:	001, room MS 1C0	1	Analysis:	SAI - PLM	
MUN Project #:	02-02-900		Work Order #:		
		Bulk	Sampling Parameters		
Pipe/Tank	Flooring	Ceiling		Roofing	Location
☐ Insulation	□12'x12' Tile	T	extured	☐ Shingle	☐ Floor
X Elbow	□ 9'x9'Tile	☐ Stucco		☐ Rolled	☐ Wall Orientation
☐ Fitting	□ Vinyl Sheet	\square P	'opcom	☐ Felt	☐ Ceiling
☐ Transite Pipe	☐ Mastic		DWJC	🗖 Таг	☐ Above Ceiling
☐ Gasket	Wall	□ P	laster		☐ Other
☐ Tank Insulation	☐ Transite Panel	$\square A$	Acoustic Tile (Dropped)		
☐ Pipe Wrap	□ Textured Wall	$\Box A$	Acoustic Tile (Glued-on)		
HVAC	☐ Plaster	\square N	/lastic	Miscellaneous:	: Parging
☐ Insulation	□ DWJC		Structural		
□ Tape		\square S	teel F. P. ing	No. of Phases:	
☐ Paper Wrap			Deck F. P. ing	Colour:

- 1. Type III (high risk) asbestos abatement procedures should be carried out for the scheduled removal of greater than 1ft² of friable asbestos containing materials. Alternatively, Type II (moderate risk) glove bag abatement procedures may be applied where practical;
- 2. Type II (moderate risk) asbestos abatement procedures should be carried out for the scheduled repair or enclosure of friable ACMs or for the removal of less than 1ft² of material;

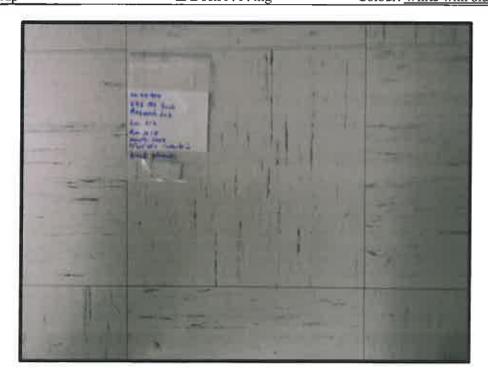
• One (1) sample was collected of the 12"x12" vinyl floor tile identified as white with black streaks from room MS-1018 and contains 5% chrysotile asbestos (reference sample 02-02-900-S002). For locations and conditions of this material at the time of the building survey refer to location & data excel document.

ONIVERSIT						
Sample #:	S002		Date Sampled:	January 16, 2013		
Building:	Mount Scio Research	ch	Sampler:	Trent Hardy		
_	Lab					
Location:	012, room 1018		Analysis:	SAI - PLM		
MUN Project #:	02-02-900		Work Order #:			
		Bulk	Sampling Parameters			
Pipe/Tank	Flooring	Ceiling		Roofing	Location	
☐ Insulation	X12'x12' Tile	☐ Textured		☐ Shingle	X Floor	
□ Elbow	□ 9'x9'Tile		stucco	□ Rolled	☐ Wall Orientation	
☐ Fitting	☐ Vinyl Sheet	\square P	opcom	☐ Felt	☐ Ceiling	
☐ Transite Pipe	☐ Mastic	ΔĽ)WJC	☐ Tar	☐ Above Ceiling	
☐ Gasket	Wall	\Box P	laster		☐ Other	
☐ Tank Insulation	☐ Transite Panel	$\square A$	Acoustic Tile (Dropped)			
□ Pipe Wrap	☐ Textured Wall	$\square A$	Acoustic Tile (Glued-on)			
HVAC	☐ Plaster	\square N	/lastic	Miscellaneous:	,	
☐ Insulation	□ DWJC		Structural			
□ Tape		\square S	teel F. P. ing	No. of Phases:		
☐ Paper Wrap			Deck F. P. ing	Colour: White	with black streaks

1. Type I (low risk) asbestos abatement procedures should be carried out for the scheduled disturbance of any non-friable materials provided the materials can be removed intact, and without the use of powered hand tools.

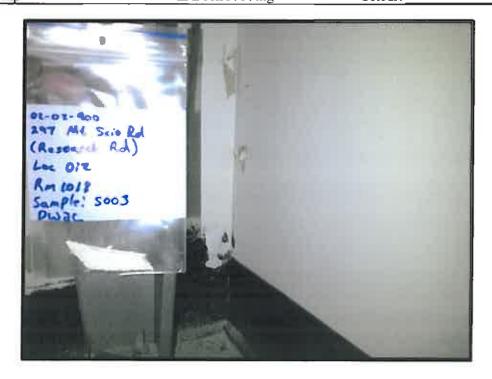
OMIAFICAL	1				
Sample #:	S003		Date Sampled:	January 16, 2013	
Building:	Mount Scio Resear	ch	Sampler:	Trent Hardy	
_	Lab				
Location:	012, room 1018		Analysis:	SAI - PLM	
MUN Project #:	02-02-900		Work Order #:		
		Bulk	Sampling Parameters		
Pipe/Tank	Flooring	Ceiling		Roofing	Location
☐ Insulation	□12'x12' Tile	☐ Textured		☐ Shingle	☐ Floor
☐ Elbow	□ 9'x9'Tile		tucco	□ Rolled	X Wall Orientation
☐ Fitting	☐ Vinyl Sheet	$\square P$	орсот	☐ Felt	☐ Ceiling
☐ Transite Pipe	☐ Mastic		WJC	☐ Tar	☐ Above Ceiling
☐ Gasket	Wall	\square P	laster		☐ Other
☐ Tank Insulation	☐ Transite Panel	\Box A	coustic Tile (Dropped)		
☐ Pipe Wrap	□ Textured Wall	\Box A	coustic Tile (Glued-on)		
HVAC	☐ Plaster	$\square N$	fastic	Miscellaneous:	
☐ Insulation	X DWJC		Structural		
□ Tape			teel F. P. ing	No. of Phases:	
☐ Paper Wrap		\Box D	eck F. P. ing	Colour:

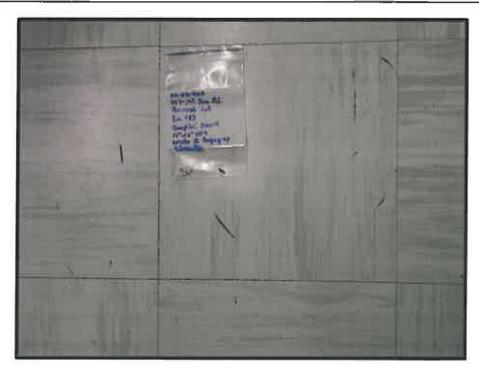
• One (1) sample was collected of the 12"x12" vinyl floor tile identified as white with large grey streaks from room MS-1018A. Analysis of this sample did not identify the presence of asbestos (reference sample 02-02-900-S004).

ONIVERSII	Y				
Sample #:	S004		Date Sampled: January 16, 2013		3
Building:	Mount Scio Resear	ch	Sampler:	Trent Hardy	-
	Lab		_		
Location:	013, room 1010		Analysis:	SAI - PLM	
MUN Project #:	02-02-900		Work Order #:		
		Bulk	Sampling Parameters	-	
Pipe/Tank	Flooring	Ceiling		Roofing	Location
☐ Insulation	X12'x12' Tile	☐ Textured		☐ Shingle	X Floor
☐ Elbow	□ 9'x9'Tile	☐ Stucco		☐ Rolled	☐ Wall Orientation
☐ Fitting	□ Vinyl Sheet	☐ Popcom		□ Felt	☐ Ceiling
☐ Transite Pipe	☐ Mastic)WJC	☐ Tar	☐ Above Ceiling
☐ Gasket	Wall	\Box P	laster		☐ Other
☐ Tank Insulation	☐ Transite Panel		coustic Tile (Dropped)		
☐ Pipe Wrap	□ Textured Wall	\Box A	coustic Tile (Glued-on)		
HVAC	☐ Plaster	\square M	fastic	Miscellaneous:	
☐ Insulation	□ DWJC		Structural		
☐ Tape		\square S	teel F. P. ing	No. of Phases:	
			Deck F. P. ing Colour: White with large streaks		with large grey

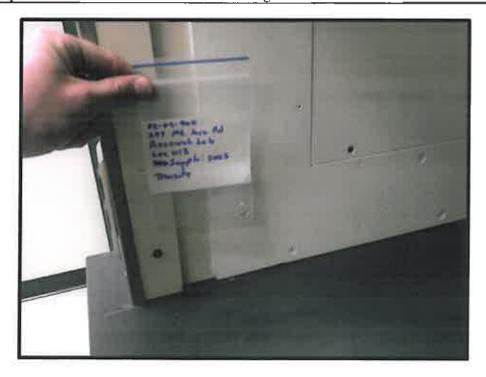
One (1) sample was of transite paneling inside of a fume hood collected from room MS-1018A and contains 20% chrysotile asbestos (reference sample 02-02-900-S005). For locations and conditions of this material at the time of the Site Building survey refer to location & data excel document.

WITT WITTE					
Sample #:	S005		Date Sampled:	January 16, 2013	
Building:	Mount Scio Resear	ch	Sampler:	Trent Hardy	
	Lab				
Location:	013, room 1010		Analysis:	SAI - PLM	
MUN Project #:	02-02-900		Work Order#:		
		Bulk	Sampling Parameters		
Pipe/Tank	Flooring	Ceiling		Roofing	Location
☐ Insulation	□12'x12' Tile	☐ Textured		☐ Shingle	☐ Floor
☐ Elbow	☐ 9'x9'Tile	☐ Stucco		□ Rolled	X Wall Orientation
☐ Fitting	□ Vinyl Sheet	\square P	opcom	☐ Felt	☐ Ceiling
☐ Transite Pipe	□ Mastic		DWJC	☐ Tar	☐ Above Ceiling
☐ Gasket	Wall	\Box P	laster		☐ Other
☐ Tank Insulation	X Transite Panel	□ ♠	Acoustic Tile (Dropped)		
☐ Pipe Wrap	□ Textured Wall		Acoustic Tile (Glued-on)		
HVAC	☐ Plaster	☐ Mastic		Miscellaneous:	
☐ Insulation	□ DWJC		Structural		
□ Tape		\square S	teel F. P. ing	No. of Phases:	
☐ Paper Wrap			Deck F. P. ing	Colour:

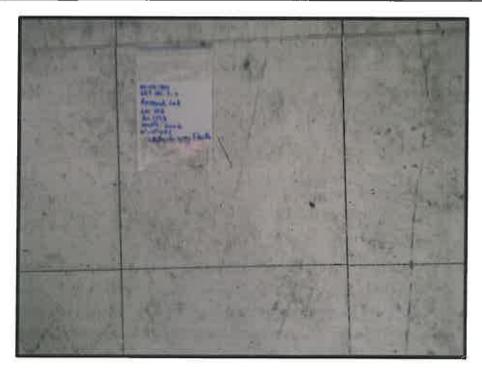
One (1) sample was collected of the 12"x12" vinyl floor tile identified as white with grey flecks from MS-1V03. Analysis of this sample did not identify the presence of asbestos (Reference sample 02-02-900-S006).

OMIAEKOLI					
Sample #:	S006		Date Sampled:	January 16, 201	3
Building:	Mount Scio Researc	ch	Sampler:	Trent Hardy	
	Lab				
Location:	015, room 1V03		Analysis:	SAI - PLM	
MUN Project #:	02-02-900		Work Order #:		
		Bulk	Sampling Parameters		
Pipe/Tank	Flooring	Ceiling		Roofing	Location
☐ Insulation	X12'x12' Tile	☐ Textured		☐ Shingle	X Floor
☐ Elbow	□ 9'x9'Tile	\square S	tucco	☐ Rolled	☐ Wall Orientation
☐ Fitting	□ Vinyl Sheet	\Box P	opcom	☐ Felt	☐ Ceiling
☐ Transite Pipe	☐ Mastic)WJC	□ Tar	☐ Above Ceiling
☐ Gasket	Wall	□P	laster		☐ Other
☐ Tank Insulation	☐ Transite Panel	$\Box A$	Acoustic Tile (Dropped)		
☐ Pipe Wrap	□ Textured Wall	$\Box A$	coustic Tile (Glued-on)		
HVAC	☐ Plaster	\square N	/lastic	Miscellaneous:	
☐ Insulation	□ DWJC		Structural		
☐ Tape		\square S	teel F. P. ing	No. of Phases:	
☐ Paper Wrap		\Box D	eck F. P. ing	Colour: White with grey flecks

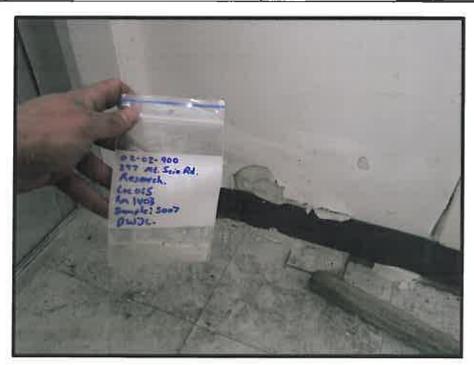
01414 EK311	<u> </u>				
Sample #:	S007		Date Sampled:	January 16, 201	3
Building:	Mount Scio Resear	ch	Sampler:	Trent Hardy	
	Lab			,	
Location:	015, room 1V03		Analysis:	SAI - PLM	
MUN Project#:	02-02-900		Work Order #:		
		Bulk	Sampling Parameters		
Pipe/Tank	Flooring		Ceiling	Roofing	Location
☐ Insulation	□12'x12' Tile	☐ Textured		☐ Shingle	☐ Floor
☐ Elbow	□ 9'x9'Tile		tucco	☐ Rolled	X Wall Orientation
☐ Fitting	□ Vinyl Sheet	\square P	opcorn	☐ Felt	☐ Ceiling
☐ Transite Pipe	□ Mastic		OWJC	□ Tar	☐ Above Ceiling
☐ Gasket	Wall	\square P	laster		☐ Other
□ Tank Insulation	□ Transite Panel	\Box A	coustic Tile (Dropped)		
☐ Pipe Wrap	☐ Textured Wall	$\Box A$	coustic Tile (Glued-on)		
HVAC	☐ Plaster	\square N	lastic	Miscellaneous:	
☐ Insulation	X DWJC		Structural		
☐ Tape		\square S	teel F. P. ing	No. of Phases:	
☐ Paper Wrap			eck F. P. ing	Colour:

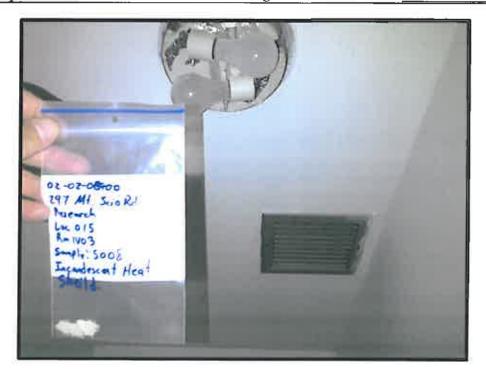
One (1) sample was collected of a heat shield present in an incandescent light fixture from room MS-1V03 and contains 60% chrysotile asbestos (reference sample 02-02-900-S008). For locations and conditions of this material at the time of the Site Building survey refer to location & data excel document.

OTTIVERSTI					
Sample #:	S008		Date Sampled:	January 16, 201	3
Building:	Mount Scio Research		Sampler:	Trent Hardy	
	Lab		•		
Location:	015, room 1V03		Analysis:	SAI - PLM	
MUN Project #:	02-02-900		Work Order#:		
		Bulk	Sampling Parameters	-	
Pipe/Tank	Flooring		Ceiling	Roofing	Location
☐ Insulation	□12'x12' Tile	☐ Textured		☐ Shingle	☐ Floor
☐ Elbow	☐ 9'x9'Tile	☐ Stucco		□ Rolled	☐ Wall Orientation
☐ Fitting	□ Vinyl Sheet	☐ Popcorn		☐ Felt	☐ Ceiling
☐ Transite Pipe	☐ Mastic	□ DWJC		☐ Tar	☐ Above Ceiling
☐ Gasket	Wall	□ P1	aster		X Other (light)
☐ Tank Insulation	☐ Transite Panel		coustic Tile (Dropped)		
□ Pipe Wrap	☐ Textured Wall	\Box A	coustic Tile (Glued-on)		
HVAC	☐ Plaster	☐ Mastic		Miscellaneous: shield	Incandescent heat
☐ Insulation	□ DWJC		Structural		
☐ Tape		☐ St	eel F. P. ing	No. of Phases:	
☐ Paper Wrap			eck F. P. ing	Colour:

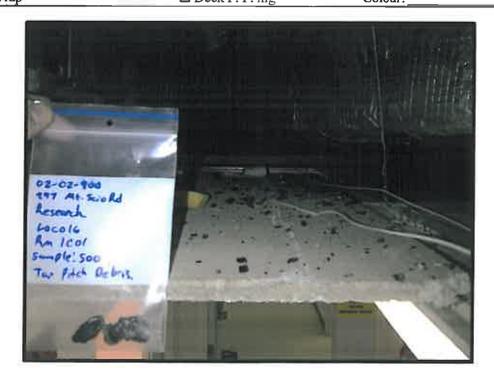
One (1) sample of tar and pitch DEBRIS resting in the ceiling space was collected from room MS-1C04. Analysis of this sample did not identify the presence of asbestos (reference sample 02-02-900-S009).

ONIVERSII	Y				
Sample #:	S009		Date Sampled:	January 16, 201	3
Building:	Mount Scio Resear	ch	Sampler:	Trent Hardy	-
_	Lab				
Location:	016, room 1C01		Analysis:	SAI - PLM	
MUN Project #:	02-02-900		Work Order#:		
		Bulk	Sampling Parameters		
Pipe/Tank	Flooring		Ceiling	Roofing	Location
☐ Insulation	□12'x12' Tile	☐ Textured		☐ Shingle	☐ Floor
☐ Elbow	□ 9'x9'Tile	☐ Stucco		☐ Rolled	☐ Wall Orientation
☐ Fitting	□ Vinyl Sheet	□ Popcom		☐ Felt	☐ Ceiling
☐ Transite Pipe	☐ Mastic		WJC	☐ Tar	☐ Above Ceiling
☐ Gasket	Wall	□P	laster		☐ Other
☐ Tank Insulation	☐ Transite Panel	$\square A$	coustic Tile (Dropped)		
☐ Pipe Wrap	□ Textured Wall	\square A	coustic Tile (Glued-on)		
HVAC	☐ Plaster	☐ Mastic		Miscellaneous: ceiling	Tar debris above
☐ Insulation	□ DWJC		Structural	<u>coming</u>	
☐ Tape		□s	teel F. P. ing	No. of Phases:	
□ Paper Wran			eck F P ing	Colour

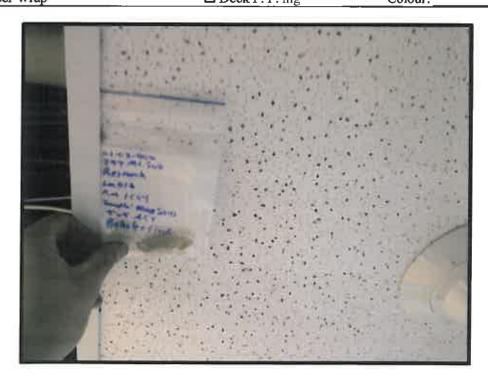
Sample #:	S010		Date Sampled:	January 16, 201	3
Building:	Mount Scio Resear	ch	Sampler:	Trent Hardy	
	Lab			-	
Location:	016, room 1C04		Analysis:	SAI - PLM	
MUN Project #:	02-02-900		Work Order #:	_	
		Bulk	Sampling Parameters		
Pipe/Tank	Flooring		Ceiling	Roofing	Location
☐ Insulation	□12'x12' Tile	☐ Textured		☐ Shingle	☐ Floor
☐ Elbow	□ 9'x9'Tile	☐ Stucco		□ Rolled	☐ Wall Orientation
☐ Fitting	□ Vinyl Sheet	□ Popcom		☐ Felt	X Ceiling
☐ Transite Pipe	☐ Mastic		DWJC	□ Tar	☐ Above Ceiling
☐ Gasket	Wall	\Box P	laster		☐ Other
☐ Tank Insulation	☐ Transite Panel	ΧA	coustic Tile (Dropped)		
☐ Pipe Wrap	☐ Textured Wall		Acoustic Tile (Glued-on)		
HVAC	☐ Plaster	☐ Mastic		Miscellaneous: 2' x 4' pinhole fleck	
☐ Insulation	□ DWJC		Structural		
☐ Tape		\square S	teel F. P. ing	No. of Phases:	
Paper Wran			leck F P ing	Colour

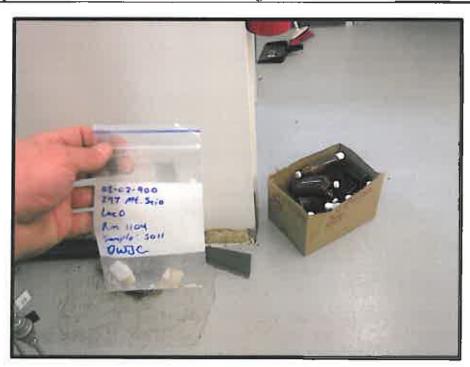
O I TI T IS IN O I I					
Sample #:	S011		Date Sampled:	January 16, 201	3
Building:	Mount Scio Resear	ch	Sampler:	Trent Hardy	
	Lab				
Location:	021, room 1104		Analysis:	SAI - PLM	
MUN Project #:	02-02-900		Work Order #:		
		Bulk	Sampling Parameters		
Pipe/Tank	Flooring	Ceiling		Roofing	Location
☐ Insulation	□12'x12' Tile	☐ Textured		☐ Shingle	□ Floor
☐ Elbow	□ 9'x9'Tile	☐ Stucco		☐ Rolled	X Wall Orientation
☐ Fitting	□ Vinyl Sheet	☐ Popcom		□ Felt	☐ Ceiling
☐ Transite Pipe	☐ Mastic		WJC	□ Tar	☐ Above Ceiling
☐ Gasket	Wall	\square P	laster		☐ Other
☐ Tank Insulation	☐ Transite Panel	$\Box A$	coustic Tile (Dropped)		
☐ Pipe Wrap	☐ Textured Wall	\Box A	coustic Tile (Glued-on)		
HVAC	☐ Plaster	□ Mastic		Miscellaneous:	
☐ Insulation	X DWJC		Structural		
☐ Tape		\square S	teel F. P. ing	No. of Phases:	
☐ Paper Wrap			eck F. P. ing	Colour:

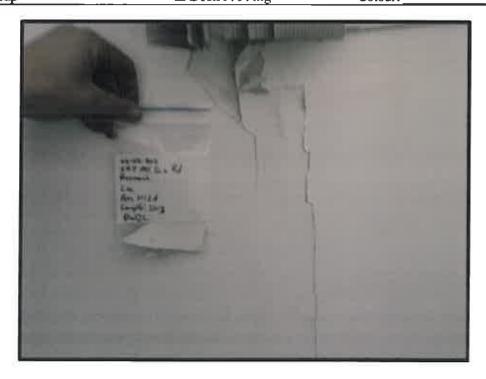
OMIAEKSII					
Sample #:	S013		Date Sampled:	January 16, 201	.3
Building:	Mount Scio Resear	ch	Sampler:	Trent Hardy	
	Lab				
Location:	025, room 1112A		Analysis:	SAI - PLM	
MUN Project #:	02-02-900		Work Order#:		
		Bulk	Sampling Parameters		
Pipe/Tank	Flooring		Ceiling	Roofing	Location
☐ Insulation	□12'x12' Tile	☐ Textured		☐ Shingle	☐ Floor
□ Elbow	□ 9'x9'Tile	☐ Stucco		□ Rolled	X Wall Orientation
☐ Fitting	□ Vinyl Sheet	\Box P	opcom	☐ Felt	☐ Ceiling
☐ Transite Pipe	☐ Mastic		OWJC	□ Tar	☐ Above Ceiling
☐ Gasket	Wall	□P	Plaster		☐ Other
☐ Tank Insulation	☐ Transite Panel		Acoustic Tile (Dropped)		
☐ Pipe Wrap	☐ Textured Wall		Acoustic Tile (Glued-on)		
HVAC	☐ Plaster	□ Mastic		Miscellaneous:	·
☐ Insulation	X DWJC		Structural		
□ Tape		\square S	iteel F. P. ing	No. of Phases:	
☐ Paper Wrap			Deck F. P. ing	Colour:

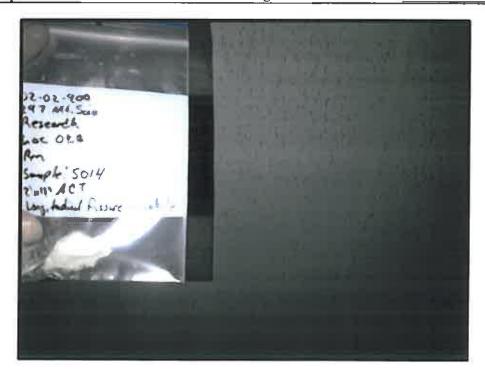
OMINEKSII						
Sample #:	S014		Date Sampled:	January 16, 201	3	
Building:	Mount Scio Research		Sampler:	Trent Hardy		
	Lab					
Location:	026, room 1111		Analysis:	SAI - PLM		
MUN Project #:	02-02-900		Work Order#:			
		Bulk	Sampling Parameters			
Pipe/Tank	Flooring		Ceiling	Roofing	Location	
☐ Insulation	□12'x12' Tile	☐ Textured		☐ Shingle	□ Floor	
☐ Elbow	□ 9'x9'Tile	☐ Stucco		☐ Rolled	☐ Wall Orientation	
☐ Fitting	□ Vinyl Sheet	☐ Popcom		☐ Felt	X Ceiling	
☐ Transite Pipe	☐ Mastic	□ DWJC		☐ Tar	☐ Above Ceiling	
☐ Gasket	Wall	\square P	laster		☐ Other	
☐ Tank Insulation	□ Transite Panel	ΧA	coustic Tile (Dropped)			
☐ Pipe Wrap	☐ Textured Wall	$\square A$	coustic Tile (Glued-on)			
HVAC	☐ Plaster	☐ Magtia		Miscellaneous: 2' x 4' longitudinal		
HVAC	L idstei	☐ Mastic		fissure and pinh	<u>iole</u>	
☐ Insulation	□ DWJC		Structural			
☐ Tape		\square S	teel F. P. ing	No. of Phases:		
☐ Paper Wrap		Deck F. P. ing		Colour:

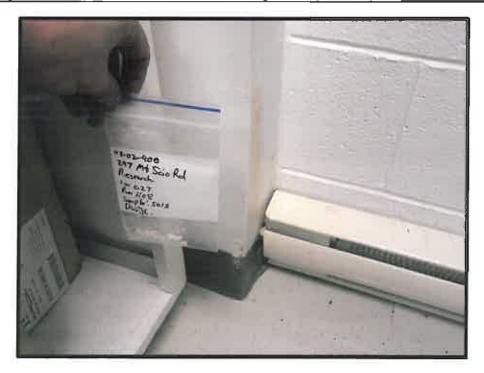
ONTVERSITI							
Sample #:	S015		Date Sampled:	January 16, 201	3		
Building:	Mount Scio Research	ch	Sampler:	Trent Hardy			
	Lab						
Location:	027, room 1108		Analysis:	SAI - PLM			
MUN Project #:	02-02-900		Work Order #:				
		Bulk	Sampling Parameters				
Pipe/Tank	Flooring		Ceiling	Roofing	Location		
☐ Insulation	□12'x12' Tile	☐ Textured		☐ Shingle	☐ Floor		
□ Elbow	□ 9'x9'Tile	☐ Stucco		□ Rolled	X Wall Orientation		
☐ Fitting	□ Vinyl Sheet	☐ Popcom		☐ Felt	☐ Ceiling		
☐ Transite Pipe	☐ Mastic	DD)WJC	□ Tar	☐ Above Ceiling		
☐ Gasket	Wall	□ P.	laster		☐ Other		
☐ Tank Insulation	□ Transite Panel	\Box A	coustic Tile (Dropped)				
☐ Pipe Wrap	☐ Textured Wall	$\Box A$	coustic Tile (Glued-on)				
HVAC	☐ Plaster	□ Mastic		Miscellaneous:			
□ Insulation	X DWJC		Structural				
☐ Tape			teel F. P. ing	No. of Phases:			
☐ Paper Wrap		\Box D	eck F. P. ing	Colour:

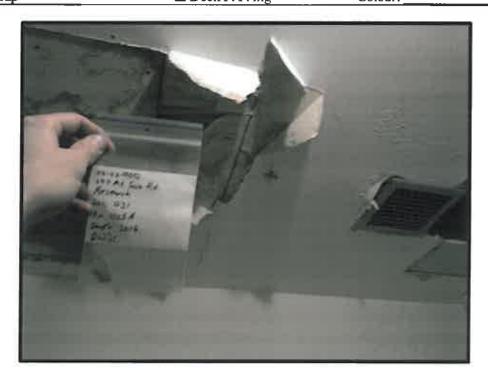
ONIVERSITI							
Sample #:	S016		Date Sampled:	January 16, 201	3		
Building:	Mount Scio Resear	ch !	Sampler:	Trent Hardy			
	Lab			,			
Location:	031, room 1105A		Analysis:	SAI - PLM			
MUN Project #:	02-02-900	7	Work Order#:				
		Bulk S	ampling Parameters				
Pipe/Tank	Flooring		Ceiling	Roofing	Location		
☐ Insulation	□12'x12' Tile	☐ Textured		☐ Shingle	☐ Floor		
□ Elbow	□ 9'x9'Tile	☐ Stucco		□ Rolled	X Wall Orientation		
☐ Fitting	□ Vinyl Sheet	□ Pop	ocom	☐ Felt	☐ Ceiling		
☐ Transite Pipe	□ Mastic	□ DŴJC		□ Tar	☐ Above Ceiling		
☐ Gasket	Wall	☐ Pla:	ster		☐ Other		
☐ Tank Insulation	☐ Transite Panel	☐ Acc	oustic Tile (Dropped)				
☐ Pipe Wrap	☐ Textured Wall	☐ Acc	oustic Tile (Glued-on)				
HVAC	☐ Plaster	☐ Mastic		Miscellaneous:			
☐ Insulation	X DWJC		Structural		,		
☐ Tape		☐ Ste	el F. P. ing	No. of Phases:			
☐ Paper Wrap		□ Dec	ck F. P. ing	Colour:	-
