# ASBESTOS AND LEAD PAINT BUILDING MATERIALS SURVEY FOR: MUSIC BUILDING MEMORIAL UNIVERSITY OF NEWFOUNDLAND

Pinchin LeBlanc Environmental Ltd Project No. 02-02-00900

March 20, 2013

**BUILDING DESCRIPTION:** MUSIC BUILDING

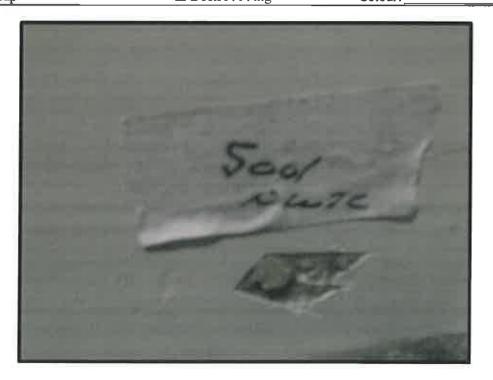
UNIVERSII	Y					
Sample #:	S001		Date Sampled:	December 13, 2012		
Building:	Music Building		Sampler:	Angela Stagg		
Location:	001, room MU105	0	Analysis:	SAI - PLM		
MUN Project #:	02-02-900		Work Order #:			
		Bulk	Sampling Parameters			
Pipe/Tank	Flooring		Ceiling	Roofing	Location	
☐ Insulation	□12'x12' Tile	□ T	extured	☐ Shingle	□ Floor	
☐ Elbow	□ 9'x9'Tile	$\square$ S	tucco	☐ Rolled	X Wall Orientation	
☐ Fitting	□ Vinyl Sheet	$\Box$ P	opcom	☐ Felt	☐ Ceiling	
☐ Transite Pipe	☐ Mastic	$\Box$ D	WJC	□ Tar	☐ Above Ceiling	
☐ Gasket	Wall	$\square$ P	laster		☐ Other	
☐ Tank Insulation	☐ Transite Panel	$\Box$ A	coustic Tile (Dropped)			
☐ Pipe Wrap	☐ Textured Wall	$\Box$ A	coustic Tile (Glued-on)			
HVAC	☐ Plaster	$\square$ M	lastic	Miscellaneous:		
☐ Insulation	X DWJC		Structural			
□ Таре			teel F. P. ing	No. of Phases:		
☐ Paper Wrap		$\Box$ D	eck F. P. ing	Colour:

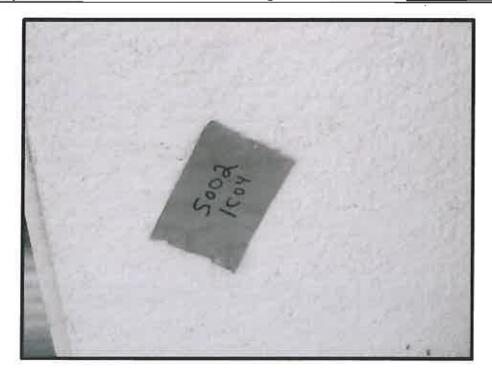
OMIAFKSII					
Sample #:	S002		Date Sampled:	December 13, 2012	
Building:	Music Building		Sampler:	Angela Stagg	
Location:	007, room MU1C0	4	Analysis:	SAI - PLM	
MUN Project #:	02-02-900		Work Order#:		
		Bulk	Sampling Parameters	_	
Pipe/Tank	Flooring		Ceiling	Roofing	Location
☐ Insulation	□12'x12' Tile	$\Box$ T	'extured	☐ Shingle	☐ Floor
□ Elbow	□ 9'x9'Tile	☐ Stucco		□ Rolled	☐ Wall Orientation
☐ Fitting	□ Vinyl Sheet	$\square$ P	opcom	☐ Felt	X Ceiling
☐ Transite Pipe	□ Mastic		)WJC	□ Таг	☐ Above Ceiling
☐ Gasket	Wall	□P	laster		□ Other
☐ Tank Insulation	□ Transite Panel	ΧA	coustic Tile (Dropped)		
☐ Pipe Wrap	□ Textured Wall	$\square A$	coustic Tile (Glued-on)		
HVAC	☐ Plaster	$\square$ N	<b>fastic</b>	Miscellaneous:	2' x 2' flat top
☐ Insulation	□ DWJC		Structural		•
☐ Tape		$\square$ S	teel F. P. ing	No. of Phases:	
☐ Paper Wrap			eck F. P. ing	Colour:

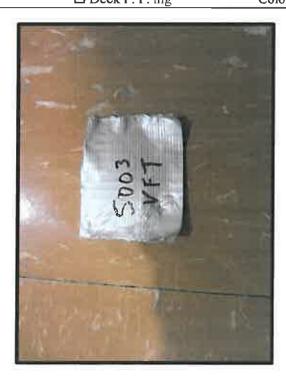
01414 212						
Sample #:	S003		Date Sampled:	December 13, 2012		
Building:	Music Building		Sampler:	Angela Stagg		
Location:	008, room MU1C0	2	Analysis:	SAI - PLM		
MUN Project #:	02-02-900		Work Order #:		-	
		Bulk	Sampling Parameters		·	
Pipe/Tank	Flooring		Ceiling	Roofing	Location	
☐ Insulation	X12'x12' Tile	□ T	`extured	☐ Shingle	X Floor	
□ Elbow	☐ 9'x9'Tile	$\square$ \$	tucco	☐ Rolled	☐ Wall Orientation	
☐ Fitting	□ Vinyl Sheet	$\Box$ P	opcorn	☐ Felt	☐ Ceiling	
☐ Transite Pipe	☐ Mastic		)WJC	□ Таг	☐ Above Ceiling	
☐ Gasket	Wall	$\Box$ P	laster		☐ Other	
☐ Tank Insulation	☐ Transite Panel		coustic Tile (Dropped)			
☐ Pipe Wrap	☐ Textured Wall	$\Box$ A	coustic Tile (Glued-on)			
HVAC	☐ Plaster	$\square$ N	1astic	Miscellaneous:		
☐ Insulation	□ DWJC		Structural			
☐ Tape			teel F. P. ing	No. of Phases:		
Daner Wran			leck F D ing	Colour Orange	with white flecks

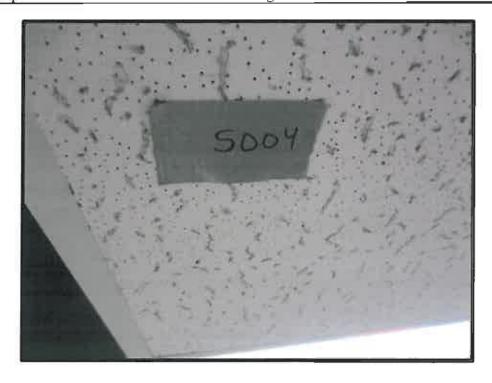
Sample #:	S004	Date Sampled:	December 13, 2	012	
Building:	Music Building	Sampler:	Angela Stagg		
Location:	008, room MU1C0	2 Analysis:	SAI - PLM		
MUN Project #:	02-02-900	Work Order #:			
		<b>Bulk Sampling Parameters</b>			
Pipe/Tank	Flooring	Ceiling	Roofing	Location	
☐ Insulation	□12'x12' Tile	☐ Textured	☐ Shingle	□ Floor	
□ Elbow	☐ 9'x9'Tile	☐ Stucco	☐ Rolled	☐ Wall Orientation	
☐ Fitting	□ Vinyl Sheet	☐ Popcom	☐ Felt	X Ceiling	
☐ Transite Pipe	☐ Mastic	□ DWJC	☐ Tar	☐ Above Ceiling	
☐ Gasket	Wall	☐ Plaster		☐ Other	
☐ Tank Insulation	□ Transite Panel	X Acoustic Tile (Dropped)			
☐ Pipe Wrap	□ Textured Wall	☐ Acoustic Tile (Glued-on)			
HVAC	☐ Plaster	☐ Mastic		2' x 4' pinhole with	
			small fissure_		
☐ Insulation	□ DWJC	Structural			
□ Tape		☐ Steel F. P. ing	No. of Phases:		
☐ Paper Wrap		☐ Deck F. P. ing	Colour:

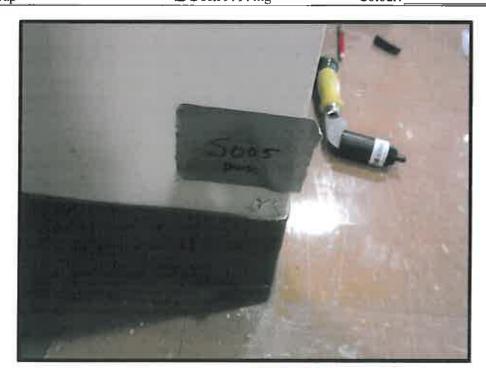
ONIVERSII	1			
Sample #:	S005	Date Sampled:	December 13, 2	012
Building:	Music Building	Sampler:	Angela Stagg	
Location:	008, room MU1C0	2 Analysis:	SAI - PLM	
MUN Project #:	02-02-900	Work Order #:		-
		<b>Bulk Sampling Parameters</b>		
Pipe/Tank	Flooring	Ceiling	Roofing	Location
☐ Insulation	□12'x12' Tile	☐ Textured	☐ Shingle	☐ Floor
☐ Elbow	□ 9'x9'Tile	☐ Stucco	□ Rolled	X Wall Orientation
☐ Fitting	□ Vinyl Sheet	□ Popcom	☐ Felt	☐ Ceiling
☐ Transite Pipe	☐ Mastic	□ DWJC	□ Tar	☐ Above Ceiling
☐ Gasket	Wall	☐ Plaster		☐ Other
☐ Tank Insulation	☐ Transite Panel	☐ Acoustic Tile (Dropped)		
☐ Pipe Wrap	□ Textured Wall	☐ Acoustic Tile (Glued-on)		
HVAC	☐ Plaster	☐ Mastic	Miscellaneous:	
☐ Insulation	X DWJC	Structural		
☐ Tape		☐ Steel F. P. ing	No. of Phases:	
☐ Paper Wrap		□ Deck F. P. ing	Colour:	_

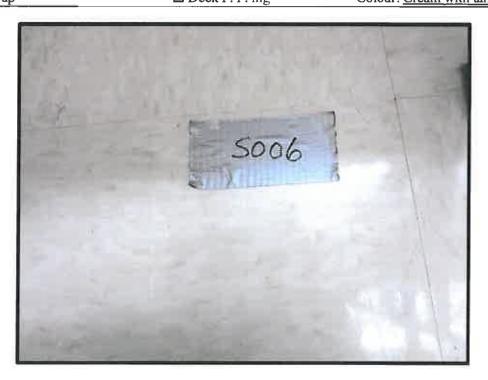
W1111 C M110	,			
Sample #:	S006	Date Sampled:	December 13, 2	012
Building:	Music Building	Sampler:	Angela Stagg	
Location:	011, room MU103	8 Analysis:	SAI - PLM	
MUN Project #:	02-02-900	Work Order #:		
		<b>Bulk Sampling Parameters</b>		
Pipe/Tank	Flooring	Ceiling	Roofing	Location
☐ Insulation	X12'x12' Tile	☐ Textured	☐ Shingle	X Floor
☐ Elbow	□ 9'x9'Tile	☐ Stucco	☐ Rolled	□ Wall Orientation
☐ Fitting	□ Vinyl Sheet	☐ Popcom	☐ Felt	☐ Ceiling
☐ Transite Pipe	☐ Mastic	□ DWJC	□ Tar	☐ Above Ceiling
☐ Gasket	Wall	☐ Plaster		☐ Other
☐ Tank Insulation	☐ Transite Panel	☐ Acoustic Tile (Dropped)		
☐ Pipe Wrap	☐ Textured Wall	☐ Acoustic Tile (Glued-on)		
HVAC	☐ Plaster	☐ Mastic	Miscellaneous:	
☐ Insulation	□ DWJC	Structural		
☐ Tape		☐ Steel F. P. ing	No. of Phases:	
Paner Wran		□ Deck F P ing	Colour: Cream	with tan fleck

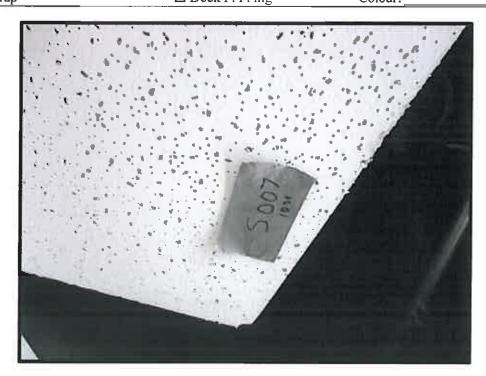
A 1.11 (						
Sample #:	S007		Date Sampled:	December 13, 2012		
Building:	Music Building		Sampler:	Angela Stagg		
Location:	011, room MU103	8	Analysis:	SAI - PLM		
MUN Project #:	02-02-900		Work Order #:			
		Bulk	Sampling Parameters			
Pipe/Tank	Flooring		Ceiling	Roofing	Location	
☐ Insulation	□12'x12' Tile	□ Ţ	extured	☐ Shingle	☐ Floor	
☐ Elbow	☐ 9'x9'Tile	☐ Stucco		☐ Rolled	□ Wall Orientation	
☐ Fitting	□ Vinyl Sheet	$\square$ P	opcorn	☐ Felt	X Ceiling	
☐ Transite Pipe	☐ Mastic	$\Box$ D	WJC	☐ Tar	☐ Above Ceiling	
☐ Gasket	Wall	$\square P$	laster		☐ Other	
☐ Tank Insulation	☐ Transite Panel	X A	coustic Tile (Dropped)			
☐ Pipe Wrap	☐ Textured Wall	$\Box$ A	coustic Tile (Glued-on)			
HVAC	☐ Plaster	☐ Mastic		Miscellaneous:	2' x 4' pinhole fleck	
☐ Insulation	□ DWJC		Structural			
☐ Tape			teel F. P. ing	No. of Phases:		
☐ Paper Wran		ПD	eck F P ing	Colour

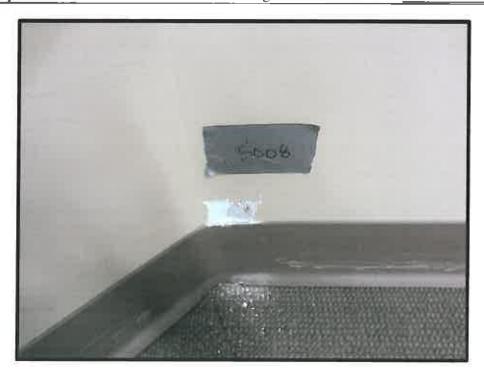
OMIVERSII	I						
Sample #:	S008		Date Sampled:	December 13, 2012			
Building:	Music Building		Sampler:	Angela Stagg			
Location:	015, room MU103	2	Analysis:	SAI - PLM			
MUN Project #:	02-02-900		Work Order#:				
Bulk Sampling Parameters							
Pipe/Tank	Flooring		Ceiling	Roofing	Location		
☐ Insulation	□12'x12' Tile	□ Te	xtured	☐ Shingle	☐ Floor		
□ Elbow	□ 9'x9'Tile	☐ Stucco		☐ Rolled	X Wall Orientation		
☐ Fitting	□ Vinyl Sheet	☐ Popcorn		☐ Felt	☐ Ceiling		
☐ Transite Pipe	☐ Mastic		VJC	☐ Tar	☐ Above Ceiling		
☐ Gasket	Wall	☐ Pla	ister		□ Other		
☐ Tank Insulation	□ Transite Panel	☐ Ac	oustic Tile (Dropped)				
☐ Pipe Wrap	☐ Textured Wall	☐ Ac	oustic Tile (Glued-on)				
HVAC	☐ Plaster	☐ Mastic		Miscellaneous:			
☐ Insulation	X DWJC		Structural				
☐ Tape		☐ Ste	el F. P. ing	No. of Phases:			
☐ Paper Wrap		☐ De	ck F. P. ing	Colour:	·

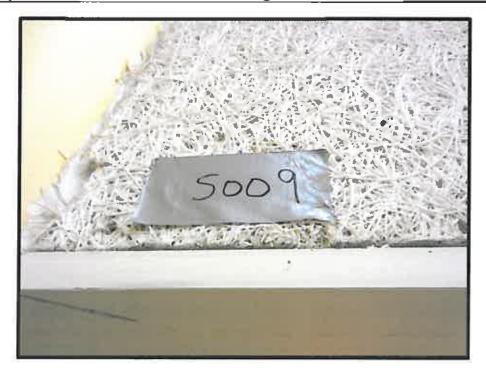
One (1) sample of sound-proofing paneling was sampled from room MU-1032. Analysis of this sample did not identify the presence of asbestos (reference sample 02-02-900-S009).

V 1417 W 17 V 11					
Sample #:	S009	Date Sampled:	December 13, 2	012	
Building:	Music Building	Sampler:	Angela Stagg		
Location:	015, room MU103	2 Analysis:	SAI - PLM		
MUN Project #:	02-02-900	Work Order #:			
		<b>Bulk Sampling Parameters</b>			
Pipe/Tank	Flooring	Ceiling	Roofing	Location	
☐ Insulation	□12'x12' Tile	☐ Textured	☐ Shingle	☐ Floor	
☐ Elbow	☐ 9'x9'Tile	☐ Stucco	☐ Rolled	☐ Wall Orientation	
☐ Fitting	□ Vinyl Sheet	☐ Popcom	☐ Felt	☐ Ceiling	
☐ Transite Pipe	☐ Mastic	□ DWJC	☐ Tar	☐ Above Ceiling	
☐ Gasket	Wall	☐ Plaster		X Other	
☐ Tank Insulation	☐ Transite Panel	☐ Acoustic Tile (Dropped)			
☐ Pipe Wrap	□ Textured Wall	☐ Acoustic Tile (Glued-on)			
HVAC	□ Plaster	☐ Mastic	Miscellaneous: soundproofing	4' x 12' sheets of	
☐ Insulation	□ DWJC	Structural			
☐ Tape		☐ Steel F. P. ing	No. of Phases:		
☐ Paper Wrap		☐ Deck F. P. ing	Colour:

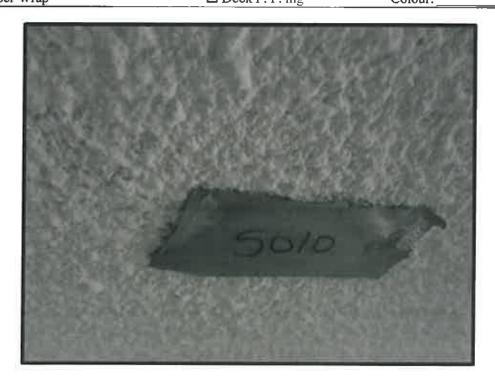
One (1) sample of textured ceiling coating was sampled from room MU-1C02. Analysis of this sample did not identify the presence of asbestos (reference sample 02-02-900-S010).

V 1 1 7 7 2 11 W 1 1				
Sample #:	S010	Date Sampled:	December 13, 2	2012
Building:	Music Building	Sampler:	Angela Stagg	
Location:	008, room MU1C0	2 Analysis:	SAI - PLM	
MUN Project #:	02-02-900	Work Order #:		
		<b>Bulk Sampling Parameters</b>		
Pipe/Tank	Flooring	Ceiling	Roofing	Location
☐ Insulation	□12'x12' Tile	X Textured	☐ Shingle	☐ Floor
□ Elbow	□ 9'x9'Tile	☐ Stucco	☐ Rolled	☐ Wall Orientation
☐ Fitting	□ Vinyl Sheet	☐ Popcom	☐ Felt	X Ceiling
☐ Transite Pipe	☐ Mastic	□ DWJC	□ Tar	☐ Above Ceiling
☐ Gasket	Wall	☐ Plaster		☐ Other
☐ Tank Insulation	☐ Transite Panel	☐ Acoustic Tile (Dropped)		
☐ Pipe Wrap	□ Textured Wall	☐ Acoustic Tile (Glued-on)		
HVAC	☐ Plaster	☐ Mastic	Miscellaneous:	
☐ Insulation	□ DWJC	Structural		
☐ Tape		☐ Steel F. P. ing	No. of Phases:	
□ Paper Wran		Deck F P ing	Colour

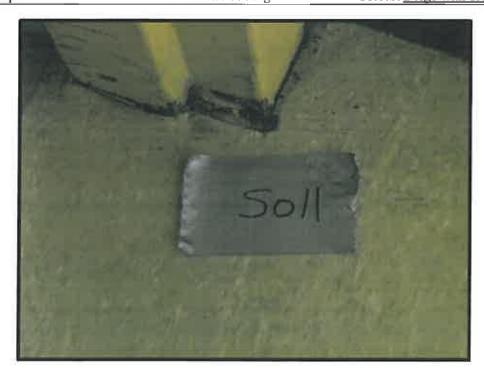
21111211				
Sample #:	S011	Date Sampled:	December 13, 2	2012
Building:	Music Building	Sampler:	Angela Stagg	
Location:	018, room MU1040	O Analysis:	SAI - PLM	
MUN Project #:	02-02-900	Work Order #:		
		<b>Bulk Sampling Parameters</b>		
Pipe/Tank	Flooring	Ceiling	Roofing	Location
☐ Insulation	□12'x12' Tile	☐ Textured	☐ Shingle	X Floor
☐ Elbow	□ 9'x9'Tile	☐ Stucco	☐ Rolled	■ Wall Orientation
☐ Fitting	X Vinyl Sheet	□ Popcom	☐ Felt	☐ Ceiling
☐ Transite Pipe	☐ Mastic	□ DWJC	□ Tar	☐ Above Ceiling
☐ Gasket	Wall	☐ Plaster		☐ Other
☐ Tank Insulation	☐ Transite Panel	☐ Acoustic Tile (Dropped)		
☐ Pipe Wrap	□ Textured Wall	☐ Acoustic Tile (Glued-on)		
HVAC	☐ Plaster	☐ Mastic	Miscellaneous:	;
☐ Insulation	□ DWJC	Structural		_
☐ Tape		☐ Steel F. P. ing	No. of Phases:	
☐ Paper Wrap		☐ Deck F. P. ing	Colour: Beige	with brown streaks

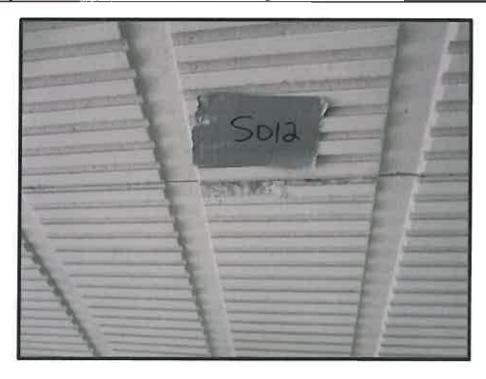
Q 1 1 1 1 E 11 Q 1 1	1				
Sample #:	S012		Date Sampled:	December 13, 2	2012
Building:	Music Building		Sampler:	Angela Stagg	
Location:	021, room MU1C0	)1	Analysis:	SAI - PLM	
MUN Project #:	02-02-900		Work Order #:		
		Bulk	Sampling Parameters		
Pipe/Tank	Flooring		Ceiling	Roofing	Location
☐ Insulation	□12'x12' Tile	□ T	extured	☐ Shingle	☐ Floor
☐ Elbow	☐ 9'x9'Tile	$\square$ S1	tucco	☐ Rolled	■ Wall Orientation
☐ Fitting	□ Vinyl Sheet	□ P <sub>0</sub>	opcom	☐ Felt	X Ceiling
☐ Transite Pipe	☐ Mastic	□ DWJC		□ Таг	☐ Above Ceiling
☐ Gasket	Wall	□ P1	laster		☐ Other
☐ Tank Insulation	☐ Transite Panel	X A	coustic Tile (Dropped)		
☐ Pipe Wrap	□ Textured Wall	$\Box$ A	coustic Tile (Glued-on)		
HVAC	□ Plaster	ПΜ	astic	Miscellaneous:	2' x 2' grey bar
IIVAC			idstic	<u>pattern</u>	
☐ Insulation	□ DWJC		Structural		
□ Tape		□ St	eel F. P. ing	No. of Phases:	
☐ Paper Wrap			eck F. P. ing	Colour:

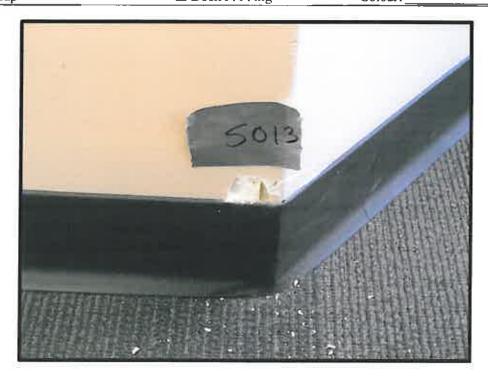
OMIAFIGIL	1				
Sample #:	S013	S013		December 13, 2	012
Building:	Music Building		Sampler:	Angela Stagg	
Location:	021, room MU1C0	1	Analysis:	SAI - PLM	
MUN Project #:	02-02-900		Work Order #:		
		Bulk	Sampling Parameters		
Pipe/Tank	Flooring		Ceiling	Roofing	Location
☐ Insulation	□12'x12' Tile	□ T	extured	☐ Shingle	☐ Floor
☐ Elbow	□ 9'x9'Tile	☐ Stucco		☐ Rolled	X Wall Orientation
☐ Fitting	□ Vinyl Sheet	$\Box$ P	орсоги	□ Felt	☐ Ceiling
☐ Transite Pipe	☐ Mastic		)ŴJC	□ Tar	☐ Above Ceiling
☐ Gasket	Wall	□P	laster		☐ Other
☐ Tank Insulation	□ Transite Panel	$\Box$ A	coustic Tile (Dropped)		
☐ Pipe Wrap	□ Textured Wall		coustic Tile (Glued-on)		
HVAC	☐ Plaster	☐ Mastic		Miscellaneous:	
☐ Insulation	X DWJC		Structural		
☐ Tape		$\square$ S	teel F. P. ing	No. of Phases:	
☐ Paper Wrap		$\Box$ D	eck F. P. ing	Colour:

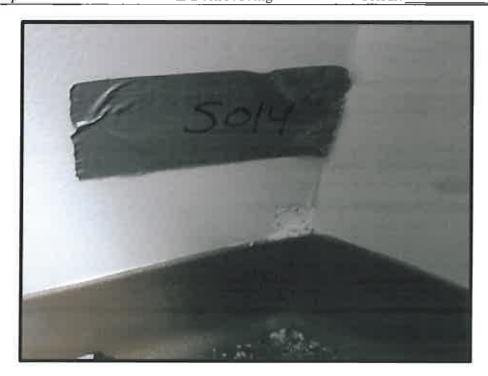
OTTIVERSTI						
Sample #:	S014		Date Sampled:	December 13, 2012		
Building:	Music Building		Sampler:	Angela Stagg		
Location:	021, room MU103	1	Analysis:	SAI - PLM		
MUN Project#:	02-02-900		Work Order #:			
		Bulk	Sampling Parameters			
Pipe/Tank	Flooring		Ceiling	Roofing	Location	
☐ Insulation	□12'x12' Tile	ΠТ	extured	☐ Shingle	☐ Floor	
☐ Elbow	☐ 9'x9'Tile		tucco	☐ Rolled	X Wall Orientation	
☐ Fitting	□ Vinyl Sheet	$\square$ P	opcorn	☐ Felt	☐ Ceiling	
☐ Transite Pipe	☐ Mastic		WJC	☐ Tar	☐ Above Ceiling	
☐ Gasket	Wall	$\square$ P	laster		☐ Other	
☐ Tank Insulation	☐ Transite Panel	$\Box$ A	coustic Tile (Dropped)			
☐ Pipe Wrap	☐ Textured Wall	$\Box$ A	coustic Tile (Glued-on)			
HVAC	☐ Plaster	$\square$ M	lastic	Miscellaneous:		
☐ Insulation	X DWJC		Structural			
☐ Tape			teel F. P. ing	No. of Phases:		
☐ Paper Wrap			eck F. P. ing	Colour:

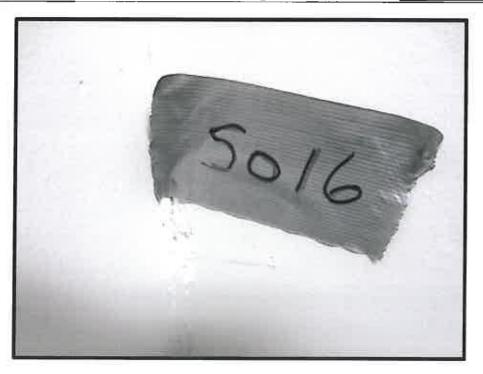
CHIVEKSII	1								
Sample #:	S016		Date Sampled:	December 13, 2012					
Building:	Music Building		Sampler:	Angela Stagg	<u> </u>				
Location:	031, room MU100	5	Analysis:	SAI - PLM					
MUN Project #:	02-02-900		Work Order#:						
	Bulk Sampling Parameters								
Pipe/Tank	Flooring		Ceiling	Roofing	Location				
☐ Insulation	□12'x12' Tile	☐ Textured		☐ Shingle	☐ Floor				
☐ Elbow	□ 9'x9'Tile	☐ Stucco		☐ Rolled	X Wall Orientation				
☐ Fitting	□ Vinyl Sheet	☐ Popcom		☐ Felt	□ Ceiling				
☐ Transite Pipe	☐ Mastic		)WJC	□ Tar	☐ Above Ceiling				
☐ Gasket	Wall	□P	laster		☐ Other				
☐ Tank Insulation	☐ Transite Panel	□A	coustic Tile (Dropped)						
☐ Pipe Wrap	☐ Textured Wall		coustic Tile (Glued-on)						
HVAC	☐ Plaster	$\square$ $\bowtie$	1astic	Miscellaneous:					
☐ Insulation	X DWJC		Structural						
☐ Tape		$\square$ S	teel F. P. ing	No. of Phases:					
□ Paper Wrap		$\Box$ D	eck F. P. ing	Colour:

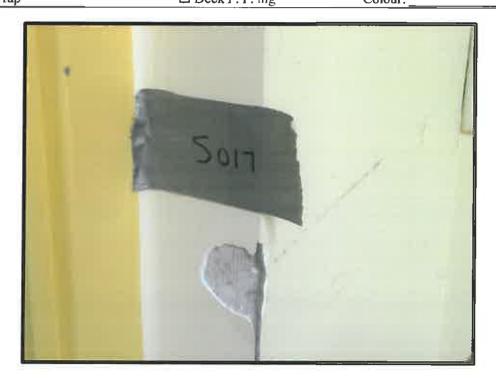
Q I I I I E I Q I I					
Sample #:	S017	Date Sampled:	December 13, 2012		
Building:	Music Building	Sampler:	Angela Stagg		
Location:	048, room 1034	Analysis:	SAI - PLM		
MUN Project #:	02-02-900	Work Order #:			
		<b>Bulk Sampling Parameters</b>		·	
Pipe/Tank	Flooring	Ceiling	Roofing	Location	
☐ Insulation	□12'x12' Tile	☐ Textured	☐ Shingle	☐ Floor	
☐ Elbow	□ 9'x9'Tile	☐ Stucco	□ Rolled	X Wall Orientation	
☐ Fitting	□ Vinyl Sheet	☐ Popcorn	☐ Felt	☐ Ceiling	
☐ Transite Pipe	☐ Mastic	□ DŴJC	□ Таг	☐ Above Ceiling	
☐ Gasket	Wall	☐ Plaster		□ Other	
☐ Tank Insulation	☐ Transite Panel	☐ Acoustic Tile (Dropped)			
☐ Pipe Wrap	□ Textured Wall	☐ Acoustic Tile (Glued-on)			
HVAC	☐ Plaster	☐ Mastic	Miscellaneous:		
☐ Insulation	X DWJC	Structural			
☐ Tape		☐ Steel F. P. ing	No. of Phases:		
Paper Wran		Deck F P ing	Colour

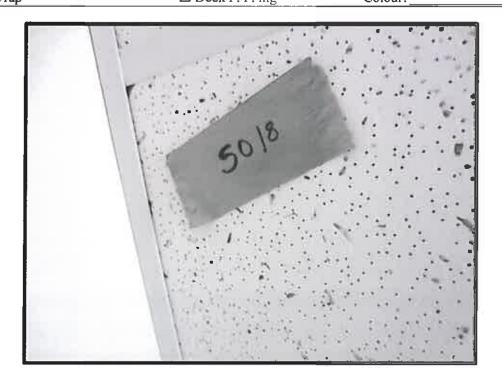
ONIVERSII	I.					
Sample #:	S018		Date Sampled:	December 13, 2012		
Building:	Music Building		Sampler:	Angela Stagg		
Location:	056, room MU1056	6	Analysis:	SAI - PLM		
MUN Project #:	02-02-900		Work Order#:		-	
		Bulk	Sampling Parameters			
Pipe/Tank	Flooring	Ceiling		Roofing	Location	
☐ Insulation	□12'x12' Tile	☐ Textured		☐ Shingle	□ Floor	
□ Elbow	□ 9'x9'Tile	☐ Stucco		☐ Rolled	Wall Orientation	
☐ Fitting	□ Vinyl Sheet	□ Popcom		☐ Felt	X Ceiling	
☐ Transite Pipe	☐ Mastic	□ DŴJC		□ Tar	☐ Above Ceiling	
☐ Gasket	Wall	$\Box$ P	laster		☐ Other	
☐ Tank Insulation	☐ Transite Panel	ХА	coustic Tile (Dropped)			
☐ Pipe Wrap	□ Textured Wall	$\Box$ A	coustic Tile (Glued-on)			
HVAC	☐ Plaster	☐ Mastic		Miscellaneous:	2' x 2' pinhole fleck	
☐ Insulation	□ DWJC		Structural			
☐ Tape		$\square$ S	teel F. P. ing	No. of Phases:		
☐ Paper Wrap		$\Box$ D	leck F P in σ	Colour:

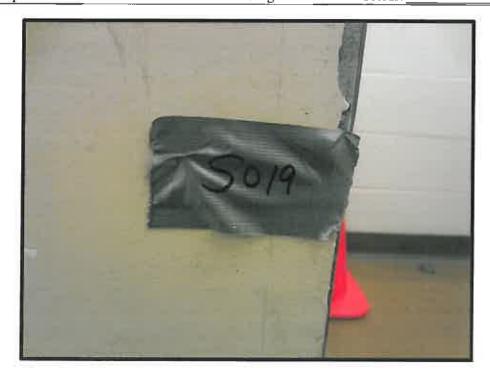
OMIAFKSII					
Sample #:	S019	Date Sampled:	December 13, 2012		
Building:	Music Building	Sampler:	Angela Stagg		
Location:	061, room MU1S0	4 Analysis:	SAI - PLM		
MUN Project #:	02-02-900	Work Order#:			
		<b>Bulk Sampling Parameters</b>			
Pipe/Tank	Flooring	Ceiling	Roofing	Location	
☐ Insulation	□12'x12' Tile	☐ Textured	☐ Shingle	☐ Floor	
☐ Elbow	□ 9'x9'Tile	☐ Stucco	☐ Rolled	X Wall Orientation	
☐ Fitting	□ Vinyl Sheet	☐ Popcom	☐ Felt	☐ Ceiling	
☐ Transite Pipe	☐ Mastic	□ DWJC	□ Tar	☐ Above Ceiling	
☐ Gasket	Wall	☐ Plaster		☐ Other	
☐ Tank Insulation	□ Transite Panel	☐ Acoustic Tile (Dropped)			
☐ Pipe Wrap	□ Textured Wall	☐ Acoustic Tile (Glued-on)			
HVAC	☐ Plaster	☐ Mastic	Miscellaneous:		
☐ Insulation	X DWJC	Structural			
□ Таре		☐ Steel F. P. ing	No. of Phases:		
☐ Paper Wrap		Deck F. P. ing	Colour:

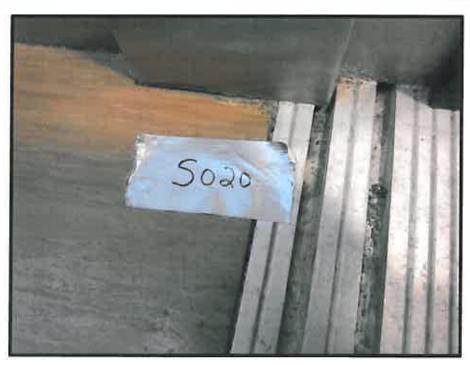
ONTALKSHI				
Sample #:	S020	Date Sampled:	December 14, 2	012
Building:	Music Building	Sampler:	Angela Stagg	
Location:	066, room MU1E0	1 Analysis:	SAI - PLM	
MUN Project #:	02-02-900	Work Order #:		
		<b>Bulk Sampling Parameters</b>		
Pipe/Tank	Flooring	Ceiling	Roofing	Location
☐ Insulation	□12'x12' Tile	☐ Textured	☐ Shingle	X Floor
□ Elbow	□ 9'x9'Tile	☐ Stucco	☐ Rolled	□ Wall Orientation
☐ Fitting	X Vinyl Sheet	☐ Popcom	☐ Felt	Ceiling
☐ Transite Pipe	☐ Mastic	□ DWJC	□ Tar	☐ Above Ceiling
☐ Gasket	Wall	☐ Plaster		☐ Other
☐ Tank Insulation	☐ Transite Panel	☐ Acoustic Tile (Dropped)		
☐ Pipe Wrap	☐ Textured Wall	☐ Acoustic Tile (Glued-on)		
HVAC	☐ Plaster	☐ Mastic	Miscellaneous:	
☐ Insulation	□ DWJC	Structural		
☐ Tape		☐ Steel F. P. ing	No. of Phases:	
☐ Paper Wrap		☐ Deck F. P. ing	Colour: <u>Brown</u> streak	with dark brown

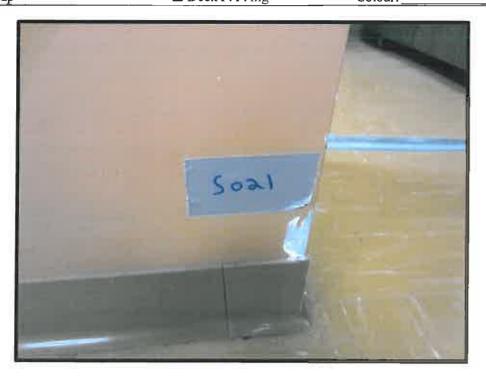
OMIAFICALI								
Sample #:	S021		Date Sampled:	December 14, 2012				
Building:	Music Building		Sampler:	Angela Stagg				
Location:	077, room MU203	2	Analysis:	SAI - PLM				
MUN Project #:	02-02-900		Work Order #:					
	Bulk Sampling Parameters							
Pipe/Tank	Flooring		Ceiling	Roofing	Location			
☐ Insulation	□12'x12' Tile	ПП	extured	☐ Shingle	☐ Floor			
☐ Elbow	□ 9'x9'Tile	☐ Stucco		☐ Rolled	X Wall Orientation			
☐ Fitting	□ Vinyl Sheet	☐ Popcorn		☐ Felt	☐ Ceiling			
☐ Transite Pipe	☐ Mastic	□ DŴJC		□ Таг	☐ Above Ceiling			
☐ Gasket	Wall	$\square$ P	laster		☐ Other			
☐ Tank Insulation	□ Transite Panel	$\square A$	(Coustic Tile (Dropped)					
☐ Pipe Wrap	☐ Textured Wall	$\Box A$	coustic Tile (Glued-on)					
HVAC	☐ Plaster	☐ Mastic		Miscellaneous:				
☐ Insulation	X DWJC		Structural		_			
☐ Tape		$\square$ S	teel F. P. ing	No. of Phases:				
☐ Paper Wrap			eck F. P. ing	Colour

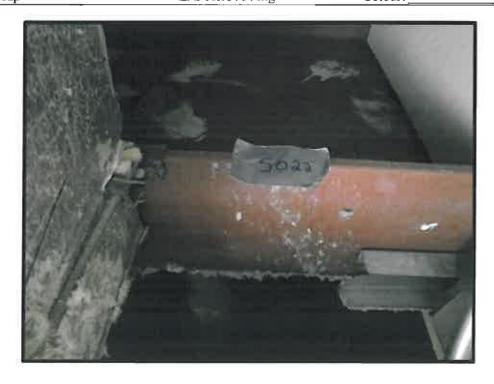
One (1) sample of spray fireproofing/insulation on structural components above the ceiling was sampled from the room MU-2030. Analysis of this sample did not identify the presence of asbestos (reference sample 02-02-900-S022).

OMIAFKZII	Y					
Sample #:	S022		Date Sampled:	December 14, 2012		
Building:	Music Building		Sampler:	Angela Stagg		
Location:	078, room MU203	0	Analysis:	SAI - PLM		
MUN Project #:	02-02-900		Work Order #:			
		Bulk	Sampling Parameters			
Pipe/Tank	Flooring	Ceiling		Roofing	Location	
☐ Insulation	□12'x12' Tile	□ T	extured	☐ Shingle	☐ Floor	
☐ Elbow	☐ 9'x9'Tile	☐ Stucco		☐ Rolled	☐ Wall Orientation	
☐ Fitting	□ Vinyl Sheet	☐ Popcorn		☐ Felt	☐ Ceiling	
☐ Transite Pipe	☐ Mastic	□ DŴJC		☐ Tar	☐ Above Ceiling	
☐ Gasket	Wall	$\square$ P	laster		X Other	
☐ Tank Insulation	☐ Transite Panel	$\Box$ A	coustic Tile (Dropped)			
☐ Pipe Wrap	☐ Textured Wall	$\Box$ A	coustic Tile (Glued-on)			
HVAC	☐ Plaster	☐ Mastic		Miscellaneous:	Spray fireproofing	
☐ Insulation	□ DWJC		Structural			
□ Tape		$\square$ S	teel F. P. ing	No. of Phases:		
☐ Paper Wrap			eck F. P. ing	Colour:

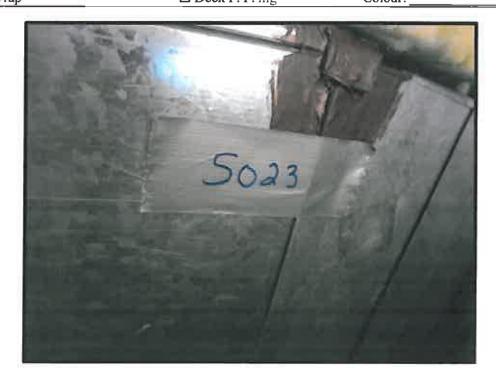
One (1) sample of red ductwork sealant was sampled from room MU-2030. Analysis of this sample did not identify the presence of asbestos (reference sample 02-02-900-S023).

ONIVERSII	Y I					
Sample #:	S023		Date Sampled:	December 14, 2012		
Building:	Music Building		Sampler:	Angela Stagg		
Location:	078, room MU2030	0	Analysis:	SAI - PLM		
MUN Project #:	02-02-900		Work Order #:			
		Bulk	Sampling Parameters			
Pipe/Tank	Flooring		Ceiling	Roofing	Location	
☐ Insulation	□12'x12' Tile	T	extured	☐ Shingle	☐ Floor	
□ Elbow	☐ 9'x9'Tile	☐ Stucco		☐ Rolled	☐ Wall Orientation	
☐ Fitting	□ Vinyl Sheet	□ Popcom		☐ Felt	☐ Ceiling	
☐ Transite Pipe	☐ Mastic	□ DŴJC		□ Tar	☐ Above Ceiling	
☐ Gasket	Wall	$\square$ P	laster		X Other	
☐ Tank Insulation	☐ Transite Panel	$\Box$ A	coustic Tile (Dropped)			
☐ Pipe Wrap	☐ Textured Wall	$\Box$ A	coustic Tile (Glued-on)			
HVAC	☐ Plaster	☐ Mastic		Miscellaneous:	Red duct sealant	
☐ Insulation	□ DWJC		Structural			
□ Tape		$\square$ S	teel F. P. ing	No. of Phases:		
☐ Paper Wrap		$\Box$ D	eck F P ino	Colour

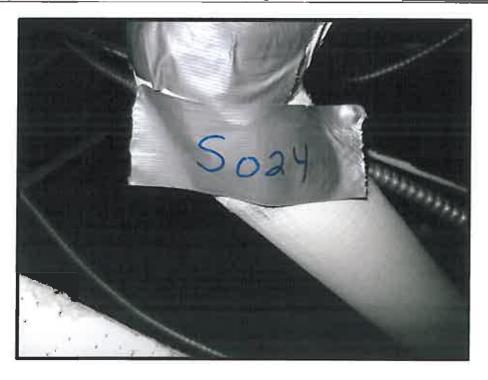
One (1) sample was sampled from room MU-2C02 of parging cement used on the elbows and fittings in the Site Building. Analysis of this sample did not identify the presence of asbestos (reference sample 02-02-900-S024).

OMINEKSII				
Sample #:	S024	Date Sampled:	December 14, 2	2012
Building:	Music Building	Sampler:	Angela Stagg	<del></del> ,-
Location:	070, room MU2C0	2 Analysis:	SAI - PLM	*
MUN Project #:	02-02-900	Work Order #:		
		<b>Bulk Sampling Parameters</b>		
Pipe/Tank	Flooring	Ceiling	Roofing	Location
☐ Insulation	□12'x12' Tile	☐ Textured	☐ Shingle	☐ Floor
X Elbow	☐ 9'x9'Tile	☐ Stucco	☐ Rolled	☐ Wall Orientation
☐ Fitting	□ Vinyl Sheet	□ Popcom	☐ Felt	☐ Ceiling
☐ Transite Pipe	☐ Mastic	□ DWJC	☐ Tar	☐ Above Ceiling
☐ Gasket	Wall	☐ Plaster		X Other
☐ Tank Insulation	□ Transite Panel	☐ Acoustic Tile (Dropped)		
☐ Pipe Wrap	☐ Textured Wall	☐ Acoustic Tile (Glued-on)		
HVAC	☐ Plaster	☐ Mastic	Miscellaneous:	Parging
☐ Insulation	□ DWJC	Structural		
☐ Tape		☐ Steel F. P. ing	No. of Phases:	
□ Paper Wrap		□ Deck F. P. ing	Colour:

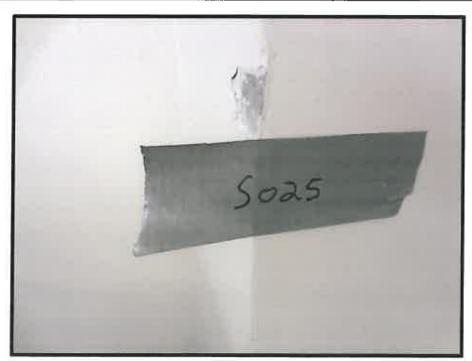
ONIVERSIT					
Sample #:	S025		Date Sampled:	December 13, 2012	
Building:	Music Building		Sampler:	Angela Stagg	
Location:	084, room MU202:	5	Analysis:	SAI - PLM	
MUN Project #:	02-02-900		Work Order #:		
		Bulk	Sampling Parameters		
Pipe/Tank	Flooring	ing Ceiling		Roofing	Location
☐ Insulation	□12'x12' Tile	☐ Textured		☐ Shingle	☐ Floor
□ Elbow	□ 9'x9'Tile	☐ Stucco		□ Rolled	X Wall Orientation
☐ Fitting	□ Vinyl Sheet	☐ Popcorn		☐ Felt	☐ Ceiling
☐ Transite Pipe	☐ Mastic	□ DŴJC		□ Таг	☐ Above Ceiling
☐ Gasket	Wall	□ P	laster		□ Other
☐ Tank Insulation	☐ Transite Panel	$\Box$ A	coustic Tile (Dropped)		
☐ Pipe Wrap	☐ Textured Wall	$\Box A$	coustic Tile (Glued-on)		
HVAC	□ Plaster	☐ Mastic		Miscellaneous:	
☐ Insulation	X DWJC		Structural		
☐ Tape		$\square$ S	teel F. P. ing	No. of Phases:	
□ Paper Wrap		$\Box$ D	eck F. P. ing	Colour:

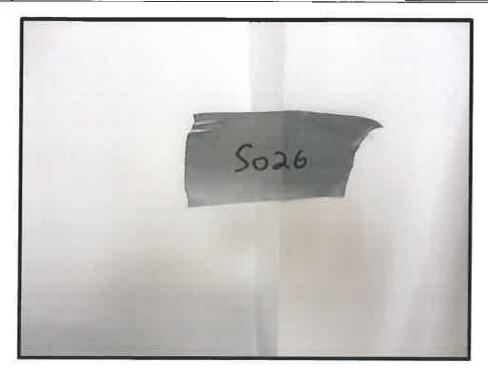
OMIAPUSII				
Sample #:	S026	Date Sampled:	December 13, 2	012
Building:	Music Building	Sampler:	Angela Stagg	
Location:	106, room MU2017	7 Analysis:	SAI - PLM	
MUN Project #:	02-02-900	Work Order #:		
		<b>Bulk Sampling Parameters</b>		
Pipe/Tank	Flooring	Ceiling	Roofing	Location
☐ Insulation	□12'x12' Tile	☐ Textured	☐ Shingle	☐ Floor
☐ Elbow	□ 9'x9'Tile	☐ Stucco	☐ Rolled	X Wall Orientation
☐ Fitting	□ Vinyl Sheet	☐ Popcom	☐ Felt	☐ Ceiling
☐ Transite Pipe	☐ Mastic	□ DWJC	🗖 Таг	☐ Above Ceiling
☐ Gasket	Wall	☐ Plaster		☐ Other
☐ Tank Insulation	☐ Transite Panel	☐ Acoustic Tile (Dropped)		
☐ Pipe Wrap	□ Textured Wall	☐ Acoustic Tile (Glued-on)		
HVAC	☐ Plaster	☐ Mastic	Miscellaneous:	
☐ Insulation	X DWJC	Structural		
☐ Tape		☐ Steel F. P. ing	No. of Phases:	
☐ Paper Wrap		☐ Deck F. P. ing	Colour:
