ASBESTOS AND LEAD PAINT BUILDING MATERIALS SURVEY FOR: OCEAN SCIENCES CENTER, MAIN BUILDING AND ANNEX MEMORIAL UNIVERSITY OF NEWFOUNDLAND

Pinchin LeBlanc Environmental Ltd Project No. 02-02-00900

March 22, 2013

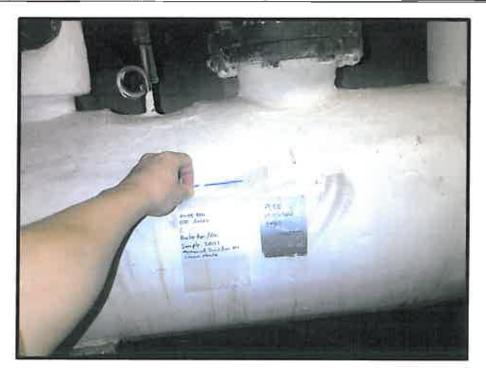
- Friable mechanical insulation present on the steam header in room AX1001 was sampled, and contains 15% amosite and 10% chrysotile asbestos (reference sample 02-02-900-S001).
- Friable mechanical insulation present on the boiler exhaust in room AX-1001 was sampled and contains 40% chrysotile asbestos (reference sample 02-02-900-S002).
- Friable mechanical insulation present on the tank in room AX-1000 was sampled, and contains 30% chrysotile asbestos (reference sample 02-02-900-S007).
- Non-friable textile cloth expansion joints present on ducting in room OS-2002 was sampled, and contains 50% chrysotile asbestos (reference sample 02-02-900-S027).
- Non-friable textile gaskets present on the heads of boilers #1 and #2 in room AX-1001 was sampled. Analysis of this sample did not identify the presence of asbestos (reference sample 02-02-900-S006).

UNIVERSIT	Y				
Sample #:	S001		Date Sampled:	November 29, 2	012
Building:	OSC Main BLDG	and	Sampler:	Trent Hardy	
	Annex				
Location:	001, room AX1001		Analysis:	SAI - PLM	
MUN Project #:	02-02-900		Work Order #:		
		Bulk	Sampling Parameters		
Pipe/Tank	Flooring		Ceiling	Roofing	Location
X Insulation	□12'x12' Tile	\Box T	extured	☐ Shingle	☐ Floor
☐ Elbow	□ 9'x9'Tile	\square S	tucco	☐ Rolled	☐ Wall Orientation
☐ Fitting	□ Vinyl Sheet	☐ Popcom		☐ Felt	☐ Ceiling
☐ Transite Pipe	☐ Mastic		WJC	□ Tar	☐ Above Ceiling
☐ Gasket	Wall	□P	laster		X Other (steam header)
☐ Tank Insulation	☐ Transite Panel	ПΑ	coustic Tile (Dropped)		neader y
☐ Pipe Wrap	☐ Textured Wall		coustic Tile (Glued-on)		
HVAC	☐ Plaster		fastic (Miscellaneous:	
☐ Insulation	□ DWJC		Structural		
☐ Tape		\square S	teel F. P. ing	No. of Phases:	
☐ Paper Wrap		\Box D	eck F. P. ing	Colour:

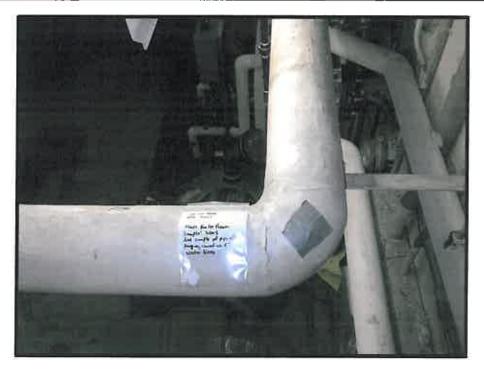
- Parging cement present on 6" water lines in room AX-1001 was sampled, and contains 30% chrysotile asbestos (reference sample 02-02-900-S005).
- Parging cement present on 4" water lines in room AX-1001 was sampled, and contains 30% chrysotile asbestos (reference sample 02-02-900-S004).
- Parging cement present on 6" water lines near the eyewash station was sampled in room AX-1001. Analysis of this sample did not identify the presence of asbestos (reference sample 02-02-900-S003).

O I I I I Z I I O I I							
Sample #:	S005		Date Sampled:	November 29, 2012			
Building:	OSC Main BLDG and		Sampler:	Trent Hardy			
_	Annex						
Location:	001, room AX1001		Analysis:	SAI - PLM			
MUN Project #:	02-02-900		Work Order #:				
Bulk Sampling Parameters							
Pipe/Tank	Flooring		Ceiling	Roofing	Location		
☐ Insulation	□12'x12' Tile	☐ Textured		☐ Shingle	☐ Floor		
X Elbow	□ 9'x9'Tile	☐ Stucco		□ Rolled	☐ Wall Orientation		
☐ Fitting	□ Vinyl Sheet	□ Popcom		☐ Felt	☐ Ceiling		
☐ Transite Pipe	☐ Mastic	□ DŴJC		☐ Tar	☐ Above Ceiling		
☐ Gasket	Wall	\Box P	laster		X Other (6" pipes)		
☐ Tank Insulation	☐ Transite Panel	$\Box A$	Acoustic Tile (Dropped)		` ' ' '		
☐ Pipe Wrap	□ Textured Wall		Acoustic Tile (Glued-on)				
HVAC	☐ Plaster	☐ Mastic		Miscellaneous:			
☐ Insulation	□ DWJC		Structural		_		
☐ Tape		\square S	teel F. P. ing	No. of Phases:			
☐ Paper Wrap			Deck F. P. ing	Colour:

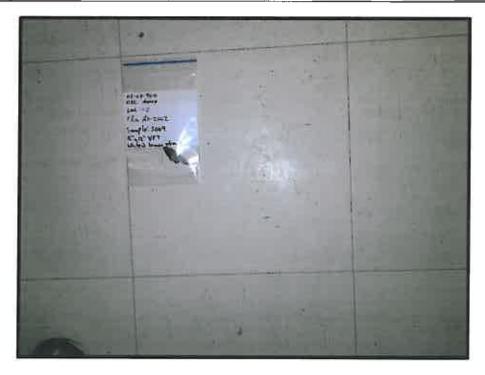
- White with brown streak, 12"x 12" vinyl floor tiles were sampled in room AX-2002.
 Analysis of the sample and associated tar mastic adhesive did not identify the presence of asbestos (reference sample 02-02-900-S009).

Sample #:	S009	S009		November 29, 2012					
Building:	OSC Main BLDG	and	Sampler:	Trent Hardy					
	Аплех								
Location:	009, hallway 2C01		Analysis:	SAI - PLM					
MUN Project #:	02-02-900		Work Order #:						
Bulk Sampling Parameters									
Pipe/Tank	Flooring		Ceiling	Roofing	Location				
☐ Insulation	X12'x12' Tile	☐ Textured		☐ Shingle	X Floor				
☐ Elbow	□ 9'x9'Tile	☐ Stucco		□ Rolled	☐ Wall Orientation				
☐ Fitting	□ Vinyl Sheet	□ P	opcorn	☐ Felt	☐ Ceiling				
☐ Transite Pipe	☐ Mastic)WJC	□ Tar	☐ Above Ceiling				
☐ Gasket	Wall	□ P	laster		☐ Other				
☐ Tank Insulation	☐ Transite Panel	\Box A	coustic Tile (Dropped)						
☐ Pipe Wrap	□ Textured Wall	\Box A	coustic Tile (Glued-on)						
HVAC	☐ Plaster	\square N	fastic	Miscellaneous:					
☐ Insulation	□ DWJC		Structural						
□ Tape		\square S	teel F. P. ing	No. of Phases:					
☐ Paper Wrap			eck F. P. ing	Colour: White	with brown streaks

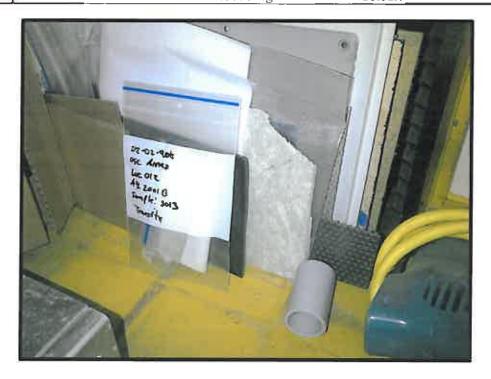
Transite present in room AX-2001B was sampled and contains 20% chrysotile asbestos (reference sample 02-02-900-S013). For locations and conditions of this material at the time of the building survey refer to location & data excel document.

DIMINERSHI	T					
Sample #:	S013		Date Sampled:	November 29, 2012		
Building:	OSC Main BLDG	and	Sampler:	Trent Hardy		
	Annex	Annex		·		
Location:	012, room AX200	1B	Analysis:	SAI - PLM		
MUN Project #:	02-02-900		Work Order #:			
		Bulk	Sampling Parameters			
Pipe/Tank	Flooring		Ceiling	Roofing	Location	
☐ Insulation	□12'x12' Tile	T	extured extured	☐ Shingle	☐ Floor	
☐ Elbow	□ 9'x9'Tile		tucco	☐ Rolled	X Wall Orientation	
☐ Fitting	□ Vinyl Sheet	□ P	opcom	☐ Felt	□ Ceiling	
☐ Transite Pipe	☐ Mastic		WJC	□ Tar	☐ Above Ceiling	
☐ Gasket	Wall	□ P	laster		☐ Other	
☐ Tank Insulation	X Transite Panel	\Box A	coustic Tile (Dropped)			
☐ Pipe Wrap	□ Textured Wall	\Box A	coustic Tile (Glued-on)			
HVAC	☐ Plaster	\square N	fastic	Miscellaneous	<u> </u>	
☐ Insulation	□ DWJC		Structural			
☐ Tape		\square S	teel F. P. ing	No. of Phases:		
☐ Paper Wrap	•		eck F. P. ing	Colour:

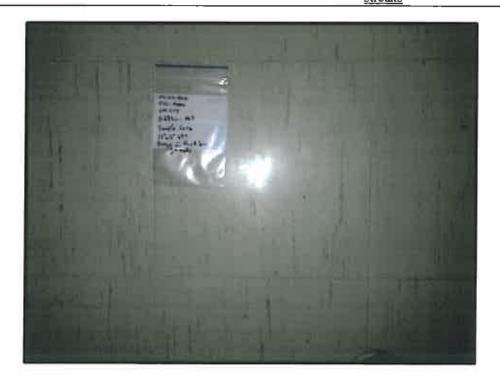
- Beige with thick brown streak, 12"x 12" vinyl floor tiles were sampled in room OS-3C01 and contain 5% chrysotile asbestos (reference sample 02-02-900-S016).
- Beige with thick brown streak, 9"x 9" vinyl floor tiles were sampled in room OS-3016 and contain 6% chrysotile asbestos (reference sample 02-02-900-S023).
- Brown with thick brown streak, 12"x 12" vinyl floor tiles were sampled in room OS-2000/200A and contain 5% chrysotile asbestos (reference sample 02-02-900-S016).

UNIVERSIT	Y								
Sample #:	S016		Date Sampled:	November 29, 2012					
Building:	OSC Main BLDG	and	Sampler:	Trent Hardy					
	Annex								
Location:	017, stairwell 2S01		Analysis:	SAI - PLM					
MUN Project #:	02-02-900		Work Order #:						
Bulk Sampling Parameters									
Pipe/Tank	Flooring		Ceiling	Roofing	Location				
☐ Insulation	X12'x12' Tile	☐ Textured		☐ Shingle	X Floor				
□ Elbow	□ 9'x9'Tile	☐ Stucco		☐ Rolled	☐ Wall Orientation				
☐ Fitting	Vinyl Sheet	\square P	opcom	☐ Felt	☐ Ceiling				
☐ Transite Pipe	☐ Mastic	\Box D	WJC	□ Tar	☐ Above Ceiling				
☐ Gasket	Wall	\square P	laster		☐ Other				
□ Tank Insulation	☐ Transite Panel	\Box A	coustic Tile (Dropped)						
☐ Pipe Wrap	☐ Textured Wall	$\Box A$	coustic Tile (Glued-on)						
HVAC	☐ Plaster	\square M	lastic	Miscellaneous:					
☐ Insulation	□ DWJC		Structural						
☐ Tape			teel F. P. ing	No. of Phases:					
☐ Paper Wrap		□D	eck F. P. ing	Colour: Beige v	with thick brown

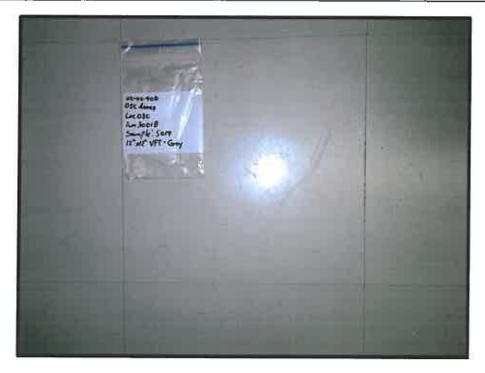
- Grey 12"x 12" vinyl floor tiles were sampled in room AX-3001B. Analysis of the sample and associated tar mastic adhesive did not identify the presence of asbestos (reference sample 02-02-900-S019).

Sample #:	S019		Date Sampled:	November 29, 2	012
Building:	OSC Main BLDG	and	Sampler:	Trent Hardy	
	Annex				
Location:	020, room 3001B		Analysis:	SAI - PLM	
MUN Project #:	02-02-900		Work Order #:		
		Bulk	Sampling Parameters	•	
Pipe/Tank	Flooring		Ceiling	Roofing	Location
☐ Insulation	X12'x12' Tile	☐ Textured		☐ Shingle	X Floor
□ Elbow	□ 9'x9'Tile	☐ Stucco		☐ Rolled	☐ Wall Orientation
☐ Fitting	□ Vinyl Sheet	□P	орсого	☐ Felt	☐ Ceiling
☐ Transite Pipe	☐ Mastic		ŴJC	☐ Tar	☐ Above Ceiling
☐ Gasket	Wall	\square P	laster		☐ Other
☐ Tank Insulation	☐ Transite Panel	□A	coustic Tile (Dropped)		
☐ Pipe Wrap	☐ Textured Wall	\Box A	coustic Tile (Glued-on)		
HVAC	☐ Plaster	\square M	fastic	Miscellaneous:	
☐ Insulation	□ DW1C		Structural	,	
☐ Tape			teel F. P. ing	No. of Phases:	
☐ Paper Wrap		\Box D	eck F. P. ing	Colour: Grey

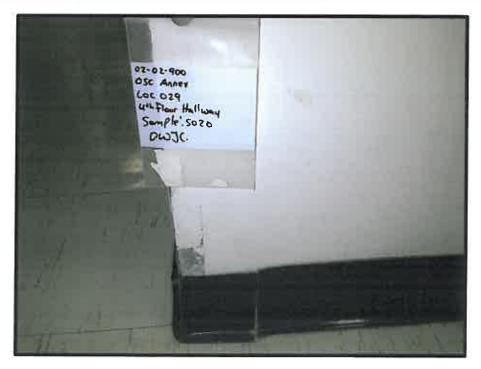
Six (6) samples, in total, of drywall joint compound were collected in the Site Building. Results from two (2) of the six (6) samples collected contain 3% chrysotile asbestos (reference samples, 02-02-900-S020, and 02-02-900-S022). For locations and conditions of this material at the time of the survey refer to location & data excel document.

ONIVERSITY								
Sample #:	S020		Date Sampled:	November 29, 2012				
Building:	OSC Main BLDG	and	Sampler:	Trent Hardy				
	Annex		_					
Location:	031, room AX4001		Analysis:	SAI - PLM				
MUN Project #:	02-02-900		Work Order #:					
Bulk Sampling Parameters								
Pipe/Tank	Flooring	Ceiling		Roofing	Location			
☐ Insulation	□12'x12' Tile	☐ Textured		☐ Shingle	☐ Floor			
☐ Elbow	□ 9'x9'Tile	☐ Stucco		☐ Rolled	X Wall Orientation			
☐ Fitting	□ Vinyl Sheet	\square P	opcorn	☐ Felt	☐ Ceiling			
☐ Transite Pipe	☐ Mastic		WJC	🛘 Таг	☐ Above Ceiling			
☐ Gasket	Wall	\square P	laster		☐ Other			
☐ Tank Insulation	☐ Transite Panel	\Box A	coustic Tile (Dropped)					
☐ Pipe Wrap	☐ Textured Wall	\square A	coustic Tile (Glued-on)					
HVAC	☐ Plaster	\square M	fastic (Miscellaneous:				
☐ Insulation	X DWJC		Structural					
☐ Tape		\square S	teel F. P. ing	No. of Phases:				
□ Paper Wrap			eck F. P. ing	Colour:

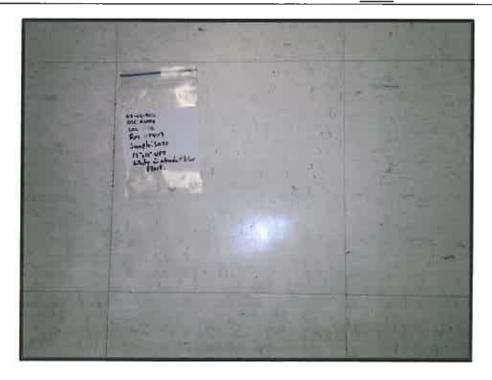
- White with abundant blue fleck, 12"x 12" vinyl floor tiles were sampled in room AX-4013. Analysis of the sample and associated tar mastic adhesive did not identify the presence of asbestos (reference sample 02-02-900-S021).

UNIVERSIT	Y					
Sample #:	S021		Date Sampled:	pled: November 29, 2012		
Building:	OSC Main BLDG	and	Sampler:	Trent Hardy		
	Annex					
Location:	036, room 4013		Analysis:	SAI - PLM		
MUN Project #:	02-02-900		Work Order #:			
		Bulk	Sampling Parameters			
Pipe/Tank	Flooring		Ceiling	Roofing	Location	
☐ Insulation	X12'x12' Tile	☐ Textured		☐ Shingle	X Floor	
☐ Elbow	□ 9'x9'Tile	☐ Stucco		☐ Rolled	☐ Wall Orientation	
☐ Fitting	□ Vinyl Sheet	\square P	opcorn	☐ Felt	☐ Ceiling	
☐ Transite Pipe	☐ Mastic	\Box D	WJC	☐ Tar	☐ Above Ceiling	
☐ Gasket	Wall	\square P	laster		☐ Other	
☐ Tank Insulation	☐ Transite Panel	\Box A	coustic Tile (Dropped)			
☐ Pipe Wrap	☐ Textured Wall	\Box A	coustic Tile (Glued-on)			
HVAC	☐ Plaster	\square M	lastic	Miscellaneous:		
☐ Insulation	□ DWJC		Structural			
☐ Tape			teel F. P. ing	No. of Phases:		
☐ Paper Wrap		□D	eck F. P. ing	Colour: White v	with abundant blue

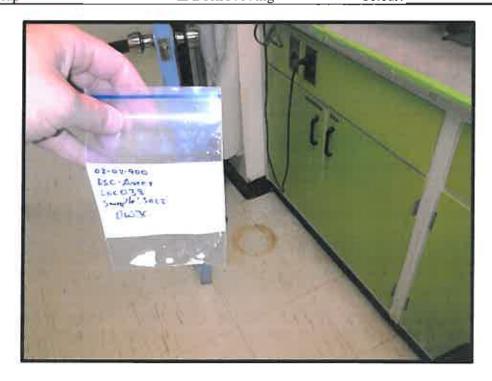
ALLIA PICALI					
Sample #:	S022		Date Sampled:	November 29, 2	012
Building:	OSC Main BLDG	and	Sampler:	Trent Hardy	
	Annex				
Location:	037, room 4016		Analysis:	SAI - PLM	
MUN Project #:	02-02-900		Work Order#:		
		Bulk	Sampling Parameters		
Pipe/Tank	Flooring		Ceiling	Roofing	Location
☐ Insulation	□12'x12' Tile	☐ Textured		☐ Shingle	☐ Floor
□ Elbow	☐ 9'x9'Tile	☐ Stucco		☐ Rolled	X Wall Orientation
☐ Fitting	□ Vinyl Sheet	□ P	opcom	☐ Felt	☐ Ceiling
☐ Transite Pipe	☐ Mastic		OWJC	□ Tar	☐ Above Ceiling
☐ Gasket	Wall	\square P	laster		☐ Other
☐ Tank Insulation	☐ Transite Panel	$\square A$	coustic Tile (Dropped)		
☐ Pipe Wrap	□ Textured Wall	\square A	coustic Tile (Glued-on)		
HVAC	□ Plaster	\square N	Mastic	Miscellaneous:	
☐ Insulation	X DWJC		Structural		
☐ Tape		\square S	teel F. P. ing	No. of Phases:	
☐ Paper Wrap			eck F. P. ing	Colour:

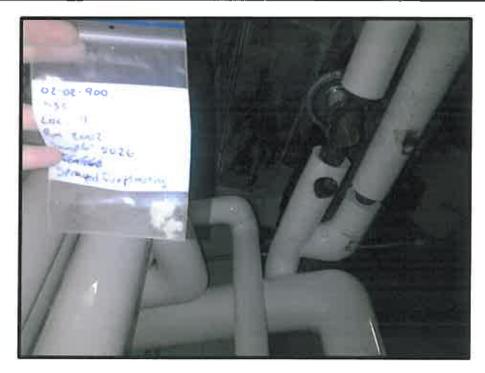
Debris present on the ceiling and surfaces in room OS-2002 was sampled and contains 60% amosite asbestos (reference samples 02-02-900-S026). This DEBRIS is suspected to be associated with spray applied fireproofing previously located on the ceiling of this room. For locations and conditions of this material at the time of the building survey refer to location & data excel document.

OMINEKSII	I								
Sample #:	S026		Date Sampled:	November 29, 2	012				
Building:	OSC Main BLDG	and	Sampler:	Trent Hardy					
_	Annex		·						
Location:	081, room OS2002		Analysis:	SAI - PLM					
MUN Project #:	02-02-900		Work Order#:						
	Bulk Sampling Parameters								
Pipe/Tank	Flooring		Ceiling	Roofing	Location				
☐ Insulation	□12'x12' Tile	ΠΠ	`extured	☐ Shingle	☐ Floor				
□ Elbow	□ 9'x9'Tile	\square S	tucco	☐ Rolled	☐ Wall Orientation				
☐ Fitting	□ Vinyl Sheet	\Box P	орсого	☐ Felt	☐ Ceiling				
☐ Transite Pipe	☐ Mastic)WJC	□ Tar	☐ Above Ceiling				
☐ Gasket	Wall	\square P	laster		☐ Other				
☐ Tank Insulation	☐ Transite Panel	\square A	coustic Tile (Dropped)						
☐ Pipe Wrap	□ Textured Wall	\Box A	coustic Tile (Glued-on)						
HVAC	☐ Plaster	\square N	lastic	Miscellaneous:					
☐ Insulation	□ DWJC		Structural						
☐ Tape		\Box S	teel F. P. ing	No. of Phases:					
☐ Paper Wrap		ΧD	eck F. P. ing	Colour:

- Any DEBRIS associated with friable asbestos containing materials should be abated as soon as reasonably possible to prevent worker exposure. Entry into these spaces should follow Type II (moderate risk) entry procedures until the hazard can be removed. Abatement of the DEBRIS and residual material would be completed using Type III (high risk) asbestos abatement procedures.
- 2. Type III (high risk) asbestos abatement procedures should be carried out for the scheduled removal of greater than 1ft² of friable asbestos containing materials. Alternatively, Type II (moderate risk) glove bag abatement procedures may be applied where practical;
