Project #: 13916

**ASBESTOS ASSESSMENT
R. Gushue Hall
Memorial University of Newfoundland
St. John's, NL**

August 2011

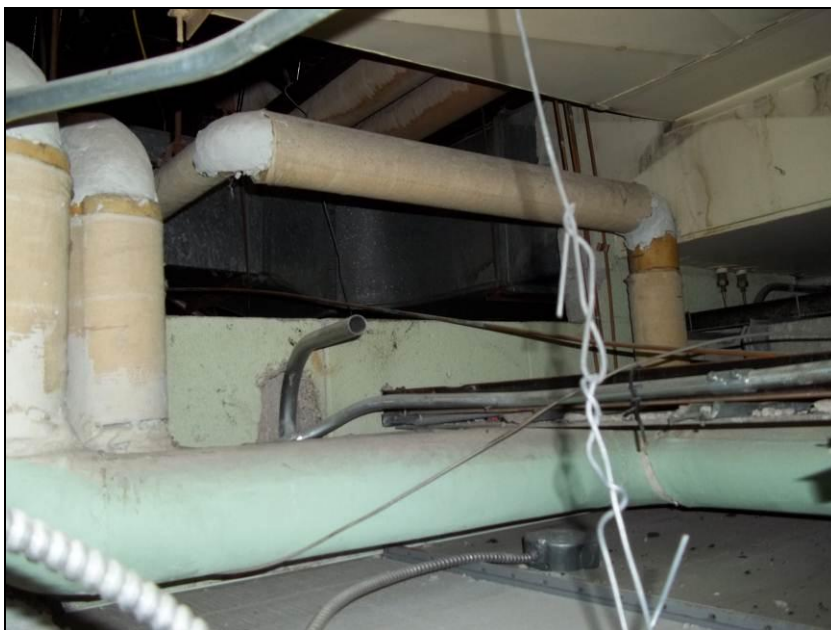
Pipe fitting insulation which could potentially contain asbestos was observed in select areas throughout the building during this assessment. Samples were collected and analyzed for asbestos content using the PLM method of detection and found to contain 40% Chrysotile asbestos (see sample DH-24 in Appendix II, Photograph 1, Appendix I)

Photograph 1: Pipe fitting insulation in DH1010, above the ceiling tile, in poor condition.

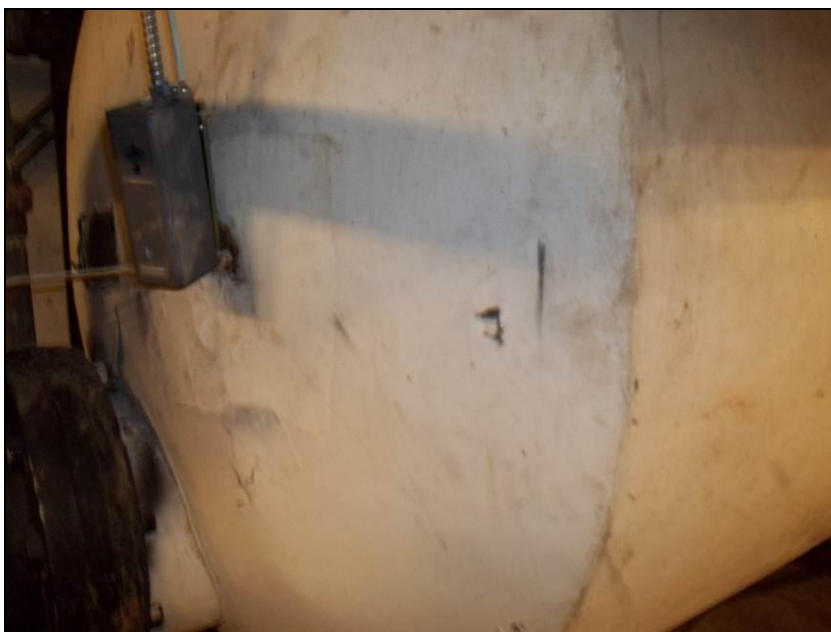
Tank insulation which could potentially contain asbestos was observed in a mechanical room within the building during this assessment. A sample was collected and analyzed for asbestos content using the PLM method of detection and found to contain 40% Chrysotile asbestos (see sample DH-25 in Appendix II, Photograph 2, Appendix I)

Photograph 2: Tank insulation in Room DH004A/004, in fair condition.

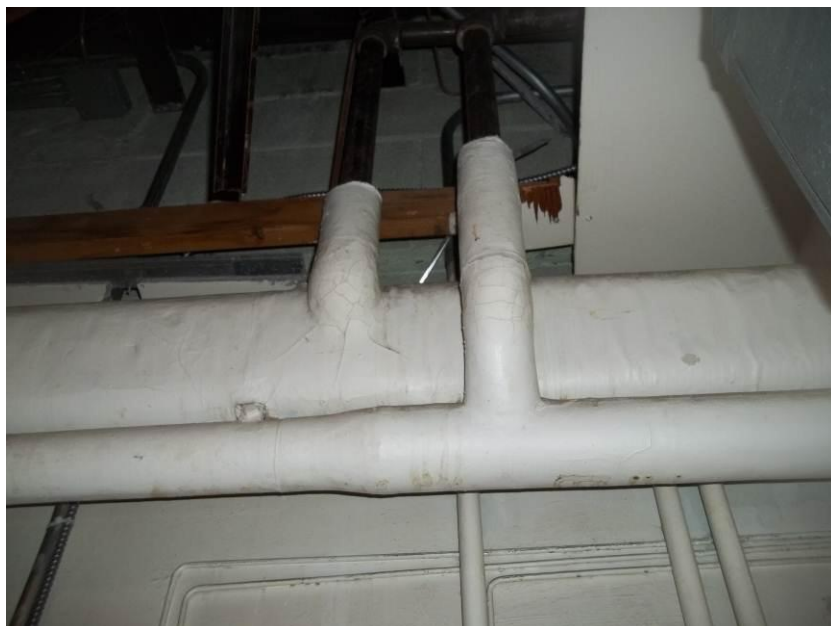
During the assessment it was observed that linear pipe insulation was fiberglass material. However, linear pipe insulation in Room DH1011 was inaccessible for either sample collection or a visual inspection. Thus, it must be considered to be asbestos containing until proven otherwise. (see Photograph 3, Appendix I)

Photograph 3: Suspect linear pipe insulation in Room HD1011. The piping was too high to access for sample collection or visual inspection.

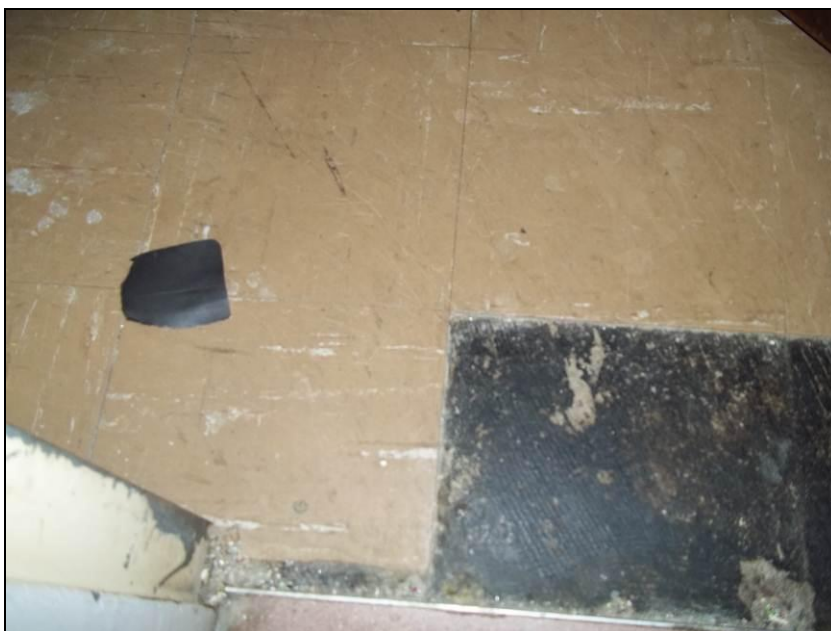
Two (2) samples of 9" x 9" vinyl floor tiles were sampled and analyzed for asbestos content using the PLM method of detection. Both of the samples were identified as containing between 3 and 8% Chrysotile asbestos. Their associated mastics were identified as non-asbestos containing. (see samples DH-16, DH-18, in Appendix II, Photographs 4, 5 in Appendix I)

Photograph 4: Asbestos containing 9" x 9" vinyl floor tile, in fair condition (sample DH-16).

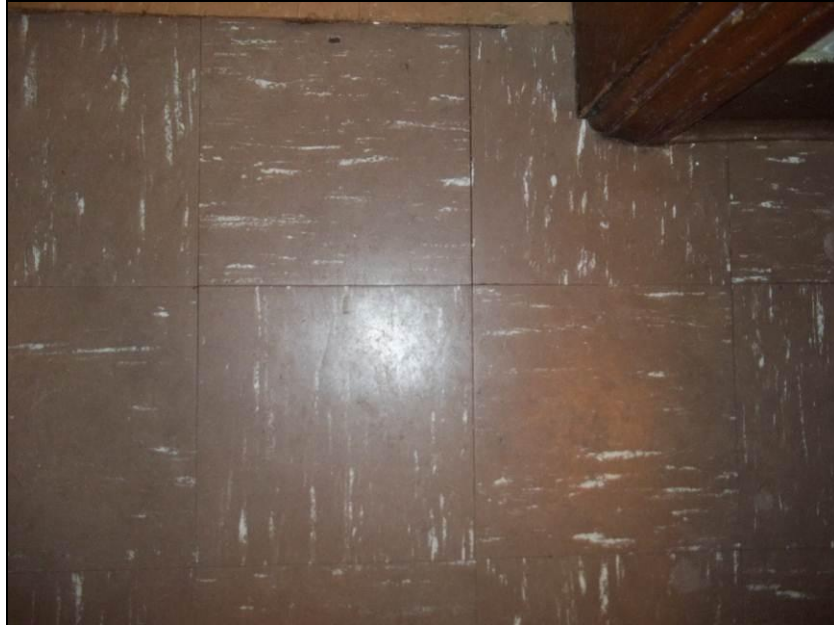
Photograph 5: Asbestos containing 9" x 9" vinyl floor tile, in fair condition (sample DH-18).

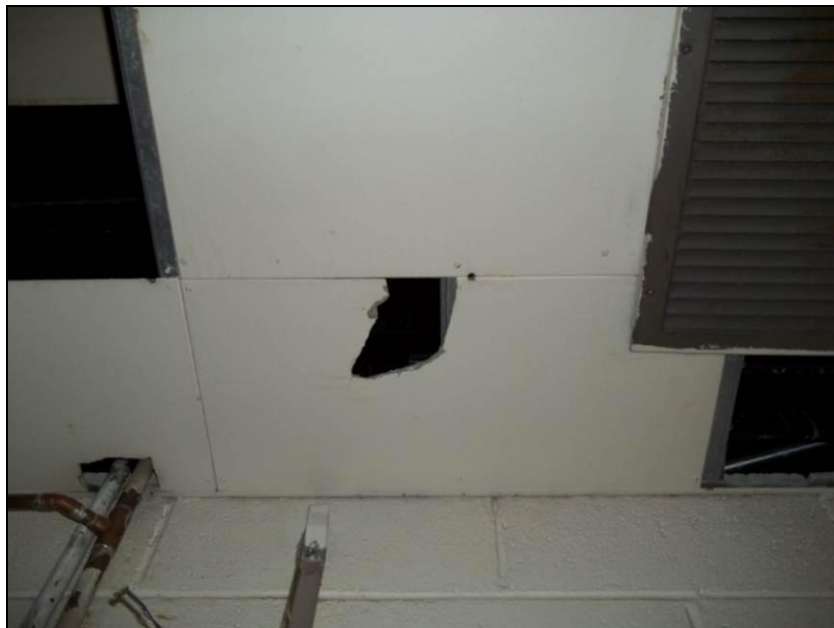
Suspect asbestos containing transite paneling was observed as a portion of the drop ceiling in Room DH1011. Samples of this material were collected and analyzed for asbestos content using the PLM method of detection. The sample was identified as containing 45% Chrysotile asbestos. (see sample DH-10 in Appendix II, Photograph 6, in Appendix I)

Photograph 6: Transite panels as the ceiling in Room DH1011, in poor condition (sample DH-10)

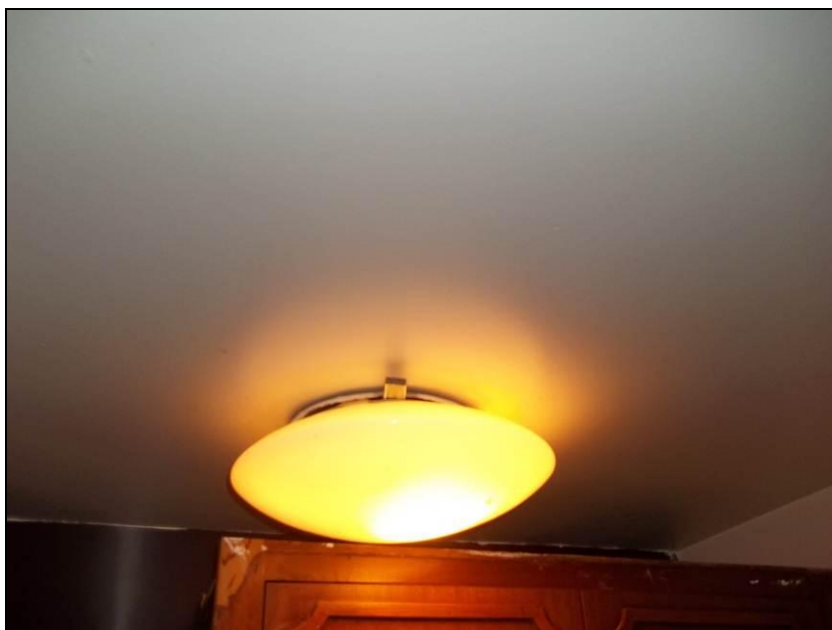
Three types of a light fixture heat shield were observed throughout the building. Samples were collected and analyzed for asbestos content using the PLM method of detection. These samples were found to contain between 25 – 35% Chrysotile asbestos (see samples DH-19, DH-20, DH-21 in Appendix II, see Photographs 7, 8 in Appendix I).

Photograph 7: Samples DH-19 and DH-20 as found in Room DH2006. The shield contained two layers, both were found to be asbestos containing.

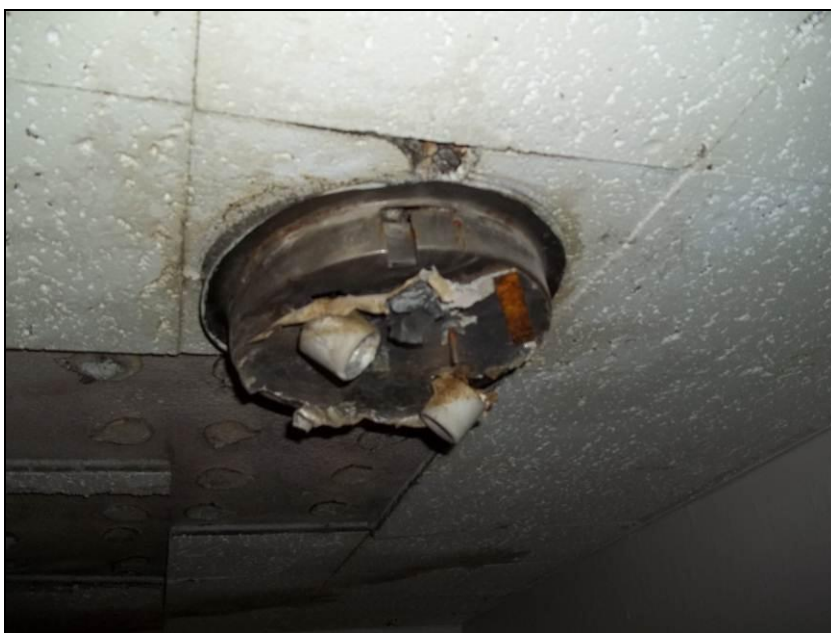
Photograph 8: Sample DH-21, of an exposed light fixture heat shield, in poor condition.

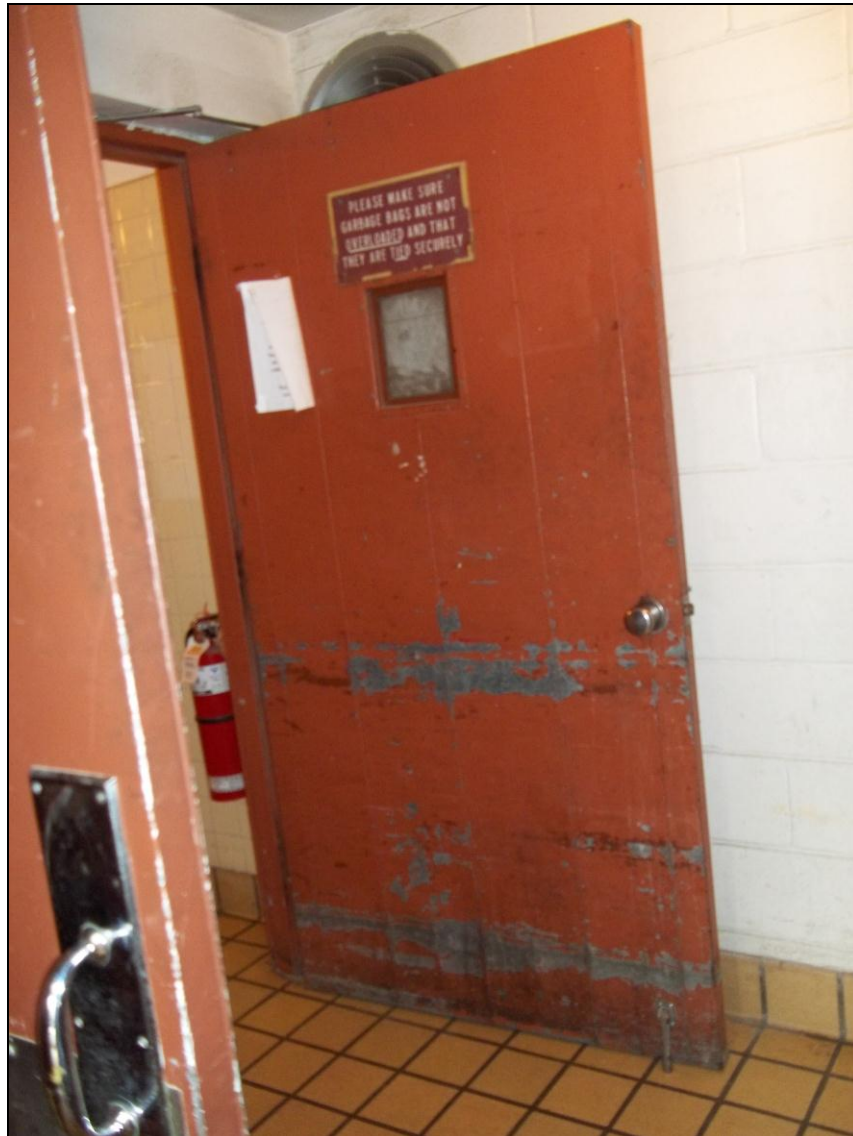
A fire-rated door manufactured by Weststeel Products Ltd. was observed in Room DH1004. Such doors have been known to contain asbestos within the door. The door could not be sampled for asbestos content, thus it must be considered to be asbestos containing until proven otherwise. (see Photograph 9, Appendix I)

**Photograph 9: Fire rated door, suspected to have asbestos material within the door.
Considered to be asbestos containing until proven otherwise.**
