**Project #: 14610**

**ASBESTOS ASSESSMENT  
Science Building  
Memorial University of Newfoundland  
St. John's, NL**

**February 2012**

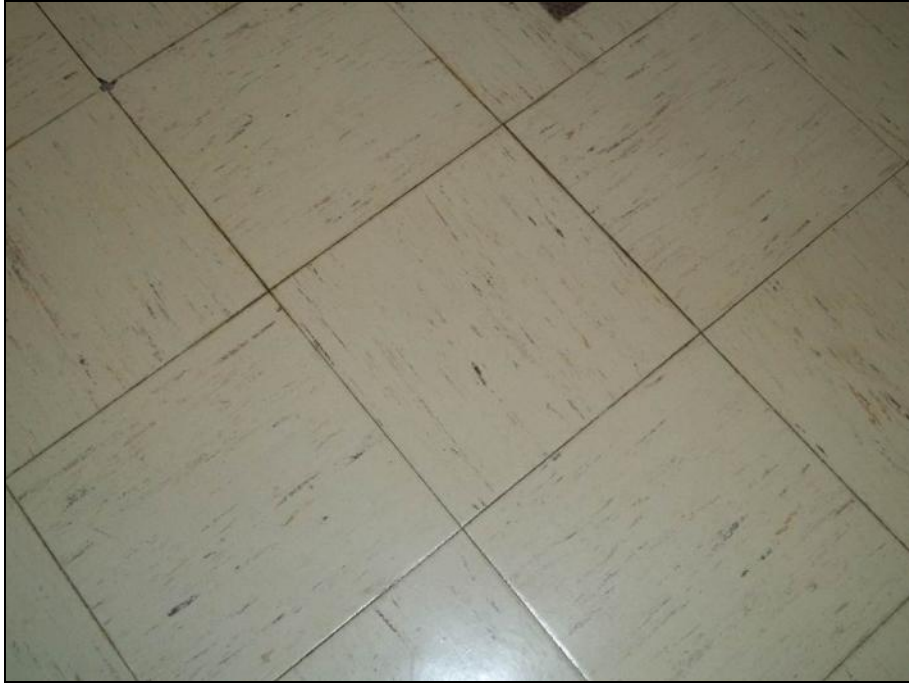
**Photograph 1: Hallway SN1C04. Asbestos containing 1' x 1' vinyl floor tile and mastic. Sample SN-47**

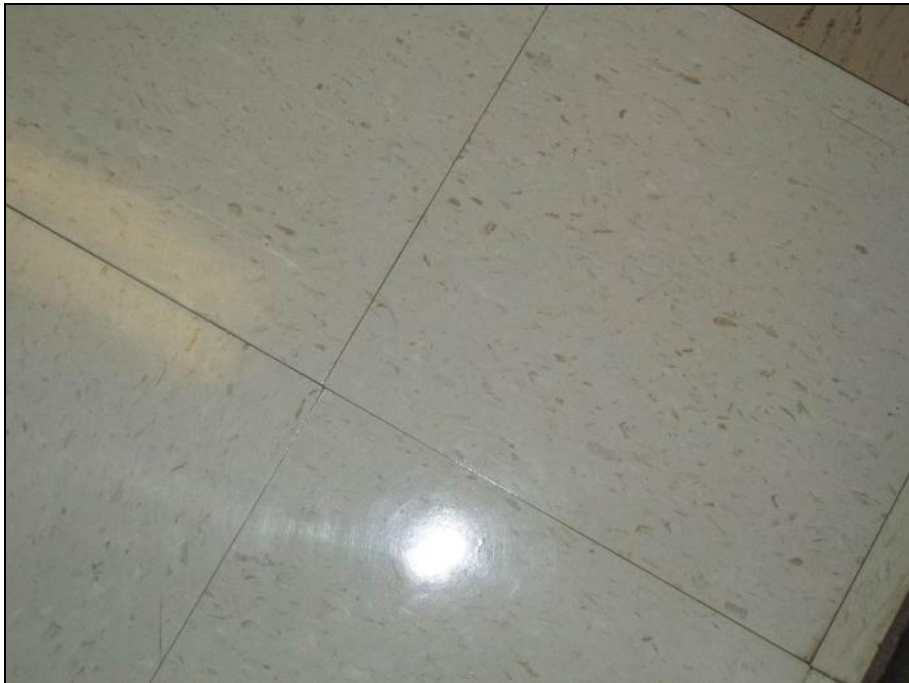
**Photograph 2: Hallway SN1C04. Asbestos containing mastic under floor tile. Sample SN-48.**

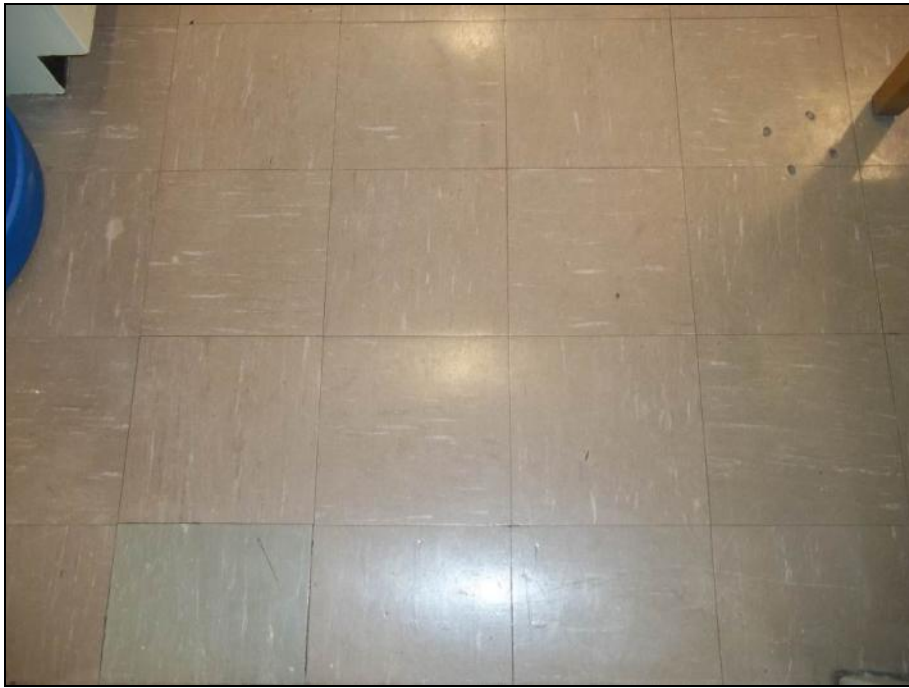
**Photograph 3: Room SN1074C. Asbestos containing 9" x 9" vinyl floor tile and mastic.  
Sample SN-52**

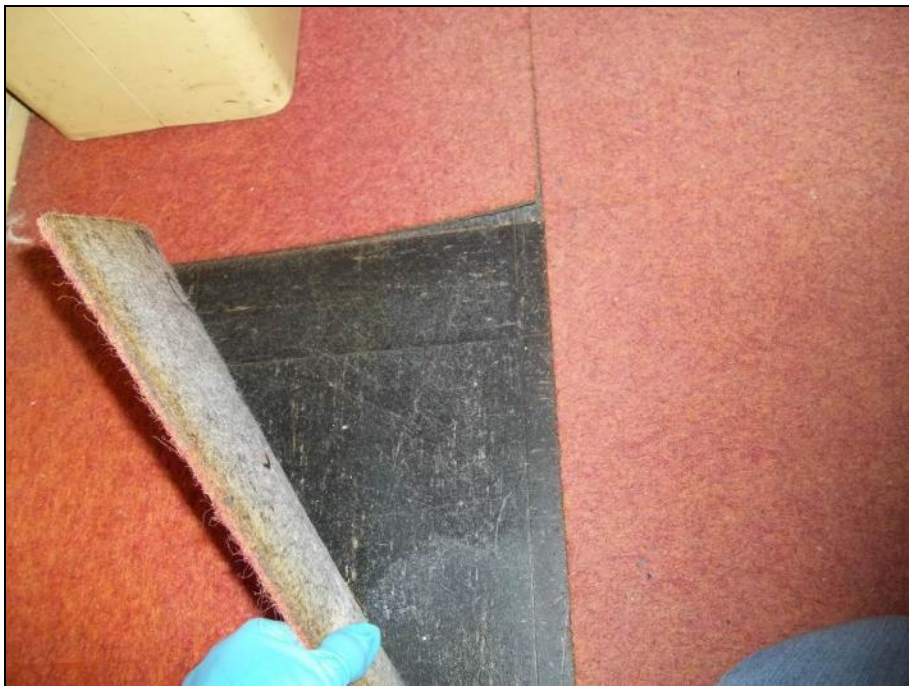
**Photograph 4: Room SN1073. Asbestos containing 1' x 1' vinyl floor tile, found under carpet.  
Sample SN-56**

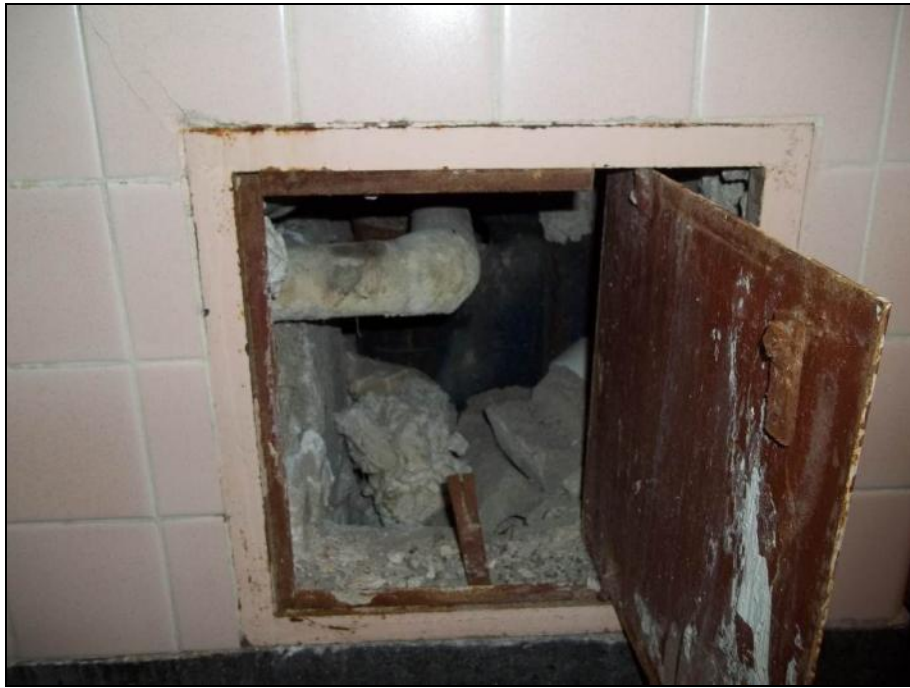
Pipe fitting insulation which could potentially contain asbestos was observed in various locations throughout the surveyed areas. Samples were collected from Rooms SN1068 and SN2087 and analyzed for asbestos content using the PLM method of detection. The samples were found to contain between 18% and 60% Chrysotile asbestos (See samples SN-61 and SN-81 in Appendix II and Photograph 6 in Appendix I)

**Photograph 6: Room SN1068. Asbestos containing pipe fitting insulation. Sample SN-61.**

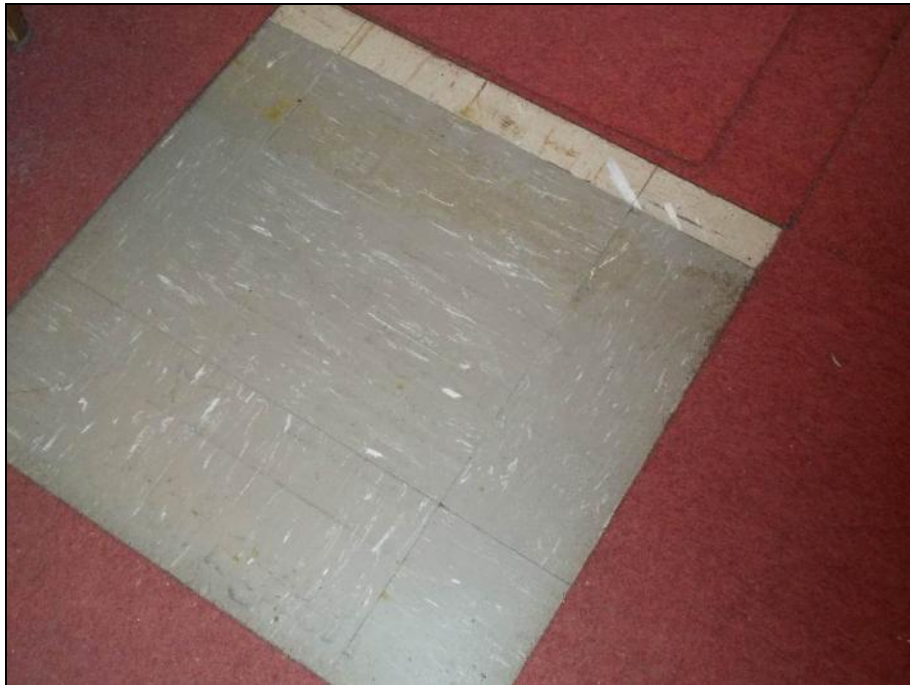
**Photograph 7: Room SN1052. Asbestos containing 1' x 1' vinyl floor tile under carpet.  
Sample SN-66.**

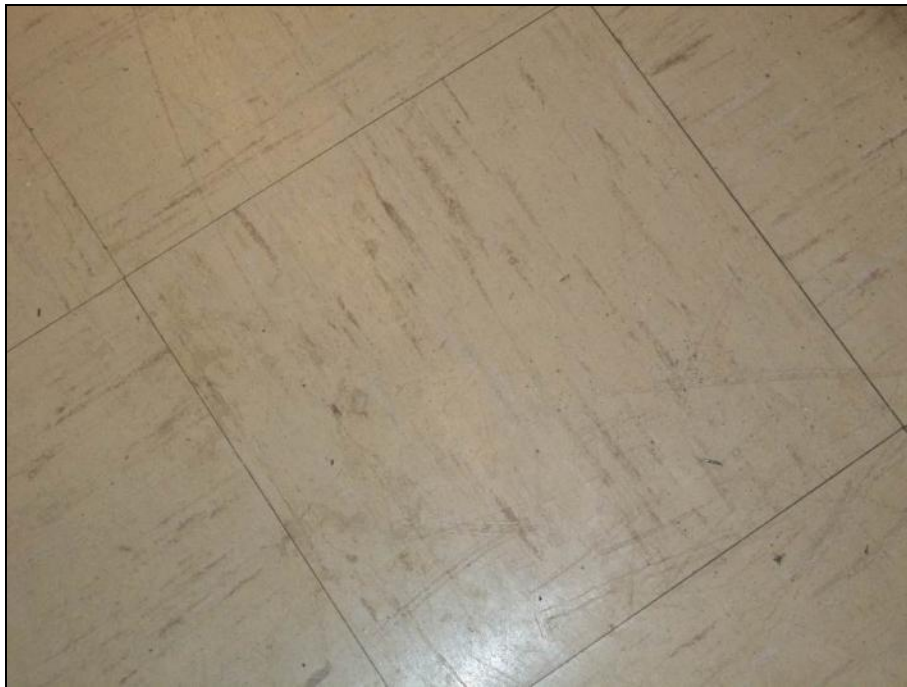
**Photograph 8: Room SN1050. Asbestos containing 1' x 1' vinyl floor tile and mastic. Sample SN-67.**

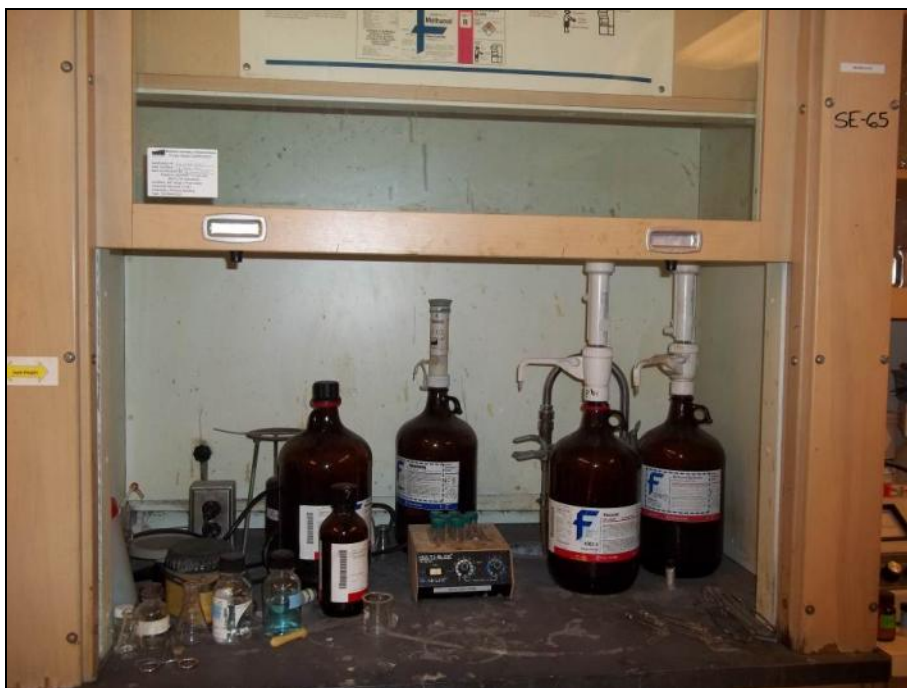
**Photograph 9: Room SN1049. Asbestos containing transite fume hood. Sample SN-69.**

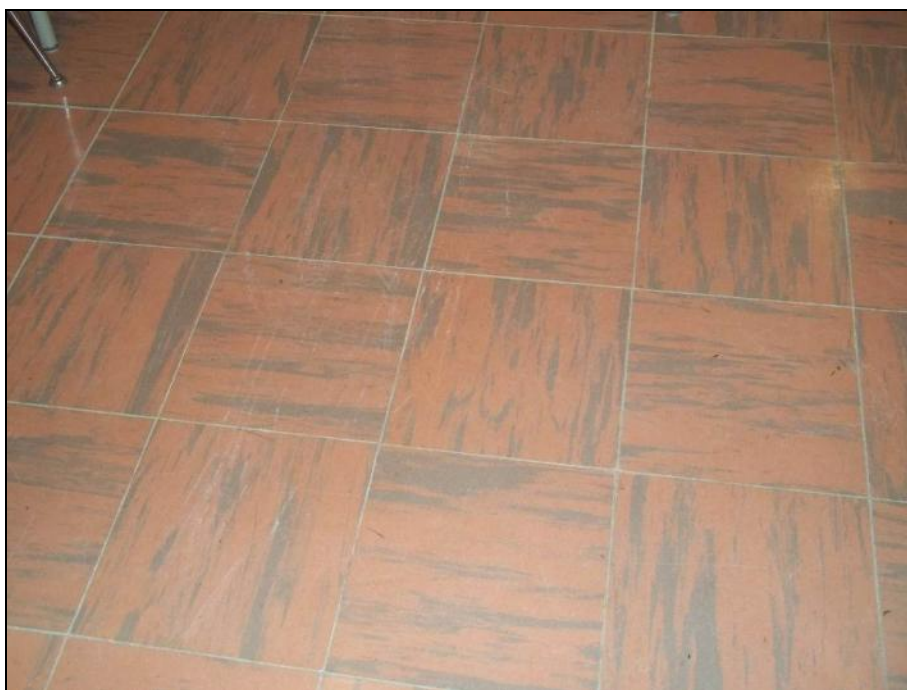
**Photograph 10: Room SN1103. Asbestos containing 1' x 1' vinyl floor tile. Sample SN-73.**

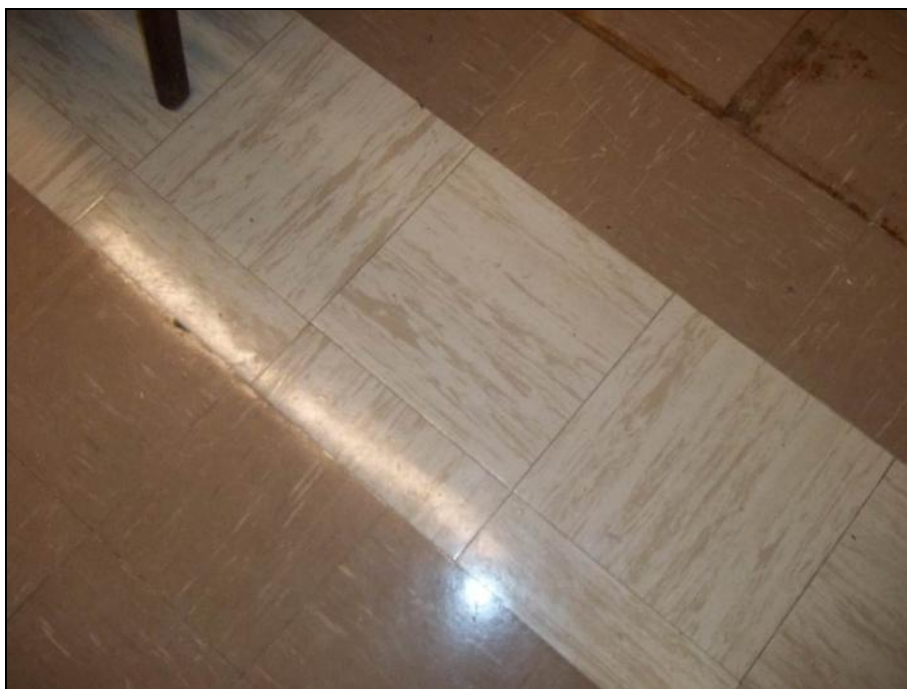
**Photograph 11: Room SN1093. Asbestos containing, light coloured 1' x 1' vinyl floor tile and mastic. Sample SN-74.**

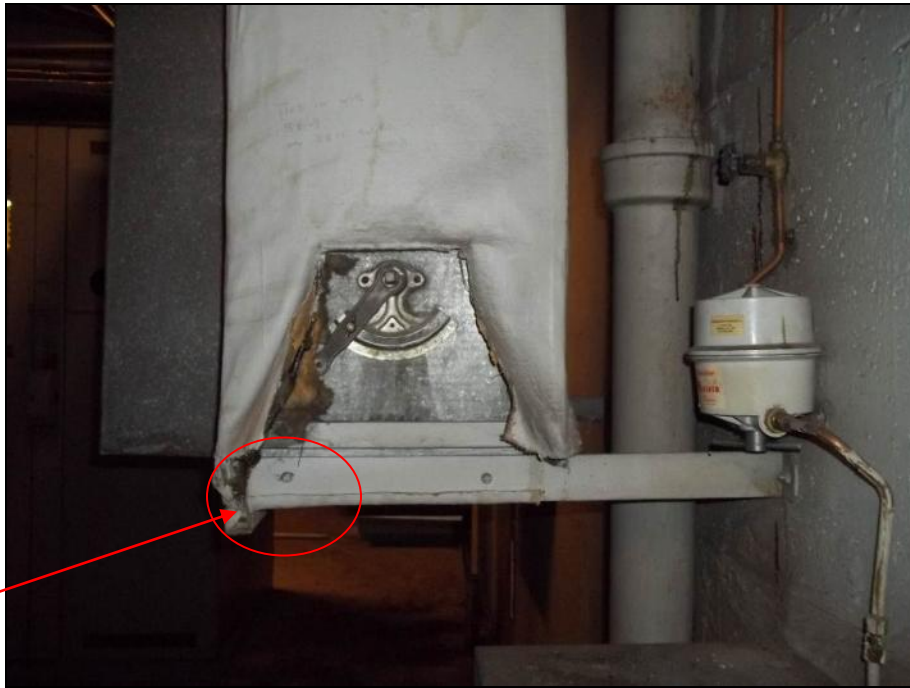
**Photograph 12: Room SN1111. Asbestos containing parging along the seam of the fiberglass insulated duct. Sample SN-75.**

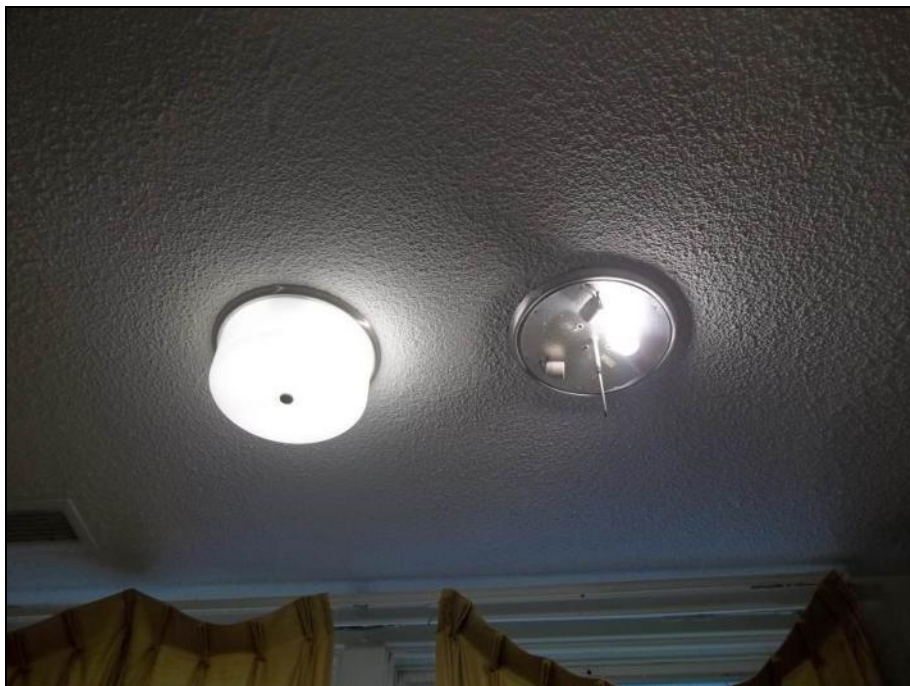
Textured finished ceilings were observed in select locations throughout the surveyed areas. Five (5) samples were collected from various locations and analyzed for asbestos content using the PLM method of detection. The samples were found to contain between 5% and 8% Chrysotile asbestos. (See samples SN-55, SN-62, SN-72, SN-76 and SN-98 in Appendix II and Photograph 13 in Appendix I)

One type of light fixture heat shield was observed in the surveyed areas. One (1) sample was collected from Room SN2091 and analyzed for asbestos content using the PLM method of detection. The sample was found to contain 50% Chrysotile asbestos (see sample SN-79 in Appendix II, photograph 13 in Appendix I).

**Photograph 13: Room SN2091. Asbestos containing light fixture heat shields Sample SN-79. Also note asbestos containing textured ceiling.**

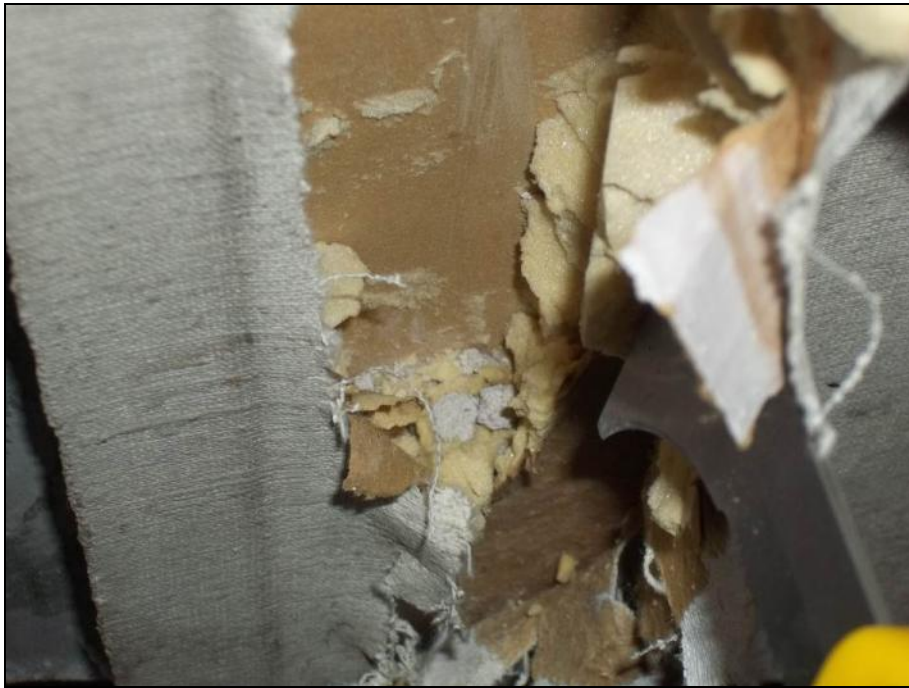
**Photograph 14: Room SN2085. Asbestos containing padding debris on foam insulated duct.  
Sample SN-85.**

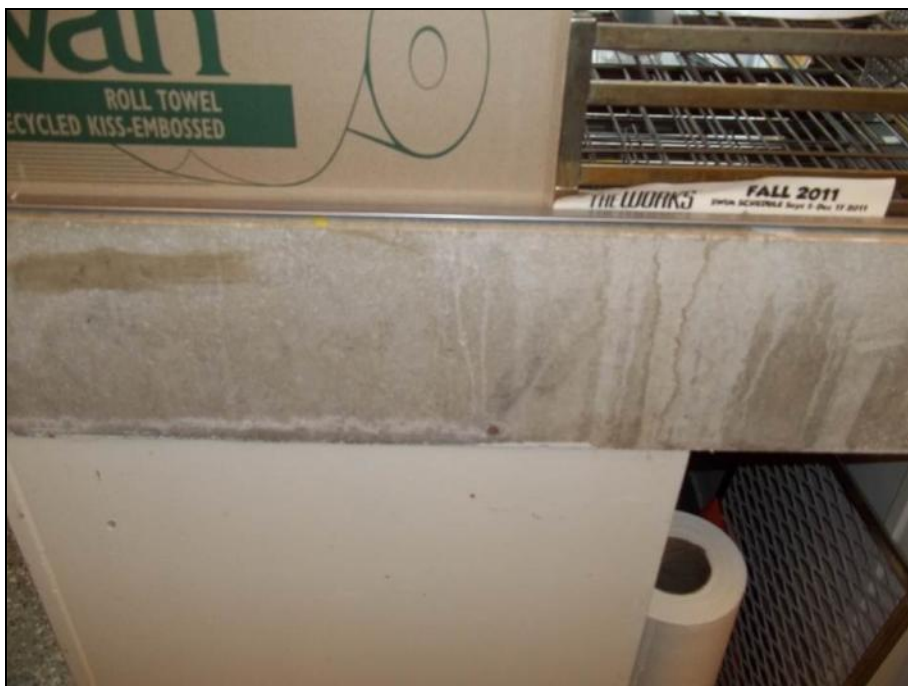
**Photograph 15: Room SN3107. Asbestos containing transite on counter.  
Sample SN-89.**

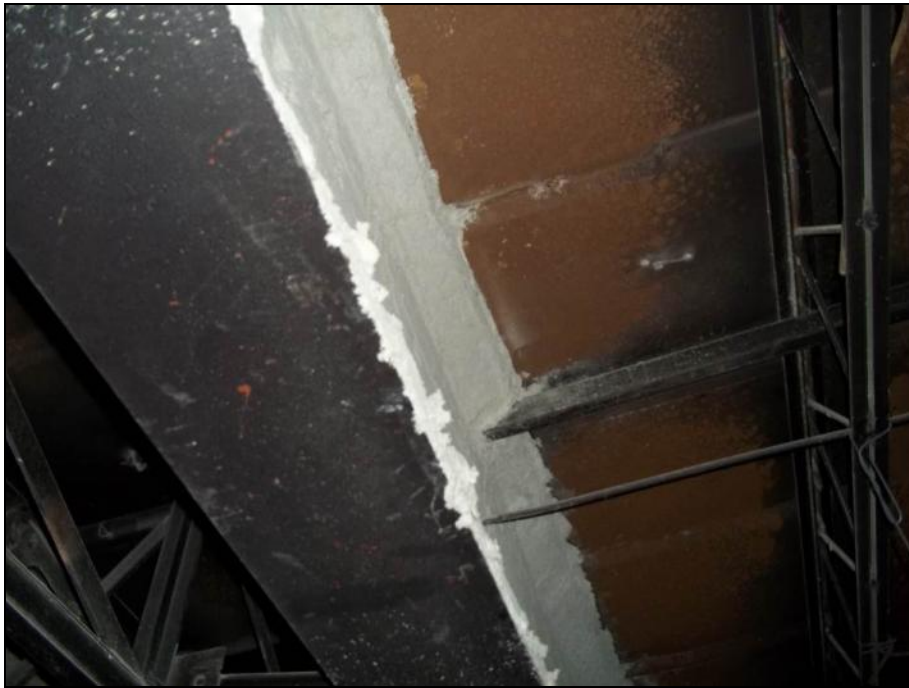
Sprayed acoustic or sprayed fireproofing was observed in the surveyed areas during the assessment. One (1) sample was collected from Room SN3125D and analyzed for asbestos content using the PLM method of detection. The sample was found to contain 40% Amosite asbestos. This material was observed in the ceiling spaces of hallways and rooms throughout the surveyed area. (See sample SN-95 in Appendix II and Photograph 16 in Appendix I)

**Photograph 16: Room SN3125D. Asbestos containing fireproofing on I-Beam.  
Sample SN-95**

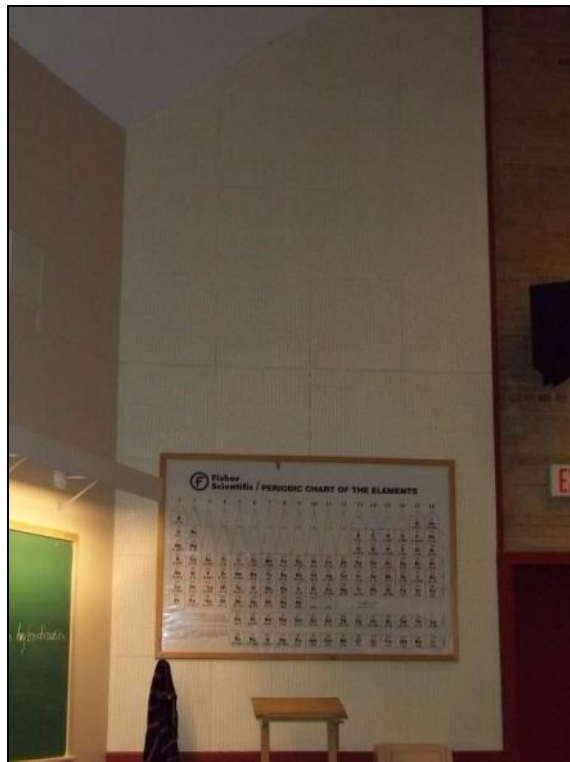
**Photograph 17: Room SN2109. Asbestos containing transite panels.  
Sample SN-105**

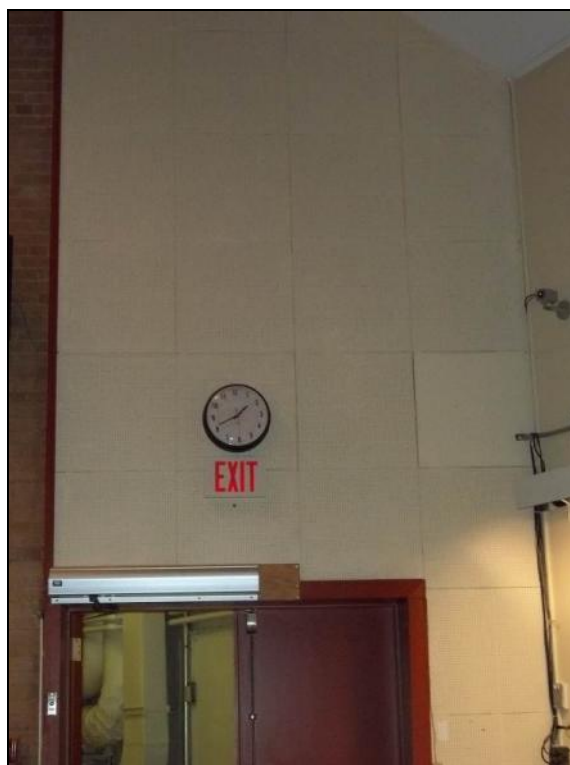
**Photograph 18: Room SN2109. Asbestos containing transite panels.  
Sample SN-105**

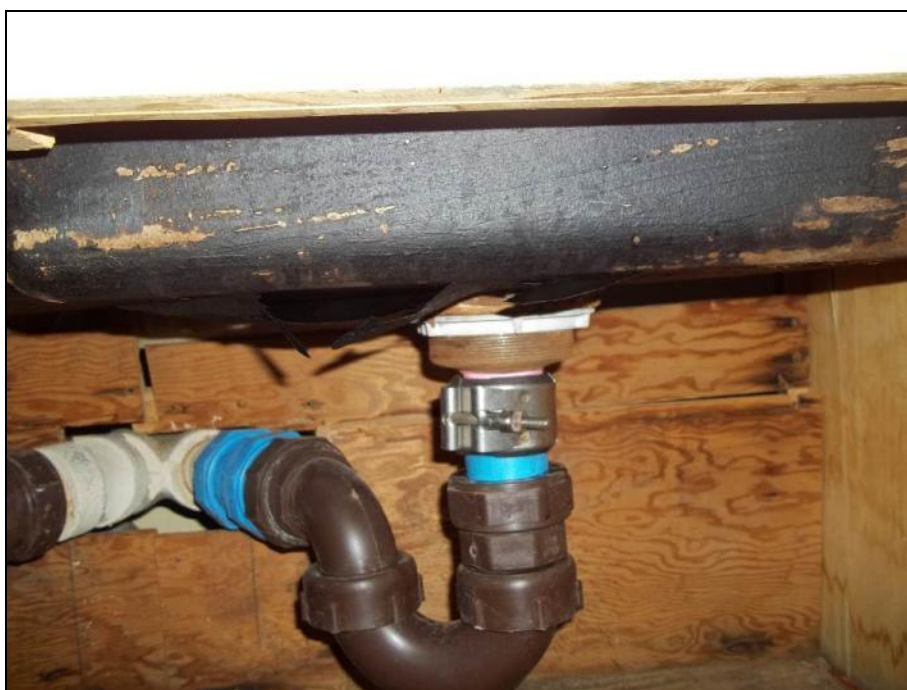
Tar was observed on sinks in select labs throughout the surveyed areas. A sample was collected from Room SN3114 and analyzed for asbestos content using the PLM method of detection. The sample was found to contain 5% Chrysotile asbestos. Based on this result, it should be noted that all tar on sinks must be considered to be asbestos containing. (See sample SN-106 in Appendix II and Photograph 19 in Appendix I)

**Photograph 19: Room SN3114. Asbestos containing tar on lab sink.  
Sample SN-106**

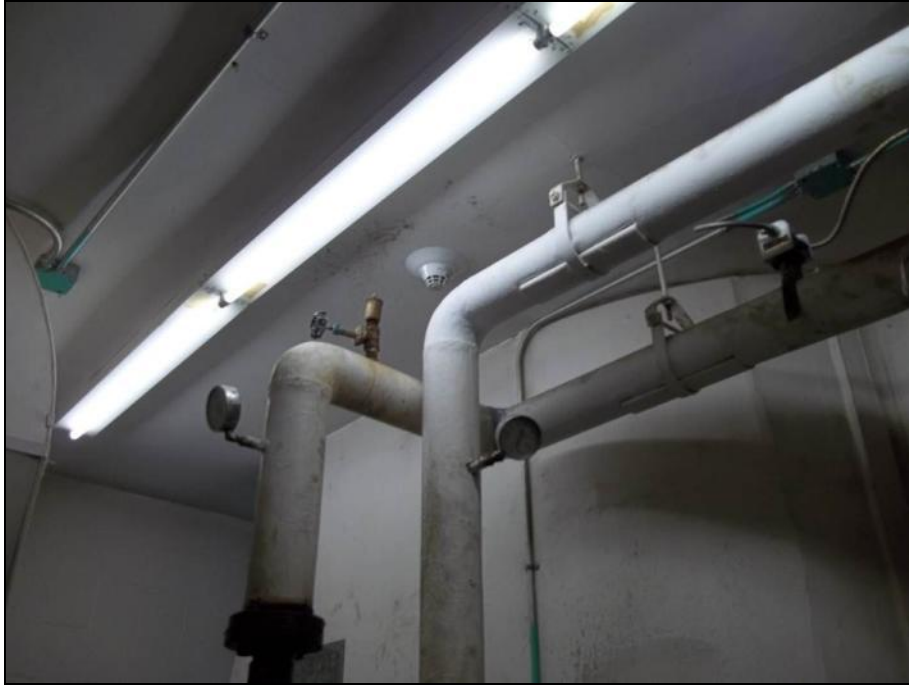
Pipe fitting insulation which could potentially contain asbestos was observed in various locations throughout the surveyed areas. Samples were collected from Rooms SN4051 and SN2048A (in this location, pipe hanger insulation) and analyzed for asbestos content using the PLM method of detection. The samples were both found to contain 20% Chrysotile asbestos (see samples SN-128 and SN-130 in Appendix II, Photographs 20 and 21 in Appendix I)

**Photograph 20: Room SN4051. Asbestos containing pipe fitting insulation.  
Sample SN-128**

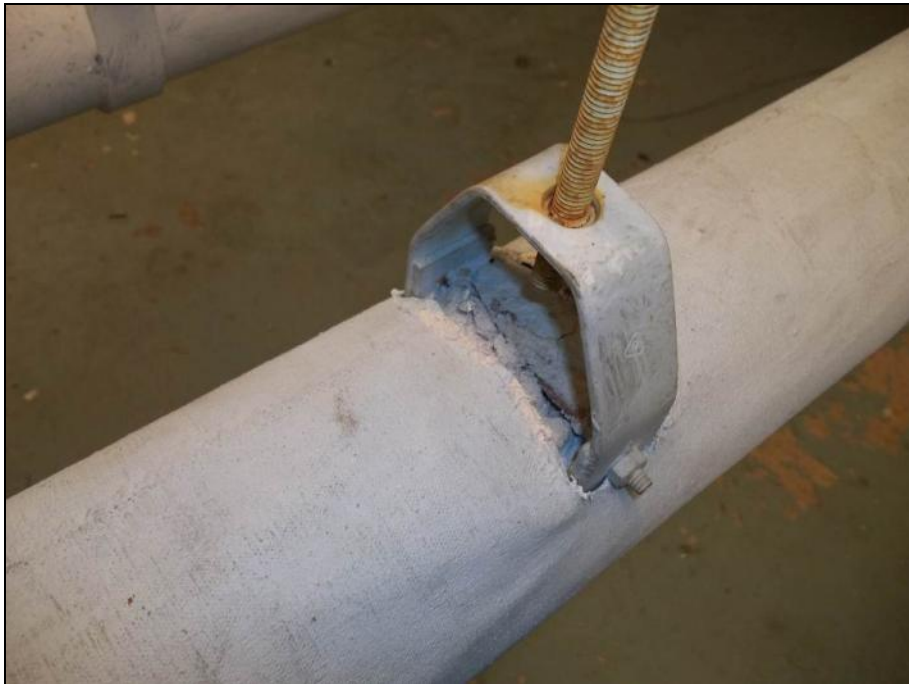
**Photograph 21: Room SN2048A. Asbestos containing pipe hanger insulation.  
Sample SN-130**

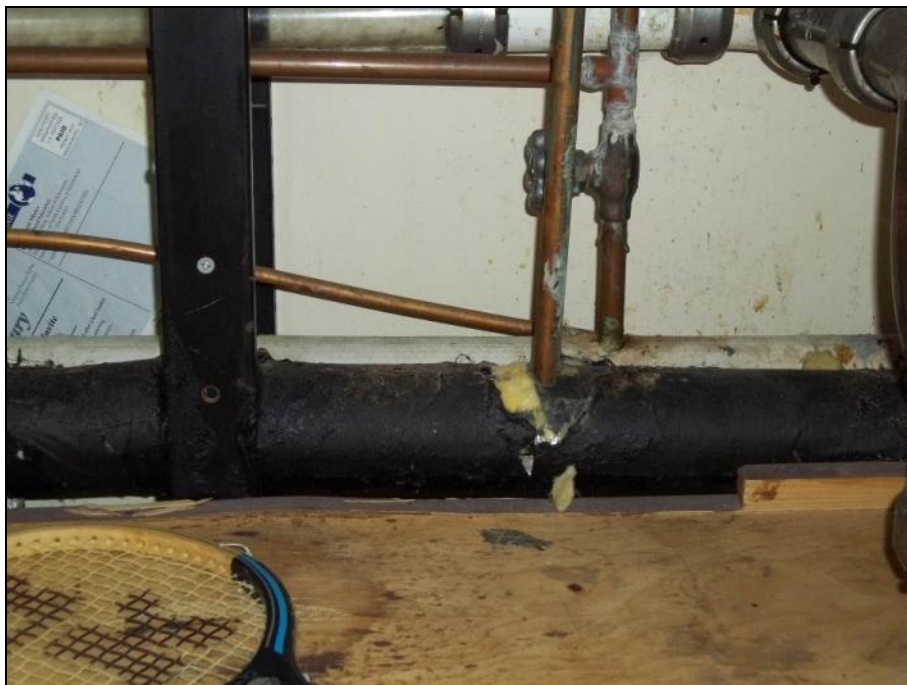
Tar mastic on fiberglass pipe was observed in various locations throughout the surveyed areas. A sample was collected from Room SN4100 and analyzed for asbestos content using the PLM method of detection. The sample was found to contain 5% Chrysotile asbestos. It should be noted that tar mastic on such pipes that may be within the surveyed areas are also considered to be asbestos containing. (See sample SN-133 in Appendix II, Photograph 22 in Appendix I)

**Photograph 22: Room SN4100. Asbestos containing tar mastic on fiberglass pipe insulation.  
Sample SN-133**

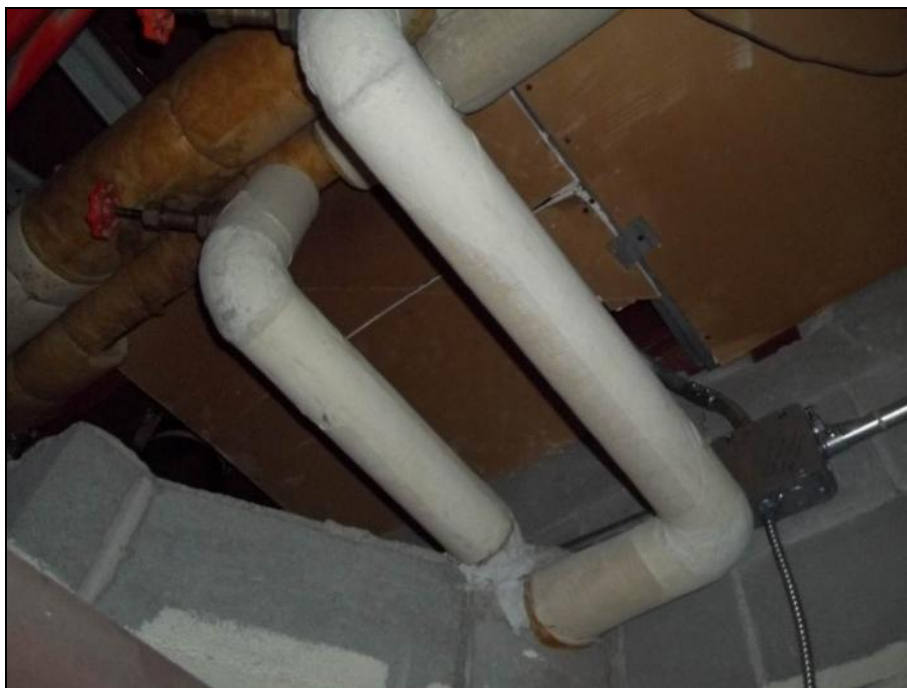
Pipe fitting insulation which could potentially contain asbestos was observed in various locations throughout the surveyed areas. A sample was collected from the vestibule SN1V03 and analyzed for asbestos content using the PLM method of detection. This sample was found to contain 35% Chrysotile asbestos (See sample SN-02 in Appendix II, Photograph 23 in Appendix I).

**Photograph 23: Vestibule SN1V03. Asbestos containing pipe fitting insulation.  
Sample SN-02**

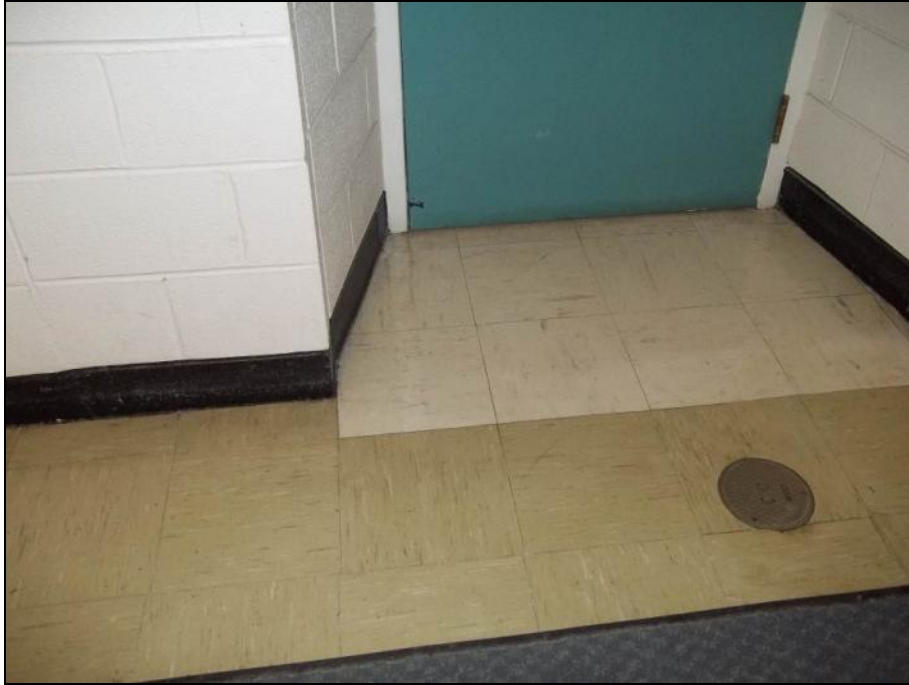
**Photograph 24: Hallway SN1C03. Asbestos containing 1' x 1' green vinyl floor tile. Sample SN-03**

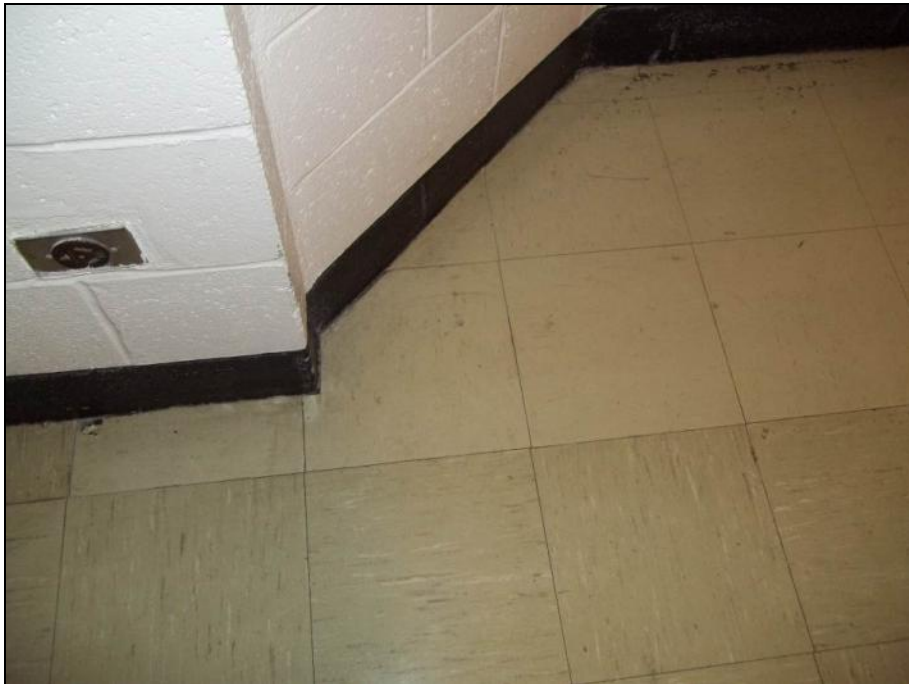
**Photograph 25: Hallway SN 1C03. Asbestos containing 1' x 1' light green vinyl floor tile and mastic; and cream with brown. Samples SN-05 and SN-06.**

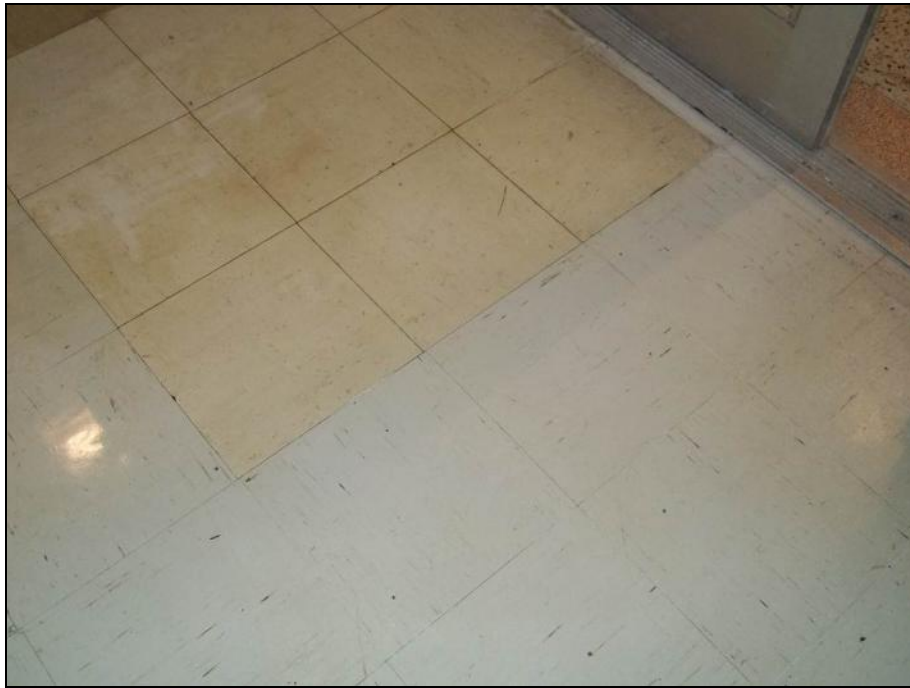
**Photograph 26: Hallway SN1C03. Asbestos containing tile associated with grey tile. Sample SN-07.**

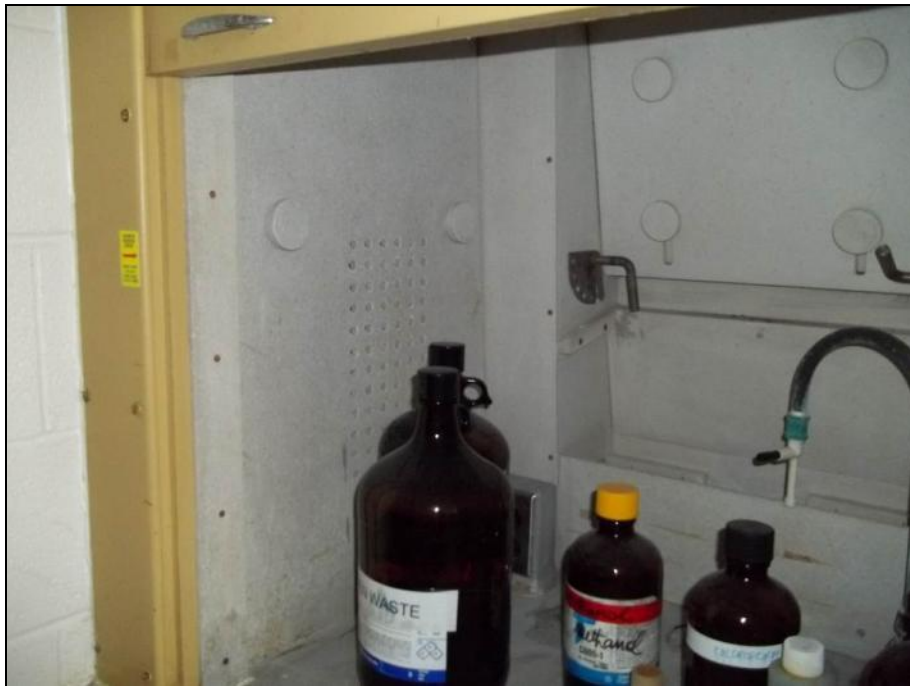
**Photograph 27: Room SN1045C. Asbestos containing transite fume hood. Sample SN-12**

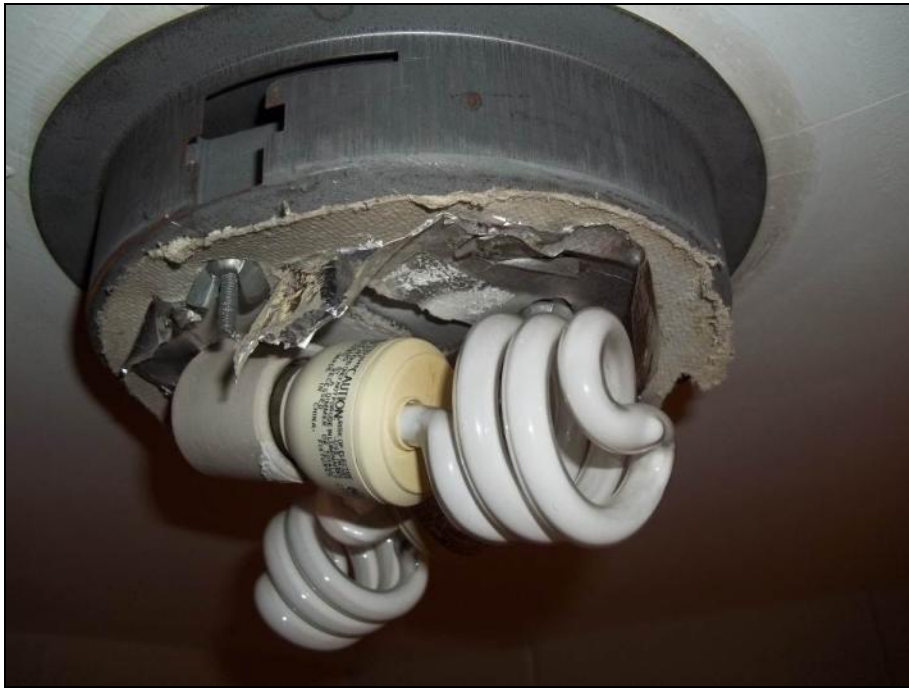
**Photograph 28: Room SN1030. Asbestos containing light fixture heat shield. Sample SN-27**

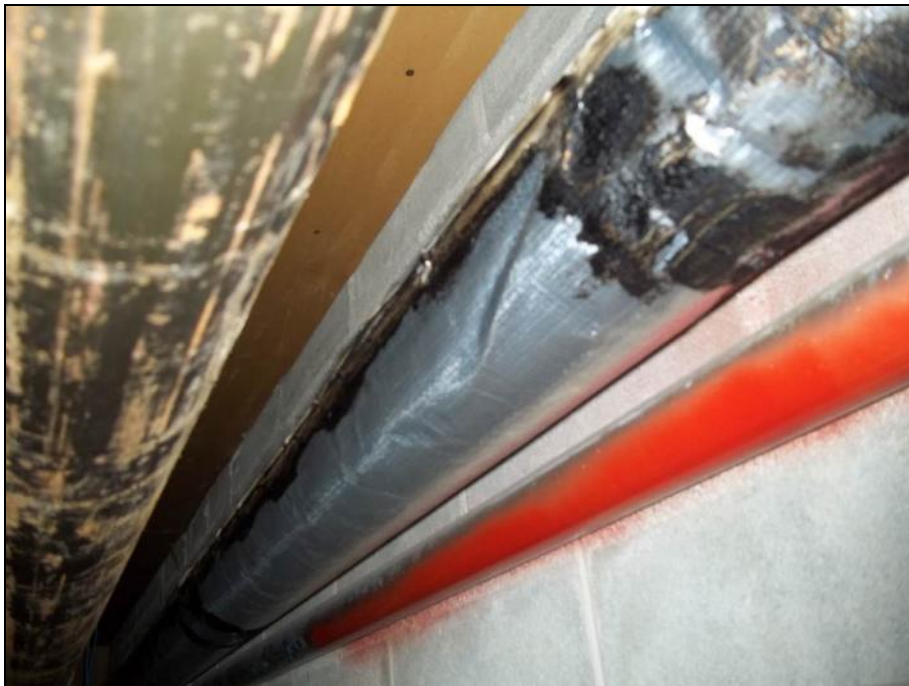
Tar mastic on fiberglass pipe was observed in various locations throughout the hallway SN2C03. A sample was collected from this area and analyzed for asbestos content using the PLM method of detection. The sample was found to contain 20% Chrysotile asbestos. It should be noted that tar mastic on such pipes that may be within D Block are also considered be asbestos containing. (See sample SN-29 in Appendix II, Photograph 29, in Appendix I)

**Photograph 29: Hallway SN2C03. Asbestos containing tar on fiberglass insulated pipe.  
Sample SN-29**

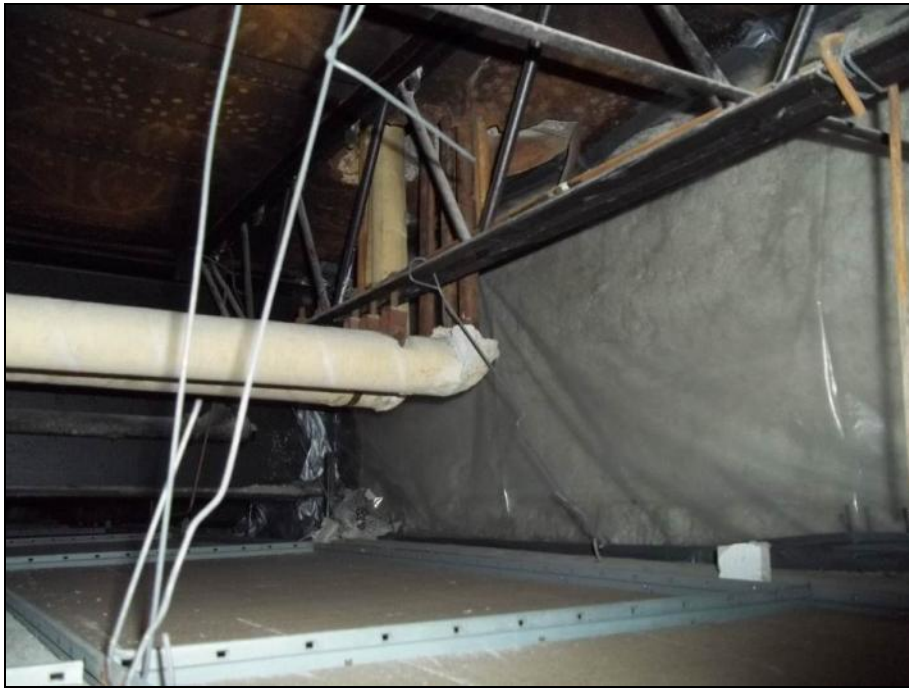
**Photograph 30: Room SN3006B. Asbestos containing pipe fittings located above ceiling tile, in fair condition.**

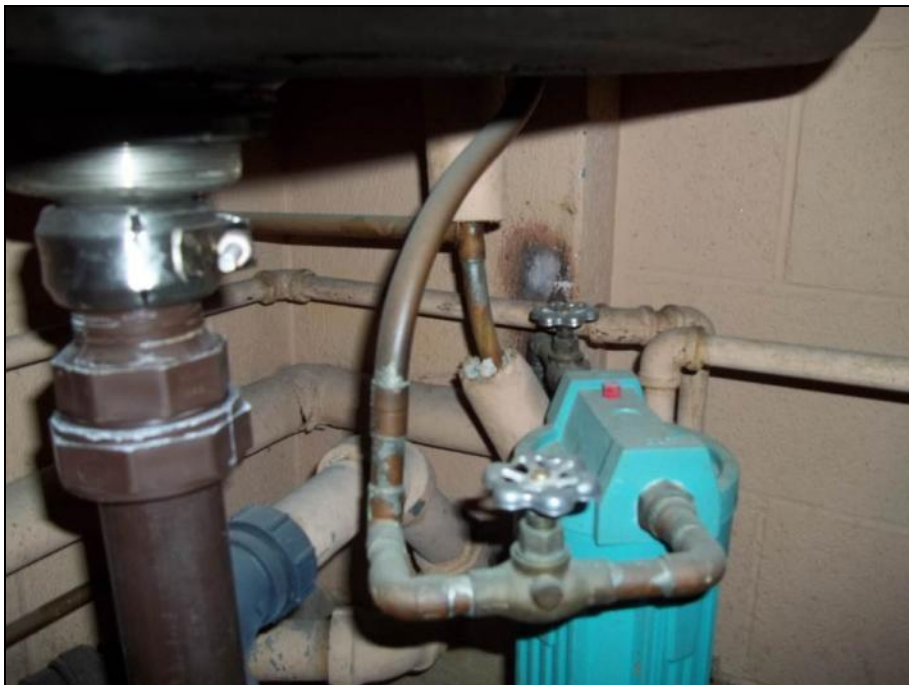
**Photograph 31: Room SN3006C. Asbestos containing pipe fittings located within a cupboard, in poor condition.**

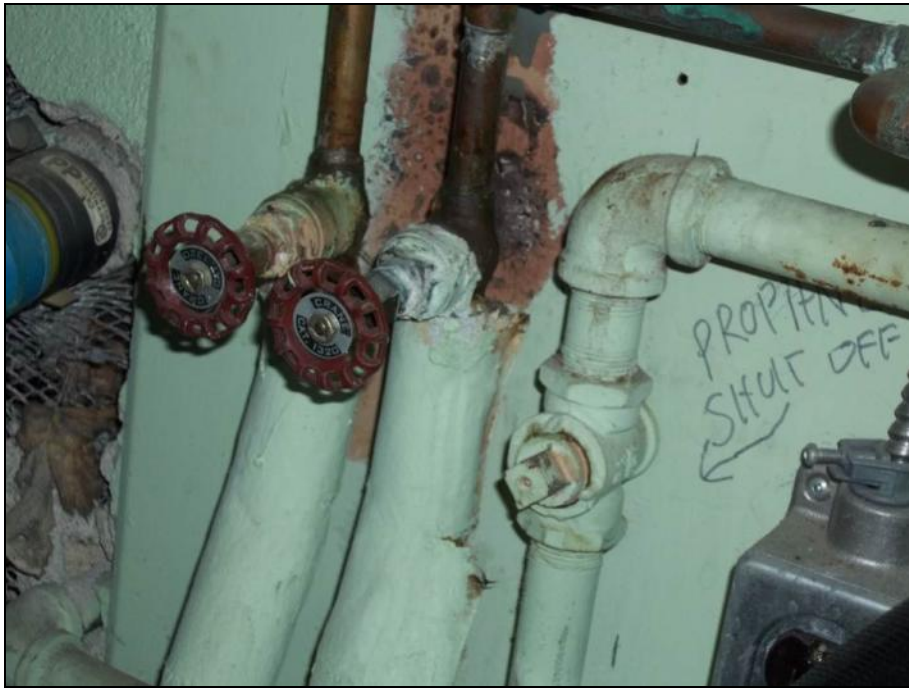
**Photograph 32: Room SN3023. Asbestos containing pipe fittings located within a cupboard, in poor condition**

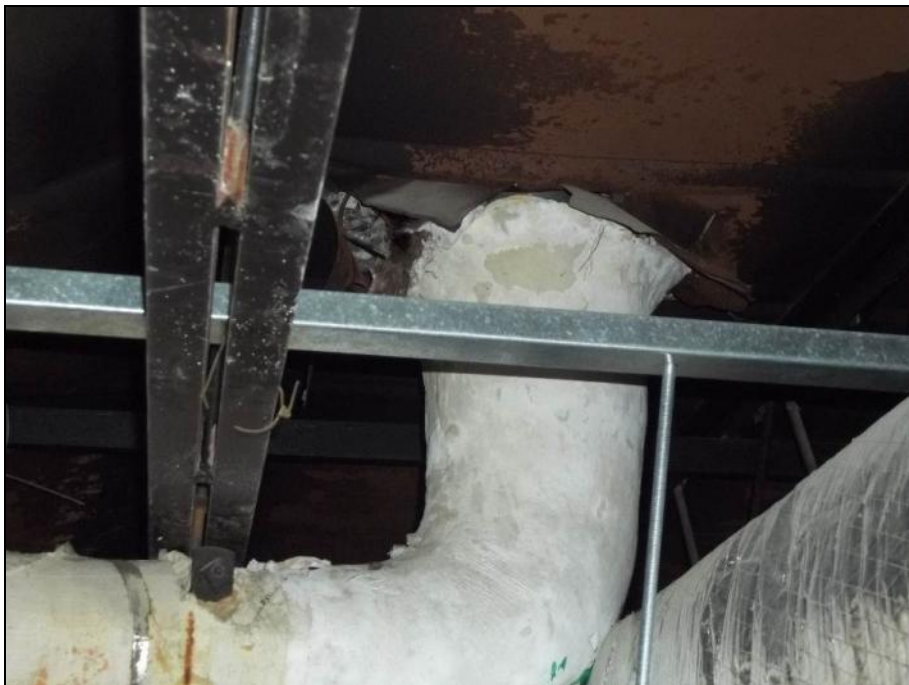
**Photograph 33: Room SN4117. Asbestos containing rain water leader, in poor condition**

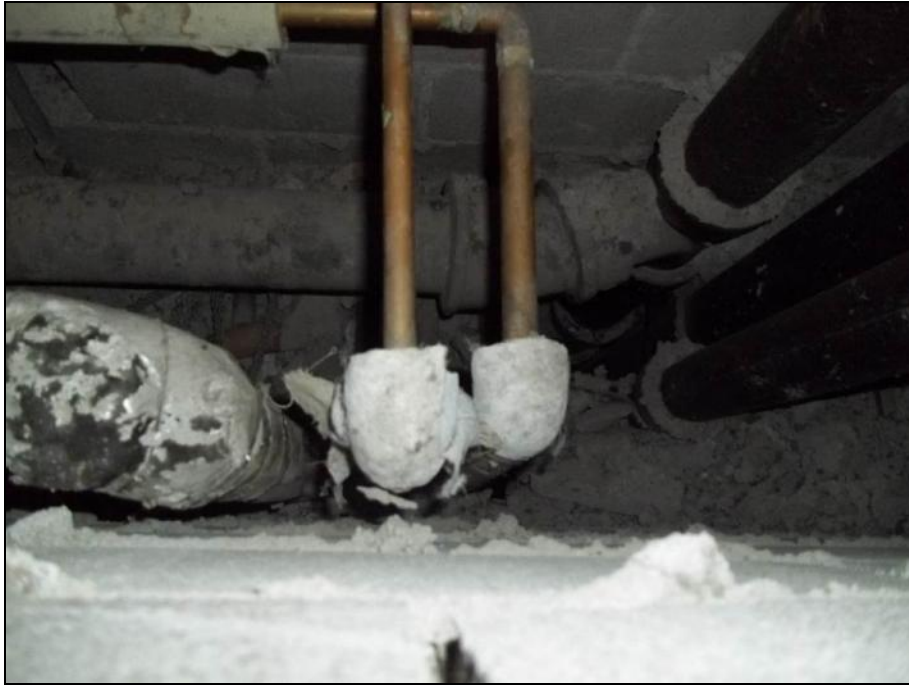
**Photograph 34: Room SN4002. Asbestos containing pipe fitting insulation, located within a wall hatch, in poor condition**

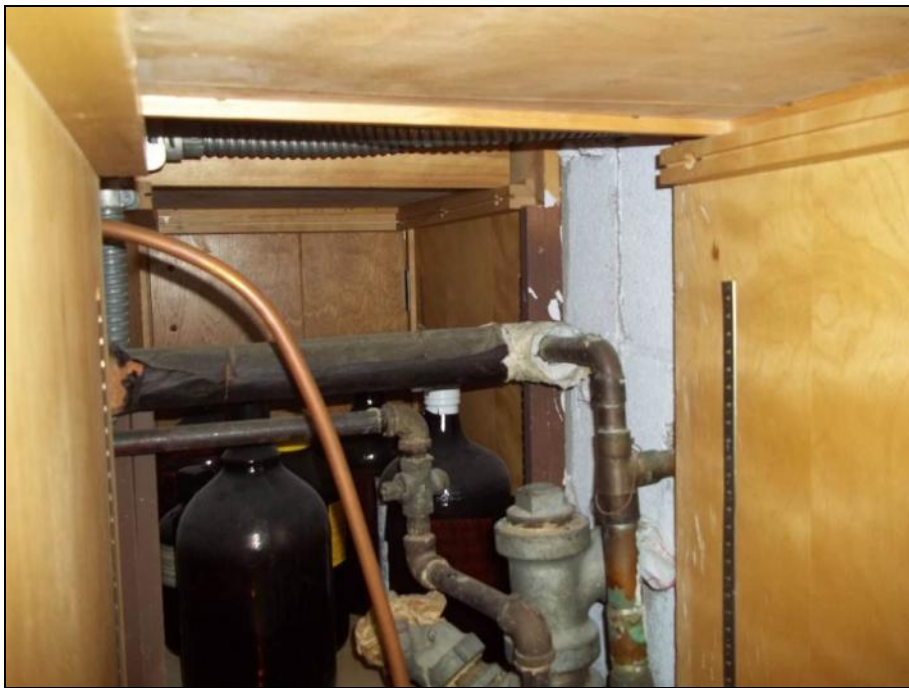
**Photograph 35: Room SN4020. Asbestos containing pipe fitting insulation, located within a cupboard, in poor condition**
