**Project #: 14610**

**ASBESTOS ASSESSMENT  
Science Building  
Memorial University of Newfoundland  
St. John's, NL**

**February 2012**

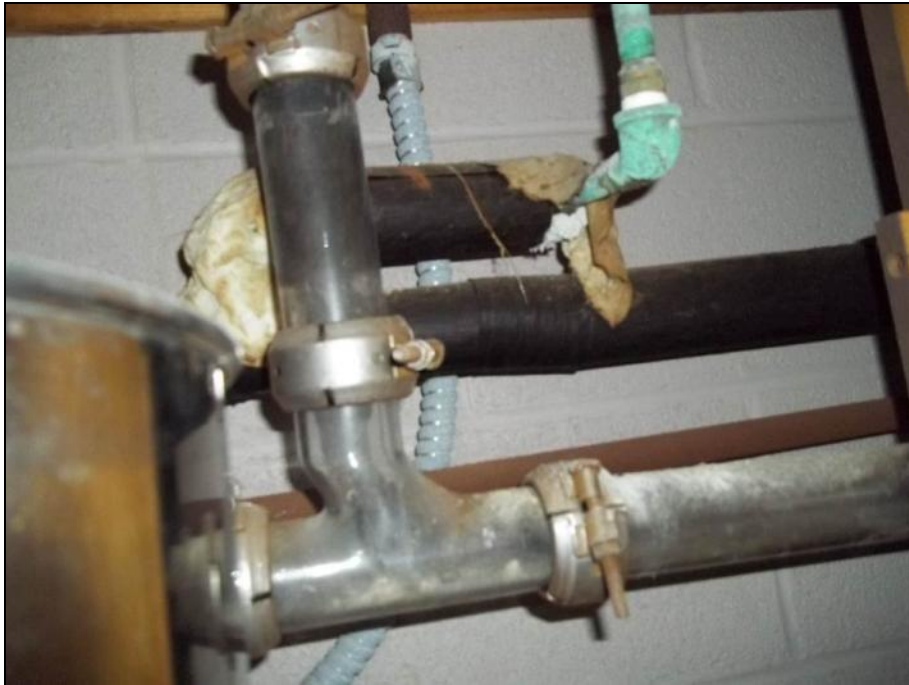
**Photograph 36: Room SN4020. Asbestos containing pipe fitting insulation, located within a cupboard, in poor condition.**

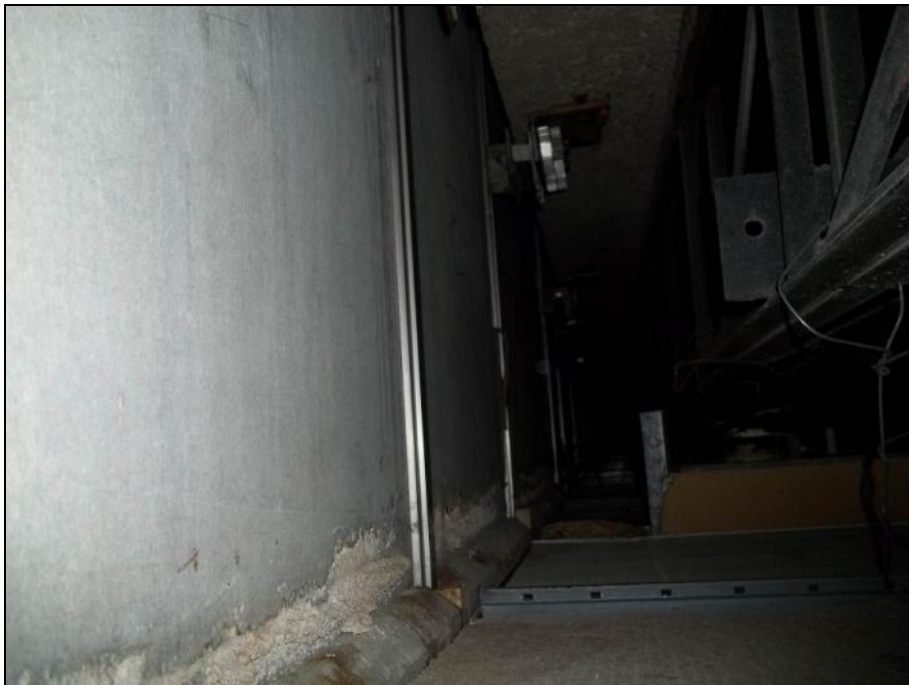
**Photograph 37: Room SN3125D. Asbestos containing transite panels on the exterior wall, above ceiling tiles.**

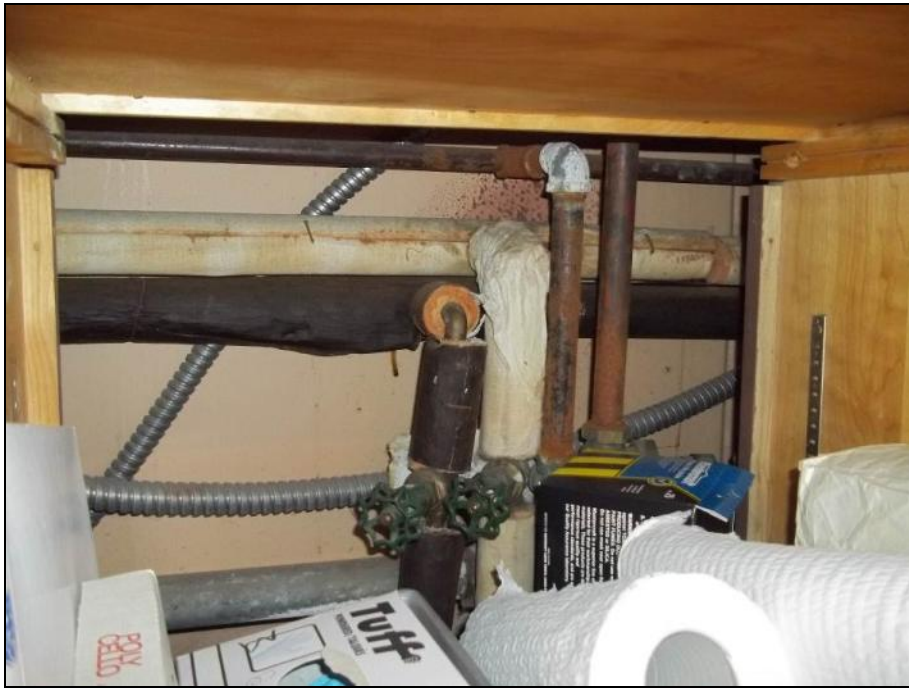
**Photograph 38: Room SN2092. Asbestos containing pipe fitting, located within a cupboard, in poor condition.**

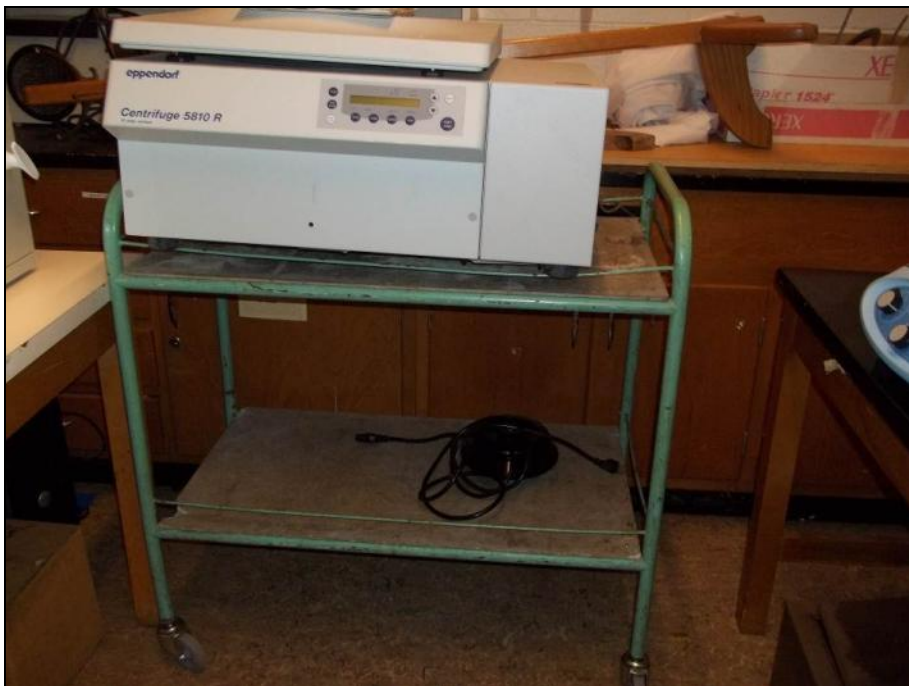
**Photograph 39: Room SN3119A. Asbestos containing transite cart, in poor condition**

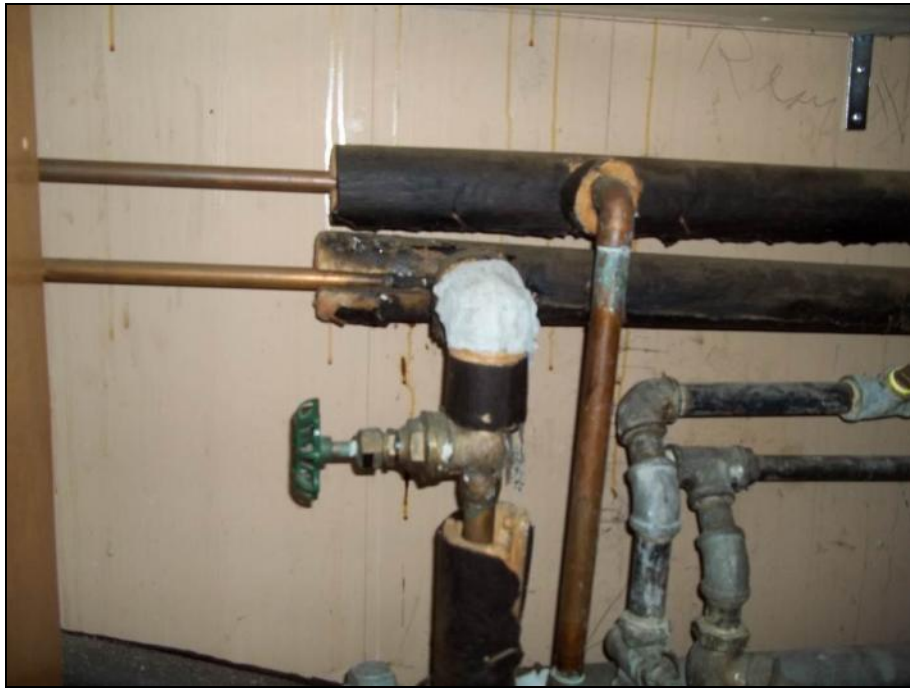
**Photograph 40: Room SN3109. Asbestos containing pipe fittings, located within a cupboard in poor condition**

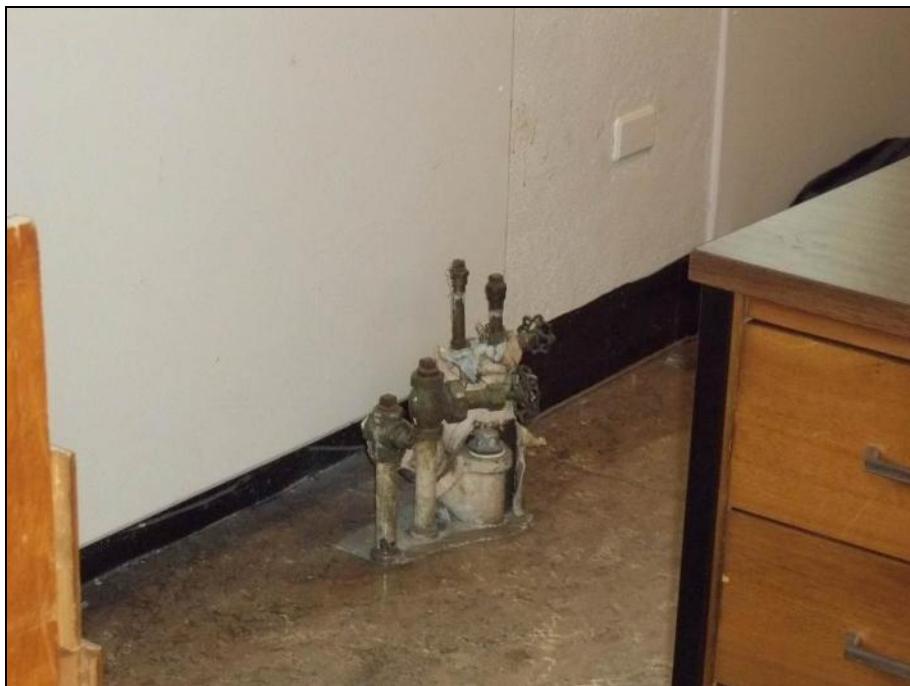
**Photograph 41: Room SN3112A. Asbestos containing pipe fittings, in poor condition**

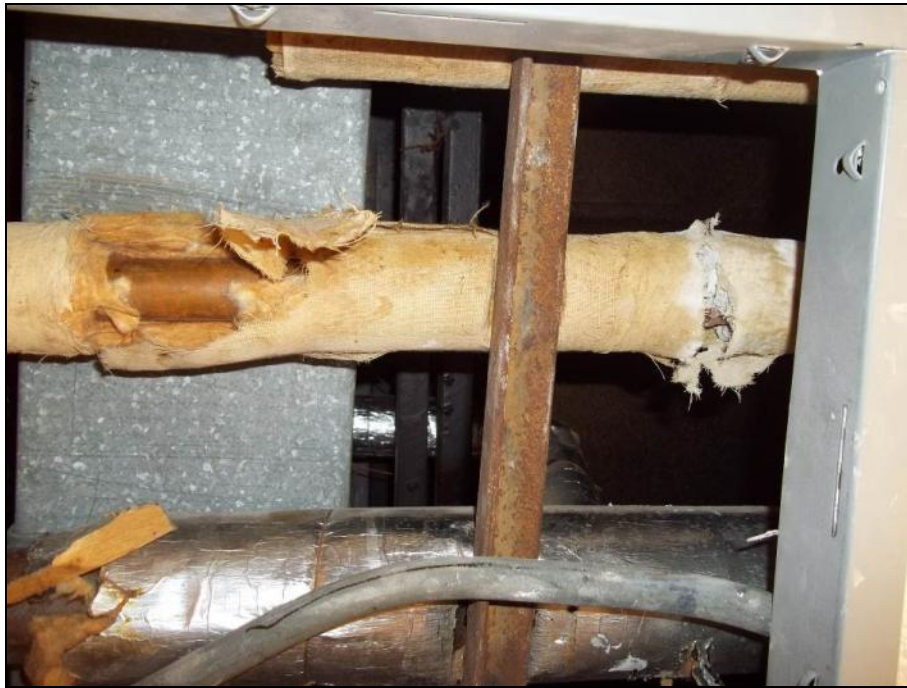
**Photograph 42: Room SN1066. Asbestos containing pipe fittings, located in the ceiling space within an access hatch, in poor condition**

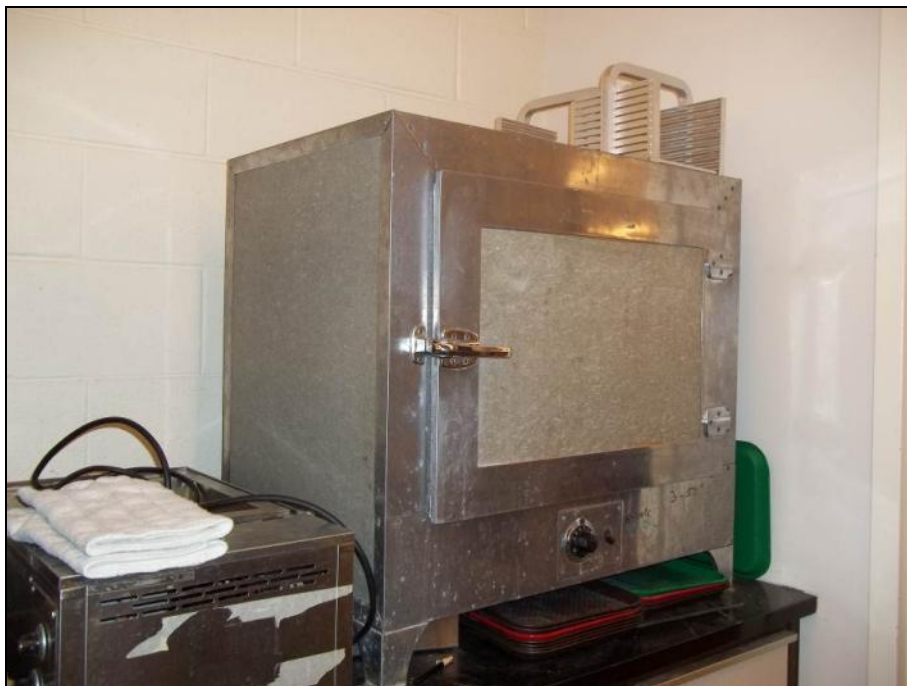
A suspect asbestos containing transite autoclave was observed in Room SN4098. A sample of this material was not available for collection. However, based on previous samples, this material should be treated as asbestos containing unless proven otherwise by subsequent testing. (See Photograph 43 in Appendix I)

**Photograph 43: Room SN4098. Suspect asbestos containing transite autoclave.**

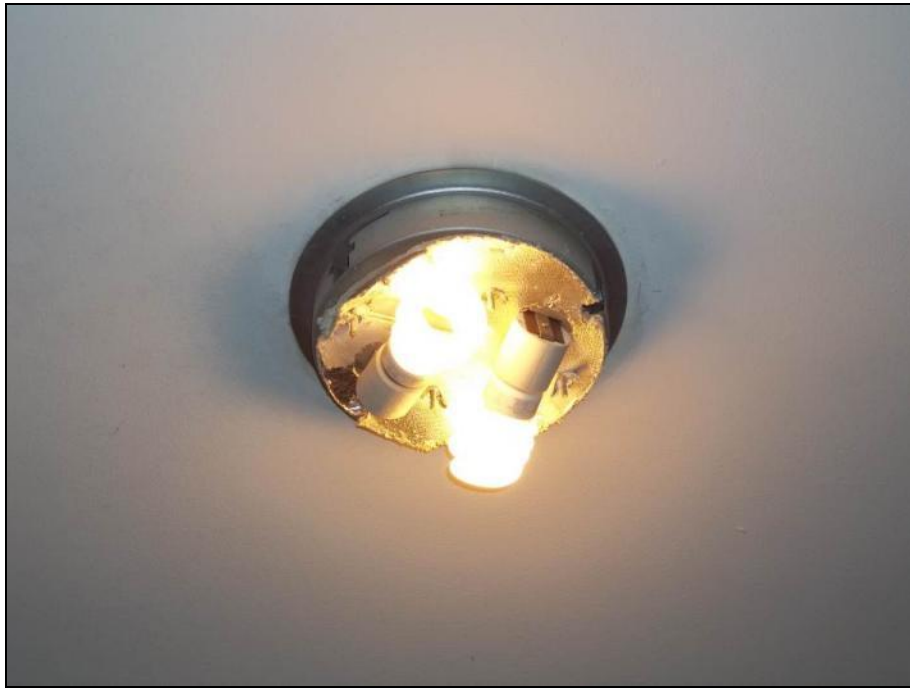
**Photograph 44: Room SN4090. Asbestos containing light fixture heat shield, in poor condition**

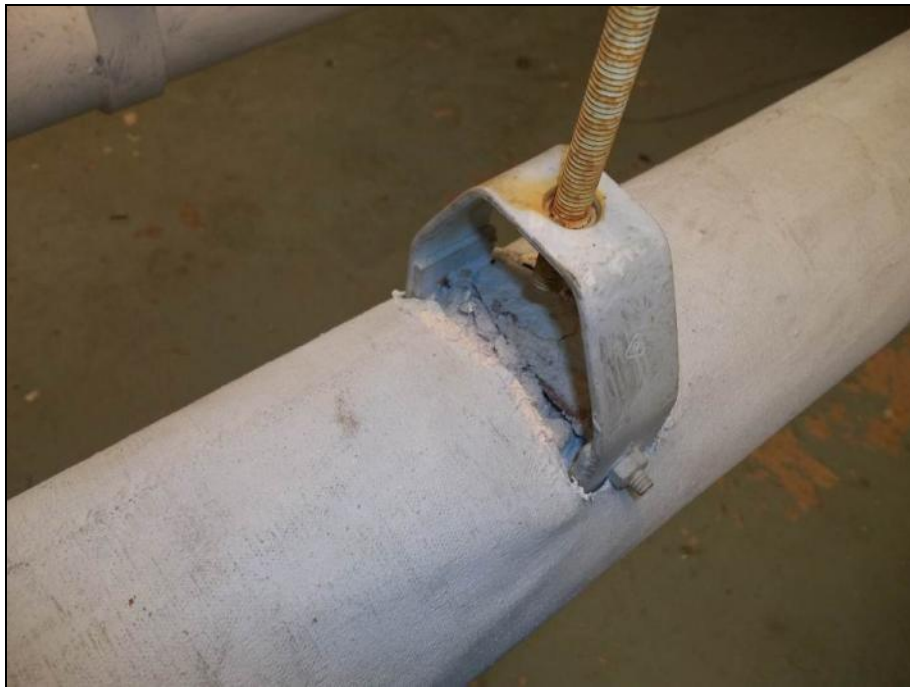
**Photograph 45: Room SN2048A. Asbestos containing pipe hanger insulation, in poor condition**

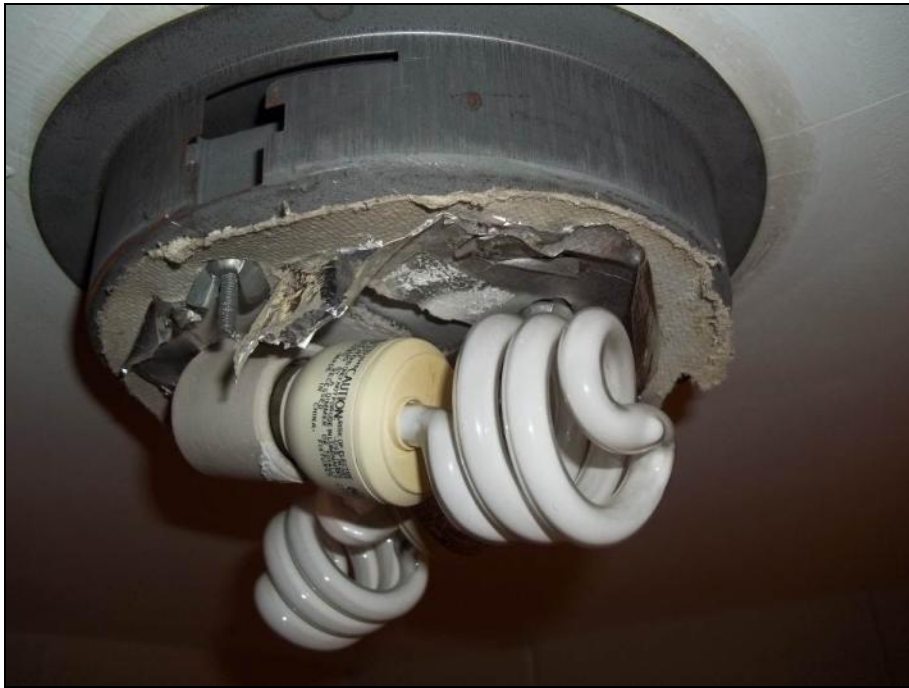
**Photograph 46: Room SN1030. Asbestos containing light fixture heat shield, in poor condition**

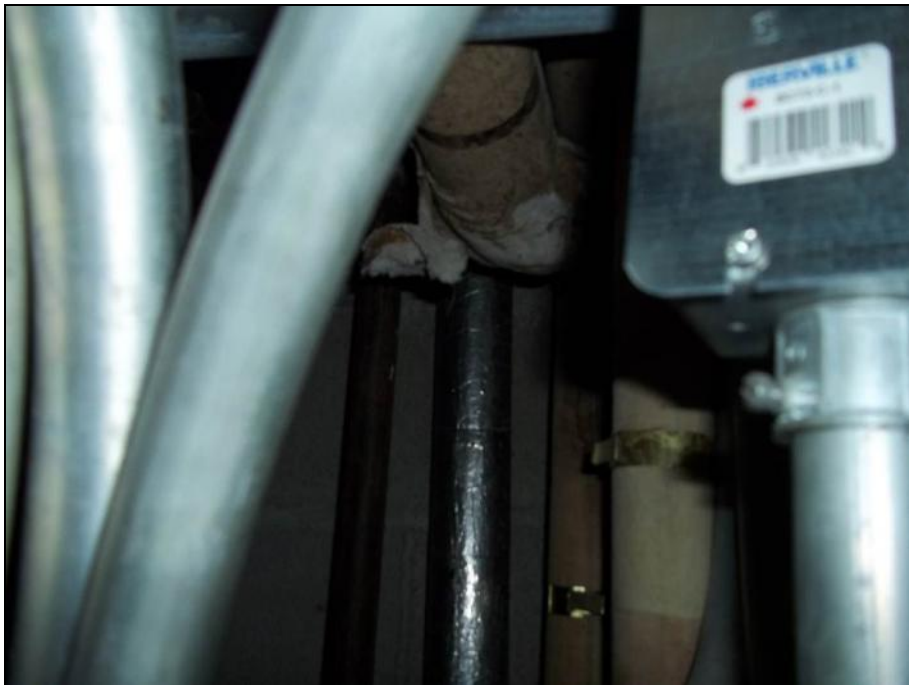
**Photograph 47: Hallway SN3C02. Asbestos containing pipe fitting, in poor condition**
