ASBESTOS AND LEAD PAINT BUILDING MATERIALS SURVEY FOR: SOUTH BOILER PLANT MEMORIAL UNIVERSITY OF NEWFOUNDLAND

Pinchin LeBlanc Environmental Ltd Project No. 02-02-00900

December 12, 2012

BUILDING DESCRIPTION: SOUTH BOILER PLANT

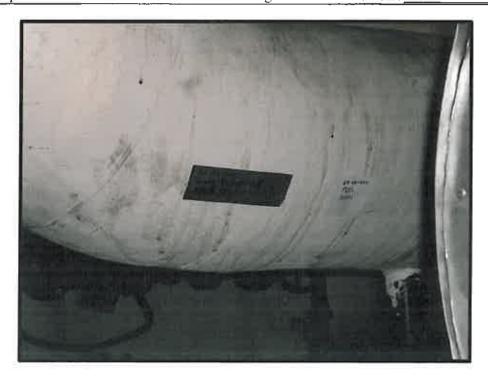
| ONIVERSIT | | | | | | |
|---|---|---|---|---|---|--|
| Sample #: | S001 | | Date Sampled: | September 21, 2012 | | |

One (1) sample of the straight insulation jacket on heat exchange # 12 was collected supply in room 1002. Analysis of the sample did not identify the presence of asbestos (reference sample 02-02-900-S001).

| Sample ID | Description | Asbestos | Fibrous | Non-Fibrous | Attributes |
|---|---|---|--|---|--|
| 02-02-900- S001 | Straight insulation jacket on heat exchange # 12 supply line | None Detected | 20% Cellulose 20% Synthetic Fibers Fiber Glass | 50% Other | Black, White Fibrous Heterogeneous |

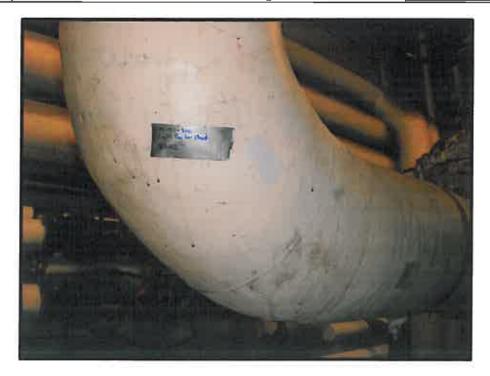
| UNIVERSIT | Y | | | | | | | | |
|---|---|---|---|---|---|--|--|--|--|
| Sample #: | S002 | | Date Sampled: | September 21, 2 | 2012 | | | | |

Insulating cement, also referred to as "parging cement", present on pipe elbows and pipe straight sections was sampled from room 1018 and contains 15% Chrysotile in the sample (reference samples 02-02-900-S003, 02-02-900-S004 02-02-900-S006). For locations and conditions of this material at the time of the building survey refer to location & data excel document.

| Sample ID | Description | Asbestos | Fibrous | Non-Fibrous | Attributes |
|---|---|---|--|---|--|
| 02-02-900- S002 | Parging cement on elbows/fittings on heat exchange# 12 supply lines | 15% Chrysotile | | 85% Other | White Fibrous Heterogeneous |

- 1. Type III (high risk) asbestos abatement procedures should be carried out for the scheduled removal of greater than 1ft² of friable asbestos containing materials. Alternatively, Type II (moderate risk) glove bag abatement procedures may be applied where practical;
- 2. Type II (moderate risk) asbestos abatement procedures should be carried out for the scheduled repair or enclosure of friable ACMs or for the removal of less than 1ft² of material;

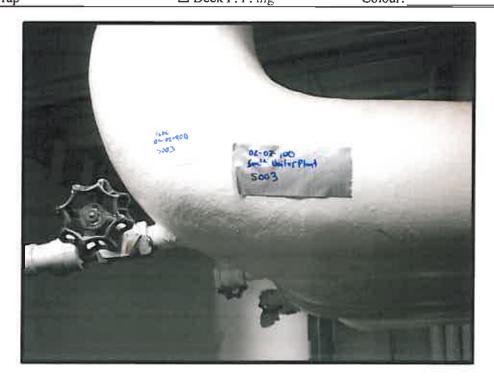
| 01411 2011011 | | | | | | |
|---|---|---|---|---|---|--|
| Sample #: | S003 | | Date Sampled: | September 21, 2012 | | |

| Sample ID | Description | Asbestos | Fibrous | Non-Fibrous | Attributes |
|---|---|---|--|---|--|
| 02-02-900- S003 | Pipe elbow parging cement secondary loop lines | 15% Chrysotile | | 85% Other | White Fibrous Helerogeneous |

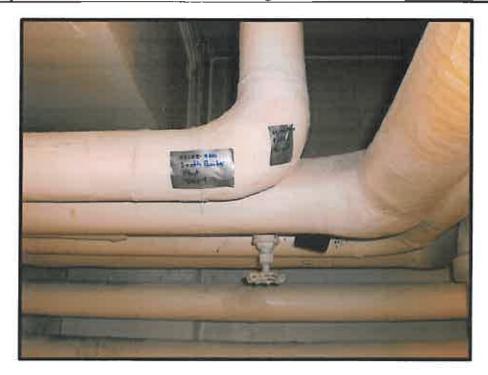
| DIALAEKSII | I | | | | | |
|---|---|---|---|---|---|--|
| Sample #: | S004 | | Date Sampled: | September 21, 2012 | | |

| Sample ID | Description | Asbestos | Fibrous | Non-Fibrous | Attributes |
|---|---|---|--|---|--|
| 02-02-900- S004 | Pipe parging cement on building water lines | 15% Chrysotile | | 85% Other | White Fibrous Heterogeneous |

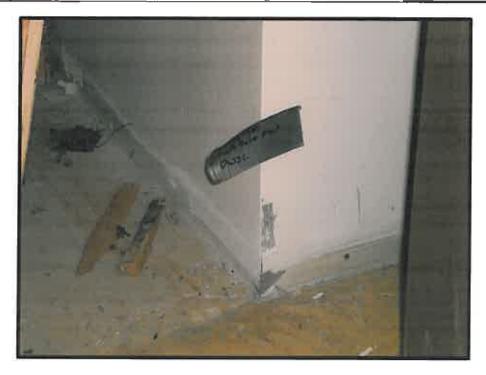
| V1111 0 011 V 11 | 1 | | | | |
|---|---|---|---|---|---|
| Sample #: | S005 | | Date Sampled: | September 21, 2 | 2012 |

Three (3) samples of drywall joint compound were collected in the site building. Analysis of these samples did not identify the presence of asbestos (reference samples 02-02-900-S005, S011, and S014).

| Sample ID | Description | Asbestos | Fibrous | Non-Fibrous | Attributes |
|---|---|---|--|---|--|
| 02-02-900- S005 | DWJC | None Detected | | 100% Other | White Non Fibrous Homogeneous |

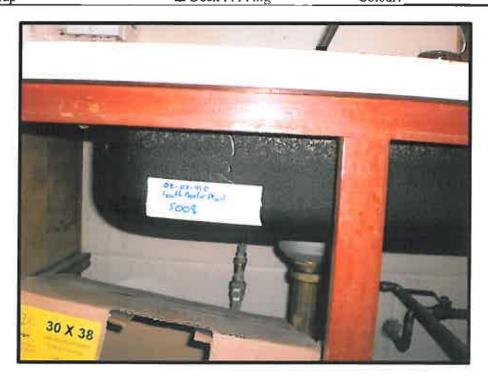
| Sample #: | S008 | | Date Sampled: | September 21, 2 | 2012 |

Two (2) samples were collected of tar mastics on the sinks throughout the site building. Results from one (1) of the two (2) samples indicate the presence of 3% chrysotile asbestos (reference sample 02-02-900-S008). For locations and conditions of this material at the time of the building survey refer to location & data excel document.

| Sample ID | Description | Asbestos | Fibrous | Non-Fibrous | Attributes |
|---|---|---|--|---|--|
| 02-02-900- S008 | Black sink liner | 3% Chrysotile | | 97% Other | Black Non Fibrous Heterogeneous |

- 1. Type I (low risk) asbestos abatement procedures should be carried out for the scheduled disturbance of any non-friable materials provided the materials can be removed intact, and without the use of powered hand tools.
- 2. Should the use of powered hand tools or excessive breakage of the materials become necessary, Type II (moderate risk) asbestos abatement procedures should be adopted.
