### ASBESTOS AND LEAD PAINT BUILDING MATERIALS SURVEY FOR: ST. JOHN'S COLLEGE MEMORIAL UNIVERSITY OF NEWFOUNDLAND

Prepared for: Memorial University of Newfoundland

Pinchin LeBlanc Environmental Ltd Project No. 02-02-00900

June 19, 2013

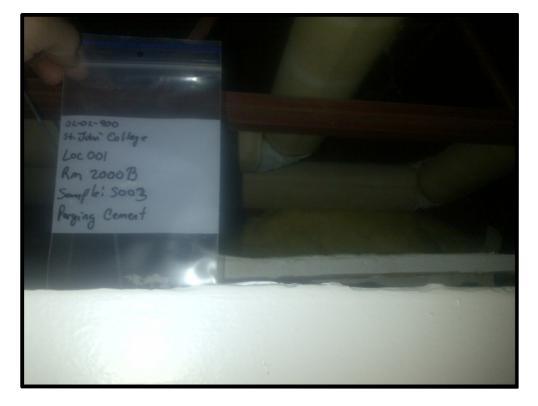
Insulating cement, also referred to as "parging cement", present on pipe elbows, fittings and as tank insulation in the site building was sampled in two locations and contains 30% Chrysotile asbestos (reference samples 02-02-900-S003, 02-02-900-S026 and 02-02-900-S047). For locations and conditions of this material at the time of the building survey refer to location & data excel document.

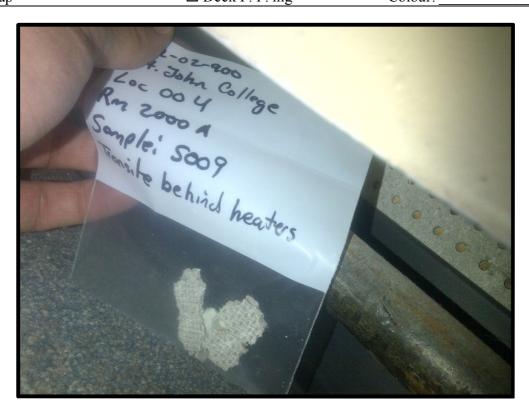
One (1) sample of transite sheeting was sampled from an office room 2000A and contains 15% chrysotile asbestos (reference sample 02-02-900-S009). For locations and conditions of this material at the time of the building survey refer to location & data excel document.

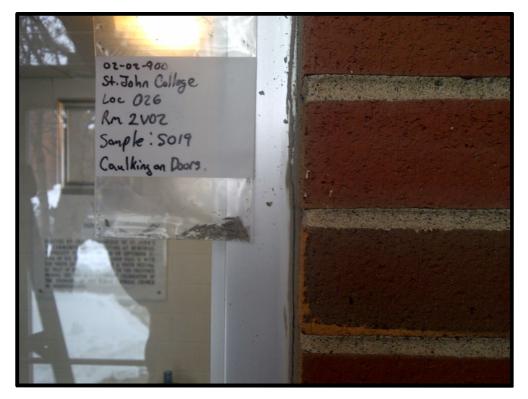
One (1) sample of door caulking was sampled from the exterior of the building and contains 3% chrysotile asbestos (reference sample 02-02-900-S019). For locations and conditions of this material at the time of the building survey refer to location & data excel document.

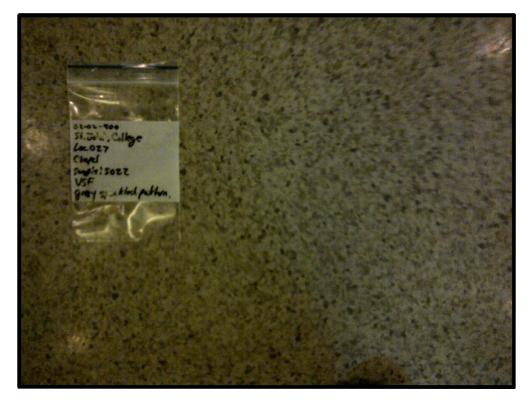
Asbestos Containing Vinyl Sheet Flooring							
St. John's College Building							
Sample NumberLocationDescriptionAsbestos (%)							
02-02-900-S013-В	Room 2001	Light Grey with Grey and White Flecks (mastic only)	4%				
02-02-900-S022-В	Room 2025	Grey Speckled Pattern (mastic only)	3%				
Ear locations and cond	For locations and conditions of these metarials at the time of the building survey refer to location

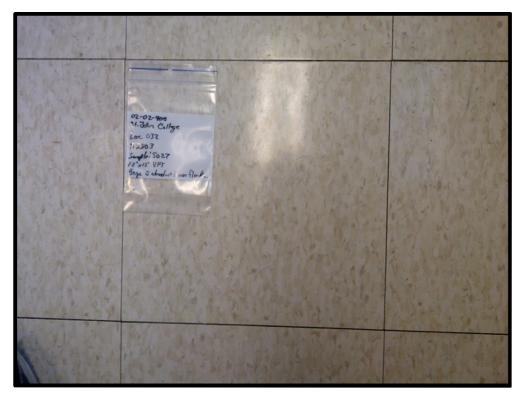
- One (1) sample of the 12"x12" vinyl floor tile identified with abundant brown flecks was sampled from the stairwell (Room 2S03). Analysis of the sample did not identify the presence of asbestos 02-02-900-S027-A and 02-02-900-S027-B).
- One (1) sample of the 12"x12" vinyl floor tile identified as green was sampled from the closet (Room 4009) and that the mastic contains 5% chrysotile asbestos (reference sample 02-02-900-S038-B). Analysis of the tile portion of the sample did not identify the presence of asbestos. For locations and conditions of this material at the time of the building survey refer to location & data excel document.
- One (1) sample of the 12"x12" vinyl floor tile identified as blue with grey flecks was sampled from the archive room (Room 1000). Analysis of the sample did not identify the presence of asbestos (reference samples 02-02-900-S045-A and 02-02-900-S045-B).

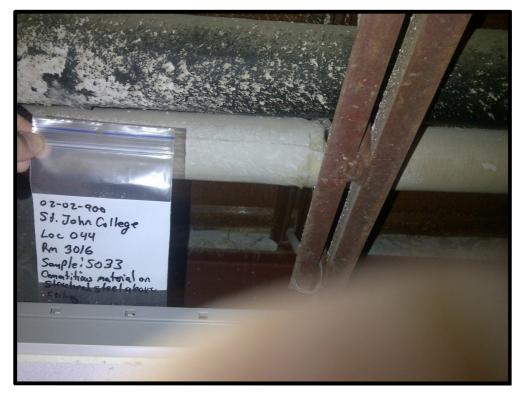
One (1) sample of cementious material on structural steel above the ceiling was sampled from an office (Room 3016) and contains 5% chrysotile asbestos (reference sample 02-02-900-S033). For locations and conditions of this material at the time of the building survey refer to location & data excel document.
