**ASBESTOS AND LEAD PAINT BUILDING MATERIALS SURVEY FOR:
THE VIVARIUM
MEMORIAL UNIVERSITY OF NEWFOUNDLAND**

Prepared for:
Memorial University of Newfoundland
St. John's, NL

Pinchin LeBlanc Environmental Ltd
Project No. 02-02-00900

March 20, 2013

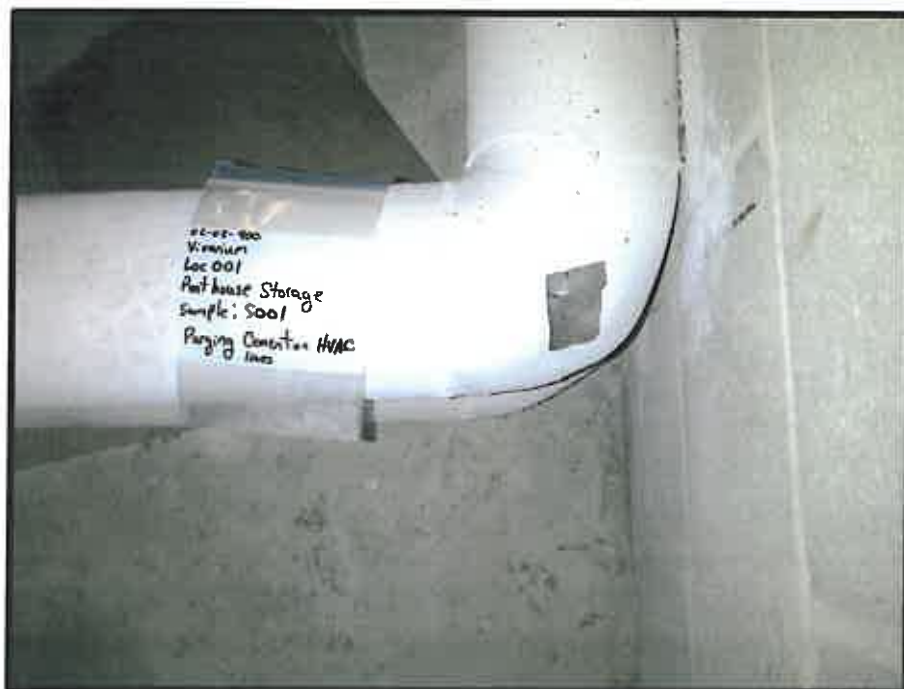
Sample #:	S001	Date Sampled:	February 11, 2013	
Building :	Vivarium	Sampler:	Trent Hardy	
Location:	001, room V2	Analysis:	SAI - PLM	
MUN Project #:	02-02-900	Work Order #:

Parging cement present cement on elbows and fittings of the HVAC lines was sampled from room V2 of the parging. Analysis of the sample did not identify the presence of asbestos (reference sample 02-02-900-S001).

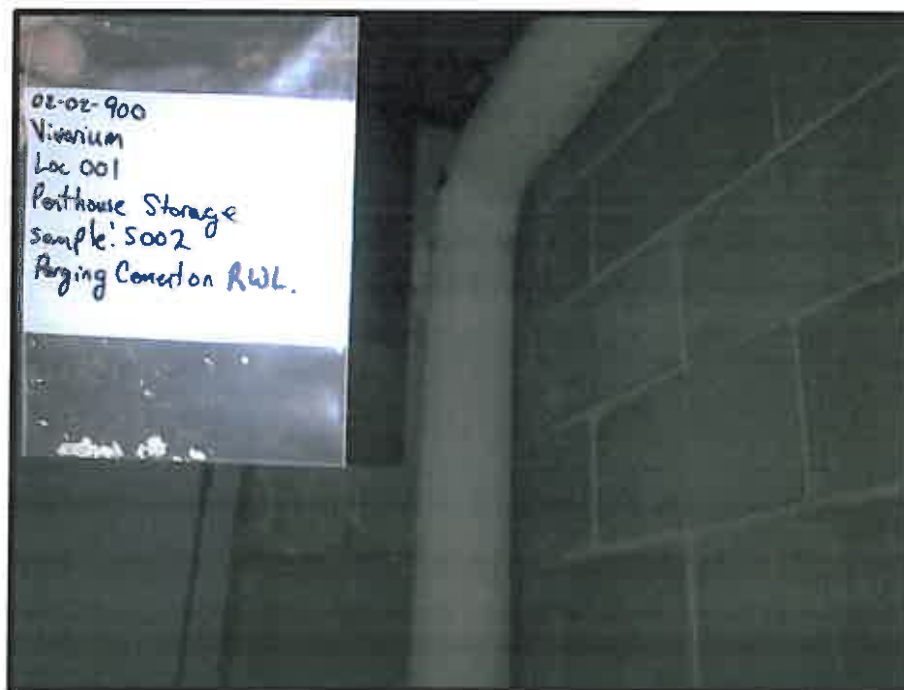
Sample #:	S002	Date Sampled:	February 11, 2013
Building :	Vivarium	Sampler:	Trent Hardy
Location:	001, room V2	Analysis:	SAI - PLM
MUN Project #:	02-02-900	Work Order #:

Insulating cement, also referred to as “parging cement”, present on pipe elbows for rain water leads was sampled in room V2 and contains 10% chrysotile asbestos (reference sample 02-02-900-S002). For locations and conditions of this material at the time of the building survey refer to location & data excel document.

1. Type III (high risk) asbestos abatement procedures should be carried out for the scheduled removal of greater than 1 ft² of friable asbestos containing materials. Alternatively, Type II (moderate risk) glove bag abatement procedures may be applied where practical;
2. Type II (moderate risk) asbestos abatement procedures should be carried out for the scheduled repair or enclosure of friable ACMs or for the removal of less than 1 ft² of material;

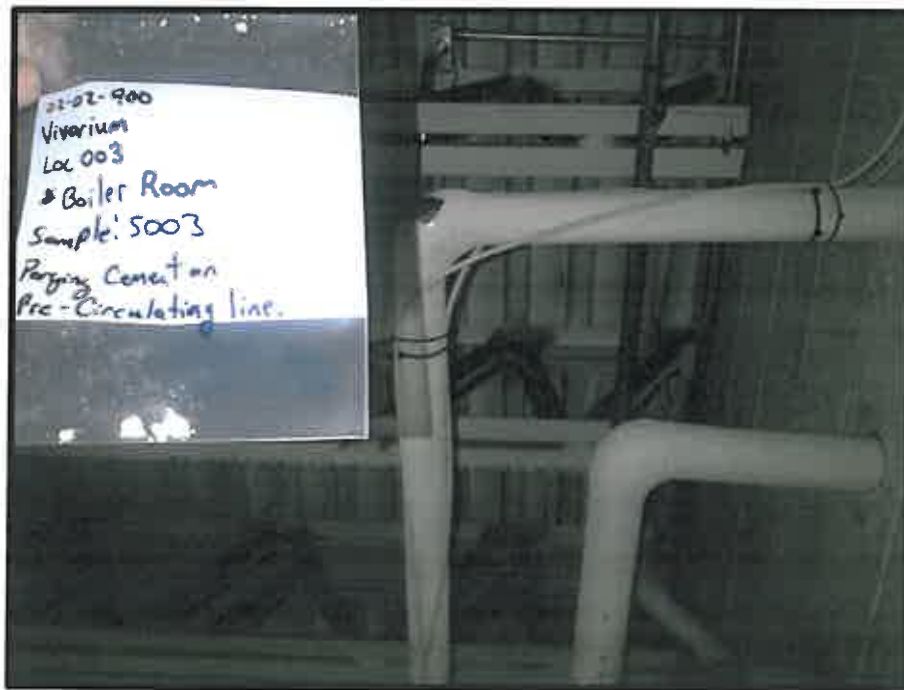
Sample #:	S003	Date Sampled:	February 11, 2013
Building :	Vivarium	Sampler:	Trent Hardy
Location:	003, boiler room	Analysis:	SAI - PLM
MUN Project #:	02-02-900	Work Order #:

Parging cement present on the re-circulating line was sampled from room V15 and contains 10% chrysotile asbestos (reference sample 02-02-900-S003). For locations and conditions of this material at the time of the building survey refer to location & data excel document.

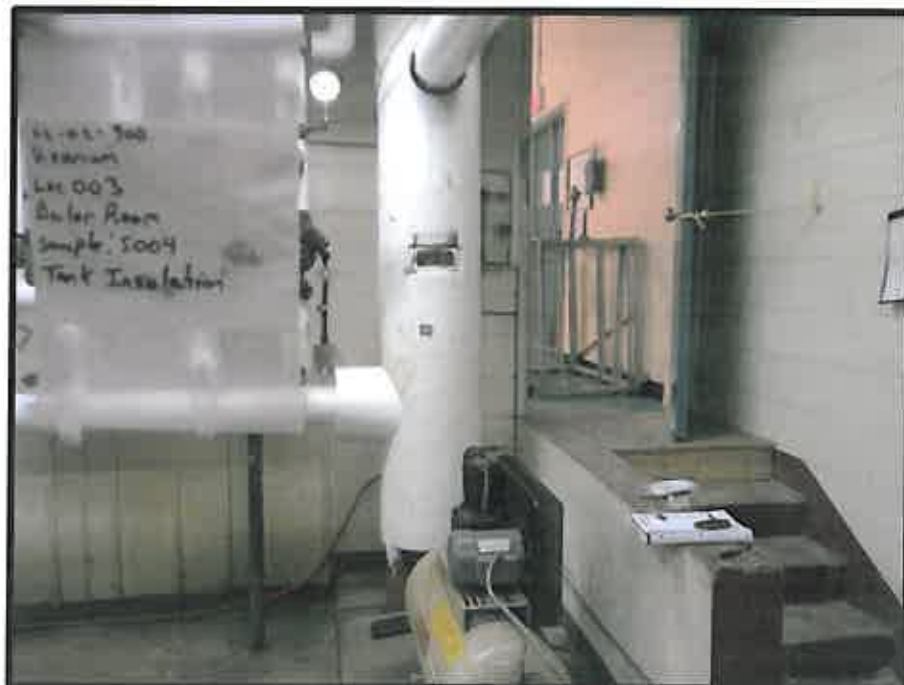
Parging cement present on the tank was sampled from room V15 and contains 10% chrysotile asbestos (reference sample 02-02-900-S004). For locations and conditions of this material at the time of the building survey refer to location & data excel document.

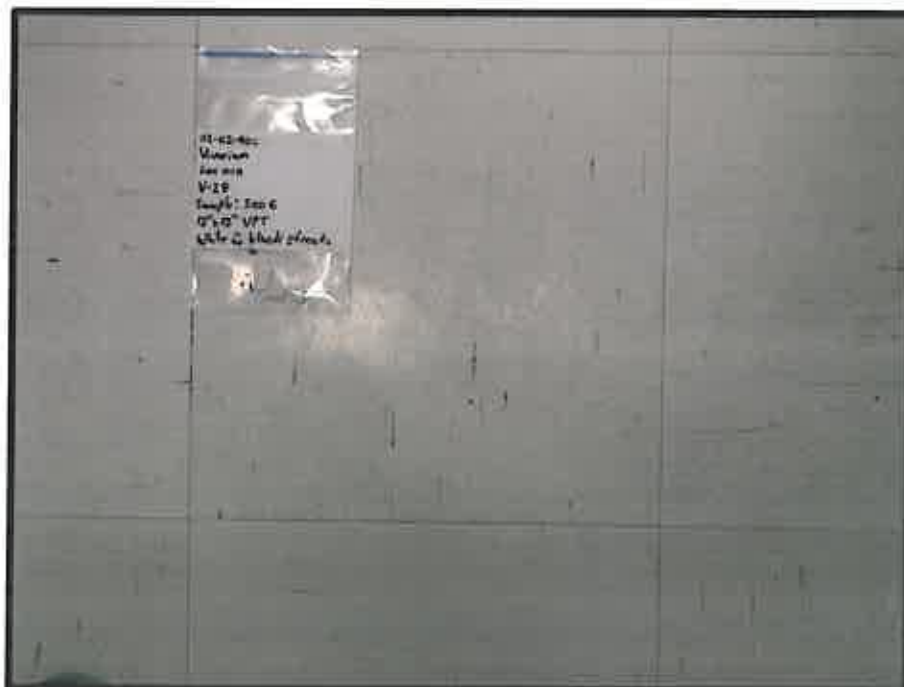
Sample #:	S006	Date Sampled:	February 11, 2013
Building :	Vivarium	Sampler:	Trent Hardy
Location:	010, room V28	Analysis:	SAI - PLM
MUN Project #:	02-02-900	Work Order #:

- One (1) sample of the 12"x12" vinyl floor tile identified as white with black streak was collected from room V28. Analysis of this sample and associated tar mastic adhesive did not identify the presence of asbestos (reference sample 02-02-900-S006).
- One (1) sample of the 12"x12" vinyl floor tile identified as white with abundant brown fleck was collected from room V32. Analysis of this sample and associated tar mastic adhesive did not identify the presence of asbestos (reference sample 02-02-900-S011).

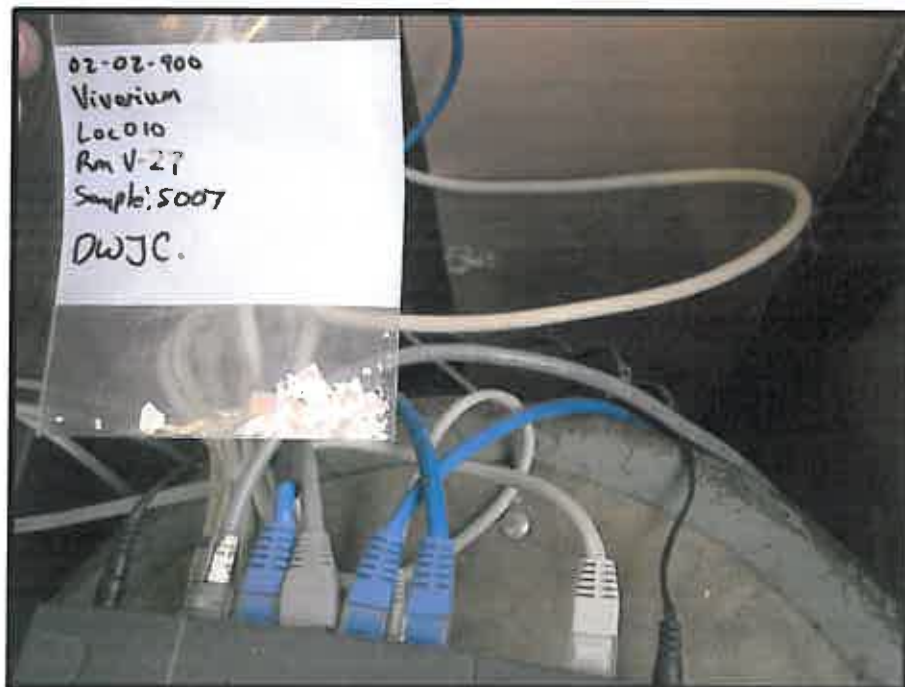
Sample #:	S007	Date Sampled:	February 11, 2013
Building :	Vivarium	Sampler:	Trent Hardy
Location:	010, room V27	Analysis:	SAI - PLM
MUN Project #:	02-02-900	Work Order #:

Four (4) samples of drywall joint compound were collected in the Site Building. Results from three (3) of the four (4) samples indicate 3% chrysotile asbestos (reference samples, 02-02-900-S007, S012, S013, and S014).

1. Type I (low risk) asbestos abatement procedures should be carried out for the scheduled disturbance of any non-friable materials provided the materials can be removed intact, and without the use of powered hand tools.

2. Should the use of powered hand tools, or excessive breakage of the materials become necessary, Type II (moderate risk) asbestos abatement procedures should be adopted.
