Project #: 13916

ASBESTOS ASSESSMENT Guy Court Memorial University of Newfoundland St. John's, NL

September 2011

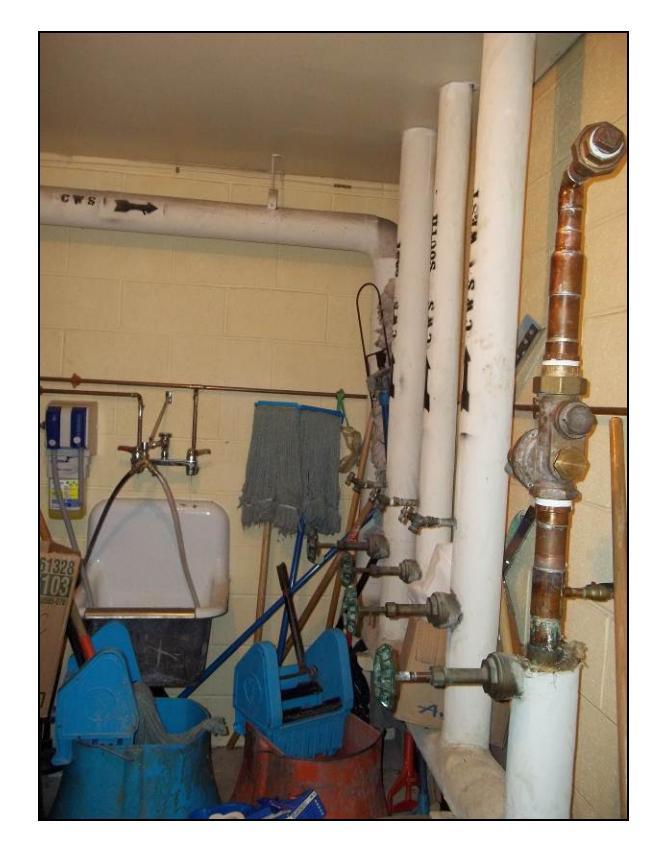
Two types of pipe fitting insulation which could potentially contain asbestos were observed in select areas throughout the building during this assessment. Samples were collected of fitting insulation in the hallways and a mechanical room and analyzed for asbestos content using the PLM method of detection. The sample from the hallway was identified as non-asbestos containing. The sample in the mechanical room was found to contain 80% Chrysotile asbestos. (see samples GY-1, GY-19 in Appendix II, Photograph 1 Appendix I)

Photograph 1: Sample GY-19, asbestos containing pipe fitting insulation in Room GY112.

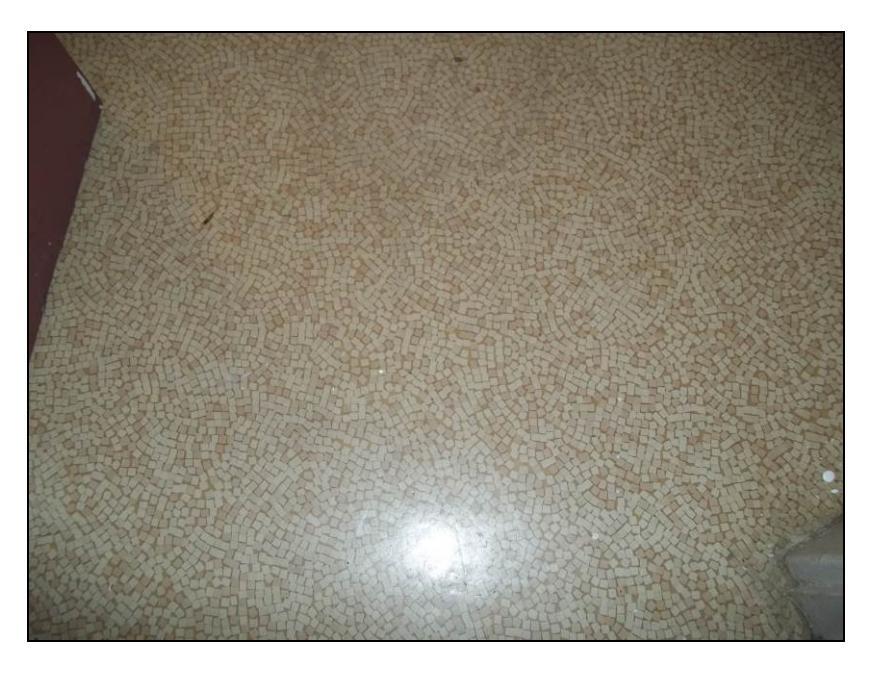
Photograph 2: Sample GY-5, asbestos containing vinyl sheet flooring.

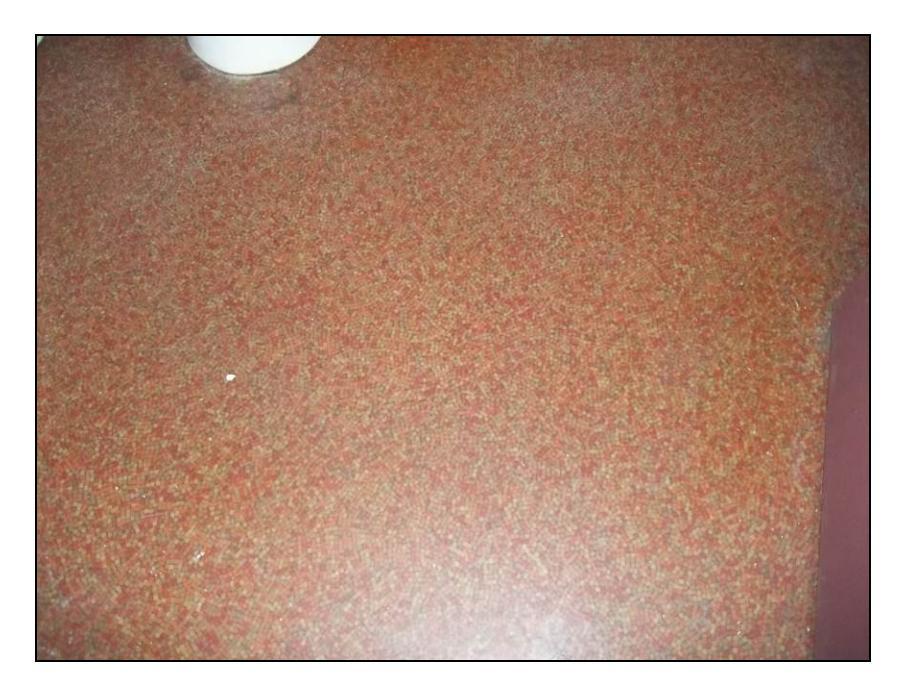
Photograph 3: Sample GY-9, asbestos containing vinyl sheet flooring.

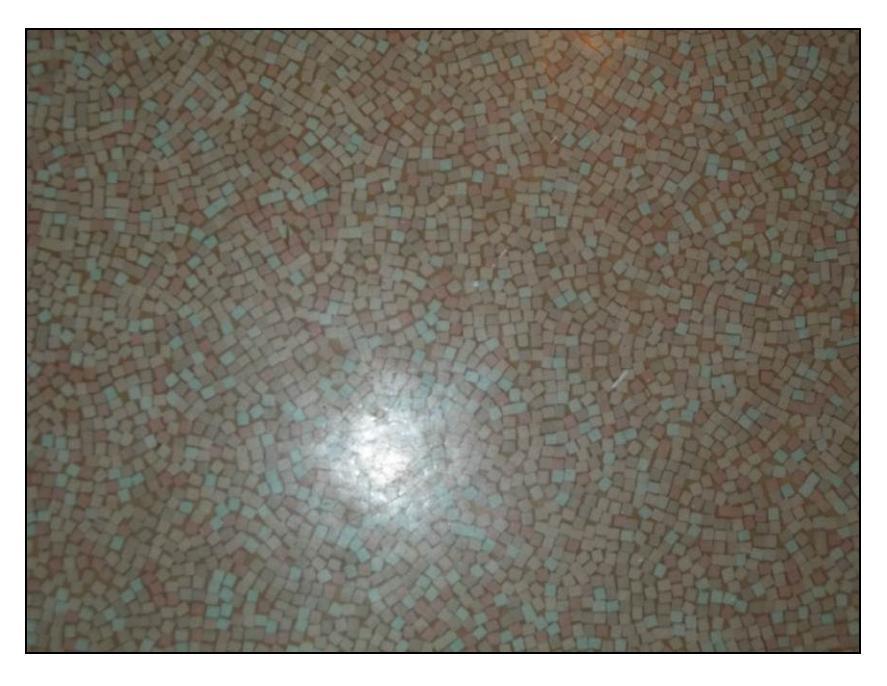
Photograph 4: Sample GY-12, asbestos containing vinyl sheet flooring

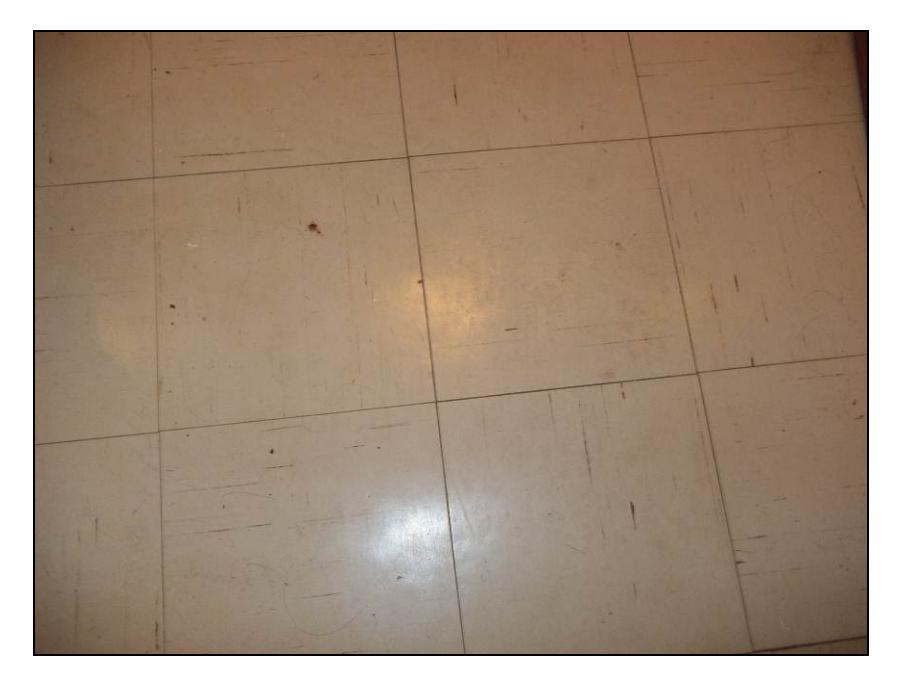
Photograph 5: Sample GY-2. The floor is non-asbestos containing, the mastic contains 3% Chrysotile asbestos.

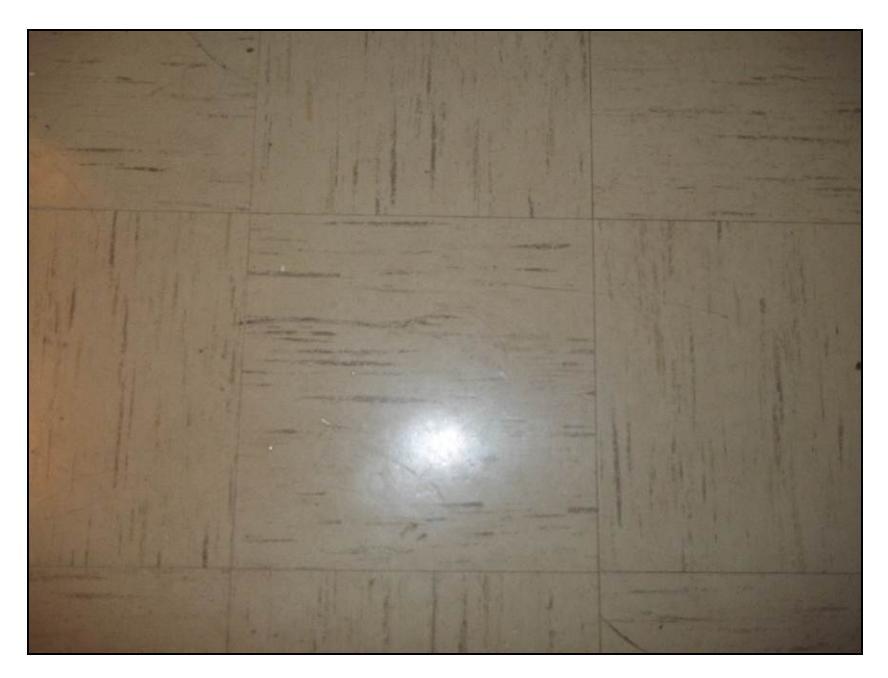
Photograph 6: Sample GY-3, asbestos containing floor tile.

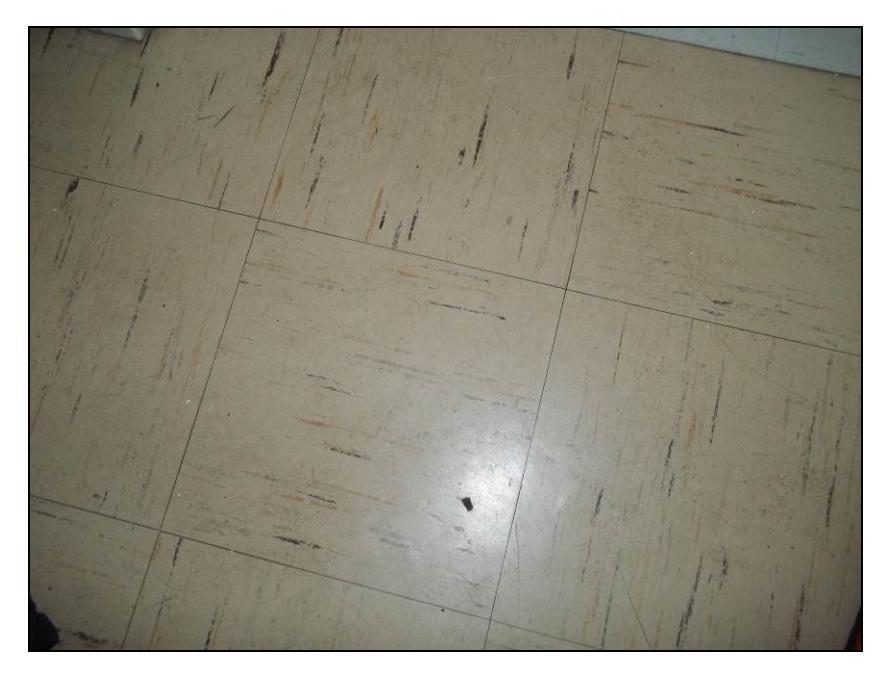
Photograph 7: Sample GY-7, asbestos containing floor tile.

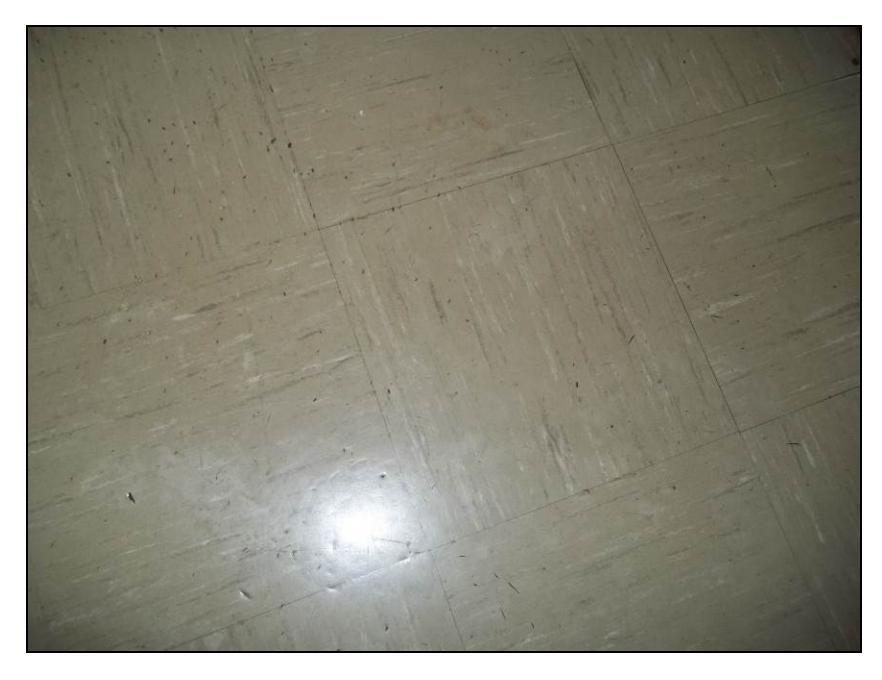
Photograph 8: Sample GY-11, asbestos containing floor tile.
