# Provincial Archaeology Office Annual Review

Provincial Archaeology Office  
Department of Tourism, Culture, Arts and Recreation  
Government of Newfoundland and Labrador  
April 2023 Volume 21

# Archaeology at Ferryland 2022

Barry Gaulton  
Memorial University

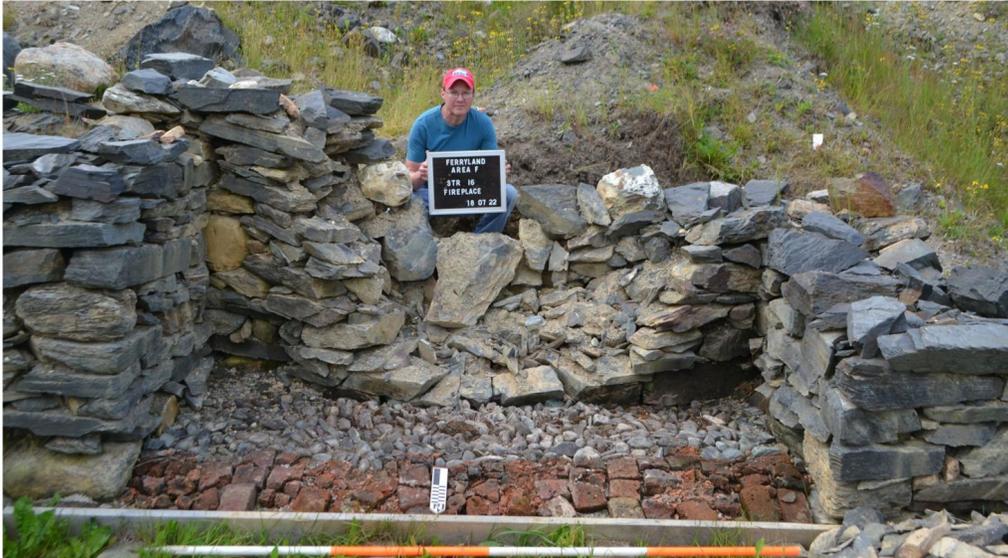
Figure 1: Collapsed back wall of the Mansion House (Structure 16) fireplace, looking south, after displaced wall rocks were removed.

The 2022 field season at Ferryland began with the repair of several extant stone wall features that partially collapsed over the previous winter. Even though many of the 17th-century remnants of the Ferryland colony are quite stable, and we protect at-risk features such as fireplaces with tarps each fall, some damage is to be expected over time due to freeze-thaw, intense storms, and other factors. The most notable feature that required attention was the large fireplace associated with the colony's principal dwelling or 'Mansion House' built in the 1620s and occupied by George Calvert, David Kirke, Sara Kirke, and other members of the Kirke family until 1696. Repairs to the back wall of the Mansion House (designated Structure 16) fireplace necessitated that we first remove dozens of large wall rocks that had pushed forward and collapsed onto the hearth floor due to pressure from infill directly behind the fireplace — fill which had been dumped there during the final construction phase of the Mansion House when a massive builder's trench was capped off with upwards of two metres of clay, gravel and rock. To facilitate the restoration of the fireplace to the condition in which it was first uncovered/recorded, we also excavated a 0.5m

by 4m trench behind this feature (Figures 1-2). The excavation trench allowed us to expose the lowest courses of intact wall upon which to rebuild, and to remove the adjacent clay and rock infill to alleviate future pressure upon the newly rebuilt fireplace. Unsurprisingly, the infill deposit contained scattered bits of building material such as brick, slate roofing tile and chunks of limestone, along with occasional ceramic and glass fragments (for additional

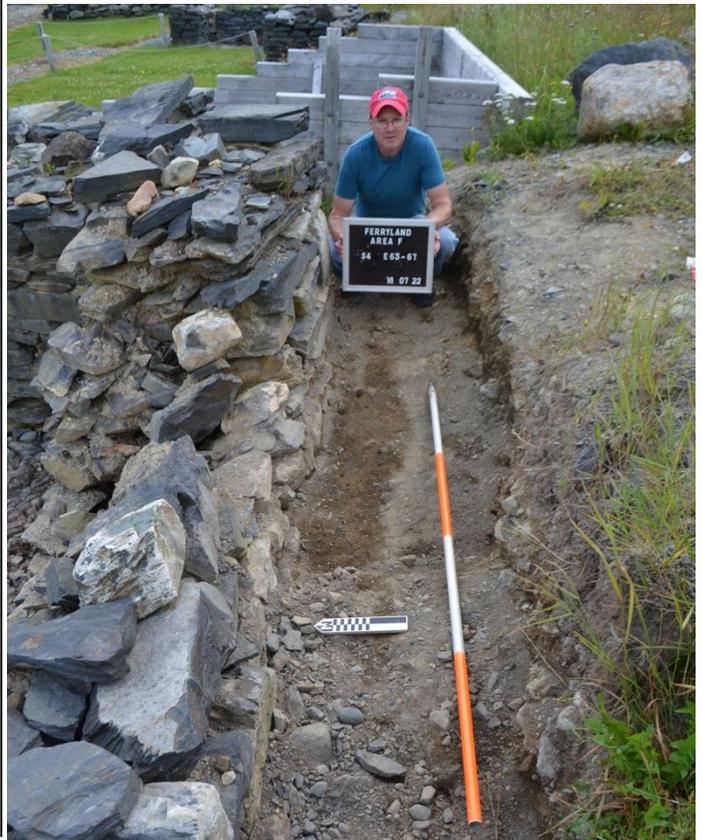
Figure 2: Excavation trench behind Structure 16 fireplace, in progress.

information on previous builder’s trench excavations see Gaulton 2015; Gaulton and Hawkins 2015, 2016, 2017). Excavations also revealed the remnants of an upright wooden post, roughly 12.5cm in diameter, set at the bottom of the builder’s trench which we interpret as part of a wooden scaffolding. Given the two-story height of the stone Mansion House, it is believed that some form of scaffolding would have been required to complete the upper level and to roof the dwelling in slate tiles; yet this is the first tangible evidence that such a temporary wooden structure existed. The repair and rebuilding activities associated with the fireplace, in this instance, brought a more

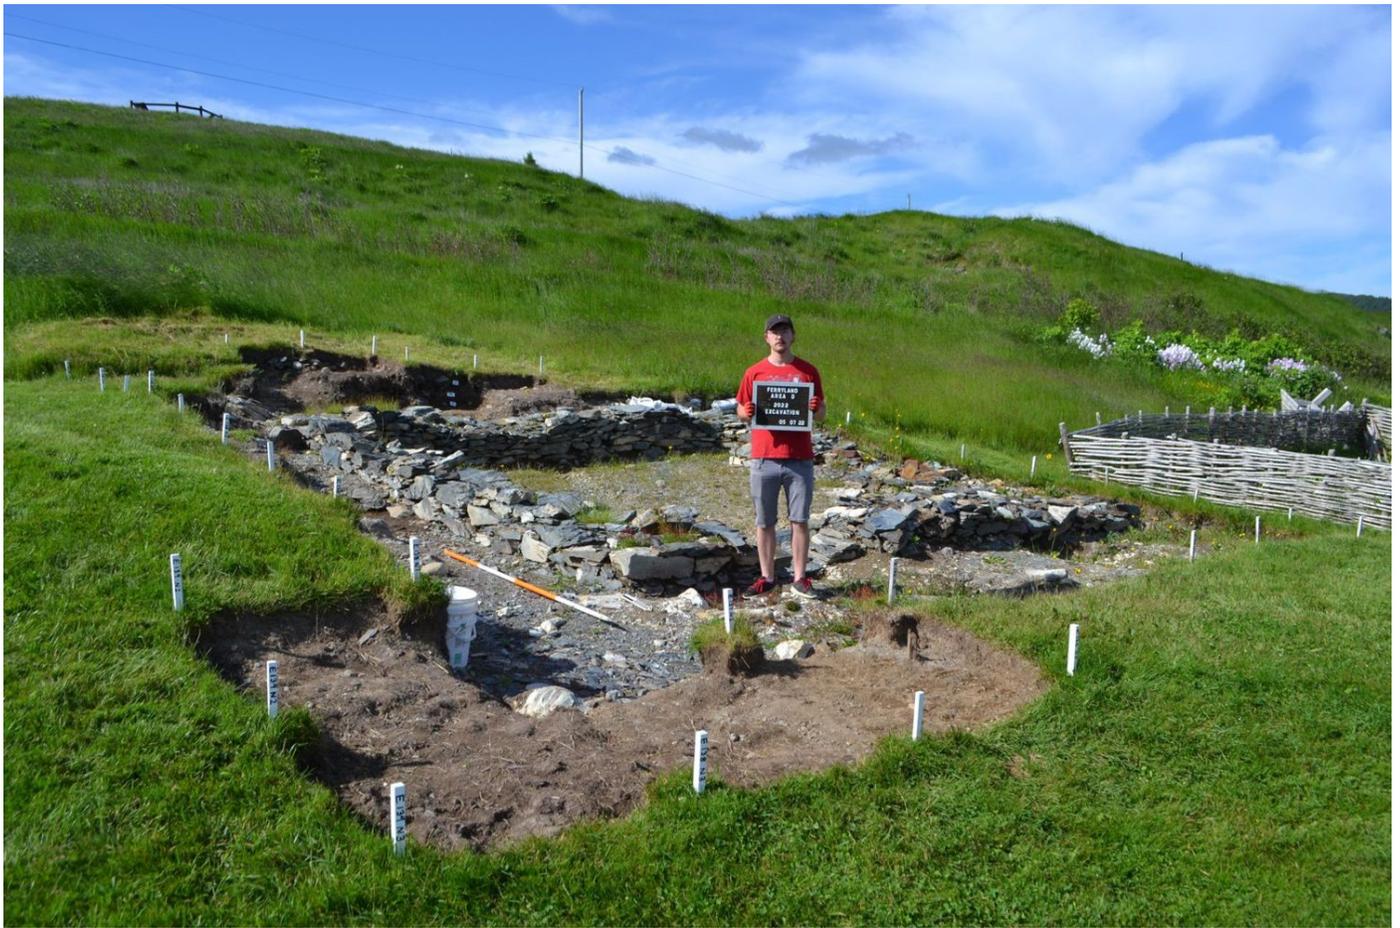
Figure 3: 1m by 4m excavation to the northeast of Feature 217, Area D, looking southwest.

Planned excavation in 2022 focused on the remaining midden deposits and builder’s trenches associated with a 1620s stone structure (Feature 217) located to 30m east of the original village and previously interpreted as an industrial or special purpose building (Gaulton and Bethune 2020; Gaulton 2021). The first operation targeted a 1m by 4m area northeast of the structure’s door where previous excavation identified the location of the primary midden (Figure 3). Here, we continued to find a substantial number of artifacts dating from the 1620s-1640s including British coarse earthenware, German stoneware, case bottle glass, a crucible fragment or two, and several datable pipe bowls (Figure 4a-b). The newly excavated material did not alter our interpretation of this structure but rather, strengthened our previous theory on its range of occupation.

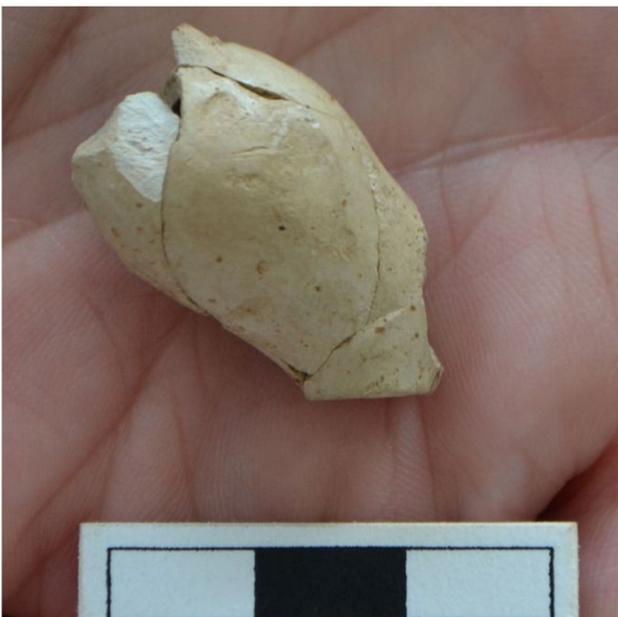
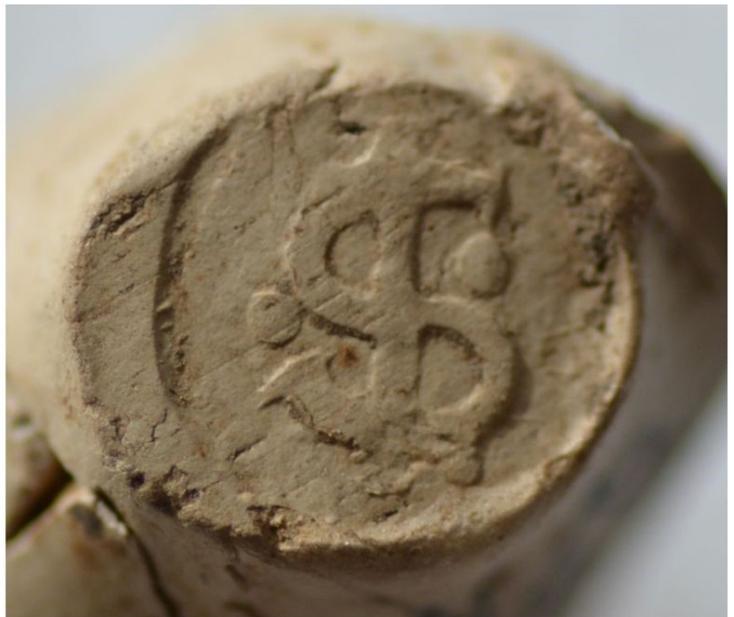
Figure 4: (left) ca. 1620s-40s clay tobacco pipe bowl fragment;  
(right) monogrammed IS maker's mark on heel of same pipe.

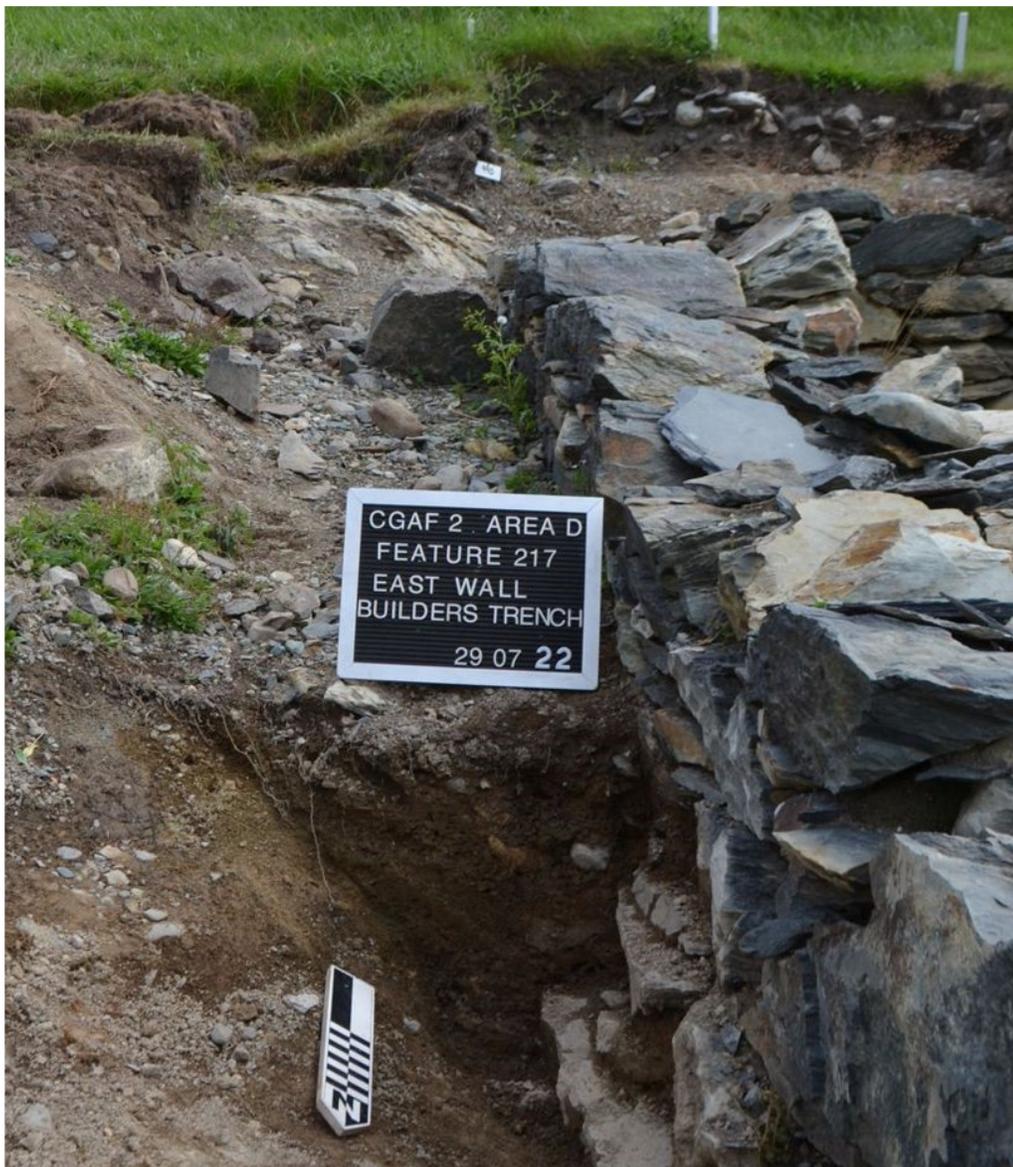
**Figure 5: Excavation of builder’s trench on the exterior east wall of Feature 2017, Area D, looking south.**

Work on the associated builder’s trench deposits, along the eastern and southern edges of the structure, resulted in a similar outcome (Figure 5). Construction debris in the form of roof tile fragments and bits of shale/slate trimmed from wall rocks was expected and recorded; however, a dearth of other artifacts such as ceramics, glass and clay tobacco pipes suggest that the 23 by 23-foot stone-walled structure was built and roofed over within a short period. Whether this was a matter of weeks or months is uncertain (for a discussion on tradesmen

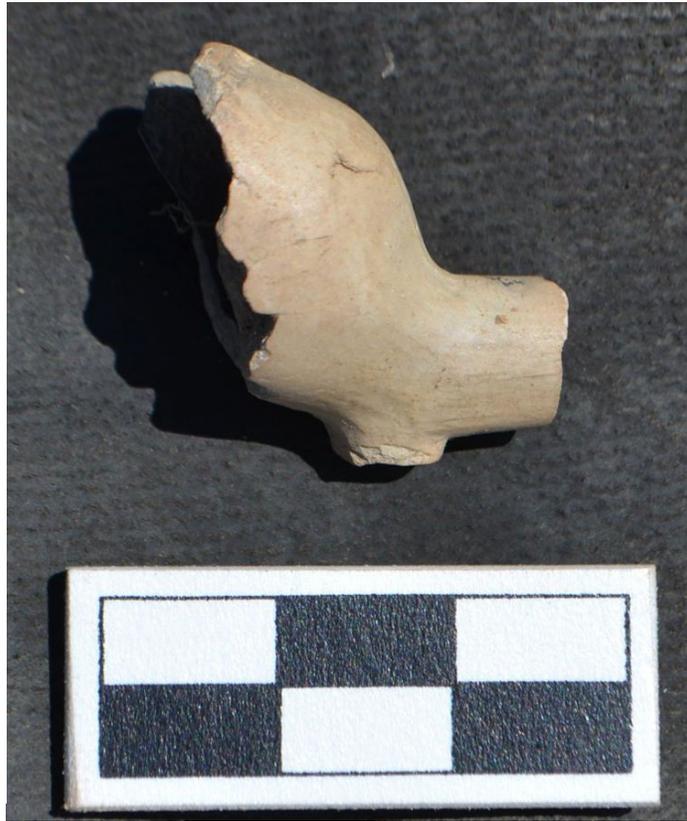
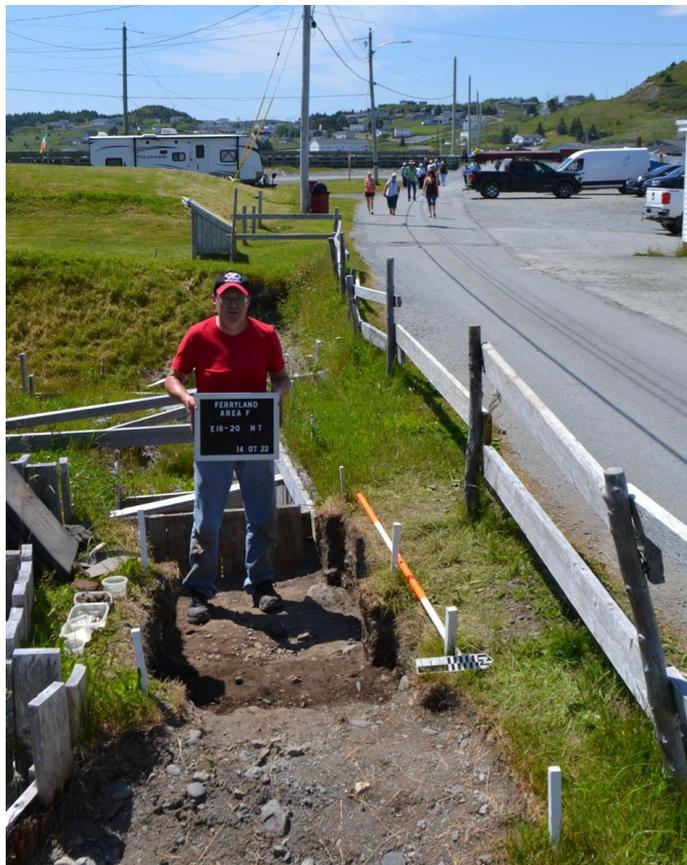
Figure 7: 1m by 3m excavation in Area F, looking west.

While the midden deposit and builder’s trench were being investigated, a 1m by 3m excavation was also taking place at the west end of the site across from the old Colony Café (Figure 7). This is the same location where, in previous years, the field crew had uncovered additional segments of the 17th-century

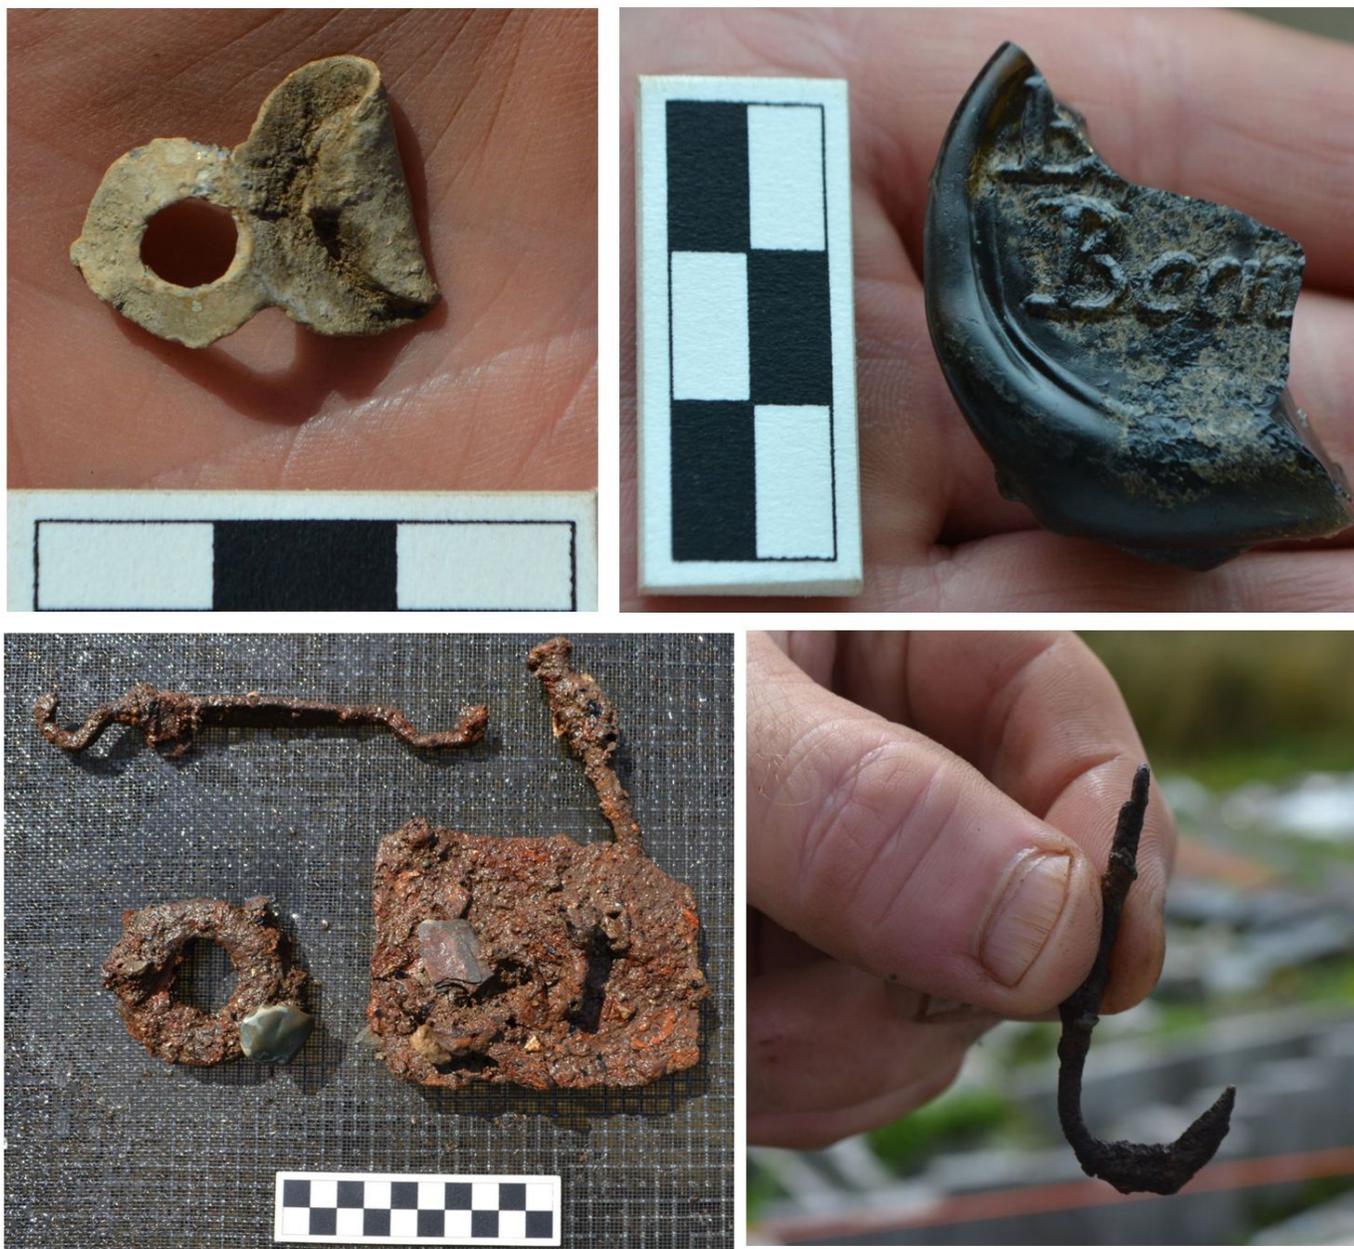
Figure 8: 17<sup>th</sup>-century artifacts in lowest midden deposit. Top left: lead bale seal; top right: partial glass bottle seal; bottom left: iron door latch and lock fragment; bottom right: small fishhook.

century wine bottle fragments, marked clay tobacco pipes from Barnstaple, German stoneware mug fragments from the Westerwald region, an iron padlock and a heavily worn copper and silver button with a floral motif. The latter and deeper 17th-century deposits contained notable objects such as a lead bale seal, a partial glass bottle seal, parts of an iron door lock, a door latch, and a very small (freshwater?) fishhook (Figure 8). The south edge of the 17th-century cobblestone street lay directly below this midden deposit.

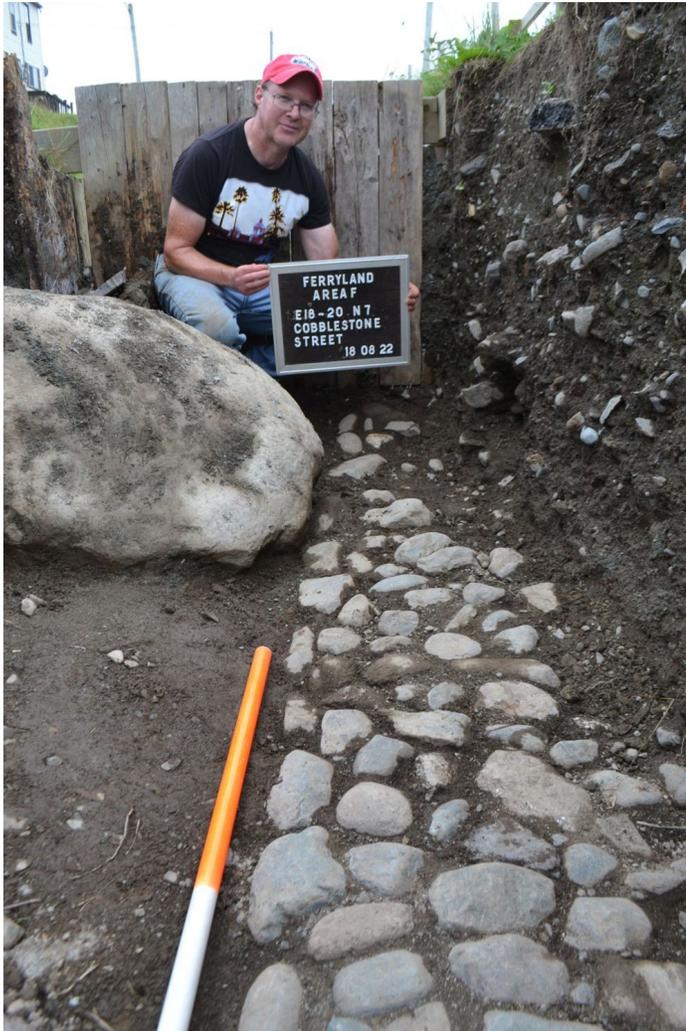
**Figure 9: Southern edge of 1620s cobblestone street and adjacent boulder, Area F, looking west.**

There was nothing particularly notable about the additional 3m section of cobblestone pavement beyond what has been reported in previous years. The installation of water and septic lines in the 20th century continue to be the primary cause of disturbance in this area, and in several places the cobblestones have been dug up. What is of particular interest however is the massive boulder situated immediately south of the edge of the street (Figure 9). Excavation revealed that the cobblestone street was set directly against the boulder. Basically, the boulder was in situ when settlers were planning the overall direction and orientation of the street and therefore, given its size, likely impacted the eventual placement and positioning of Newfoundland and Labrador's first paved street here at Ferryland. Previous assumptions regarding the unusual curvature and positioning of the cobblestone street at Ferryland centered on the town's layout in relation to the Mansion House as its central hub (Bethune 2022). This new discovery, while not overturning earlier theories, could suggest that more mundane factors (such as this and other boulders) played an important part in the street's final positioning.
