# ASBESTOS AND LEAD PAINT BUILDING MATERIALS SURVEY 208 ELIZABETH AVENUE MEMORIAL UNIVERSITY OF NEWFOUNDLAND

Pinchin LeBlanc Environmental Ltd Project No. 02-02-00900

March, 2013

BUILDING DESCRIPTION: 208 ELIZABETH AVENUE

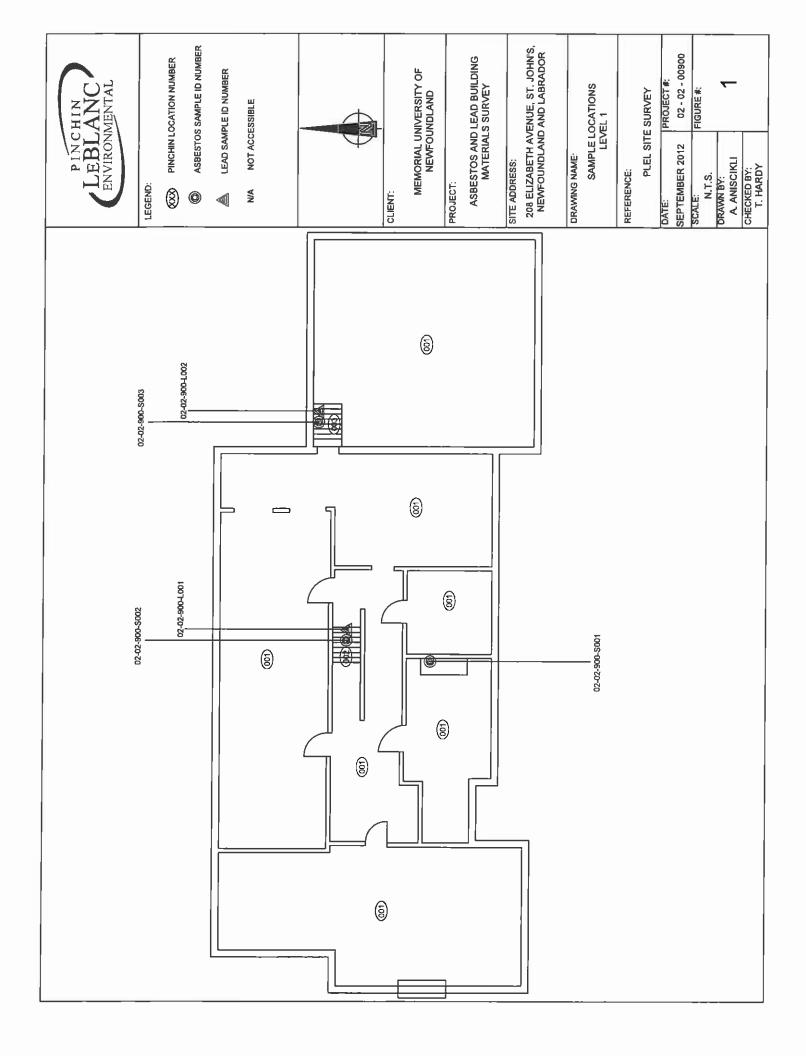
<u> </u>				
Sample #:	S001	Date Sampled:	August 24, 2012		
Building:	208 Elizabeth Ave	nue Sampler:	Trent Hardy		
Location:	001, basement	Analysis:	SAI - PLM		
MUN Project #:	02-02-900	Work Order #:			
		<b>Bulk Sampling Parameters</b>			
Pipe/Tank	Flooring	Ceiling	Roofing	Location	
☐ Insulation	□12'x12' Tile	☐ Textured	☐ Shingle	☐ Floor	
□ Elbow	☐ 9'x9'Tile	☐ Stucco	☐ Rolled	☐ Wall Orientation	
☐ Fitting	□ Vinyl Sheet	□ Popcom	☐ Felt	☐ Ceiling	
☐ Transite Pipe	☐ Mastic	□ DWJC	☐ Tar	☐ Above Ceiling	
☐ Gasket	Wall	☐ Plaster		X Other (chimney)	
☐ Tank Insulation	☐ Transite Panel	☐ Acoustic Tile (Dropped)			
☐ Pipe Wrap	☐ Textured Wall	☐ Acoustic Tile (Glued-on)			
HVAC	☐ Plaster	☐ Mastic	Miscellaneous:	Insulation on	
IIVAC		□ Iviastic	furnace chimne	<u>y</u>	
☐ Insulation	□ DWJC	Structural			
□ Tape		☐ Steel F. P. ing	No. of Phases:		
☐ Paper Wrap		Deck F. P. ing	Colour:
