Project #: 13916

**ASBESTOS ASSESSMENT
Curtis House
Memorial University of Newfoundland
St. John's, NL**

AUGUST 2011

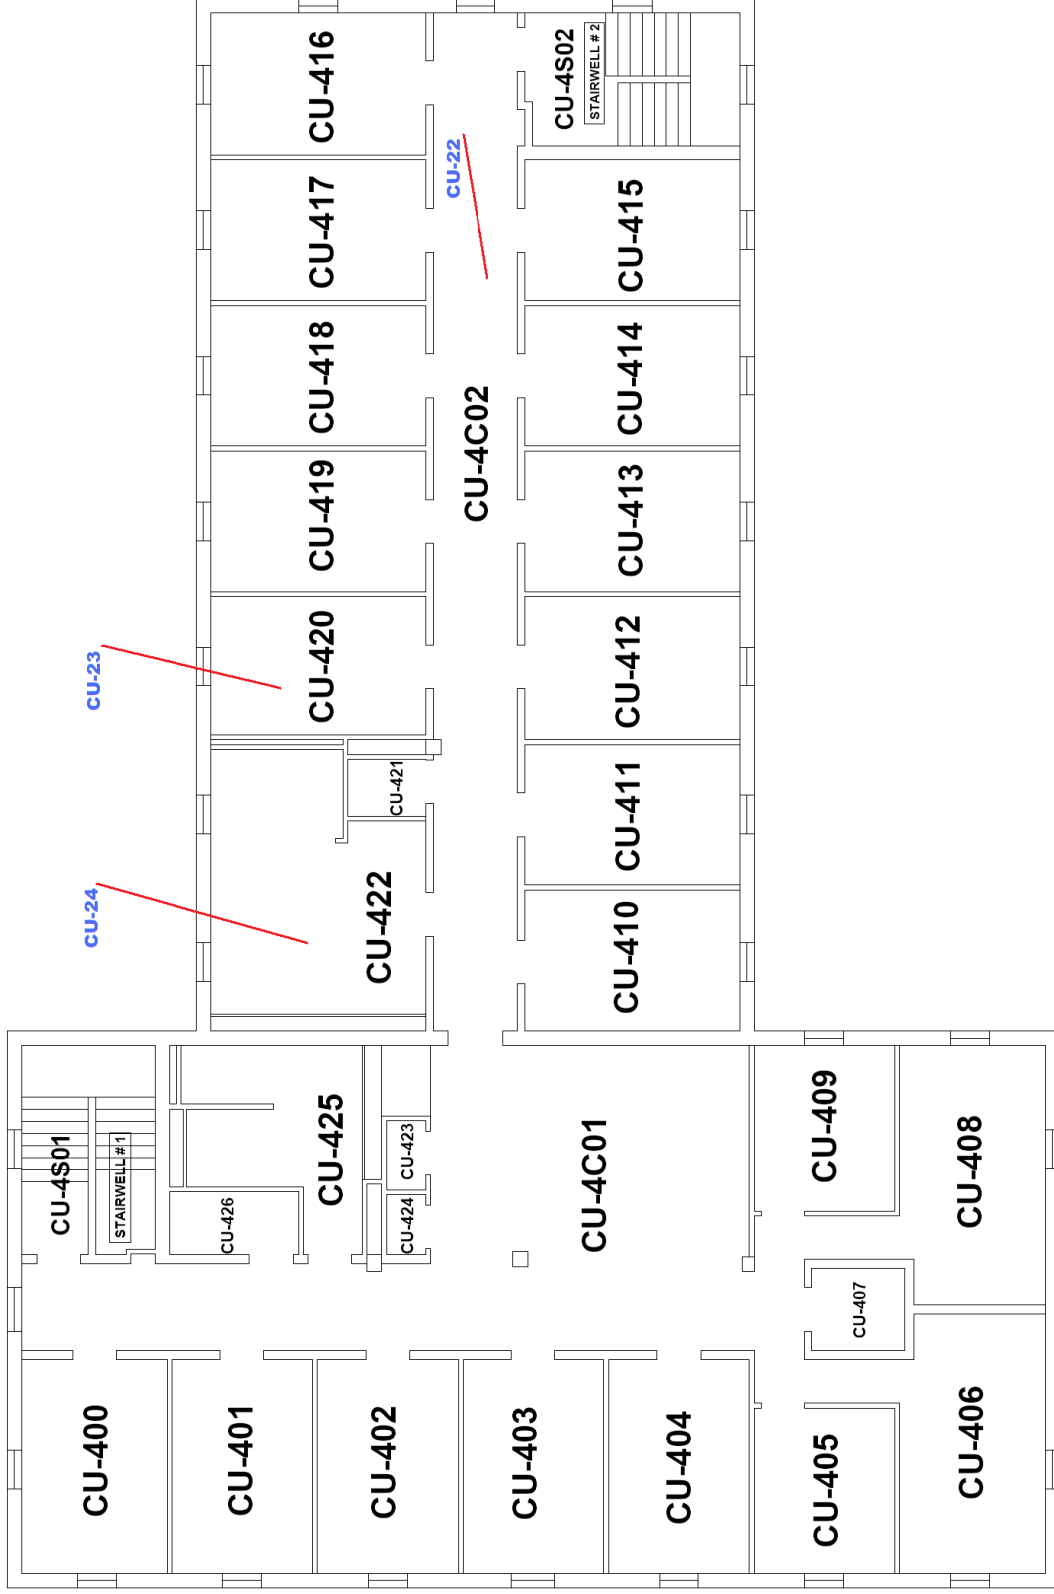
CURTIS HOUSE - LEVEL - 4

In addition, three rain water leaders were observed above ceiling tiles in the corridors on the 4th floor. These materials were too high to access, thus they were not sampled. As such, they must be considered to be asbestos containing until proven otherwise. (see Photograph 10, Appendix I)

A tar sealant on fiberglass linear pipe was observed above the ceiling tiles of the hallway CU4C02. One (1) sample of the sealant was collected and analyzed for as asbestos content using the PLM method of detection. The sample was identified as non-asbestos containing.
