ASBESTOS AND LEAD PAINT BUILDING MATERIALS SURVEY FOR: OCEAN SCIENCES CENTER, MAIN BUILDING AND ANNEX MEMORIAL UNIVERSITY OF NEWFOUNDLAND

Pinchin LeBlanc Environmental Ltd Project No. 02-02-00900

March 22, 2013

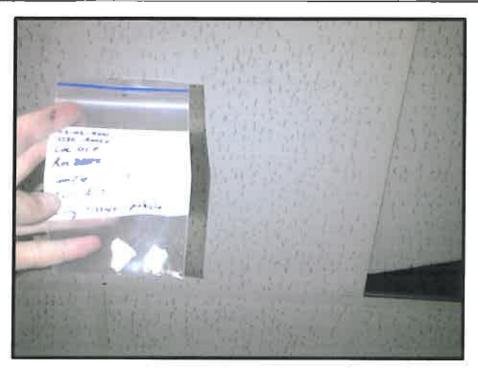
- 2'x 4' acoustic ceiling tile distinguished with a longitudinal fissure and pinhole pattern were sampled in room AX-2S02. Analysis of this sample did not identify the presence of asbestos (reference sample 02-02-900-S014).
- 2'x 4' acoustic ceiling tile distinguished with a longitudinal fissure and pinhole pattern were sampled in room AX-3C01. Analysis of this sample did not identify the presence of asbestos (reference sample 02-02-900-S017).
