ASBESTOS AND LEAD PAINT BUILDING MATERIALS SURVEY FOR: SOUTH BOILER PLANT MEMORIAL UNIVERSITY OF NEWFOUNDLAND

Pinchin LeBlanc Environmental Ltd Project No. 02-02-00900

December 12, 2012

BUILDING DESCRIPTION: SOUTH BOILER PLANT

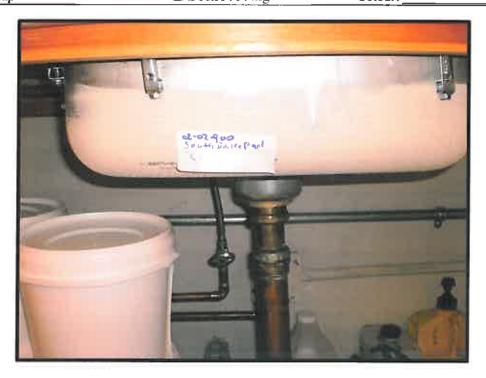
Two (2) samples were collected of tar mastics on the sinks throughout the site building. Results from one (1) of the two (2) samples indicate the presence of 3% chrysotile asbestos (reference sample 02-02-900-S008). For locations and conditions of this material at the time of the building survey refer to location & data excel document.

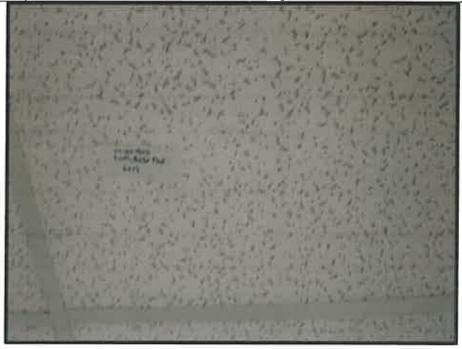
One (1) sample of the 2'x2' ACT acoustic ceiling tile distinguished with a pinhole and small fissure pattern was sampled from room 2006. Analysis of the sample did not identify the presence of asbestos (reference sample 02-02-900-S012).

| Sample #: | S013 | | Date Sampled: | September 21, 2012 | | | |
|---|---|---|---|---|---|--|--|
| HVAC | ☐ Plaster | ☐ Mastic | | Miscellaneous: 2' x 2' pinhole with small fissure | | | |
