### ASBESTOS AND LEAD PAINT BUILDING MATERIALS SURVEY FOR: ST. JOHN'S COLLEGE MEMORIAL UNIVERSITY OF NEWFOUNDLAND

Prepared for: Memorial University of Newfoundland

Pinchin LeBlanc Environmental Ltd Project No. 02-02-00900

June 19, 2013

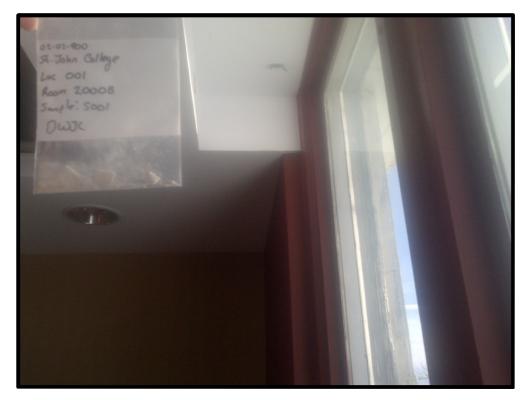
UNIVERSIT	Y				
Sample #: S001		Date Sampled:	February 12, 20	13	
<b>Building</b> :	St. John's College		Sampler:	Trent Hardy	
Location:	001, room 2000B		Analysis:	SAI - PLM	
MUN Project #:	02-02-900		Work Order #:		
		Bulk	Sampling Parameters		
Pipe/Tank	pe/Tank Flooring		Ceiling	Roofing	Location
□ Insulation	□12'x12' Tile			□ Shingle	□ Floor
□ Elbow	$\Box$ 9'x9'Tile $\Box$ St		tucco	□ Rolled	□ Wall Orientation
□ Fitting	$\Box$ Vinyl Sheet $\Box$ Po		opcorn	□ Felt	X Ceiling
□ Transite Pipe	□ Mastic X D'		WJC	🗆 Tar	□ Above Ceiling
□ Gasket	Wall	$\Box P$	laster		□ Other
□ Tank Insulation	□ Transite Panel	$\Box A$	coustic Tile (Dropped)		
□ Pipe Wrap	□ Textured Wall	$\Box A$	coustic Tile (Glued-on)		
		$\Box$ N	Iastic	Miscellaneous:	
$\Box$ Insulation $\Box$ DWJC			Structural		
□ Tape		$\Box$ S	teel F. P. ing	No. of Phases:	
□ Paper Wrap		$\Box$ D	Deck F. P. ing	Colour:

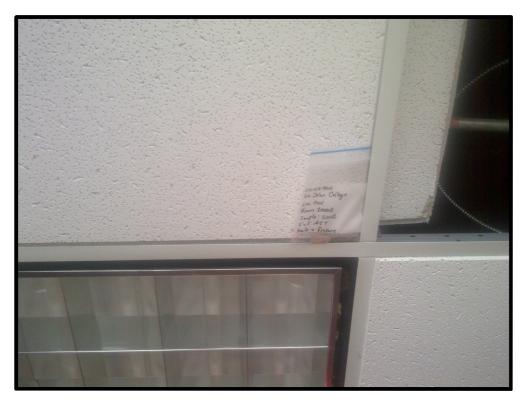
UNIVERSITY							
Sample #:	S002		Date Sampled:	July16, 2012			
<b>Building</b> :	St. John's College		Sampler:	Trent Hardy			
Location:	001, room 2000B		Analysis:	SAI - PLM			
MUN Project #:	02-02-900		Work Order #:				
Bulk Sampling Parameters							
Pipe/Tank	Flooring		Ceiling	Roofing	Location		
□ Insulation	$\Box$ 12'x12' Tile	ΠT	extured	□ Shingle	□ Floor		
□ Elbow	□ 9'x9'Tile	$\Box$ S	tucco	□ Rolled	□Wall Orientation		
□ Fitting	□ Vinyl Sheet	$\Box P$	opcorn	🗆 Felt	X Ceiling		
□ Transite Pipe	□ Mastic	DD	WJC	🗆 Tar	□ Above Ceiling		
□ Gasket	Wall	$\Box P$	laster		□ Other		
□ Tank Insulation	□ Transite Panel	ΧА	coustic Tile (Dropped)				
□ Pipe Wrap	□ Textured Wall	$\Box A$	coustic Tile (Glued-on)				
HVAC	□ Plaster	$\Box N$	Iastic	Miscellaneous: <u>fissure</u>	2' x 2' pinhole		
□ Insulation	DWJC		Structural				
□ Tape		$\Box$ S	teel F. P. ing	No. of Phases:			
□ Paper Wrap		$\Box$ D	beck F. P. ing	Colour:

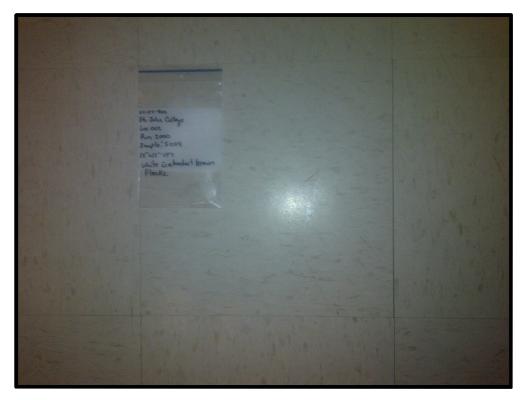
UNIVERSITY							
Sample #: S004		Date Sampled:	February 12, 20	13			
<b>Building</b> :	St. John's College		Sampler:	Trent Hardy			
Location:	002, room 2000		Analysis:	SAI - PLM			
MUN Project #:	02-02-900		Work Order #:				
		Bulk	Sampling Parameters				
Pipe/Tank	Flooring		Ceiling	Roofing	Location		
□ Insulation	X12'x12' Tile	ΠT	extured	□ Shingle	X Floor		
□ Elbow	□ 9'x9'Tile	9'x9'Tile □ Stucco		□ Rolled	U Wall Orientation		
□ Fitting	$\Box$ Vinyl Sheet $\Box$ Po		opcorn	🗆 Felt	□ Ceiling		
□ Transite Pipe	$\Box$ Mastic $\Box$ D		OWJC	🗆 Tar	□ Above Ceiling		
□ Gasket	Wall	$\Box P$	laster		□ Other		
□ Tank Insulation	□ Transite Panel	$\Box A$	coustic Tile (Dropped)				
□ Pipe Wrap	□ Textured Wall	$\Box A$	coustic Tile (Glued-on)				
HVAC	□ Plaster	$\Box N$	Iastic	Miscellaneous: abundant brow			
□ Insulation	□ DWJC		Structural				
□ Tape		$\Box$ S	teel F. P. ing	No. of Phases:			
□ Paper Wrap		DD	Deck F. P. ing	Colour:

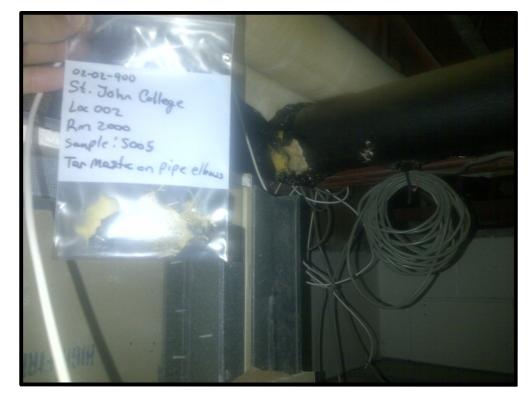
UNIVERSITY								
Sample #: \$005		Date Sampled:	February 12, 20	013				
<b>Building</b> :	St. John's College		Sampler:	Trent Hardy				
Location:	002, room 2000		Analysis:	SAI - PLM				
MUN Project #:	02-02-900		Work Order #:					
	Bulk Sampling Parameters							
Pipe/Tank	Pipe/Tank Flooring		Ceiling	Roofing	Location			
□ Insulation	□12'x12' Tile	□ T	extured	□ Shingle	□ Floor			
X Elbow	$\Box$ 9'x9'Tile $\Box$ St		tucco	□ Rolled	□ Wall Orientation			
□ Fitting	$\Box$ Vinyl Sheet $\Box$ Po		opcorn	🗆 Felt	□ Ceiling			
□ Transite Pipe	-		OWJC	🗆 Tar	X Above Ceiling			
□ Gasket	Wall	$\Box P$	laster		□ Other			
□ Tank Insulation	□ Transite Panel	$\Box A$	coustic Tile (Dropped)					
□ Pipe Wrap	□ Textured Wall	$\Box A$	coustic Tile (Glued-on)					
HVAC	□ Plaster	$\Box N$	Iastic	Miscellaneous: Tar mastic				
$\Box$ Insulation $\Box$ DWJC			Structural					
□ Tape		$\Box$ S	teel F. P. ing	No. of Phases:				
□ Paper Wrap		$\Box$ D	Deck F. P. ing	Colour:

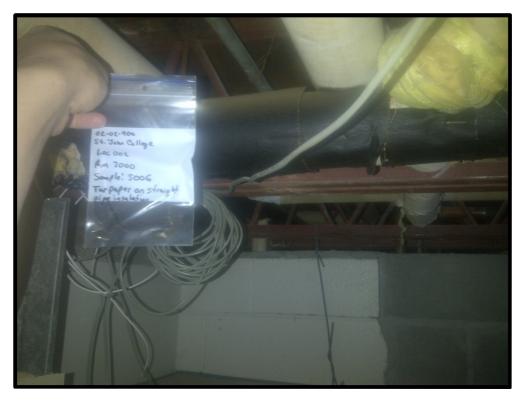
UNIVERSIT	Y							
Sample #:	S006	Date Sampled:	February 12, 20	)13				
<b>Building</b> :	St. John's College	Sampler:	Trent Hardy					
Location:	002, room 2000	Analysis:	SAI - PLM					
MUN Project #:	02-02-900	Work Order #:						
Bulk Sampling Parameters								
Pipe/Tank	Flooring	Ceiling	Roofing	Location				
X Insulation	□12'x12' Tile	□ Textured	□ Shingle	□ Floor				
□ Elbow	□ 9'x9'Tile	□ Stucco	□ Rolled	□ Wall Orientation				
□ Fitting	□ Vinyl Sheet	□ Popcorn	🗆 Felt	□ Ceiling				
□ Transite Pipe	□ Mastic	□ DWJC	🗆 Tar	X Above Ceiling				
□ Gasket	Wall	□ Plaster		□ Other				
□ Tank Insulation	□ Transite Panel	$\Box$ Acoustic Tile (Dropped)						
□ Pipe Wrap	□ Textured Wall	$\Box$ Acoustic Tile (Glued-on)						
HVAC	□ Plaster	□ Mastic	Miscellaneous	: <u>Tar paper</u>				
$\Box$ Insulation	□ DWJC	Structural						
□ Tape		□ Steel F. P. ing	No. of Phases:					
□ Paper Wrap		Deck F. P. ing	Colour:

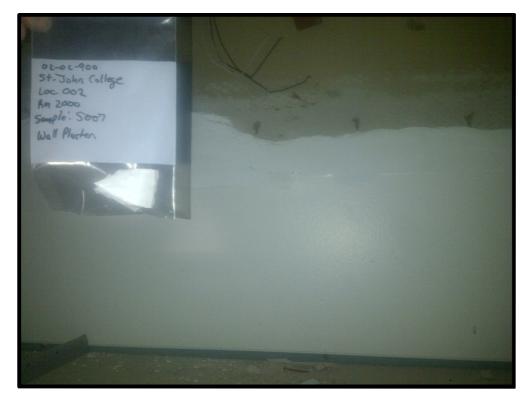
UNIVERSII	Y							
Sample #:	S007		Date Sampled:	February 12, 20	13			
<b>Building</b> :	St. John's College		Sampler:	Trent Hardy				
Location:	002, room 2000		Analysis:	SAI - PLM				
MUN Project #:	02-02-900		Work Order #:					
Bulk Sampling Parameters								
Pipe/Tank	Flooring		Ceiling	Roofing	Location			
□ Insulation	□12'x12' Tile	□ T	extured	□ Shingle	□ Floor			
□ Elbow	□ 9'x9'Tile	□ Stucco		□ Rolled	X Wall Orientation			
□ Fitting	□ Vinyl Sheet	$\Box P$	opcorn	□ Felt	□ Ceiling			
□ Transite Pipe	□ Mastic	$\Box$ D	WJC	🗆 Tar	□ Above Ceiling			
□ Gasket	Wall	$\Box P$	laster		□ Other			
□ Tank Insulation	□ Transite Panel	$\Box A$	coustic Tile (Dropped)					
□ Pipe Wrap	□ Textured Wall	$\Box A$	coustic Tile (Glued-on)					
HVAC	X Plaster	$\Box N$	lastic	Miscellaneous:				
□ Insulation	□ DWJC		Structural					
□ Tape		$\Box S$	teel F. P. ing	No. of Phases:				
□ Paper Wrap		$\Box$ D	eck F. P. ing	Colour:	· · · · · · · · · · · · · · · · · · ·

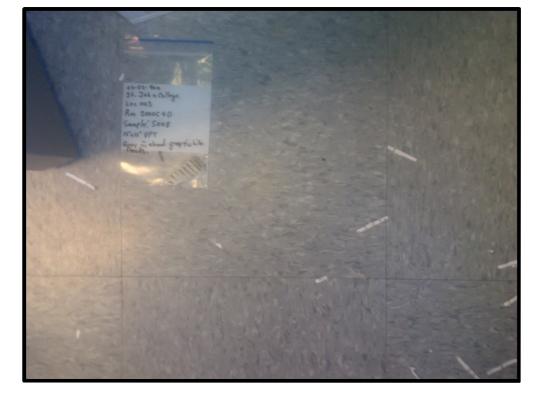
MEMORIA UNIVERSIT		ASB	ESTOS BULK SA	MPLING FO	ORM		
Sample #:	S008		Date Sampled:	February 12, 20	13		
<b>Building</b> :	St. John's College		Sampler:	Trent Hardy			
Location:	003, room		Analysis:	SAI - PLM			
	2000C/2000D						
MUN Project #:	02-02-900		Work Order #:				
Bulk Sampling Parameters							
Pipe/Tank	Flooring	Ceiling		Roofing	Location		
□ Insulation	X12'x12' Tile	ΠT	extured	□ Shingle	X Floor		
□ Elbow	□ 9'x9'Tile	$\Box$ S	tucco	□ Rolled	□ Wall Orientation		
□ Fitting	□ Vinyl Sheet	$\Box P$	opcorn	🗆 Felt	□ Ceiling		
□ Transite Pipe	□ Mastic	ΠD	WJC	🗆 Tar	□ Above Ceiling		
□ Gasket	Wall	$\Box P$	laster		□ Other		
□ Tank Insulation	□ Transite Panel	$\Box A$	coustic Tile (Dropped)				
□ Pipe Wrap	□ Textured Wall	$\Box A$	coustic Tile (Glued-on)				
HVAC	□ Plaster	$\Box N$	Iastic	Miscellaneous: <u>flecks</u>	Grey with grey		
□ Insulation	DWJC		Structural				
□ Tape		$\Box$ S	teel F. P. ing	No. of Phases:

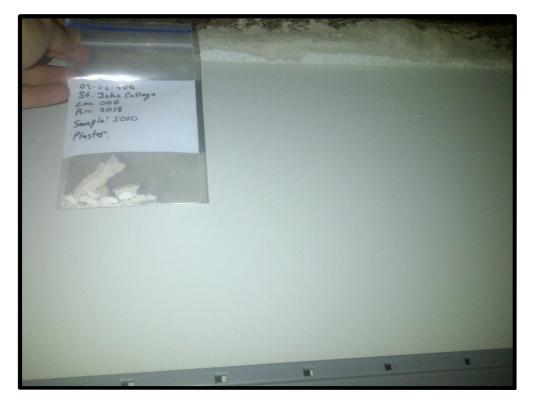
UNIVERSII	Y							
Sample #:	S010	Date Sample	d:	February 12, 20	13			
<b>Building</b> :	St. John's College	Sampler:		Trent Hardy				
Location:	006, room 2018	Analysis:		SAI - PLM				
MUN Project #:	02-02-900	Work Order	#:					
Bulk Sampling Parameters								
Pipe/Tank	Flooring	Ceiling		Roofing	Location			
□ Insulation	□12'x12' Tile	□ Textured		□ Shingle	□ Floor			
□ Elbow	□ 9'x9'Tile	□ Stucco		□ Rolled	□ Wall Orientation			
□ Fitting	□ Vinyl Sheet	□ Popcorn		🗆 Felt	X Ceiling			
□ Transite Pipe	□ Mastic	□ DWJC		🗖 Tar	□ Above Ceiling			
□ Gasket	Wall	X Plaster			□ Other			
□ Tank Insulation	□ Transite Panel	□ Acoustic Tile (D	ropped)					
□ Pipe Wrap	□ Textured Wall	□ Acoustic Tile (G	lued-on)					
HVAC	□ Plaster	□ Mastic		Miscellaneous:				
$\Box$ Insulation	□ DWJC	Structura	ıl					
□ Tape		□ Steel F. P. ing		No. of Phases:				
□ Paper Wrap		Deck F. P. ing		Colour:

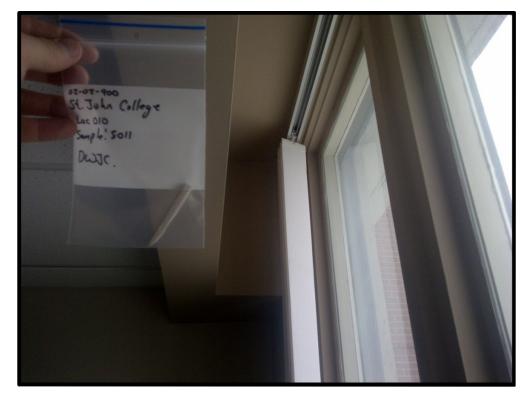
UNIVERSIT	Y								
Sample #:	S011		Date Sampled:	February 12, 20	13				
<b>Building</b> :	St. John's College		Sampler:	Trent Hardy					
Location:	010, room 2017		Analysis:	SAI - PLM					
MUN Project #:	02-02-900		Work Order #:						
Bulk Sampling Parameters									
Pipe/Tank	Flooring		Ceiling	Roofing	Location				
□ Insulation	□12'x12' Tile	□ Textured		□ Shingle	□ Floor				
□ Elbow	□ 9'x9'Tile	□ Stucco		□ Rolled	X Wall Orientation				
□ Fitting	□ Vinyl Sheet	$\Box P$	opcorn	□ Felt	□ Ceiling				
□ Transite Pipe	□ Mastic	$\Box$ D	OWJC	🗆 Tar	□ Above Ceiling				
□ Gasket	Wall	$\Box P$	laster		□ Other				
□ Tank Insulation	□ Transite Panel	$\Box A$	coustic Tile (Dropped)						
□ Pipe Wrap	□ Textured Wall	$\Box A$	coustic Tile (Glued-on)						
HVAC	□ Plaster	$\Box N$	Iastic	Miscellaneous:					
□ Insulation	X DWJC		Structural						
□ Tape		$\Box$ S	teel F. P. ing	No. of Phases:					
□ Paper Wrap		ΠD	eck F. P. ing	Colour:

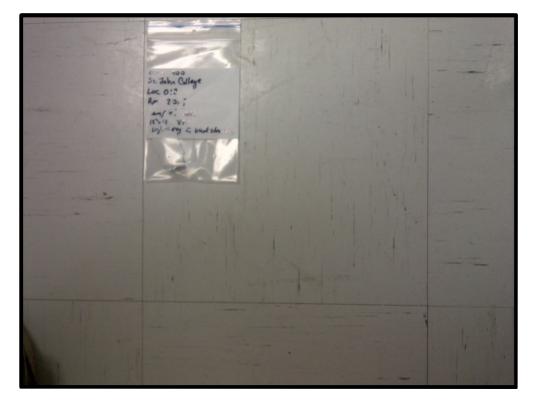
UNIVERSII	Y							
Sample #:	S012		Date Sampled:	February 12, 20	13			
<b>Building</b> :	St. John's College		Sampler:	Trent Hardy				
Location:	012, room 2014		Analysis:	SAI - PLM				
MUN Project #:	02-02-900		Work Order #:					
Bulk Sampling Parameters								
Pipe/Tank	Flooring		Ceiling	Roofing	Location			
□ Insulation	X12'x12' Tile	$\Box$ T	extured	□ Shingle	X Floor			
□ Elbow	□ 9'x9'Tile	□ Stucco		□ Rolled	□ Wall Orientation			
□ Fitting	□ Vinyl Sheet	Popcorn		□ Felt	□ Ceiling			
□ Transite Pipe	□ Mastic	□ DŴJC		🗆 Tar	□ Above Ceiling			
□ Gasket	Wall	$\Box$ Pl	aster		□ Other			
□ Tank Insulation	□ Transite Panel	$\Box A$	coustic Tile (Dropped)					
□ Pipe Wrap	□ Textured Wall	$\Box A$	coustic Tile (Glued-on)					
HVAC	□ Plaster	$\Box$ M	lastic	Miscellaneous:				
□ Insulation	□ DWJC		Structural					
□ Tape		□ St	teel F. P. ing	No. of Phases:				
□ Paper Wrap		$\Box$ D	eck F. P. ing	Colour: Grey w	vith black streaks

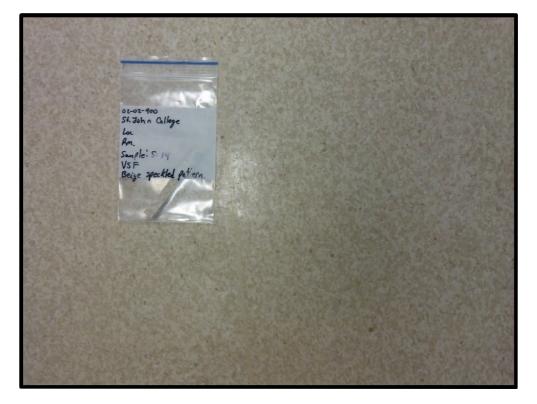
UNIVERSIT	Y							
Sample #:	S014		Date Sampled:	February 12, 20	13			
<b>Building</b> :	St. John's College		Sampler:	Trent Hardy				
Location:	019, room 2008		Analysis:	SAI - PLM				
MUN Project #:	02-02-900		Work Order #:					
Bulk Sampling Parameters								
Pipe/Tank	Flooring		Ceiling	Roofing	Location			
□ Insulation	□12'x12' Tile	□ Textured		□ Shingle	X Floor			
□ Elbow	□ 9'x9'Tile	□ Stucco		$\Box$ Rolled	□ Wall Orientation			
□ Fitting	X Vinyl Sheet	$\Box P$	opcorn	□ Felt	□ Ceiling			
□ Transite Pipe	□ Mastic	DD	WJC	🗆 Tar	□ Above Ceiling			
□ Gasket	Wall	$\Box P$	laster		□ Other			
□ Tank Insulation	□ Transite Panel	$\Box A$	coustic Tile (Dropped)					
□ Pipe Wrap	□ Textured Wall	$\Box A$	coustic Tile (Glued-on)					
HVAC	□ Plaster	$\Box N$	lastic	Miscellaneous:				
□ Insulation	DWJC		Structural					
□ Tape		$\Box$ S	teel F. P. ing	No. of Phases:				
□ Paper Wrap		$\Box$ D	eck F. P. ing	Colour: Beige s	speckled pattern

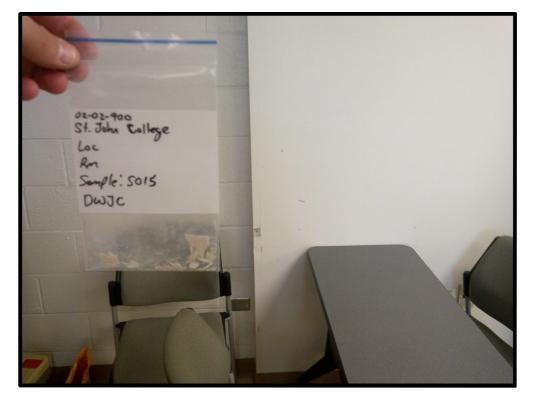
UNIVERSIT								
Sample #:	S015		Date Sampled:	February 12, 20	13			
Building :	St. John's College		Sampler:	Trent Hardy				
Location:	019, room 2008		Analysis:	SAI - PLM				
MUN Project #:	02-02-900		Work Order #:					
Bulk Sampling Parameters								
Pipe/Tank	Flooring		Ceiling	Roofing	Location			
□ Insulation	□12'x12' Tile	□ Textured		□ Shingle	□ Floor			
□ Elbow	□ 9'x9'Tile	□ Stucco		□ Rolled	X Wall Orientation			
□ Fitting	□ Vinyl Sheet	$\Box P$	opcorn	🗆 Felt	□ Ceiling			
□ Transite Pipe	□ Mastic	$\Box$ D	OWJC	🗖 Tar	□ Above Ceiling			
□ Gasket	Wall	$\Box P$	laster		□ Other			
□ Tank Insulation	□ Transite Panel	$\Box A$	coustic Tile (Dropped)					
□ Pipe Wrap	□ Textured Wall	$\Box A$	coustic Tile (Glued-on)					
HVAC	□ Plaster	$\Box N$	Iastic	Miscellaneous:				
□ Insulation	X DWJC		Structural					
□ Tape		$\Box$ S	teel F. P. ing	No. of Phases:				
□ Paper Wrap		$\Box$ D	Deck F. P. ing	Colour:

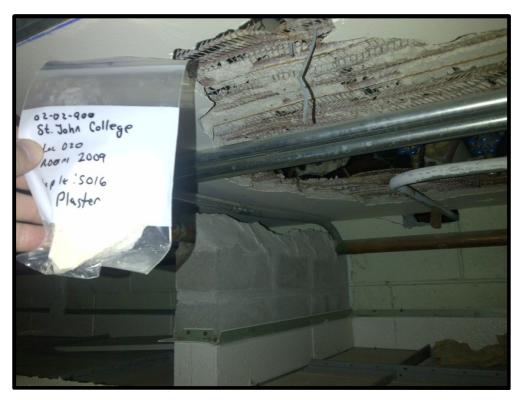
UNIVERSIT	Y							
Sample #:	S016		Date Sampled:	February 12, 20	13			
<b>Building</b> :	St. John's College		Sampler:	Trent Hardy				
Location:	020, room 2009		Analysis:	SAI - PLM				
MUN Project #:	02-02-900		Work Order #:					
Bulk Sampling Parameters								
Pipe/Tank	Flooring		Ceiling	Roofing	Location			
□ Insulation	□12'x12' Tile	□ T	extured	□ Shingle	□ Floor			
□ Elbow	□ 9'x9'Tile	□ Stucco		□ Rolled	U Wall Orientation			
□ Fitting	□ Vinyl Sheet	$\Box P$	opcorn	□ Felt	X Ceiling			
□ Transite Pipe	□ Mastic	DD	OWJC	🗖 Tar	□ Above Ceiling			
□ Gasket	Wall	X Pl	laster		□ Other			
□ Tank Insulation	□ Transite Panel	$\Box A$	coustic Tile (Dropped)					
□ Pipe Wrap	□ Textured Wall	$\Box A$	coustic Tile (Glued-on)					
HVAC	□ Plaster	$\Box N$	Iastic	Miscellaneous:				
□ Insulation	DWJC		Structural					
□ Tape		$\Box$ S	teel F. P. ing	No. of Phases:				
□ Paper Wrap		$\Box$ D	Deck F. P. ing	Colour:

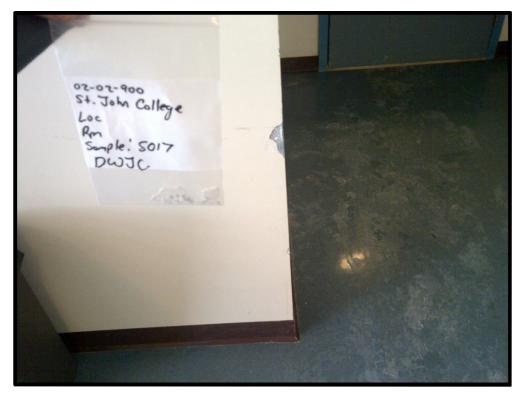
Sample #:	S017	Date Sampled:	February 12, 20	13
Building :	St. John's College	Sampler:	Trent Hardy	
Location:	Hallway 2C04	Analysis:	SAI - PLM	
MUN Project #:	02-02-900	Work Order #:		
		<b>Bulk Sampling Parameters</b>	S	
Pipe/Tank	Flooring	Ceiling	Roofing	Location
□ Insulation	□12'x12' Tile	□ Textured	□ Shingle	□ Floor
□ Elbow	□ 9'x9'Tile	□ Stucco	$\Box$ Rolled	X Wall Orientation
□ Fitting	□ Vinyl Sheet	□ Popcorn	🗆 Felt	□ Ceiling
□ Transite Pipe	□ Mastic	□ DŴJC	🗆 Tar	□ Above Ceiling
□ Gasket	Wall	□ Plaster		□ Other
$\Box$ Tank Insulation	□ Transite Panel	□ Acoustic Tile (Dropped)	)	
□ Pipe Wrap	□ Textured Wall	□ Acoustic Tile (Glued-on	ı)	
HVAC	□ Plaster	□ Mastic	Miscellaneous:	
□ Insulation	X DWJC	Structural		
□ Tape		□ Steel F. P. ing	No. of Phases:	
□ Paper Wrap		Deck F. P. ing	Colour:

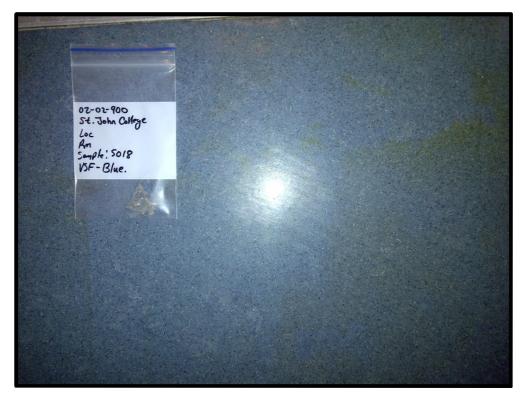
UNIVERSIT					
Sample #:	S018		Date Sampled:	February 12, 20	13
<b>Building</b> :	St. John's College		Sampler:	Trent Hardy	
Location:	Hallway 2C04		Analysis:	SAI - PLM	
MUN Project #:	02-02-900		Work Order #:		
		Bulk	Sampling Parameters		
Pipe/Tank	Flooring		Ceiling	Roofing	Location
□ Insulation	□12'x12' Tile			□ Shingle	X Floor
□ Elbow	□ 9'x9'Tile	$\Box$ S	tucco	□ Rolled	U Wall Orientation
□ Fitting	X Vinyl Sheet $\Box$ P		opcorn	🗆 Felt	□ Ceiling
□ Transite Pipe	□ Mastic	$\Box$ D	WJC	🗆 Tar	□ Above Ceiling
□ Gasket	Wall	$\Box P$	laster		□ Other
□ Tank Insulation	□ Transite Panel	$\Box A$	coustic Tile (Dropped)		
□ Pipe Wrap	□ Textured Wall	$\Box A$	coustic Tile (Glued-on)		
HVAC	□ Plaster	$\Box N$	lastic	Miscellaneous:	
□ Insulation	DWJC		Structural		
□ Tape		$\Box$ S	teel F. P. ing	No. of Phases:	
□ Paper Wrap		$\Box$ D	eck F. P. ing	Colour: <u>Blue</u>

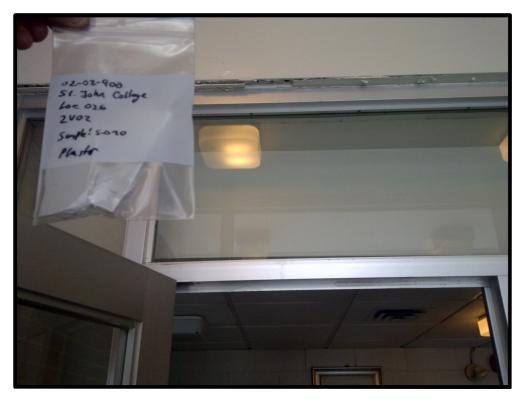
UNIVERSIT	Y				
Sample #:	S020		Date Sampled:	February 12, 20	13
<b>Building</b> :	St. John's College		Sampler:	Trent Hardy	
Location:	026, room 2V02		Analysis:	SAI - PLM	
MUN Project #:	02-02-900		Work Order #:		
		Bulk	Sampling Parameters		
Pipe/Tank	Flooring		Ceiling	Roofing	Location
$\Box$ Insulation	□12'x12' Tile			□ Shingle	□ Floor
□ Elbow	□ 9'x9'Tile	$\Box$ S	tucco	□ Rolled	X Wall Orientation
□ Fitting	$\Box$ Vinyl Sheet $\Box$ P		opcorn	□ Felt	□ Ceiling
□ Transite Pipe	□ Mastic	$\Box D$	WJC	🗆 Tar	□ Above Ceiling
□ Gasket	Wall	$\square P$	laster		□ Other
□ Tank Insulation	□ Transite Panel	$\Box A$	coustic Tile (Dropped)		
□ Pipe Wrap	□ Textured Wall	$\Box A$	coustic Tile (Glued-on)		
HVAC	X Plaster	$\Box N$	lastic	Miscellaneous:	
□ Insulation	DWJC		Structural		
□ Tape		$\Box$ S	teel F. P. ing	No. of Phases:	
□ Paper Wrap		$\Box$ D	eck F. P. ing	Colour:

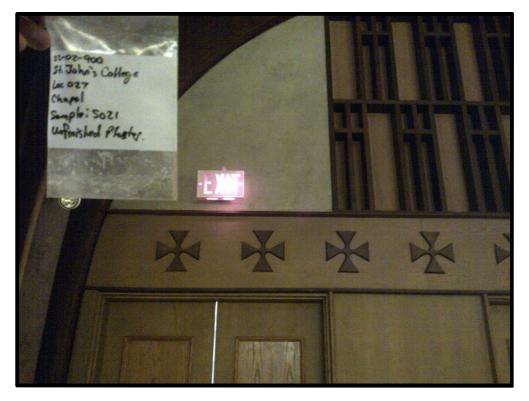
UNIVERSIT	Y				
Sample #:	S021		Date Sampled:	February 12, 20	13
<b>Building</b> :	St. John's College		Sampler:	Trent Hardy	
Location:	027, room 2025		Analysis:	SAI - PLM	
MUN Project #:	02-02-900		Work Order #:		
		Bulk	Sampling Parameters		
Pipe/Tank	Flooring		Ceiling	Roofing	Location
□ Insulation	□12'x12' Tile			□ Shingle	□ Floor
□ Elbow	□ 9'x9'Tile	$\Box$ S	tucco	$\Box$ Rolled	X Wall Orientation
□ Fitting	□ Vinyl Sheet	$\Box P$	opcorn	□ Felt	□ Ceiling
□ Transite Pipe	□ Mastic	$\Box$ D	WJC	🗆 Tar	□ Above Ceiling
□ Gasket	Wall	$\Box P$	laster		□ Other
□ Tank Insulation	□ Transite Panel	$\Box A$	coustic Tile (Dropped)		
□ Pipe Wrap	□ Textured Wall	$\Box A$	coustic Tile (Glued-on)		
HVAC	X Plaster	□ Mastic		Miscellaneous:	
□ Insulation	DWJC		Structural		
□ Tape		$\Box$ S	teel F. P. ing	No. of Phases:	
□ Paper Wrap		$\Box$ D	eck F. P. ing	Colour:

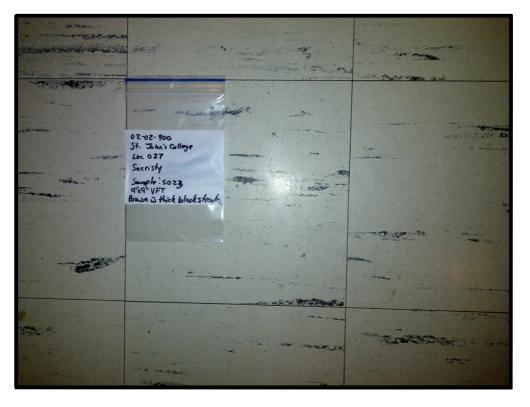
UNIVERSIT	Y				
Sample #:	S023		Date Sampled:	February 12, 20	13
Building :	St. John's College		Sampler:	Trent Hardy	
Location:	027, room 2025		Analysis:	SAI - PLM	
MUN Project #:	02-02-900		Work Order #:		
		Bulk	Sampling Parameters		
Pipe/Tank	Flooring		Ceiling	Roofing	Location
□ Insulation	□12'x12' Tile	ΠT	extured	□ Shingle	X Floor
□ Elbow	X 9'x9'Tile	□ Stucco		□ Rolled	U Wall Orientation
□ Fitting	□ Vinyl Sheet	□ Popcorn		🗆 Felt	□ Ceiling
□ Transite Pipe	□ Mastic	$\Box$ D	<b>WJC</b>	🗖 Tar	□ Above Ceiling
□ Gasket	Wall	$\Box P$	laster		□ Other
$\Box$ Tank Insulation	□ Transite Panel	$\Box A$	coustic Tile (Dropped)		
□ Pipe Wrap	□ Textured Wall	$\Box A$	coustic Tile (Glued-on)		
HVAC	□ Plaster	$\Box$ N	Iastic	Miscellaneous:	
$\Box$ Insulation	□ DWJC		Structural		
□ Tape		$\Box$ S	teel F. P. ing	No. of Phases:	
□ Paper Wrap			Deck F. P. ing	Colour: <u>Brown</u> streaks	with thick black

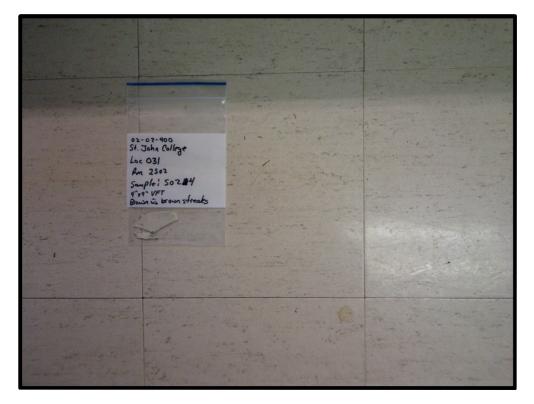
UNIVERSII	Y				
Sample #:	S024		Date Sampled:	February 12, 20	13
<b>Building</b> :	St. John's College		Sampler:	Trent Hardy	
Location:	031, room 2S02		Analysis:	SAI - PLM	
MUN Project #:	02-02-900		Work Order #:		
		Bulk	Sampling Parameters		
Pipe/Tank	Flooring		Ceiling	Roofing	Location
□ Insulation	□12'x12' Tile			□ Shingle	X Floor
□ Elbow	X 9'x9'Tile	$\Box$ S	tucco	$\Box$ Rolled	□ Wall Orientation
□ Fitting	□ Vinyl Sheet	$\Box P$	opcorn	□ Felt	□ Ceiling
□ Transite Pipe	□ Mastic	DD	WJC	🗆 Tar	□ Above Ceiling
□ Gasket	Wall	$\Box P$	laster		□ Other
□ Tank Insulation	□ Transite Panel	$\Box A$	coustic Tile (Dropped)		
□ Pipe Wrap	□ Textured Wall	$\Box A$	coustic Tile (Glued-on)		
HVAC	□ Plaster	$\Box N$	lastic	Miscellaneous:	
$\Box$ Insulation	□ DWJC		Structural		
□ Tape		$\Box$ S	teel F. P. ing	No. of Phases:	
□ Paper Wrap		$\Box$ D	eck F. P. ing	Colour: Brown	with brown streaks

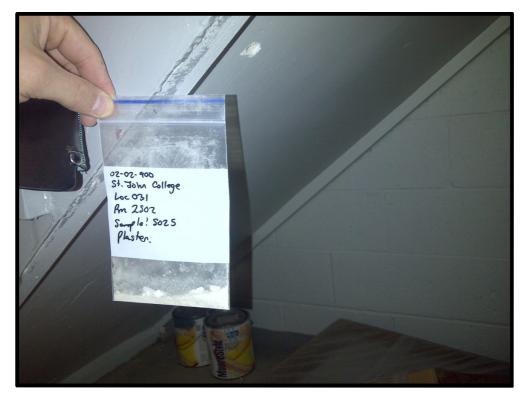
UNIVERSIT	Y			
Sample #:	S025	Date Sampled:	February 12, 20	13
<b>Building</b> :	St. John's College	Sampler:	Trent Hardy	
Location:	031, room 2S02	Analysis:	SAI - PLM	
MUN Project #:	02-02-900	Work Order #:		
		<b>Bulk Sampling Paramete</b>	ers	
Pipe/Tank	Flooring	Ceiling	Roofing	Location
□ Insulation	□12'x12' Tile	□ Textured	□ Shingle	□ Floor
□ Elbow	□ 9'x9'Tile	□ Stucco	$\Box$ Rolled	X Wall Orientation
□ Fitting	□ Vinyl Sheet	Popcorn	🗆 Felt	□ Ceiling
□ Transite Pipe	□ Mastic	□ DWJC	🗆 Tar	□ Above Ceiling
□ Gasket	Wall	□ Plaster		□ Other
□ Tank Insulation	□ Transite Panel	□ Acoustic Tile (Droppe	d)	
□ Pipe Wrap	□ Textured Wall	□ Acoustic Tile (Glued-o	on)	
HVAC	X Plaster	□ Mastic	Miscellaneous:	
□ Insulation	DWJC	Structural		
□ Tape		□ Steel F. P. ing	No. of Phases:	
□ Paper Wrap		Deck F. P. ing	Colour: Brown

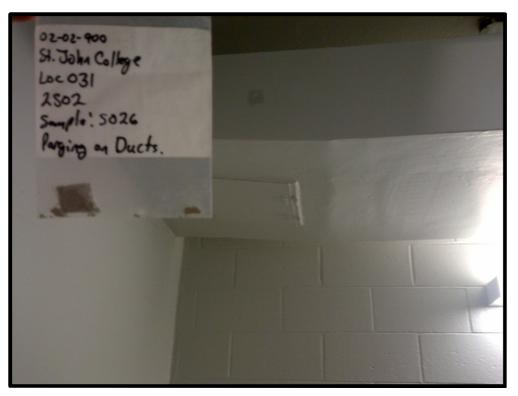
UNIVERSIT	Y				
Sample #:	S026		Date Sampled:	February 12, 2013	
Building :	St. John's College		Sampler:	Trent Hardy	
Location:	031, room 2S02		Analysis:	SAI - PLM	
MUN Project #:	02-02-900		Work Order #:		
		Bulk	Sampling Parameters		
Pipe/Tank	Flooring		Ceiling	Roofing	Location
□ Insulation	□12'x12' Tile			□ Shingle	□ Floor
□ Elbow	□ 9'x9'Tile	□ Stucco		□ Rolled	□ Wall Orientation
□ Fitting	□ Vinyl Sheet	□ Popcorn		🗆 Felt	□ Ceiling
□ Transite Pipe	□ Mastic	ΠD	WJC	🗆 Tar	□ Above Ceiling
□ Gasket	Wall	□ Plaster			X Other (ductwork)
□ Tank Insulation	□ Transite Panel	$\Box A$	coustic Tile (Dropped)		
🗆 Pipe Wrap	□ Textured Wall	$\Box A$	coustic Tile (Glued-on)		
HVAC	□ Plaster	□ Mastic		Miscellaneous:	Parging cement
X Insulation	DWJC		Structural		
□ Tape		$\Box$ S	teel F. P. ing	No. of Phases:	
□ Paper Wrap		$\Box D$	eck F. P. ing	Colour: <u>Tan</u>

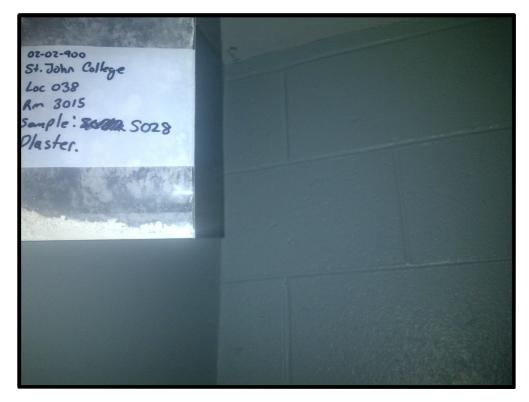
UNIVERSIT	Y			
Sample #:	S028	Date Sampled:	July 18, 2012	
<b>Building</b> :	St. John's College	Sampler:	Trent Hardy	
Location:	038, room 3015	Analysis:	SAI - PLM	
MUN Project #:	02-02-900	Work Order #:		
		<b>Bulk Sampling Parameters</b>		
Pipe/Tank	Flooring	Ceiling	Roofing	Location
□ Insulation	□12'x12' Tile	□ Textured	□ Shingle	□ Floor
□ Elbow	□ 9'x9'Tile	□ Stucco	$\Box$ Rolled	□ Wall Orientation
□ Fitting	□ Vinyl Sheet	□ Popcorn	□ Felt	X Ceiling
□ Transite Pipe	□ Mastic	□ DWJC	🗖 Tar	□ Above Ceiling
□ Gasket	Wall	X Plaster		□ Other
□ Tank Insulation	□ Transite Panel	□ Acoustic Tile (Dropped)		
□ Pipe Wrap	□ Textured Wall	$\Box$ Acoustic Tile (Glued-on)		
HVAC	□ Plaster	□ Mastic	Miscellaneous:	
□ Insulation	DWJC	Structural		
□ Tape		□ Steel F. P. ing	No. of Phases:	
□ Paper Wrap		Deck F. P. ing	Colour:

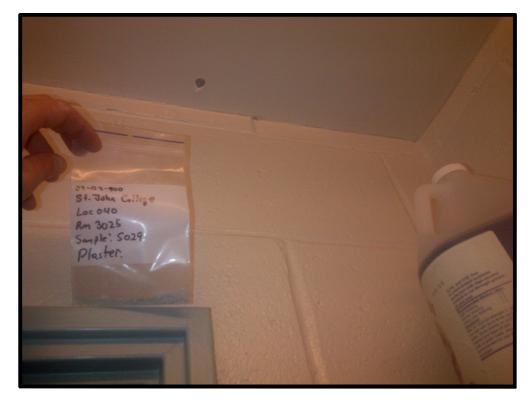
UNIVERSII	Y				
Sample #:	S029		Date Sampled:	July 18, 2012	
<b>Building</b> :	St. John's College		Sampler:	Trent Hardy	
Location:	040, room 3025		Analysis:	SAI - PLM	
MUN Project #:	02-02-900		Work Order #:		
		Bulk	Sampling Parameters		
Pipe/Tank	Flooring		Ceiling	Roofing	Location
□ Insulation	□12'x12' Tile	ΠT	extured	□ Shingle	□ Floor
□ Elbow	□ 9'x9'Tile	$\Box$ S	tucco	$\Box$ Rolled	□ Wall Orientation
□ Fitting	□ Vinyl Sheet	$\Box P$	opcorn	□ Felt	X Ceiling
□ Transite Pipe	□ Mastic	ΠD	WJC	🗖 Tar	□ Above Ceiling
□ Gasket	Wall	X Pl	aster		$\Box$ Other
$\Box$ Tank Insulation	□ Transite Panel	$\Box A$	coustic Tile (Dropped)		
□ Pipe Wrap	□ Textured Wall	$\Box A$	coustic Tile (Glued-on)		
HVAC	□ Plaster	$\Box N$	Iastic	Miscellaneous:	
□ Insulation	□ DWJC		Structural		
□ Tape		$\Box$ S	teel F. P. ing	No. of Phases:	
□ Paper Wrap		$\Box$ D	eck F. P. ing	Colour:	<u> </u>
