**ASBESTOS AND LEAD PAINT BUILDING MATERIALS SURVEY FOR:
THE VIVARIUM
MEMORIAL UNIVERSITY OF NEWFOUNDLAND**

Prepared for:
Memorial University of Newfoundland
St. John's, NL

Pinchin LeBlanc Environmental Ltd
Project No. 02-02-00900

March 20, 2013

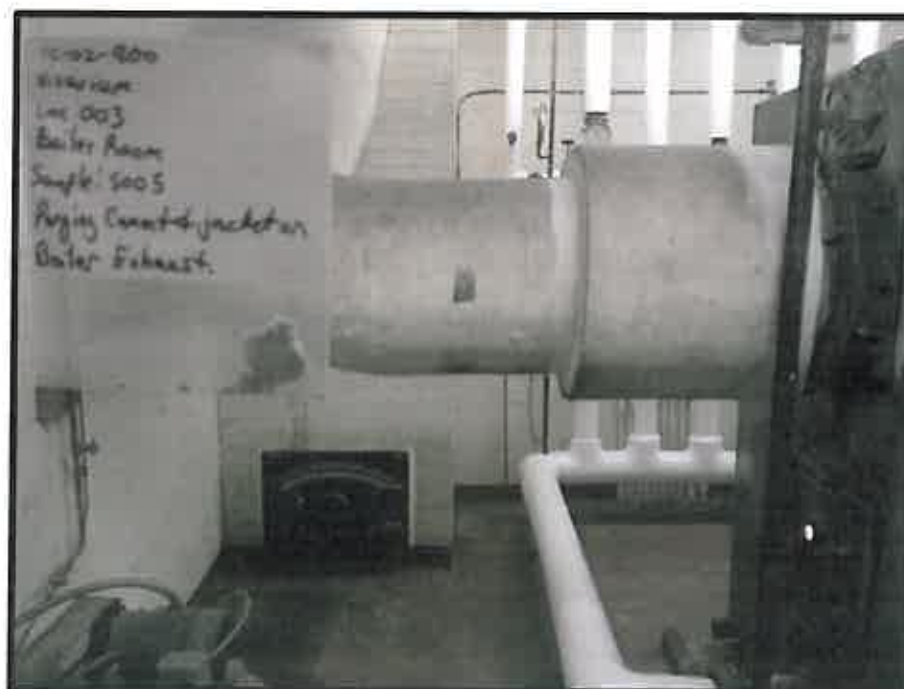
Bulk Sampling Parameters				
Pipe/Tank	Flooring	Ceiling	Roofing	Location
<input checked="" type="checkbox"/> Insulation	<input type="checkbox"/> 12'x12' Tile	<input type="checkbox"/> Textured	<input type="checkbox"/> Shingle	<input type="checkbox"/> Floor
<input type="checkbox"/> Elbow	<input type="checkbox"/> 9'x9' Tile	<input type="checkbox"/> Stucco	<input type="checkbox"/> Rolled	<input type="checkbox"/> Wall Orientation
<input type="checkbox"/> Fitting	<input type="checkbox"/> Vinyl Sheet	<input type="checkbox"/> Popcorn	<input type="checkbox"/> Felt	<input type="checkbox"/> Ceiling
<input type="checkbox"/> Transite Pipe	<input type="checkbox"/> Mastic	<input type="checkbox"/> DWJC	<input type="checkbox"/> Tar	<input type="checkbox"/> Above Ceiling
<input type="checkbox"/> Gasket	Wall	<input type="checkbox"/> Plaster		<input type="checkbox"/> Other
<input type="checkbox"/> Tank Insulation	<input type="checkbox"/> Transite Panel	<input type="checkbox"/> Acoustic Tile (Dropped)

<input type="checkbox"/> Pipe Wrap	<input type="checkbox"/> Textured Wall	<input type="checkbox"/> Acoustic Tile (Glued-on)		
HVAC	<input type="checkbox"/> Plaster	<input type="checkbox"/> Mastic		
<input type="checkbox"/> Insulation	<input type="checkbox"/> DWJC	Structural	Miscellaneous: <u>Boiler exhaust</u>	
<input type="checkbox"/> Tape		<input type="checkbox"/> Steel F. P. ing	No. of Phases: _____	
<input type="checkbox"/> Paper Wrap		<input type="checkbox"/> Deck F. P. ing	Colour: _____

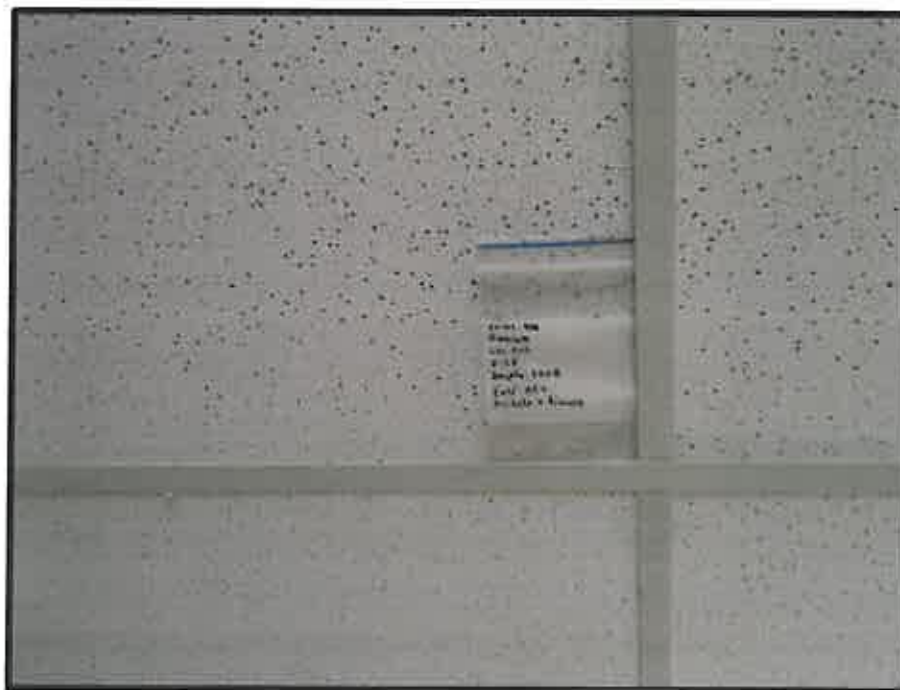
Bulk Sampling Parameters				
Pipe/Tank	Flooring	Ceiling	Roofing	Location
<input type="checkbox"/> Insulation	<input type="checkbox"/> 12'x12' Tile	<input type="checkbox"/> Textured	<input type="checkbox"/> Shingle	<input type="checkbox"/> Floor
<input type="checkbox"/> Elbow	<input type="checkbox"/> 9'x9' Tile	<input type="checkbox"/> Stucco	<input type="checkbox"/> Rolled	<input type="checkbox"/> Wall Orientation
<input type="checkbox"/> Fitting	<input type="checkbox"/> Vinyl Sheet	<input type="checkbox"/> Popcorn	<input type="checkbox"/> Felt	<input checked="" type="checkbox"/> X Ceiling
<input type="checkbox"/> Transite Pipe	<input type="checkbox"/> Mastic	<input type="checkbox"/> DWJC	<input type="checkbox"/> Tar	<input type="checkbox"/> Above Ceiling
<input type="checkbox"/> Gasket	Wall	<input type="checkbox"/> Plaster		<input type="checkbox"/> Other
<input type="checkbox"/> Tank Insulation	<input type="checkbox"/> Transite Panel	<input checked="" type="checkbox"/> X Acoustic Tile (Dropped)

<input type="checkbox"/> Pipe Wrap	<input type="checkbox"/> Textured Wall	<input type="checkbox"/> Acoustic Tile (Glued-on)		
HVAC	<input type="checkbox"/> Plaster	<input type="checkbox"/> Mastic	Miscellaneous: <u>2' x 4' pinhole fissure</u>	
<input type="checkbox"/> Insulation	<input type="checkbox"/> DWJC	Structural	No. of Phases: _____	
<input type="checkbox"/> Tape		<input type="checkbox"/> Steel F. P. ing	Colour: _____	
<input type="checkbox"/> Paper Wrap		<input type="checkbox"/> Deck F. P. ing

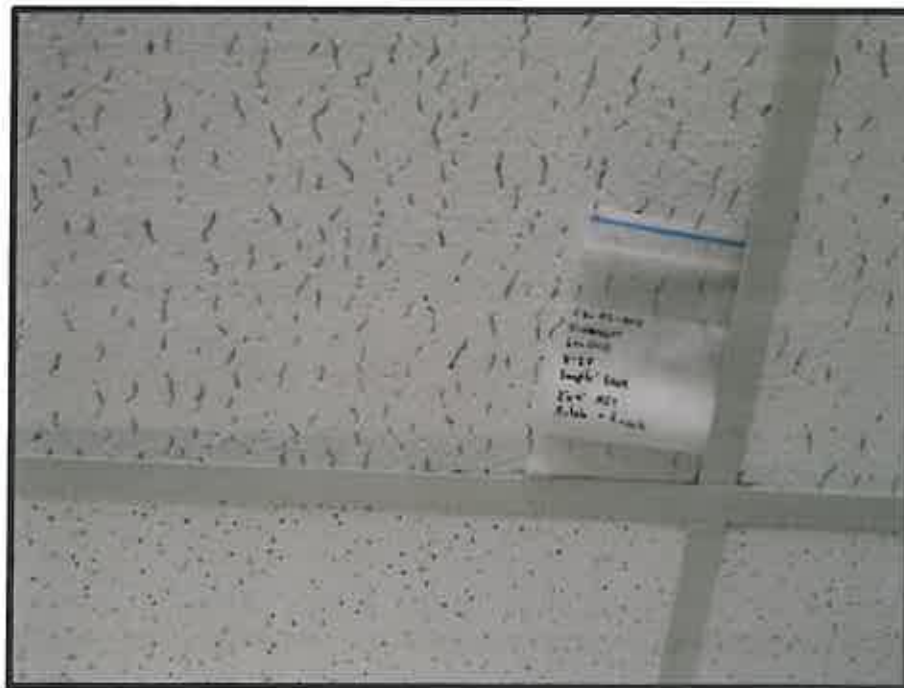
Bulk Sampling Parameters				
Pipe/Tank	Flooring	Ceiling	Roofing	Location
<input type="checkbox"/> Insulation	<input type="checkbox"/> 12'x12' Tile	<input type="checkbox"/> Textured	<input type="checkbox"/> Shingle	<input type="checkbox"/> Floor
<input type="checkbox"/> Elbow	<input type="checkbox"/> 9'x9' Tile	<input type="checkbox"/> Stucco	<input type="checkbox"/> Rolled	<input type="checkbox"/> Wall Orientation
<input type="checkbox"/> Fitting	<input type="checkbox"/> Vinyl Sheet	<input type="checkbox"/> Popcorn	<input type="checkbox"/> Felt	<input checked="" type="checkbox"/> X Ceiling
<input type="checkbox"/> Transite Pipe	<input type="checkbox"/> Mastic	<input type="checkbox"/> DWJC	<input type="checkbox"/> Tar	<input type="checkbox"/> Above Ceiling
<input type="checkbox"/> Gasket	Wall	<input type="checkbox"/> Plaster		<input type="checkbox"/> Other
<input type="checkbox"/> Tank Insulation	<input type="checkbox"/> Transite Panel	<input checked="" type="checkbox"/> X Acoustic Tile (Dropped)

<input type="checkbox"/> Pipe Wrap	<input type="checkbox"/> Textured Wall	<input type="checkbox"/> Acoustic Tile (Glued-on)		
HVAC	<input type="checkbox"/> Plaster	<input type="checkbox"/> Mastic	Miscellaneous: <u>2' x 4' pinhole fissure</u>	
<input type="checkbox"/> Insulation	<input type="checkbox"/> DWJC	Structural	No. of Phases: _____	
<input type="checkbox"/> Tape		<input type="checkbox"/> Steel F. P. ing	Colour: _____	
<input type="checkbox"/> Paper Wrap		<input type="checkbox"/> Deck F. P. ing
