ASBESTOS AND LEAD PAINT BUILDING MATERIALS SURVEY FOR: EDUCATION BUILDING MEMORIAL UNIVERSITY OF NEWFOUNDLAND

Prepared for: Memorial University of Newfoundland

Pinchin LeBlanc Environmental Ltd Project No. 02-02-00900

June 19, 2013

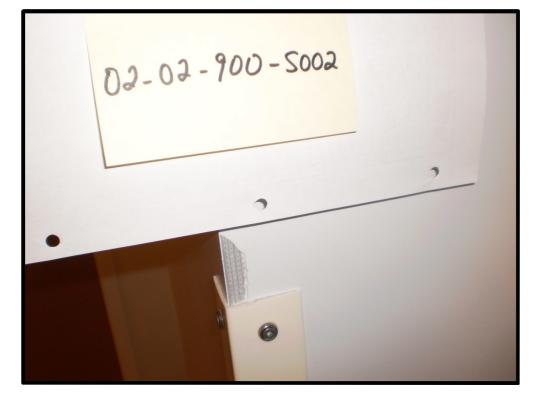
MEMORIA UNIVERSIT		ASB	ESTOS BULK SA	MPLING FO	ORM		
Sample #:	S003		Date Sampled:	July 16, 2012			
Building :	Education		Sampler:	Andy Mitchell			
Location:	005, room 2011		Analysis:	SAI - PLM			
MUN Project #:	02-02-900	02-900 Work Order #:					
Bulk Sampling Parameters							
Pipe/Tank	Flooring	Ceiling		Roofing	Location		
□ Insulation	□12'x12' Tile	ΠT	extured	□ Shingle	□ Floor		
\Box Elbow	□ 9'x9'Tile	\Box S	tucco	□ Rolled	□ Wall Orientation		
□ Fitting	□ Vinyl Sheet	$\Box P$	opcorn	🗆 Felt	X Ceiling		
□ Transite Pipe	□ Mastic	DD	WJC	🗆 Tar	□ Above Ceiling		
□ Gasket	Wall	$\Box P$	laster		□ Other		
□ Tank Insulation	□ Transite Panel	ΧА	coustic Tile (Dropped)				
□ Pipe Wrap	□ Textured Wall	$\Box A$	coustic Tile (Glued-on)				
HVAC	□ Plaster	$\Box N$	lastic	Miscellaneous:			
□ Insulation	DWJC		Structural				
□ Tape		\Box S	teel F. P. ing	No. of Phases:			
D Paper Wrap		DD	eck F. P. ing	Colour:

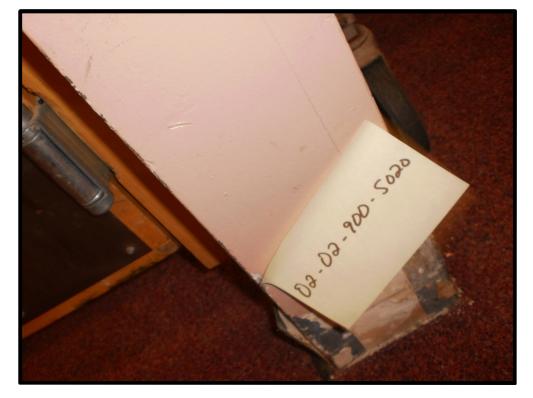
ASBESTOS BULK SAMPLING FORM						
Sample #:	S021		Date Sampled:	July 17, 2012		
Building :	Education		Sampler:	Andy Mitchell		
Location:	063, room 1008	Analysis:		SAI - PLM		
MUN Project #:	02-02-900	Work Order #:				
Bulk Sampling Parameters						
Pipe/Tank	Flooring	Ceiling		Roofing	Location	
□ Insulation	□12'x12' Tile	□ Textured		□ Shingle	□ Floor	
\Box Elbow	□ 9'x9'Tile	□ Stucco		□ Rolled	□ Wall Orientation	
□ Fitting	□ Vinyl Sheet	$\Box P$	opcorn	🗆 Felt	X Ceiling	
□ Transite Pipe	□ Mastic	DD	WJC	🗆 Tar	□ Above Ceiling	
□ Gasket	Wall	$\Box P$	laster		□ Other	
□ Tank Insulation	□ Transite Panel	ΧA	coustic Tile (Dropped)			
□ Pipe Wrap	□ Textured Wall	$\Box A$	coustic Tile (Glued-on)			
HVAC	□ Plaster	$\Box M$	lastic	Miscellaneous: <u>pattern</u>	2' x 2' pinhole	
\Box Insulation	DWJC		Structural			
□ Tape		$\Box S$	teel F. P. ing	No. of Phases:		
□ Paper Wrap		$\Box D$	eck F. P. ing	Colour:

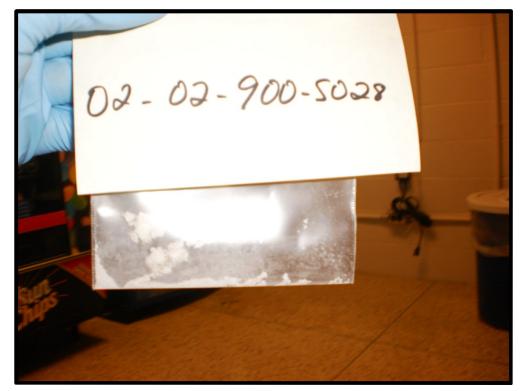
ASBESTOS BULK SAMPLING FORM						
Sample #:	S028		Date Sampled:	July 18, 2012		
Building :	Education		Sampler:	Andy Mitchell		
Location:	111, room 1009		Analysis:	SAI - PLM		
MUN Project #:	02-02-900		Work Order #:			
Bulk Sampling Parameters						
Pipe/Tank	Flooring		Ceiling	Roofing	Location	
\Box Insulation	□12'x12' Tile	🗆 Te	extured	\Box Shingle	□ Floor	
X Elbow	□ 9'x9'Tile	🗆 Sti	иссо	□ Rolled	□ Wall Orientation	
□ Fitting	□ Vinyl Sheet	🗆 Po	pcorn	🗆 Felt	□ Ceiling	
□ Transite Pipe	□ Mastic	\Box DV	WJC	🗆 Tar	□ Above Ceiling	
□ Gasket	Wall	🗆 Pla	aster		X Other	
\Box Tank Insulation	□ Transite Panel	\Box Ac	coustic Tile (Dropped)			
□ Pipe Wrap	□ Textured Wall	\Box Ac	coustic Tile (Glued-on)			
HVAC	□ Plaster	\Box Ma	astic	Miscellaneous:		
□ Insulation	DWJC		Structural			
□ Tape		\Box Ste	eel F. P. ing	No. of Phases:		
Paper Wrap		\Box De	eck F. P. ing	Colour:

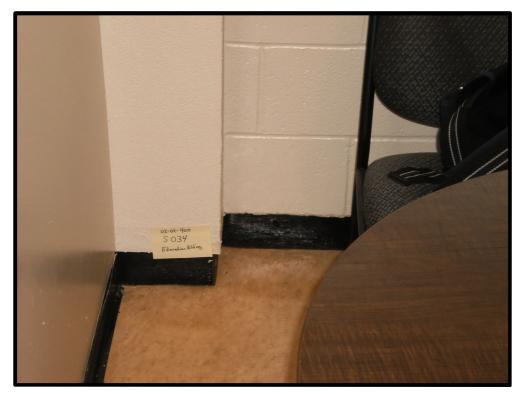
MEMORIA UNIVERSIT		ASBESTOS BULK SA	MPLING F(ORM				
Sample #:	S034	Date Sampled:	July 20, 2012					
Building :	Education	Sampler:	Andy Mitchell					
Location:	132, room 3066	Analysis:	SAI - PLM					
MUN Project #:	02-02-900	Work Order #:						
Bulk Sampling Parameters								
Pipe/Tank	Flooring	Ceiling	Roofing	Location				
□ Insulation	□12'x12' Tile	□ Textured	□ Shingle	□ Floor				
□ Elbow	□ 9'x9'Tile	□ Stucco	□ Rolled	X Wall Orientation				
□ Fitting	□ Vinyl Sheet	□ Popcorn	🗆 Felt	□ Ceiling				
□ Transite Pipe	□ Mastic	□ DWJC	🗆 Tar	□ Above Ceiling				
□ Gasket	Wall	□ Plaster		□ Other				
□ Tank Insulation	□ Transite Panel	□ Acoustic Tile (Dropped)						
□ Pipe Wrap	X Textured Wall	□ Acoustic Tile (Glued-on)						
HVAC	□ Plaster	□ Mastic	Miscellaneous:					
□ Insulation	X DWJC	Structural						
□ Tape		□ Steel F. P. ing	No. of Phases:					
□ Paper Wrap		Deck F. P. ing	Colour:

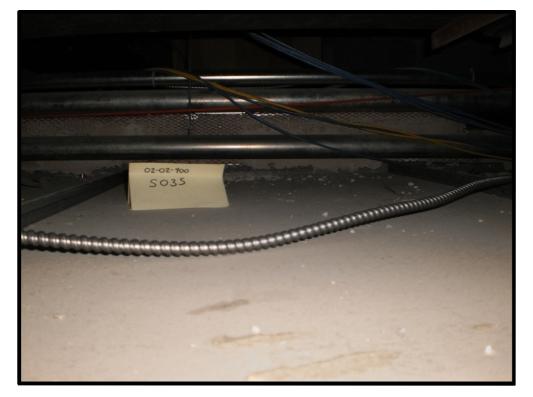
MEMORIA UNIVERSIT		ASB	ESTOS BULK SA	MPLING FO	ORM			
Sample #:	S035		Date Sampled:	July 20, 2012				
Building :	Education		Sampler:	Trent Hardy				
Location:	135, hallway 2C0S		Analysis:	SAI - PLM				
MUN Project #:	02-02-900		Work Order #:					
Bulk Sampling Parameters								
Pipe/Tank	Flooring		Ceiling	Roofing	Location			
□ Insulation	□12'x12' Tile	ΠT	extured	□ Shingle	□ Floor			
\Box Elbow	□ 9'x9'Tile	\Box S	tucco	\Box Rolled	□ Wall Orientation			
□ Fitting	□ Vinyl Sheet	$\square P$	opcorn	□ Felt	X Ceiling			
□ Transite Pipe	□ Mastic	$\Box D$	WJC	🗖 Tar	□ Above Ceiling			
□ Gasket								
	Wall	X Pl	aster		\Box Other			
\Box Tank Insulation	Wall □ Transite Panel		aster coustic Tile (Dropped)		□ Other			
		$\Box A$			□ Other			
□ Tank Insulation	Transite Panel	$\Box A$ $\Box A$	coustic Tile (Dropped)	Miscellaneous:				
□ Tank Insulation □ Pipe Wrap	□ Transite Panel □ Textured Wall	$\Box A$ $\Box A$	coustic Tile (Dropped) coustic Tile (Glued-on)	Miscellaneous:

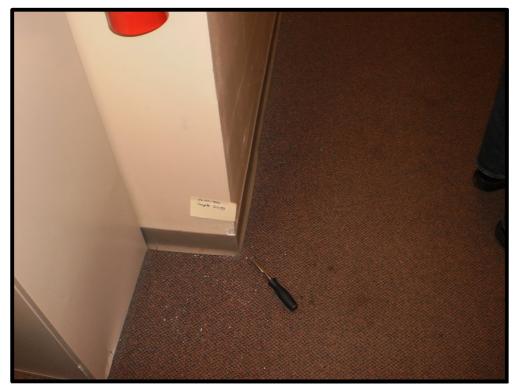
MEMORIA UNIVERSIT		ASB	ESTOS BULK SA	MPLING FO	ORM		
Sample #:	S039		Date Sampled:	July 20, 2012			
Building :	Education		Sampler:	Trent Hardy			
Location:	158, room CDCI 30	-000	Analysis:	SAI - PLM			
	3003						
MUN Project #:	02-02-900		Work Order #:				
Bulk Sampling Parameters							
Pipe/Tank	Flooring		Ceiling	Roofing	Location		
□ Insulation	□12'x12' Tile	ΠT	extured	□ Shingle	□ Floor		
□ Elbow	□ 9'x9'Tile	\Box S	tucco	□ Rolled	X Wall Orientation		
□ Fitting	□ Vinyl Sheet	$\Box P$	opcorn	□ Felt	□ Ceiling		
□ Transite Pipe	□ Mastic	$\Box D$	WJC	🗆 Tar	□ Above Ceiling		
□ Gasket	Wall	$\Box P$	laster		□ Other		
\Box Tank Insulation	□ Transite Panel	$\Box A$	coustic Tile (Dropped)				
□ Pipe Wrap	□ Textured Wall	$\Box A$	coustic Tile (Glued-on)				
HVAĊ	□ Plaster	$\Box N$	lastic	Miscellaneous:			
□ Insulation	X DWJC		Structural				
□ Tape		\Box S	teel F. P. ing	No. of Phases:			
□ Paper Wrap		$\Box D$	Deck F. P. ing	Colour:

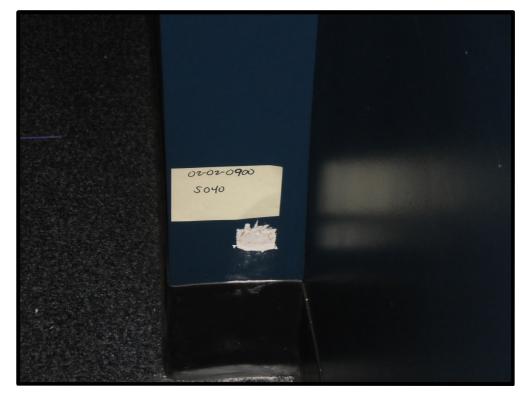
MEMORIA UNIVERSIT		ASB	ESTOS BULK SA	MPLING FO	ORM			
Sample #:	S040		Date Sampled:	July 20, 2012				
Building :	Education		Sampler:	Trent Hardy				
Location:	159, room 3005		Analysis:	SAI - PLM				
MUN Project #:	02-02-900	-900 Work Order #:						
Bulk Sampling Parameters								
Pipe/Tank	Flooring		Ceiling	Roofing	Location			
□ Insulation	□12'x12' Tile	ΠT	extured	□ Shingle	□ Floor			
□ Elbow	□ 9'x9'Tile	\Box S	tucco	□ Rolled	X Wall Orientation			
□ Fitting	□ Vinyl Sheet	$\Box P$	opcorn	🗆 Felt	□ Ceiling			
□ Transite Pipe	□ Mastic	DD	WJC	🗆 Tar	□ Above Ceiling			
□ Gasket	Wall	$\Box P$	laster		□ Other			
\Box Tank Insulation	□ Transite Panel	$\Box A$	coustic Tile (Dropped)					
□ Pipe Wrap	□ Textured Wall	$\Box A$	coustic Tile (Glued-on)					
HVAC	□ Plaster	$\Box M$	lastic	Miscellaneous:				
□ Insulation	X DWJC		Structural					
□ Tape		\Box S	teel F. P. ing	No. of Phases:				
Paper Wrap		\Box D	eck F. P. ing	Colour:

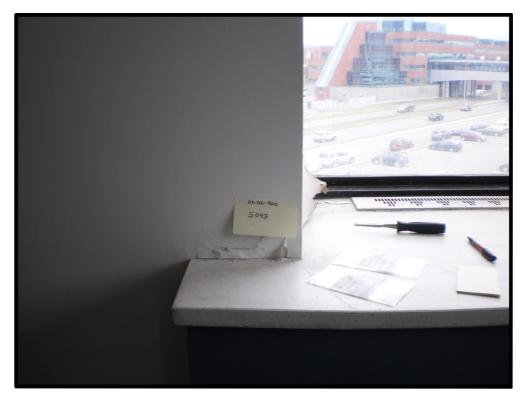
UNIVERSIT	Y			
Sample #:	S043	Date Sampled:	July 20, 2012	
Building :	Education	Sampler:	Trent Hardy	
Location:	169, room 3034B	Analysis:	SAI - PLM	
MUN Project #:	02-02-900	Work Order #:		
		Bulk Sampling Parameters		
Pipe/Tank	Flooring	Ceiling	Roofing	Location
□ Insulation	□12'x12' Tile	□ Textured	□ Shingle	□ Floor
□ Elbow	□ 9'x9'Tile	□ Stucco	\Box Rolled	X Wall Orientation
□ Fitting	□ Vinyl Sheet	□ Popcorn	□ Felt	□ Ceiling
□ Transite Pipe	□ Mastic	□ DWJC	🗆 Tar	□ Above Ceiling
□ Gasket	Wall	□ Plaster		□ Other
□ Tank Insulation	□ Transite Panel	□ Acoustic Tile (Dropped)		
□ Pipe Wrap	□ Textured Wall	\Box Acoustic Tile (Glued-on)		
HVAC	□ Plaster	□ Mastic	Miscellaneous:	
\Box Insulation	X DWJC	Structural		
□ Tape		□ Steel F. P. ing	No. of Phases:	
□ Paper Wrap		Deck F. P. ing	Colour: White

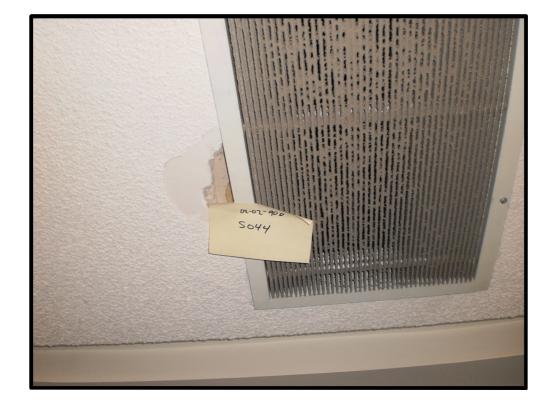
ASBESTOS BULK SAMPLING FORM							
Sample #:	S044		Date Sampled:	July 20, 2012			
Building :	Education		Sampler:	Trent Hardy			
Location:	169, room 3034B		Analysis:	SAI - PLM			
MUN Project #:	02-02-900	2-02-900 Work Order #:					
Bulk Sampling Parameters							
Pipe/Tank	Flooring		Ceiling	Roofing	Location		
□ Insulation	□12'x12' Tile	ΠT	extured	□ Shingle	□ Floor		
□ Elbow	□ 9'x9'Tile	\Box S	tucco	□ Rolled	□ Wall Orientation		
□ Fitting	□ Vinyl Sheet	$\Box P$	opcorn	🗆 Felt	X Ceiling		
□ Transite Pipe	□ Mastic	\Box D	WJC	🗆 Tar	□ Above Ceiling		
□ Gasket	Wall	X Pl	aster		□ Other		
\Box Tank Insulation	□ Transite Panel	$\Box A$	coustic Tile (Dropped)				
□ Pipe Wrap	□ Textured Wall	$\Box A$	coustic Tile (Glued-on)				
HVAC	□ Plaster	□ Mastic		Miscellaneous:			
□ Insulation	□ DWJC		Structural				
□ Tape		\Box S	teel F. P. ing	No. of Phases:	2		
□ Paper Wrap		\Box D	eck F. P. ing	Colour: White	- grey

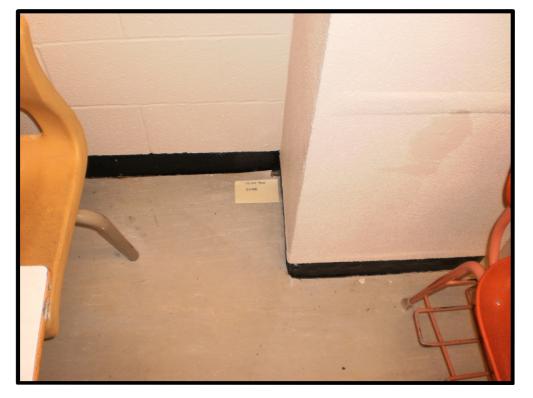
MEMORIA UNIVERSIT		ASBESTOS BULK SA	MPLING FO	ORM			
Sample #:	S046	Date Sampled:	July 20, 2012				
Building :	Education	Sampler:	Trent Hardy				
Location:	176, room 3030	Analysis:	SAI - PLM				
MUN Project #:	02-02-900	Work Order #:					
Bulk Sampling Parameters							
Pipe/Tank	Flooring	Ceiling	Roofing	Location			
□ Insulation	□12'x12' Tile	□ Textured	□ Shingle	X Floor			
□ Elbow	□ 9'x9'Tile	□ Stucco	□ Rolled	□ Wall Orientation			
□ Fitting	X Vinyl Sheet	□ Popcorn	🗆 Felt	□ Ceiling			
□ Transite Pipe	□ Mastic	□ DWJC	🗆 Tar	□ Above Ceiling			
□ Gasket	Wall	□ Plaster		□ Other			
□ Tank Insulation	□ Transite Panel	□ Acoustic Tile (Dropped)					
□ Pipe Wrap	□ Textured Wall	\Box Acoustic Tile (Glued-on)					
HVAC	□ Plaster	□ Mastic	Miscellaneous:				
\Box Insulation	□ DWJC	Structural					
□ Tape		□ Steel F. P. ing	No. of Phases:				
□ Paper Wrap		Deck F. P. ing	Colour: Green	- white

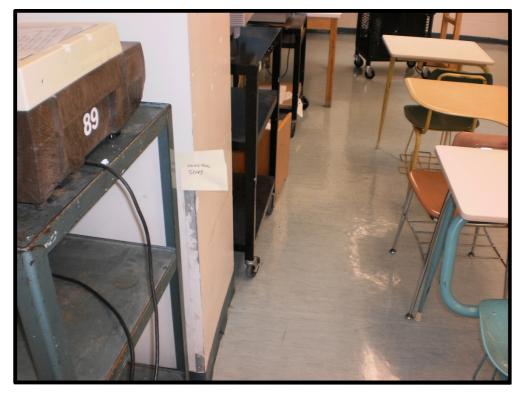
Sample #:	S047	Date Sampled:	July 20, 2012		
Building :	Education	Sampler:	Trent Hardy		
Location:	177, room 3023	Analysis:	SAI - PLM		
MUN Project #:	02-02-900	Work Order #:			
Bulk Sampling Parameters					
Pipe/Tank	Flooring	Ceiling	Roofing	Location	
□ Insulation	□12'x12' Tile	□ Textured	□ Shingle	□ Floor	
□ Elbow	□ 9'x9'Tile	□ Stucco	\Box Rolled	X Wall Orientation	
□ Fitting	□ Vinyl Sheet	□ Popcorn	🗆 Felt	□ Ceiling	
□ Transite Pipe	□ Mastic	□ DWJC	🗖 Tar	□ Above Ceiling	
□ Gasket	Wall	□ Plaster		□ Other	
□ Tank Insulation	□ Transite Panel	□ Acoustic Tile (Dropped)			
□ Pipe Wrap	□ Textured Wall	□ Acoustic Tile (Glued-on)			
HVAC	□ Plaster	□ Mastic	Miscellaneous:		
\Box Insulation	X DWJC	Structural			
□ Tape		□ Steel F. P. ing	No. of Phases:		
Paper Wrap		Deck F. P. ing	Colour:

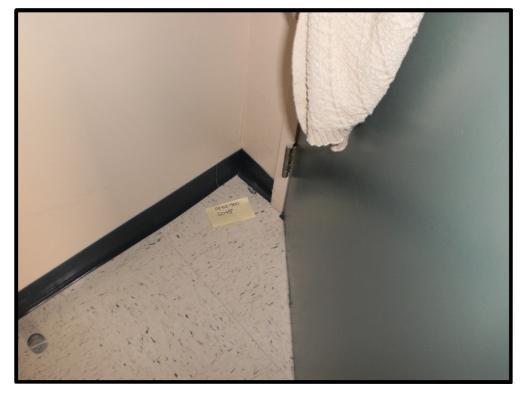
MEMORIA UNIVERSIT		ASBESTOS BULK SA	MPLING FO	ORM		
Sample #:	S048	Date Sampled:	July 20, 2012			
Building :	Education	Sampler:	Trent Hardy			
Location:	182, room 3019	Analysis:	SAI - PLM			
MUN Project #:	02-02-900	Work Order #:				
Bulk Sampling Parameters						
Pipe/Tank	Flooring	Ceiling	Roofing	Location		
□ Insulation	X12'x12' Tile	□ Textured	□ Shingle	X Floor		
□ Elbow	□ 9'x9'Tile	□ Stucco	□ Rolled	□ Wall Orientation		
□ Fitting	□ Vinyl Sheet	□ Popcorn	□ Felt	□ Ceiling		
□ Transite Pipe	□ Mastic	□ DWJC	🗆 Tar	□ Above Ceiling		
□ Gasket	Wall	□ Plaster		□ Other		
□ Tank Insulation	□ Transite Panel	□ Acoustic Tile (Dropped)				
□ Pipe Wrap	□ Textured Wall	\Box Acoustic Tile (Glued-on)				
HVAC	□ Plaster	□ Mastic	Miscellaneous:			
\Box Insulation	DWJC	Structural				
□ Tape		□ Steel F. P. ing	No. of Phases:			
□ Paper Wrap		Deck F. P. ing	Colour: Grey b	lack streak

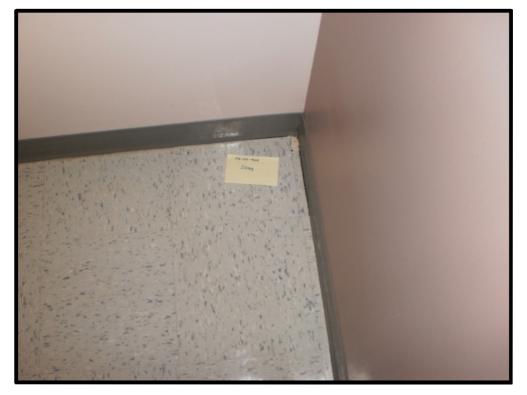
MEMORIA UNIVERSIT		ASBI	ESTOS BULK SA	MPLING FO	ORM	
Sample #:	S049		Date Sampled:	July 20, 2012		
Building :	Education		Sampler:	Trent Hardy		
Location:	189, room 3011		Analysis:	SAI - PLM		
MUN Project #:	02-02-900		Work Order #:			
Bulk Sampling Parameters						
Pipe/Tank	Flooring		Ceiling	Roofing	Location	
□ Insulation	X12'x12' Tile	$\Box T \epsilon$	extured	□ Shingle	X Floor	
□ Elbow	□ 9'x9'Tile	\Box St	ucco	□ Rolled	□ Wall Orientation	
□ Fitting	□ Vinyl Sheet	\Box Pc	opcorn	🗆 Felt	□ Ceiling	
□ Transite Pipe	□ Mastic	\Box D'	WJC	🗆 Tar	□ Above Ceiling	
□ Gasket	Wall	🗆 Pl	aster		□ Other	
□ Tank Insulation	□ Transite Panel	\Box Ac	coustic Tile (Dropped)			
□ Pipe Wrap	□ Textured Wall	\Box Ac	coustic Tile (Glued-on)			
HVAC	□ Plaster	\Box M	astic	Miscellaneous:		
□ Insulation	DWJC	Structural				
□ Tape		\Box St	eel F. P. ing	No. of Phases:		
□ Paper Wrap		\Box De	eck F. P. ing	Colour: <u>Light g</u>	rey

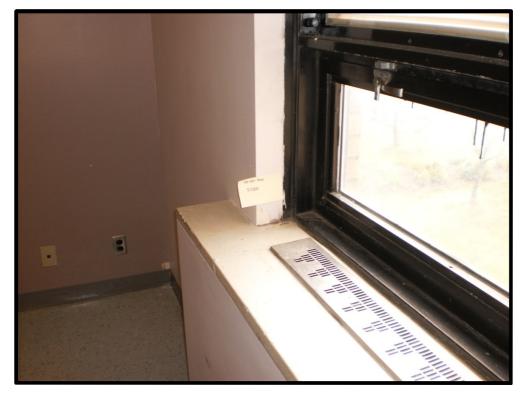
MEMORIA UNIVERSIT		ASB	ESTOS BULK SA	MPLING FO	ORM	
Sample #:	S050		Date Sampled:	July 20, 2012		
Building :	Education		Sampler:	Trent Hardy		
Location:	189, room 3011		Analysis:	SAI - PLM		
MUN Project #:	02-02-900	02-02-900 Work Order #:				
Bulk Sampling Parameters						
Pipe/Tank	Flooring		Ceiling	Roofing	Location	
□ Insulation	□12'x12' Tile	ΠT	extured	□ Shingle	□ Floor	
□ Elbow	□ 9'x9'Tile	\Box St	tucco	\Box Rolled	X Wall Orientation	
□ Fitting	□ Vinyl Sheet	\Box Pe	opcorn	🗆 Felt	□ Ceiling	
□ Transite Pipe	□ Mastic	\Box D	WJC	🗖 Tar	□ Above Ceiling	
□ Gasket	Wall	\Box Pl	laster		□ Other	
\Box Tank Insulation	□ Transite Panel	$\Box A$	coustic Tile (Dropped)			
□ Pipe Wrap	□ Textured Wall	$\Box A$	coustic Tile (Glued-on)			
HVAC	□ Plaster	\Box M	lastic	Miscellaneous:		
□ Insulation	X DWJC		Structural			
□ Tape		\Box St	teel F. P. ing	No. of Phases:		
Paper Wrap		\Box D	eck F. P. ing	Colour:

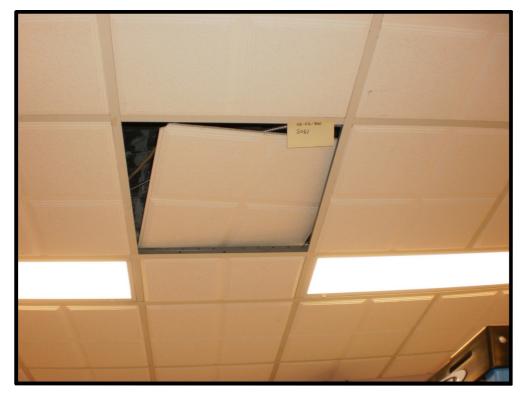
MEMORIA UNIVERSIT		ASBESTOS BULK SA	MPLING F	ORM		
Sample #:	S051	Date Sampled:	July 20, 2012			
Building :	Education	Sampler:	Trent Hardy			
Location:	189, room 3011	Analysis:	SAI - PLM			
MUN Project #:	02-02-900	Work Order #:				
Bulk Sampling Parameters						
Pipe/Tank	Flooring	Ceiling	Roofing	Location		
\Box Insulation	□12'x12' Tile	□ Textured	□ Shingle	□ Floor		
\Box Elbow	□ 9'x9'Tile	□ Stucco	\Box Rolled	□ Wall Orientation		
□ Fitting	□ Vinyl Sheet	□ Popcorn	🗆 Felt	X Ceiling		
□ Transite Pipe	□ Mastic	□ DWJC	🗖 Tar	□ Above Ceiling		
□ Gasket	Wall	□ Plaster		□ Other		
□ Tank Insulation	□ Transite Panel	X Acoustic Tile (Dropped)				
□ Pipe Wrap	□ Textured Wall	\Box Acoustic Tile (Glued-on)				
HVAC	□ Plaster	□ Mastic	Miscellaneous: 2' x 2'			
\Box Insulation	DWJC	Structural				
□ Tape		□ Steel F. P. ing	No. of Phases:			
□ Paper Wrap		Deck F. P. ing	Colour:

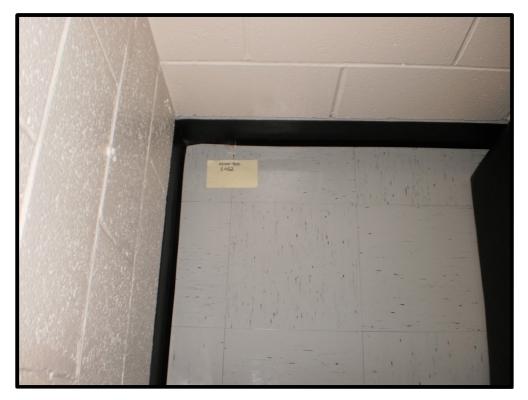
MEMORIA UNIVERSIT		ASB	ESTOS BULK SA	MPLING FO	ORM			
Sample #:	S052		Date Sampled:	July 23, 2012				
Building :	Education		Sampler:	Trent Hardy				
Location:	190, room 3010		Analysis:	SAI - PLM				
MUN Project #:	02-02-900		Work Order #:					
Bulk Sampling Parameters								
Pipe/Tank	Flooring		Ceiling	Roofing	Location			
□ Insulation	X12'x12' Tile	ΠT	extured	□ Shingle	X Floor			
□ Elbow	□ 9'x9'Tile	\Box S	tucco	□ Rolled	□ Wall Orientation			
□ Fitting	□ Vinyl Sheet	$\Box P$	opcorn	🗆 Felt	□ Ceiling			
□ Transite Pipe	□ Mastic	\Box D	WJC	🗆 Tar	□ Above Ceiling			
□ Gasket	Wall	$\Box P$	laster		□ Other			
□ Tank Insulation	□ Transite Panel	$\Box A$	coustic Tile (Dropped)					
□ Pipe Wrap	□ Textured Wall	$\Box A$	coustic Tile (Glued-on)					
HVAC	□ Plaster	$\Box N$	lastic	Miscellaneous:				
□ Insulation	□ DWJC		Structural					
□ Tape		\Box S	teel F. P. ing	No. of Phases:				
□ Paper Wrap		DD	eck F. P. ing	Colour: <u>Very li</u> streaks	ght grey with brown

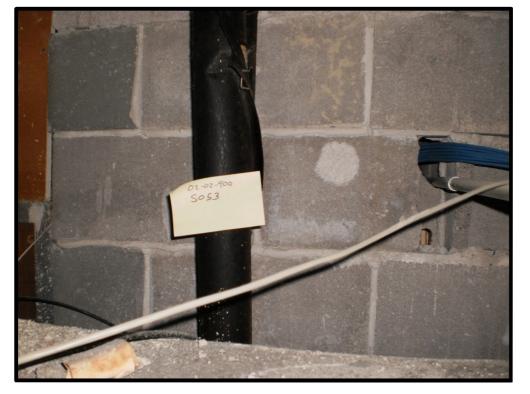
ASBESTOS BULK SAMPLING FORM								
Sample #:	S053		Date Sampled:	July 23, 2012				
Building :	Education		Sampler:	Trent Hardy				
Location:	200, hallway 3C03		Analysis:	SAI - PLM				
MUN Project #:	02-02-900		Work Order #:					
Bulk Sampling Parameters								
Pipe/Tank	Flooring	Ceiling		Roofing	Location			
\Box Insulation	□12'x12' Tile	П Т	extured	\Box Shingle	□ Floor			
□ Elbow	□ 9'x9'Tile	$\Box S$	tucco	\Box Rolled	□ Wall Orientation			
□ Fitting	□ Vinyl Sheet	$\Box P$	opcorn	🗆 Felt	□ Ceiling			
□ Transite Pipe	□ Mastic	$\Box D$	WJC	🗆 Tar	X Above Ceiling			
□ Gasket	Wall	$\Box P$	laster		□ Other			
\Box Tank Insulation	□ Transite Panel	$\Box A$	coustic Tile (Dropped)					
X Pipe Wrap	□ Textured Wall	$\Box A$	coustic Tile (Glued-on)					
HVAC	□ Plaster	□ Mastic Miscellaneous: <u>T</u> fiberglass insulat			* *			
\Box Insulation	DWJC		Structural					
□ Tape		$\Box S$	teel F. P. ing	No. of Phases:				
□ Paper Wrap		\Box D	eck F. P. ing	Colour:

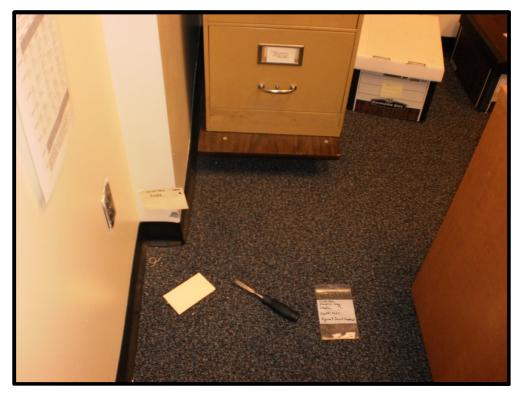
MEMORIA UNIVERSIT		ASBESTOS BULK SA	MPLING FO	ORM					
Sample #:	S054	Date Sampled:	July 23, 2012						
Building :	Education	Sampler:	Trent Hardy						
Location:	210, room 4038	Analysis:	SAI - PLM						
MUN Project #:	02-02-900	Work Order #:							
Bulk Sampling Parameters									
Pipe/Tank	Flooring	Ceiling	Roofing	Location					
□ Insulation	□12'x12' Tile	□ Textured	\Box Shingle	□ Floor					
□ Elbow	□ 9'x9'Tile	□ Stucco	□ Rolled	X Wall Orientation					
□ Fitting	□ Vinyl Sheet	□ Popcorn	🗆 Felt	□ Ceiling					
□ Transite Pipe	□ Mastic	□ DWJC	🗆 Tar	□ Above Ceiling					
□ Gasket	Wall	□ Plaster		□ Other					
□ Tank Insulation	□ Transite Panel	□ Acoustic Tile (Dropped)							
□ Pipe Wrap	□ Textured Wall	□ Acoustic Tile (Glued-on)							
HVAC	□ Plaster	□ Mastic	Miscellaneous:						
\Box Insulation	X DWJC	Structural							
□ Tape		□ Steel F. P. ing	No. of Phases:						
□ Paper Wrap		Deck F. P. ing	Colour:

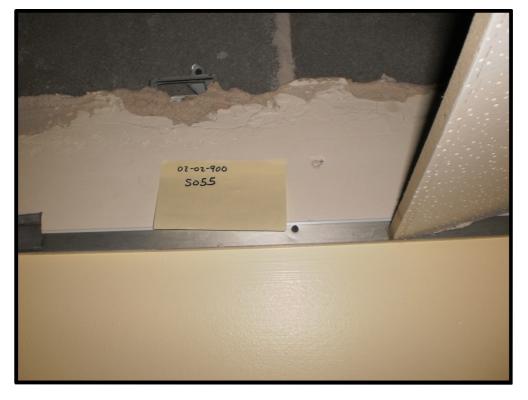
MEMORIA UNIVERSIT		ASB	ESTOS BULK SA	MPLING FO	ORM			
Sample #:	S055		Date Sampled:	July 23, 2012				
Building :	Education		Sampler:	Trent Hardy				
Location:	214, room 4044		Analysis:	SAI - PLM				
MUN Project #:	02-02-900	2-900 Work Order #:						
Bulk Sampling Parameters								
Pipe/Tank	Flooring	Ceiling		Roofing	Location			
□ Insulation	□12'x12' Tile	ΠT	extured	□ Shingle	□ Floor			
□ Elbow	□ 9'x9'Tile	\Box S	tucco	□ Rolled	□ Wall Orientation			
□ Fitting	□ Vinyl Sheet	$\Box P$	opcorn	🗆 Felt	□ Ceiling			
□ Transite Pipe	□ Mastic	\Box D	WJC	🗆 Tar	X Above Ceiling			
□ Gasket	Wall	X Pl	aster		□ Other			
□ Tank Insulation	□ Transite Panel	$\Box A$	coustic Tile (Dropped)					
□ Pipe Wrap	□ Textured Wall	$\Box A$	coustic Tile (Glued-on)					
HVAC	□ Plaster	$\Box M$	lastic	Miscellaneous:				
□ Insulation	DWJC		Structural					
□ Tape		\Box S	teel F. P. ing	No. of Phases:	2			
□ Paper Wrap		DD	eck F. P. ing	Colour: White-

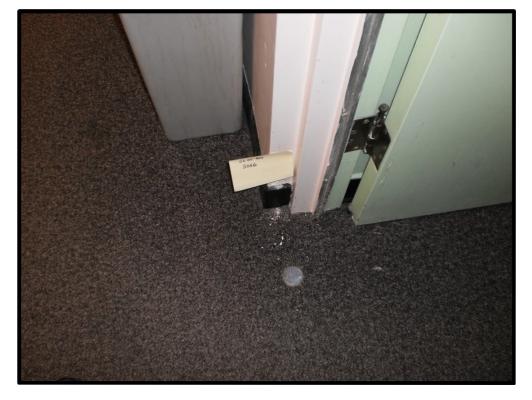
MEMORIA UNIVERSIT		ASBESTOS BULK SA	MPLING F(ORM				
Sample #:	S056	Date Sampled:	July 23, 2012					
Building :	Education	Sampler:	Trent Hardy					
Location:	218, room 4037	Analysis:	SAI - PLM					
MUN Project #:	02-02-900	Work Order #:						
Bulk Sampling Parameters								
Pipe/Tank	Flooring	Ceiling	Roofing	Location				
□ Insulation	□12'x12' Tile	□ Textured	□ Shingle	□ Floor				
□ Elbow	□ 9'x9'Tile	□ Stucco	□ Rolled	X Wall Orientation				
□ Fitting	□ Vinyl Sheet	□ Popcorn	🗆 Felt	□ Ceiling				
□ Transite Pipe	□ Mastic	□ DWJC	🗆 Tar	□ Above Ceiling				
□ Gasket	Wall	□ Plaster		□ Other				
□ Tank Insulation	□ Transite Panel	□ Acoustic Tile (Dropped)						
□ Pipe Wrap	□ Textured Wall	□ Acoustic Tile (Glued-on)						
HVAC	X Plaster	□ Mastic	Miscellaneous:					
□ Insulation	DWJC	Structural						
□ Tape		□ Steel F. P. ing	No. of Phases:					
Paper Wrap		Deck F. P. ing	Colour:

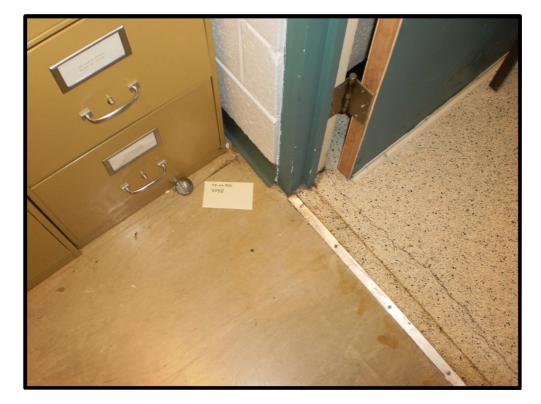
MEMORIA UNIVERSIT		ASB	ESTOS BULK SA	MPLING FO	ORM				
Sample #:	S058		Date Sampled:	July 23, 2012					
Building :	Education		Sampler:	Trent Hardy					
Location:	222, room 4036A		Analysis:	SAI - PLM					
MUN Project #:	N Project #: 02-02-900 Work Order #:								
	Bulk Sampling Parameters								
Pipe/Tank	Flooring	Ceiling		Roofing	Location				
□ Insulation	□12'x12' Tile	ΠT	extured	\Box Shingle	x Floor				
□ Elbow	□ 9'x9'Tile	\Box S	tucco	\Box Rolled	□ Wall Orientation				
□ Fitting	x Vinyl Sheet	$\Box P$	opcorn	□ Felt	□ Ceiling				
□ Transite Pipe	□ Mastic	\Box D	WJC	🗆 Tar	□ Above Ceiling				
□ Gasket	Wall	$\Box P$	laster		□ Other				
□ Tank Insulation	□ Transite Panel	$\Box A$	coustic Tile (Dropped)						
□ Pipe Wrap	□ Textured Wall	$\Box A$	coustic Tile (Glued-on)						
HVAC	□ Plaster	\Box N	lastic	Miscellaneous:					
\Box Insulation	DWJC		Structural						
□ Tape		\Box S	teel F. P. ing	No. of Phases:

□ Paper Wrap		\Box D	eck F. P. ing	Colour: Tan wi	ith white waves VSF

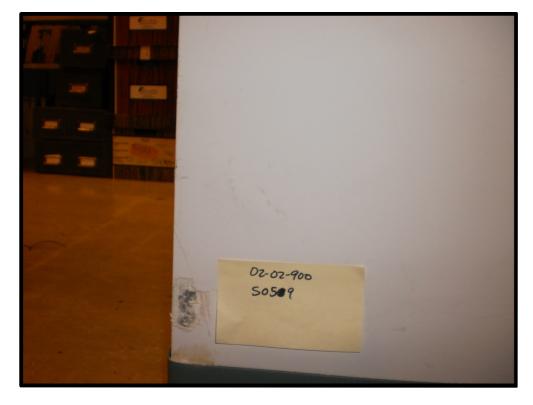
MEMORIA UNIVERSIT		ASB	ESTOS BULK SA	MPLING FO	ORM				
Sample #:	S059		Date Sampled:	July 23, 2012					
Building :	Education		Sampler:	Trent Hardy					
Location:	222, room 4036A		Analysis:	SAI - PLM					
MUN Project #:	02-02-900		Work Order #:						
Bulk Sampling Parameters									
Pipe/Tank	Flooring	Ceiling		Roofing	Location				
□ Insulation	□12'x12' Tile	T 🗆	extured	□ Shingle	□ Floor				
\Box Elbow	□ 9'x9'Tile	\Box St	tucco	\Box Rolled	x Wall Orientation				
□ Fitting	□ Vinyl Sheet	\Box Pe	opcorn	□ Felt	□ Ceiling				
□ Transite Pipe	□ Mastic	$\Box D$	WJC	🗆 Tar	□ Above Ceiling				
□ Gasket	Wall	\Box Pl	aster		□ Other				
□ Tank Insulation	□ Transite Panel	$\Box A$	coustic Tile (Dropped)						
□ Pipe Wrap	□ Textured Wall	$\Box A$	coustic Tile (Glued-on)						
HVAC	□ Plaster	\Box M	lastic	Miscellaneous:					
\Box Insulation	x DWJC		Structural						
□ Tape		🗆 St	teel F. P. ing	No. of Phases:					
□ Paper Wrap		\Box D	eck F. P. ing	Colour:

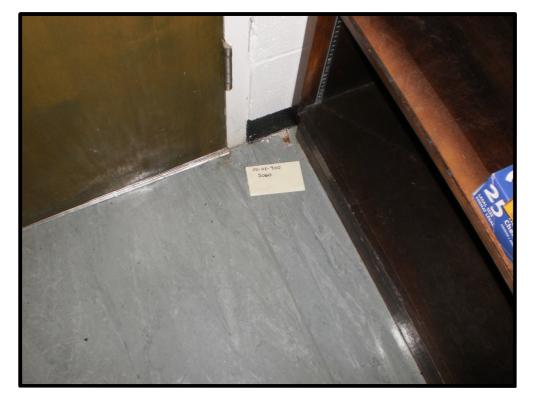
MEMORIA UNIVERSIT		ASBI	ESTOS BULK SA	MPLING FO	ORM			
Sample #:	S060		Date Sampled:	July 23, 2012				
Building :	Education		Sampler:	Trent Hardy				
Location:	223, room 4049		Analysis:	SAI - PLM				
MUN Project #:	02-02-900		Work Order #:					
	Bulk Sampling Parameters							
Pipe/Tank	Flooring	Ceiling		Roofing	Location			
□ Insulation	□12'x12' Tile			□ Shingle	x Floor			
\Box Elbow	□ 9'x9'Tile	□ Stucco		□ Rolled	□ Wall Orientation			
□ Fitting	x Vinyl Sheet	\Box Pc	opcorn	🗆 Felt	□ Ceiling			
□ Transite Pipe	□ Mastic	\Box D'	ŴJC	🗆 Tar	□ Above Ceiling			
□ Gasket	Wall	🗆 Pl	aster		□ Other			
□ Tank Insulation	□ Transite Panel	\Box Ac	coustic Tile (Dropped)					
□ Pipe Wrap	□ Textured Wall	\Box Ac	coustic Tile (Glued-on)					
HVAC	□ Plaster	\Box M	astic	Miscellaneous:				
□ Insulation	DWJC		Structural					
□ Tape		\Box St	eel F. P. ing	No. of Phases:				
□ Paper Wrap			eck F. P. ing	Colour: Green with white wave pattern VSF

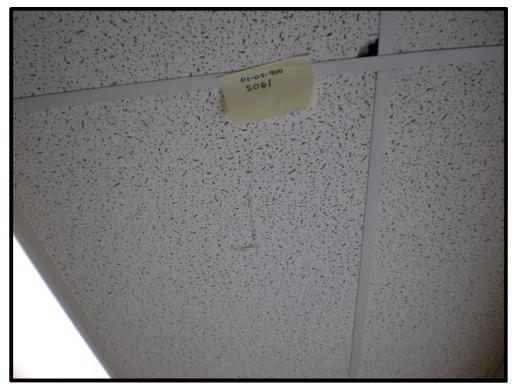
MEMORIA UNIVERSIT		ASB	ESTOS BULK SA	MPLING FO	ORM			
Sample #:	S061		Date Sampled:	July 23, 2012				
Building :	Education		Sampler:	Trent Hardy				
Location:	233, hallway 4C03		Analysis:	SAI - PLM				
MUN Project #:	02-02-900	Work Order #:						
Bulk Sampling Parameters								
Pipe/Tank	Flooring		Ceiling	Roofing	Location			
□ Insulation	□12'x12' Tile	ΠT	extured	\Box Shingle	□ Floor			
\Box Elbow	□ 9'x9'Tile	\Box S	tucco	\Box Rolled	□ Wall Orientation			
□ Fitting	□ Vinlye Sheet	$\Box P$	opcorn	🗆 Felt	X Ceiling			
□ Transite Pipe	□ Mastic	$\Box D$	WJC	🗆 Tar	□ Above Ceiling			
□ Gasket	Wall	$\square P$	laster		\Box Other			
\Box Tank Insulation	□ Transite Panel	ΧA	coustic Tile (Dropped)					
□ Pipe Wrap	□ Textured Wall	$\Box A$	coustic Tile (Glued-on)					
HVAC	□ Plaster	$\Box N$	lastic	Miscellaneous:	2' x 4' pinhole fleck			
\Box Insulation	□ DWJC		Structural					
□ Tape		\Box S	teel F. P. ing	No. of Phases:	<u>1</u>

□ Paper Wrap		\Box D	eck F. P. ing	Colour: White

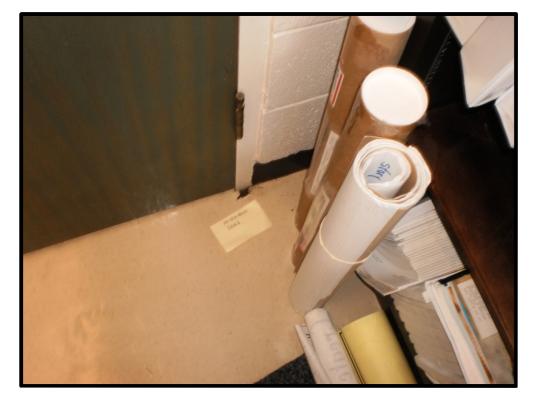
MEMORIA UNIVERSIT		ASB	ESTOS BULK SA	MPLING FO	ORM		
Sample #:	S062		Date Sampled:	July 23, 2012			
Building :	Education		Sampler:	Trent Hardy			
Location:	235, room 4004		Analysis:	SAI - PLM			
MUN Project #:	02-02-900		Work Order #:				
Bulk Sampling Parameters							
Pipe/Tank	Flooring		Ceiling	Roofing	Location		
□ Insulation	□12'x12' Tile	□ Textured		□ Shingle	X Floor		
□ Elbow	□ 9'x9'Tile	\Box S	tucco	□ Rolled	□ Wall Orientation		
□ Fitting	X Vinyl Sheet	$\Box P$	opcorn	□ Felt	□ Ceiling		
□ Transite Pipe	□ Mastic	\Box D	WJC	🗆 Tar	□ Above Ceiling		
□ Gasket	Wall	$\Box P$	laster		□ Other		
□ Tank Insulation	□ Transite Panel	$\Box A$	coustic Tile (Dropped)				
□ Pipe Wrap	□ Textured Wall	$\Box A$	coustic Tile (Glued-on)				
HVAC	□ Plaster	$\Box N$	lastic	Miscellaneous:			
□ Insulation	□ DWJC		Structural				
□ Tape		\Box S	teel F. P. ing	No. of Phases:			
□ Paper Wrap			eck F. P. ing	Colour: <u>Light tan VSF with brown</u> specks.

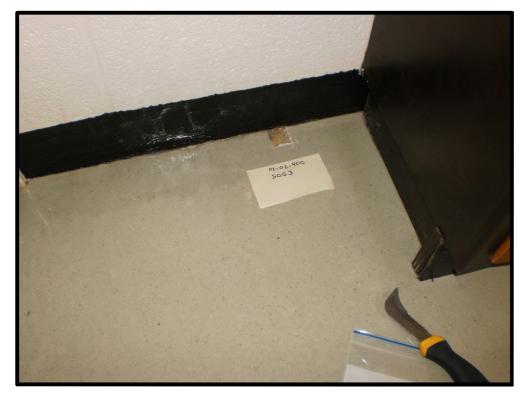
MEMORIA UNIVERSIT		ASB	ESTOS BULK SA	MPLING FO	ORM			
Sample #:	S063		Date Sampled:	July 23, 2012				
Building :	Education		Sampler:	Trent Hardy				
Location:	237, room 4006		Analysis:	SAI - PLM				
MUN Project #:	02-02-900		Work Order #:					
Bulk Sampling Parameters								
Pipe/Tank	Flooring		Ceiling	Roofing	Location			
\Box Insulation	□12'x12' Tile	🗆 T	extured	\Box Shingle	X Floor			
□ Elbow	□ 9'x9'Tile	\Box S	tucco	□ Rolled	□ Wall Orientation			
□ Fitting	X Vinyl Sheet	$\Box P$	opcorn	🗆 Felt	□ Ceiling			
□ Transite Pipe	□ Mastic	DD	WJC	🗆 Tar	□ Above Ceiling			
□ Gasket	Wall	$\Box P$	laster		□ Other			
\Box Tank Insulation	□ Transite Panel	$\Box A$	coustic Tile (Dropped)					
□ Pipe Wrap	□ Textured Wall	$\Box A$	coustic Tile (Glued-on)					
HVAC	□ Plaster	$\Box M$	lastic	Miscellaneous:				
□ Insulation	DWJC		Structural					
□ Tape		\Box S	teel F. P. ing	No. of Phases:				
□ Paper Wrap		DD	eck F. P. ing	Colour: <u>Green</u> specks.	VSF with brown

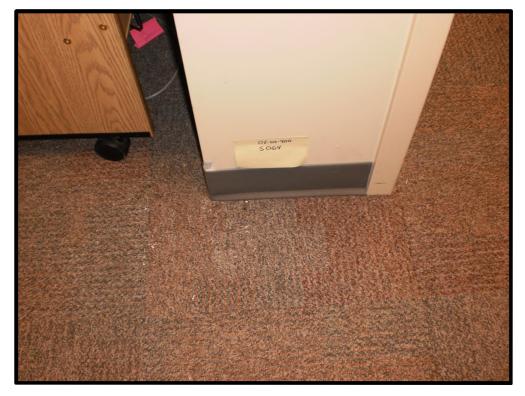
ASBESTOS BULK SAMPLING FORM										
Sample #:	S064	Date Sampled:	July 23, 2012							
Building :	Education	lucation Sampler:		Trent Hardy						
Location:	239, room 4007	Analysis:	SAI - PLM							
MUN Project #:	02-02-900	Work Order #:								
Bulk Sampling Parameters										
Pipe/Tank	Flooring	Ceiling	Roofing	Location						
□ Insulation	□12'x12' Tile	□ Textured	□ Shingle	□ Floor						
□ Elbow	□ 9'x9'Tile	□ Stucco	□ Rolled	X Wall Orientation						
□ Fitting	□ Vinlye Sheet	□ Popcorn	🗆 Felt	□ Ceiling						
□ Transite Pipe	□ Mastic	□ DWJC	🗆 Tar	□ Above Ceiling						
□ Gasket	Wall	□ Plaster		□ Other						
□ Tank Insulation	□ Transite Panel	□ Acoustic Tile (Dropped)								
□ Pipe Wrap	□ Textured Wall	□ Acoustic Tile (Glued-on)								
HVAC	□ Plaster	□ Mastic	Miscellaneous:							
□ Insulation	X DWJC	Structural								
□ Tape		□ Steel F. P. ing	No. of Phases:							
□ Paper Wrap		Deck F. P. ing	Colour:

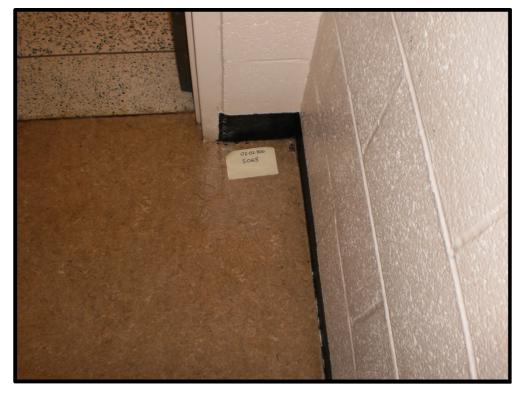
ASBESTOS BULK SAMPLING FORM									
Sample #:	S065		Date Sampled:	July 23, 2012					
Building :	Education		Sampler:	Trent Hardy					
Location:	240, room 4008		Analysis:	SAI - PLM					
MUN Project #:	02-02-900		Work Order #:						
Bulk Sampling Parameters									
Pipe/Tank	Flooring		Ceiling	Roofing	Location				
□ Insulation	□12'x12' Tile			□ Shingle	X Floor				
□ Elbow	□ 9'x9'Tile	□ Stucco		□ Rolled	□ Wall Orientation				
□ Fitting	X Vinyl Sheet	□ Popcorn		□ Felt	□ Ceiling				
□ Transite Pipe	□ Mastic	□ DWJC		🗖 Tar	□ Above Ceiling				
□ Gasket	Wall	$\square P$	laster		□ Other				
\Box Tank Insulation	□ Transite Panel	$\Box A$	coustic Tile (Dropped)						
□ Pipe Wrap	□ Textured Wall	$\Box A$	coustic Tile (Glued-on)						
HVAC	□ Plaster	□ Mastic		Miscellaneous:					
□ Insulation	DWJC		Structural						
□ Tape		\Box St	teel F. P. ing	No. of Phases:					
D Paper Wrap		Deck F. P. ing		Colour: Brown stone pattern VSF.

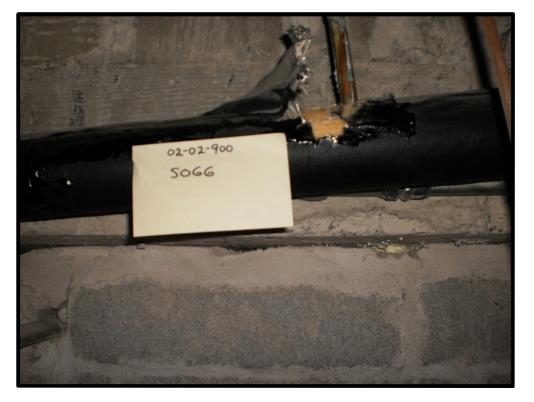
ASBESTOS BULK SAMPLING FORM										
Sample #:	S066		Date Sampled:	July 23, 2012						
Building :	Education		Sampler:	Trent Hardy						
Location:	256, room 4013		Analysis:	SAI - PLM						
MUN Project #:	02-02-900		Work Order #:							
	Bulk Sampling Parameters									
Pipe/Tank	Flooring		Ceiling	Roofing	Location					
□ Insulation	□12'x12' Tile	□ Textured		□ Shingle	□ Floor					
\Box Elbow	□ 9'x9'Tile	□ Stucco		\Box Rolled	□ Wall Orientation					
□ Fitting	□ Vinlye Sheet	□ Popcorn		🗆 Felt	□ Ceiling					
□ Transite Pipe	□ Mastic	□ DŴJC		🗆 Tar	X Above Ceiling					
□ Gasket	Wall	□ Plaster			X Other					
□ Tank Insulation	□ Transite Panel	$\Box A$	coustic Tile (Dropped)							
□ Pipe Wrap	□ Textured Wall	$\Box A$	coustic Tile (Glued-on)							
HVAC	□ Plaster			Miscellaneous: Tar Mastic						
□ Insulation	DWJC		Structural							
□ Tape		□ Steel F. P. ing		No. of Phases:						
D Paper Wrap		\Box D	eck F. P. ing	Colour:

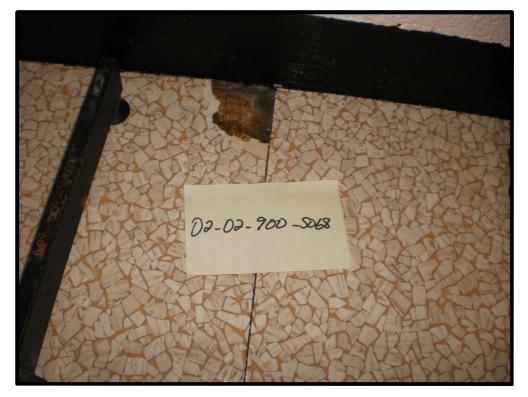
MEMORIA UNIVERSIT		ASBESTOS	S BULK SA	MPLING FO	ORM			
Sample #:	S068	Date Sar	npled:	July 24, 2012				
Building :	Education	Sampler	•	Erika Ryan				
Location:	262, room 5002	Analysis	•	SAI - PLM				
MUN Project #:	02-02-900	2-900 Work Order #:						
Bulk Sampling Parameters								
Pipe/Tank	Flooring	Ceiling		Roofing	Location			
□ Insulation	□12'x12' Tile	□ Textured		□ Shingle	X Floor			
\Box Elbow	□ 9'x9'Tile	□ Stucco		□ Rolled	□ Wall Orientation			
□ Fitting	X Vinlye Sheet	Popcorn		□ Felt	□ Ceiling			
□ Transite Pipe	□ Mastic	□ DWJC		🗆 Tar	□ Above Ceiling			
□ Gasket	Wall	□ Plaster			□ Other			
\Box Tank Insulation	□ Transite Panel	🗆 Acoustic Ti	le (Dropped)					
□ Pipe Wrap	□ Textured Wall	🗆 Acoustic Ti	le (Glued-on)					
HVAC	□ Plaster	□ Mastic	,	Miscellaneous:				
□ Insulation	DWJC	Stru	ctural					
□ Tape		🗆 Steel F. P. i	ng	No. of Phases:				
D Paper Wrap		🗆 Deck F. P. i	ng	Colour: Marble	e stone pattern VSF.

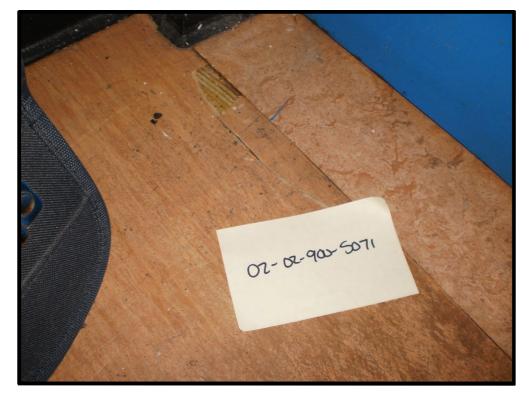
MEMORIA UNIVERSIT		ASB	ESTOS BULK SA	MPLING FO	ORM			
Sample #:	S071		Date Sampled:	July 24, 2012				
Building :	Education		Sampler:	Erika Ryan				
Location:	275, room 5008		Analysis:	SAI - PLM				
MUN Project #:	02-02-900	2-02-900 Work Order #:						
Bulk Sampling Parameters								
Pipe/Tank	Flooring	Ceiling		Roofing	Location			
□ Insulation	□12'x12' Tile	ΠT	extured	□ Shingle	X Floor			
□ Elbow	□ 9'x9'Tile	\Box S	tucco	□ Rolled	□ Wall Orientation			
□ Fitting	X Vinlye Sheet	$\Box P$	opcorn	🗆 Felt	□ Ceiling			
□ Transite Pipe	□ Mastic	$\Box D$	WJC	🗆 Tar	□ Above Ceiling			
□ Gasket	Wall	$\Box P$	laster		□ Other			
□ Tank Insulation	□ Transite Panel	$\Box A$	coustic Tile (Dropped)					
□ Pipe Wrap	□ Textured Wall	$\Box A$	coustic Tile (Glued-on)					
HVAC	□ Plaster	$\Box N$	lastic	Miscellaneous:				
□ Insulation	DWJC		Structural					
□ Tape		\Box S	teel F. P. ing	No. of Phases:				
D Paper Wrap		\Box D	eck F. P. ing	Colour: Pink w	vith red streaks.

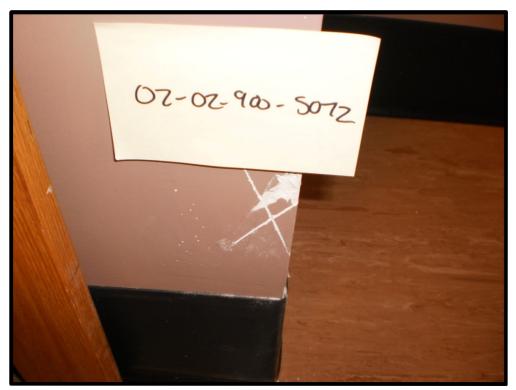
MEMORIA UNIVERSIT		ASB	ESTOS BULK SA	MPLING FO	ORM			
Sample #:	S072		Date Sampled:	July 24, 2012				
Building :	Education		Sampler:	Erika Ryan				
Location:	277, room 5010		Analysis:	SAI - PLM				
MUN Project #:	02-02-900	-02-900 Work Order #:						
Bulk Sampling Parameters								
Pipe/Tank	Flooring		Ceiling	Roofing	Location			
□ Insulation	□12'x12' Tile	ΠT	extured	\Box Shingle	□ Floor			
\Box Elbow	□ 9'x9'Tile	\Box St	tucco	□ Rolled	X Wall Orientation			
□ Fitting	□ Vinlye Sheet	$\Box P$	opcorn	🗆 Felt	□ Ceiling			
□ Transite Pipe	□ Mastic	\Box D	WJC	🗆 Tar	□ Above Ceiling			
□ Gasket	Wall	$\square P$	laster		□ Other			
□ Tank Insulation	□ Transite Panel	$\Box A$	coustic Tile (Dropped)					
□ Pipe Wrap	□ Textured Wall	$\Box A$	coustic Tile (Glued-on)					
HVAC	□ Plaster	$\Box M$	lastic	Miscellaneous:				
□ Insulation	X DWJC		Structural					
□ Tape		\Box St	teel F. P. ing	No. of Phases:				
D Paper Wrap		\Box D	eck F. P. ing	Colour:

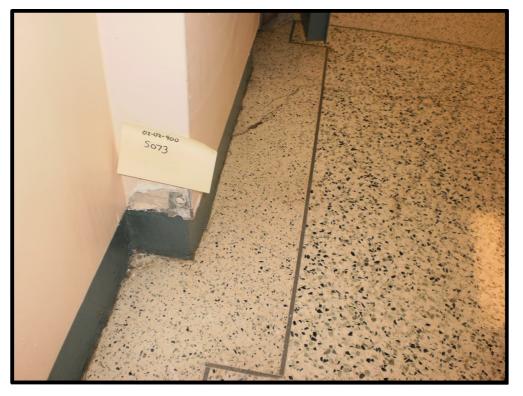
MEMORIA UNIVERSIT		ASB	ESTOS BULK SA	MPLING FO	ORM			
Sample #:	S073		Date Sampled:	July 25, 2012				
Building :	Education		Sampler:	Trent Hardy				
Location:	291, stairwell 5C02	2	Analysis:	SAI - PLM				
MUN Project #:	02-02-900	-02-900 Work Order #:						
Bulk Sampling Parameters								
Pipe/Tank	Flooring		Ceiling	Roofing	Location			
□ Insulation	□12'x12' Tile	ΠT	extured	□ Shingle	□ Floor			
□ Elbow	□ 9'x9'Tile	\Box S	tucco	□ Rolled	X Wall Orientation			
□ Fitting	□ Vinlye Sheet	$\Box P$	opcorn	🗆 Felt	□ Ceiling			
□ Transite Pipe	□ Mastic	\Box D	WJC	🗆 Tar	□ Above Ceiling			
□ Gasket	Wall	$\Box P$	laster		□ Other			
\Box Tank Insulation	□ Transite Panel	$\Box A$	coustic Tile (Dropped)					
□ Pipe Wrap	□ Textured Wall	$\Box A$	coustic Tile (Glued-on)					
HVAC	X Plaster	$\Box N$	lastic	Miscellaneous:				
□ Insulation	□ DWJC		Structural					
□ Tape		\Box S	teel F. P. ing	No. of Phases:				
D Paper Wrap		\Box D	eck F. P. ing	Colour:

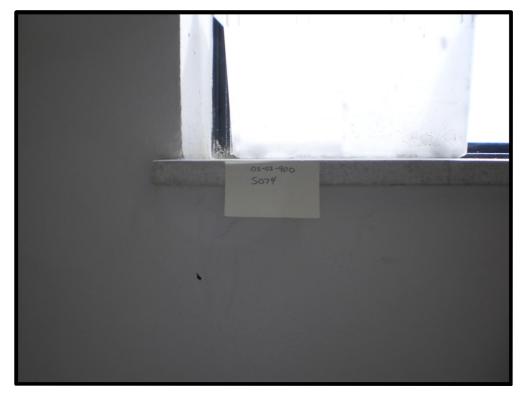
MEMORIA UNIVERSIT		ASB	ESTOS BULK SA	MPLING FO	ORM			
Sample #:	S074		Date Sampled:	July 25, 2012				
Building :	Education		Sampler:	Trent Hardy				
Location:	291, stairwell 5S02		Analysis:	SAI - PLM				
MUN Project #:	02-02-900	2-02-900 Work Order #:						
Bulk Sampling Parameters								
Pipe/Tank	Flooring	Ceiling		Roofing	Location			
□ Insulation	□12'x12' Tile	ΠT	extured	□ Shingle	□ Floor			
\Box Elbow	□ 9'x9'Tile	\Box S	tucco	□ Rolled	□ Wall Orientation			
□ Fitting	□ Vinlye Sheet	$\Box P$	opcorn	🗆 Felt	X Ceiling			
□ Transite Pipe	□ Mastic	\Box D	OWJC	🗆 Tar	□ Above Ceiling			
□ Gasket	Wall	$\Box P$	laster		□ Other			
\Box Tank Insulation	□ Transite Panel	$\Box A$	coustic Tile (Dropped)					
□ Pipe Wrap	□ Textured Wall	$\Box A$	coustic Tile (Glued-on)					
HVAC	X Plaster	$\Box N$	lastic	Miscellaneous:				
□ Insulation	□ DWJC		Structural					
□ Tape		\Box S	teel F. P. ing	No. of Phases:				
□ Paper Wrap		\Box D	Deck F. P. ing	Colour:

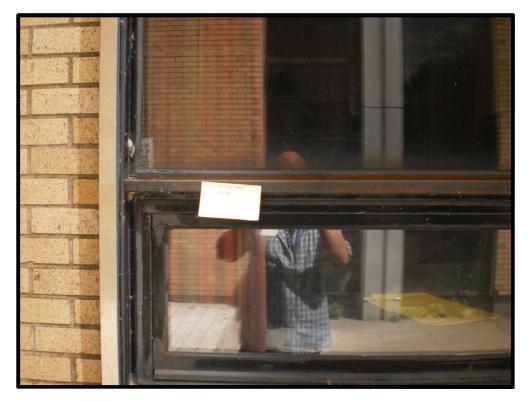
UNIVERSIT	Y						
Sample #:	S078		Date Sampled:	July 25, 2012			
Building :	Education		Sampler:	Trent Hardy			
Location:	313, exterior of bld	g	Analysis:	SAI - PLM			
MUN Project #:	02-02-900		Work Order #:				
Bulk Sampling Parameters							
Pipe/Tank	Flooring		Ceiling	Roofing	Location		
□ Insulation	□12'x12' Tile	□ Textured		□ Shingle	□ Floor		
□ Elbow	□ 9'x9'Tile	□ Stucco		□ Rolled	□ Wall Orientation		
□ Fitting	□ Vinlye Sheet	□ Popcorn		🗆 Felt	□ Ceiling		
□ Transite Pipe	□ Mastic	\Box D	OWJC	🗆 Tar	□ Above Ceiling		
□ Gasket	Wall	□ Plaster			X Other (exterior)		
□ Tank Insulation	□ Transite Panel	$\Box A$	coustic Tile (Dropped)				
□ Pipe Wrap	□ Textured Wall	$\Box A$	coustic Tile (Glued-on)				
HVAC	□ Plaster	$\Box N$	Iastic	Miscellaneous:	Window caulking		
\Box Insulation	□ DWJC		Structural				
□ Tape		\Box S	teel F. P. ing	No. of Phases:			
□ Paper Wrap		\Box D	Deck F. P. ing	Colour:
